Performance and durability of photovoltaic backsheets and comparison to outdoor performance

William Gambogi

DuPont Photovoltaic Solutions, Wilmington, DE, 19803

Atlas NIST Workshop on PV Materials Durability,
Gaithersburg, MD

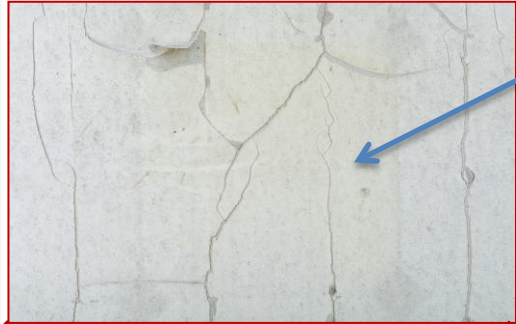
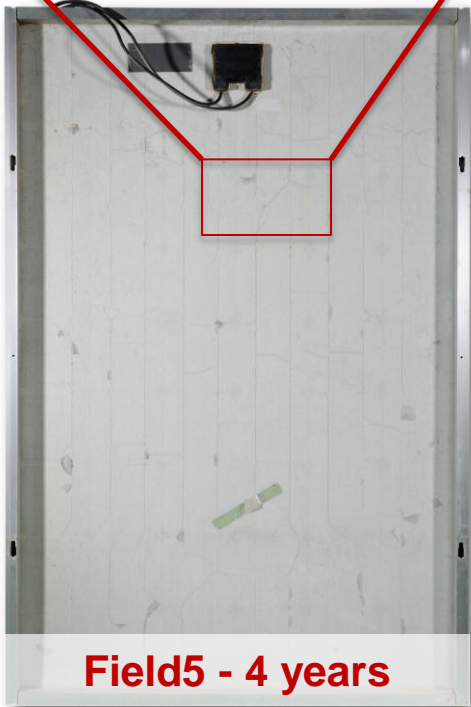
Spain

Module Failures due to UV Exposure: Polyester Yellowing and/or Cracking on Junction Box Side

Field5 - 4 years

Cracking &
Yellowing

Yellowing

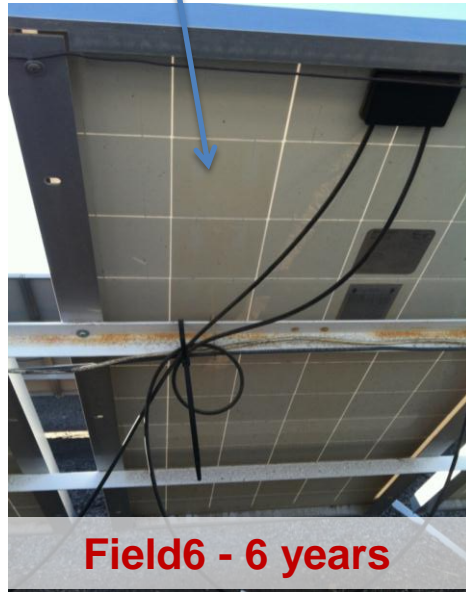
Arizona, USA

Field6 - 6 years

Failures from UV damage observed in the field early in expected module lifetime

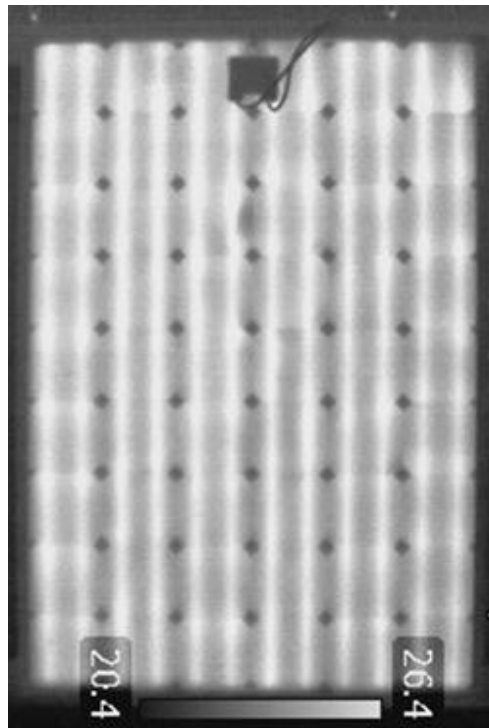
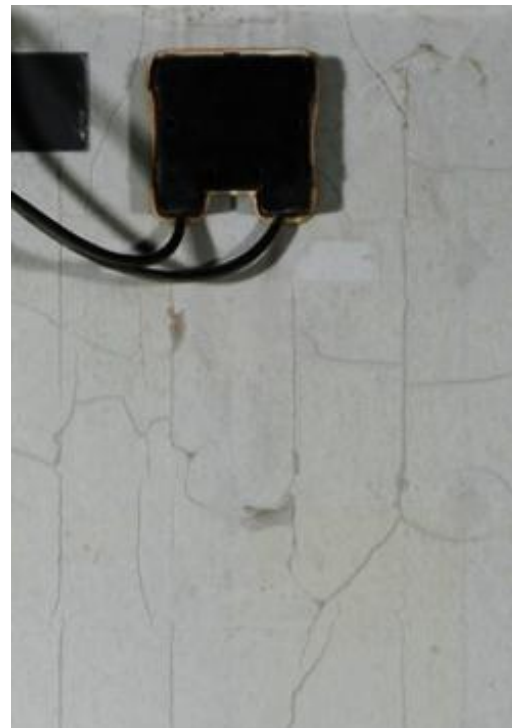
Cracking on the outer polyester layer of backsheet

- Modules were removed from a commercial MW plant after 5 years for cracking and delamination on the backsheet along the rear tabbing ribbons and 9% loss of power.
- The IR analysis identified outer layer as polyester.
- Thermal image shows localized heating at cell contacts.

Cracking of the backsheet is likely due to indirect UV exposure. Backsheet testing to reflected light from albedo can identify instability in the outdoor environment.

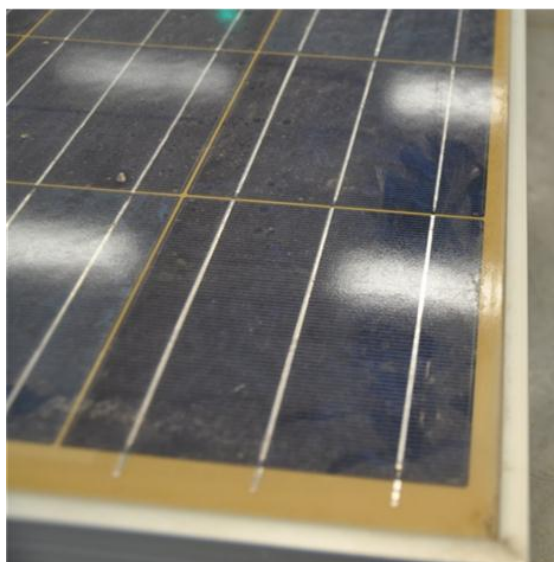
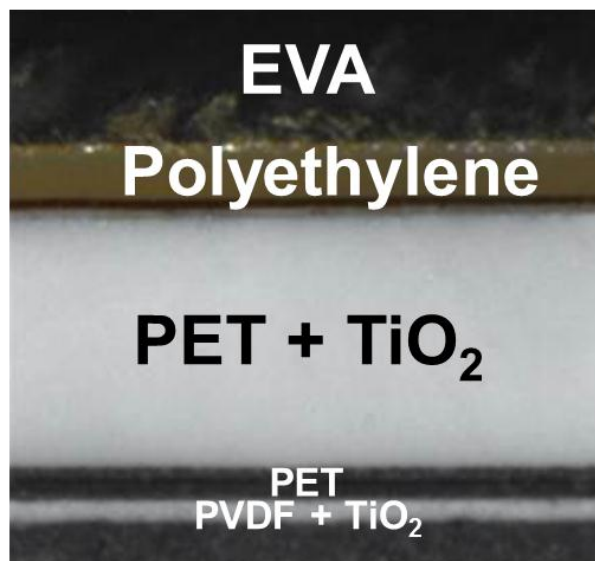
Discoloration in the inner layer of a PV module backsheet

- Modules removed from a commercial MW power plant after 2 years for severe yellowing and loss of ~4% power.
- Destructive analysis determined yellowing of inner polyethylene layer and associated adhesive layers in the PVDF/PET/PET/PE backsheet structure.
- UV absorbance of the EVA lower than expected resulting in higher UV exposure of the inner layer of the backsheet

Testing of the stability of the inner layer to UV exposure would have identified the instability and avoided damage

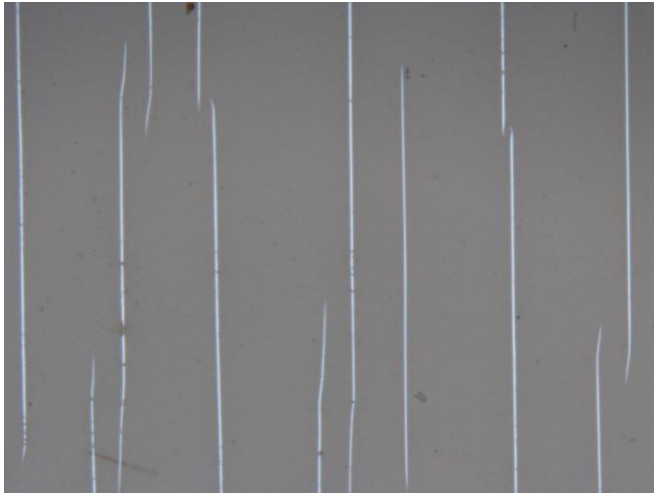
Xenon-Water Spray Weathering of Backsheets*

Cracking of inner tie layer in PET backsheet after 1500h outer layer exposure. Xenon exposure only, cracking seen at 5000 hours

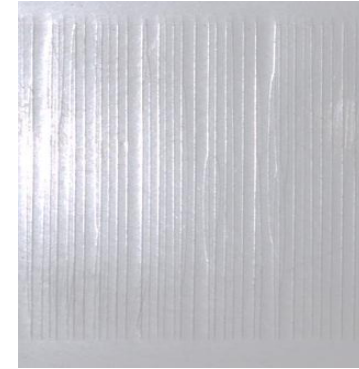
HPET1 inner tie layer cracking after 5000 hour air side xenon exposure

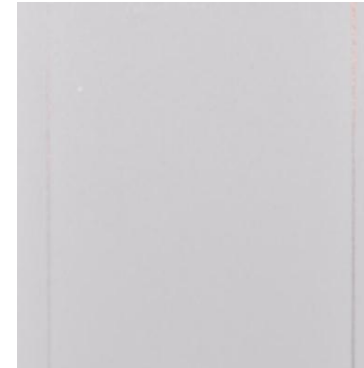
TPT™- E side - no cracking after 5000 hour air side xenon exposure

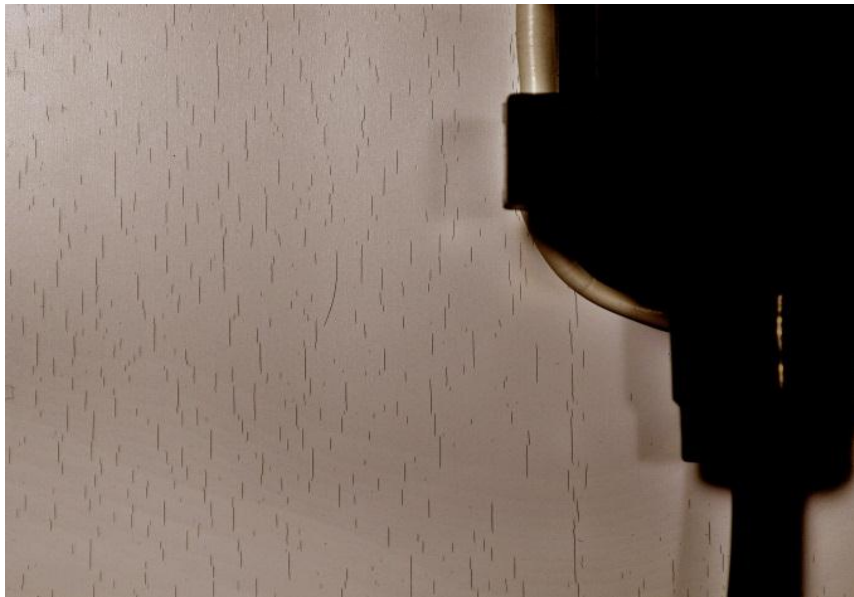
Sequential Stress #1: DH1000/UVA1000/TC200

Cracking of a single-sided PVDF backsheet after sequential exposure to damp heat, UV and thermal cycling (contrast increased to highlight cracking)

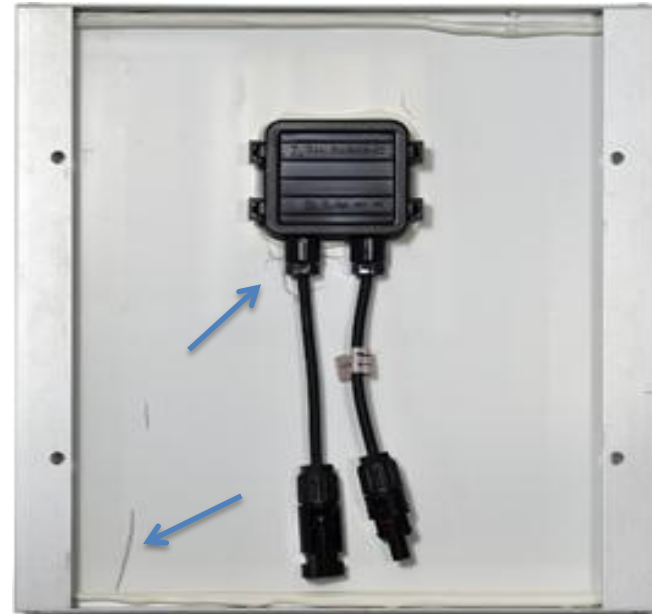
Sequential Stress #2: 2x(DH1000/TC200)

Cracking of a single-sided PVDF backsheet after sequential exposure to damp heat and thermal cycling
