“What’s going on Inside Today’s Fuel Storage Tank?”

Lorri Grainawi
Director of Technical Services
STI/SPFA
Lake Zurich, IL
July 22, 2013

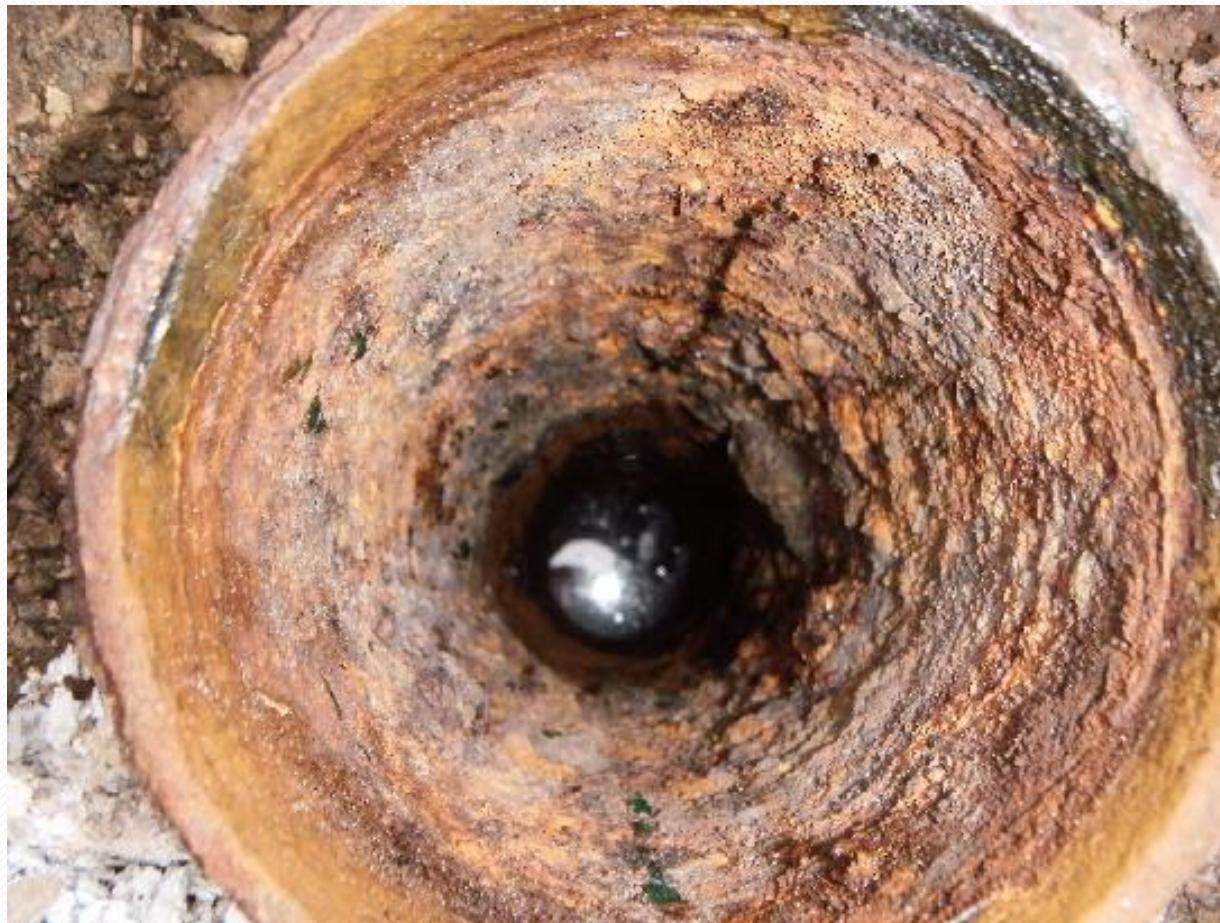
FRP tank riser NW area

Acetate 462 ppm

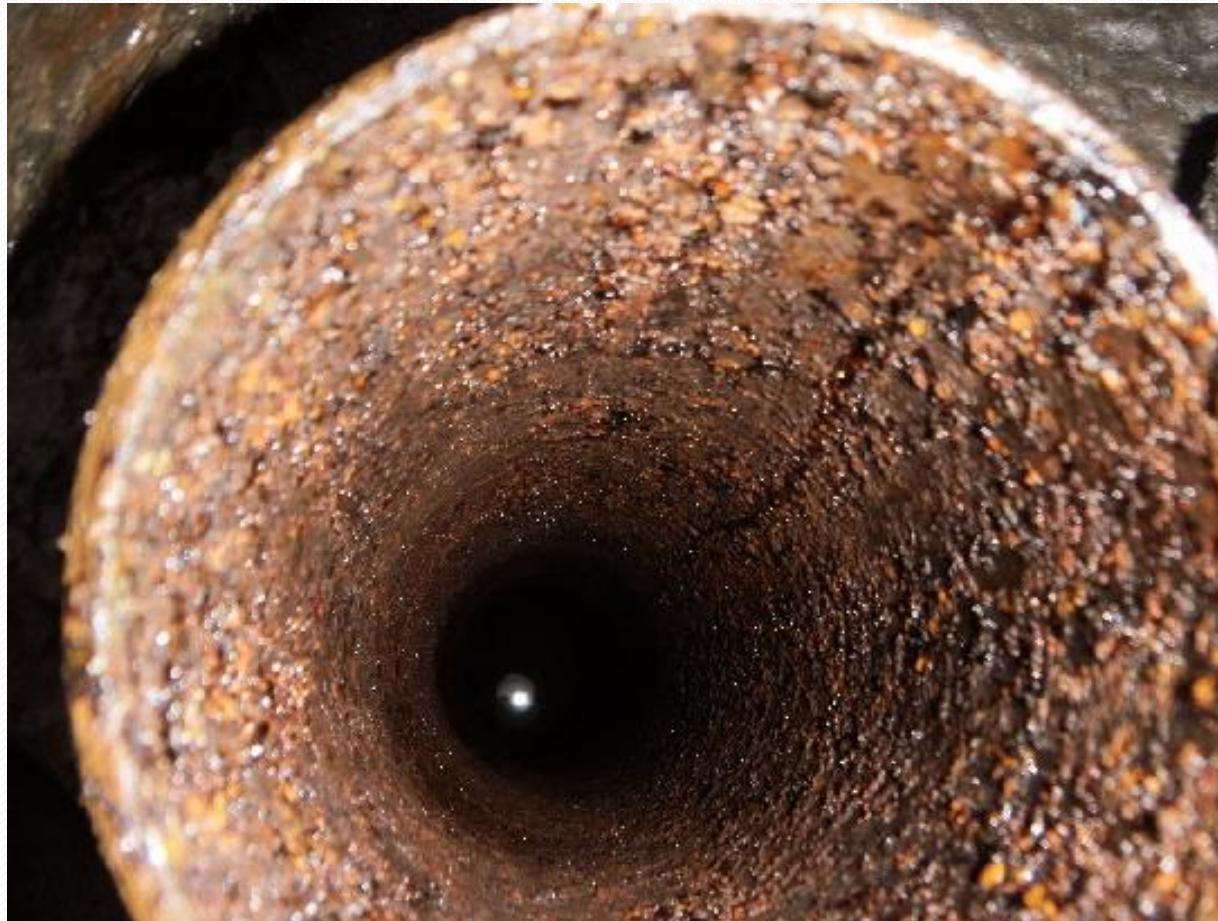
Steel Tank riser, NW area

Acetate 108 ppm

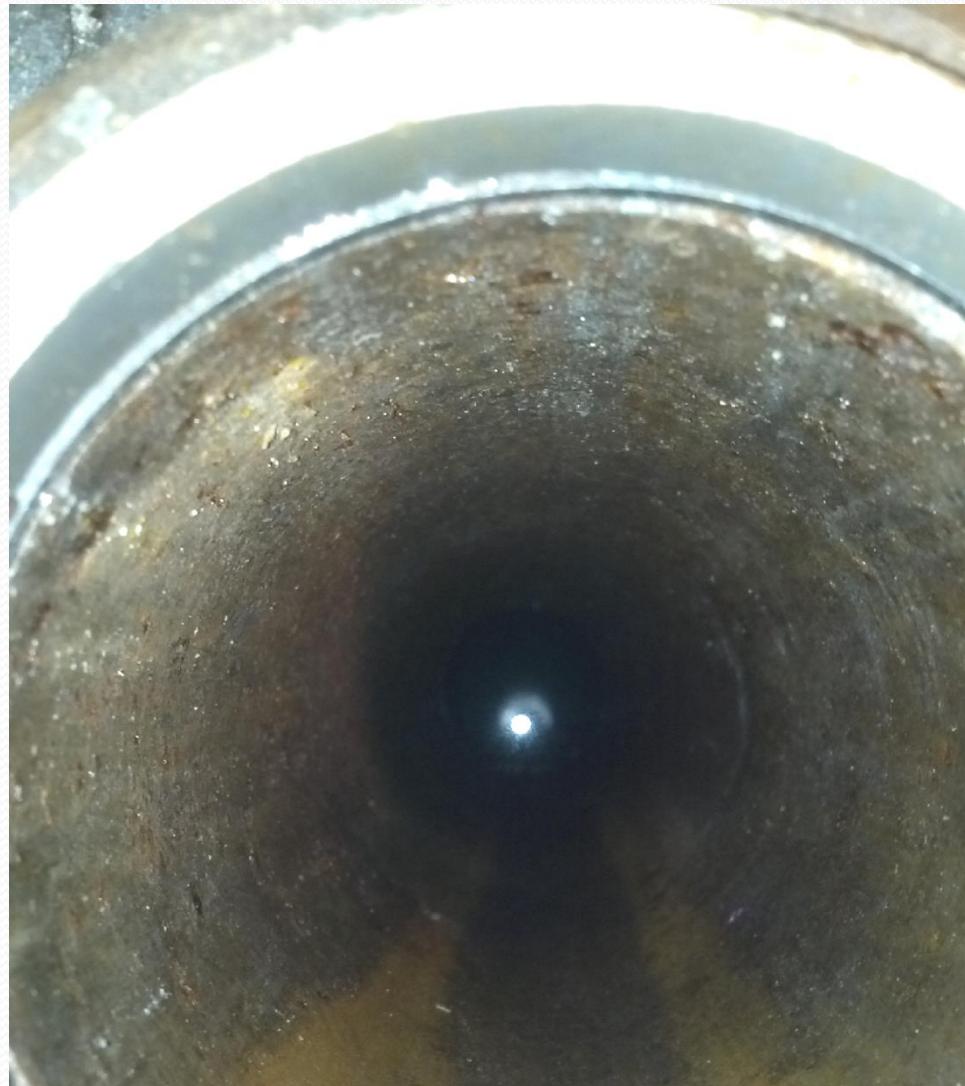
FRP riser, MA area

Acetate 25,600 ppm

- Hypothesis that high acetate would indicate high corrosion
- Photos of risers don't indicate this
- Next step is to place cameras inside tanks at 3 locations
- Analysis to be done by end of July

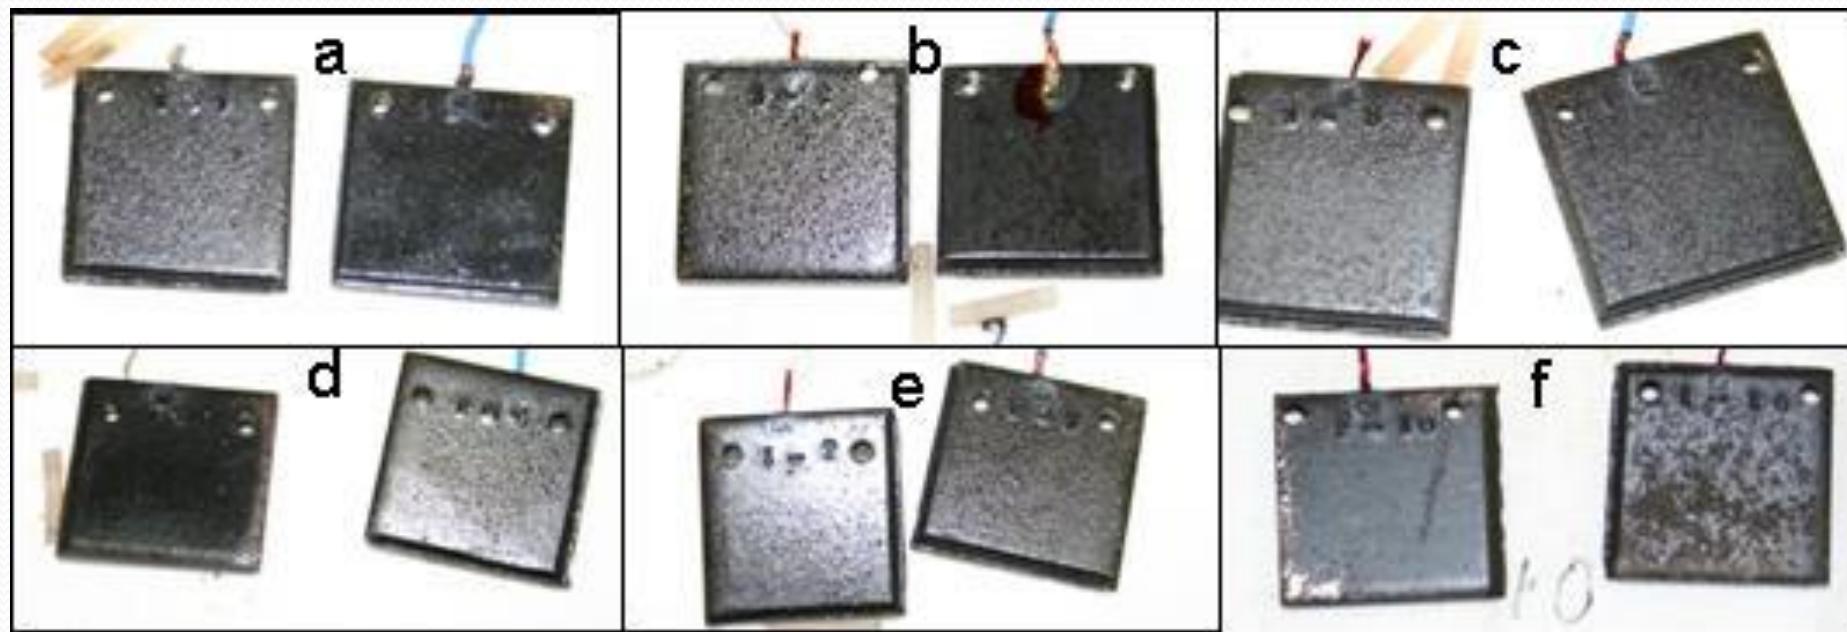
- Upon visual inspection of the test coupons, a small amount of surface rusting was observed

Figure 4. Photographs of carbon steel specimens exposed to ULSD and soy-based biodiesel blends with and without the presence of water: (a) 100 % biodiesel, no water added; (b) 50 % biodiesel + 50 %ULSD, no water added; (c) 100 % petrodiesel, no water added; (d) 100 % biodiesel, 1 vol% water added; (e) 50% biodiesel + 50 %ULSD, 1 vol% water added and (f) 100 % ULSD, 1 vol% water added. Exposure time: 2 months.

- In most cases, the amount of surface rusting was slightly higher in 100 % ULSD than in biodiesel or biodiesel + ULSD blends.
- This surface rusting was caused by a reaction between the surface oxide layer of the metal and the fuel blend.

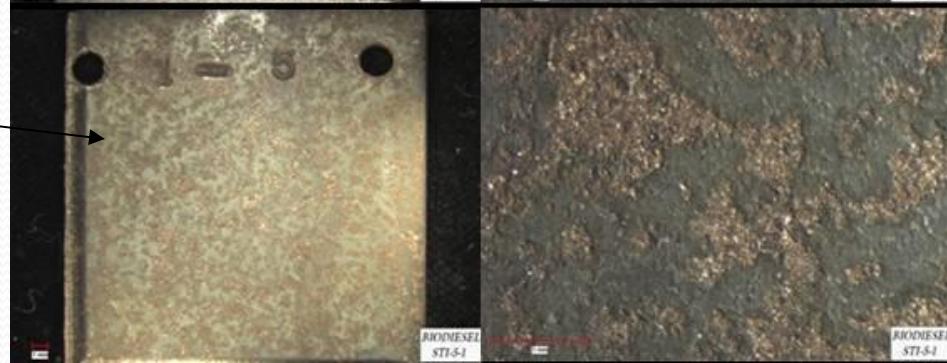
100% ULSD
No water added
to any fuel

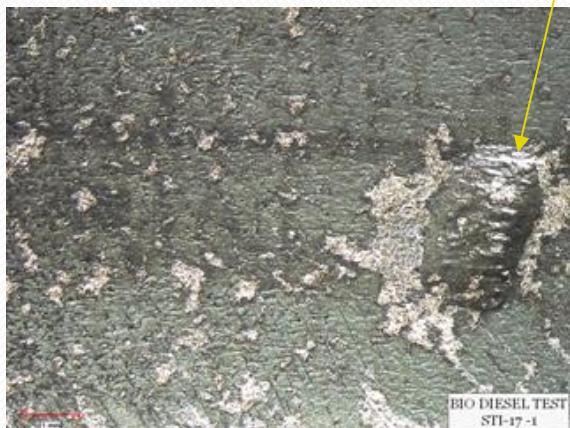
toolmark

100 % animal-based biodiesel, no water added

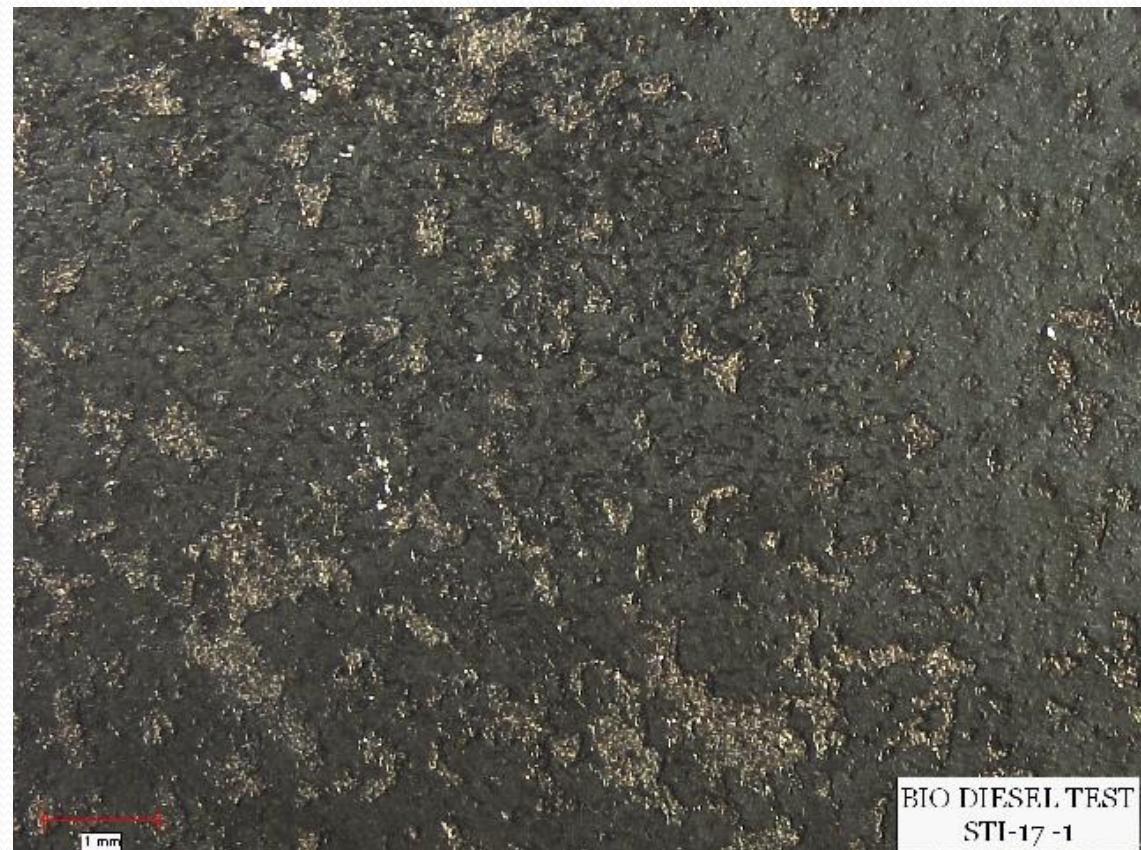
Sample 25

- Greatest weight loss occurred with 5% animal based biodiesel/ ULSD/ 1% water
- Optical examination indicated no measurable pits on this sample
- Corrosion rate calculated at 0.09 mm/yr (.00354 in/yr)
- Equates to Excellent Corrosion Resistance rating
