Technical Study of the Sofa Super Store Fire - South Carolina, June 18, 2007

Draft for Public Comments

*Fire Research Division
Engineering Laboratory
National Institute of Standards and Technology*

October 2010

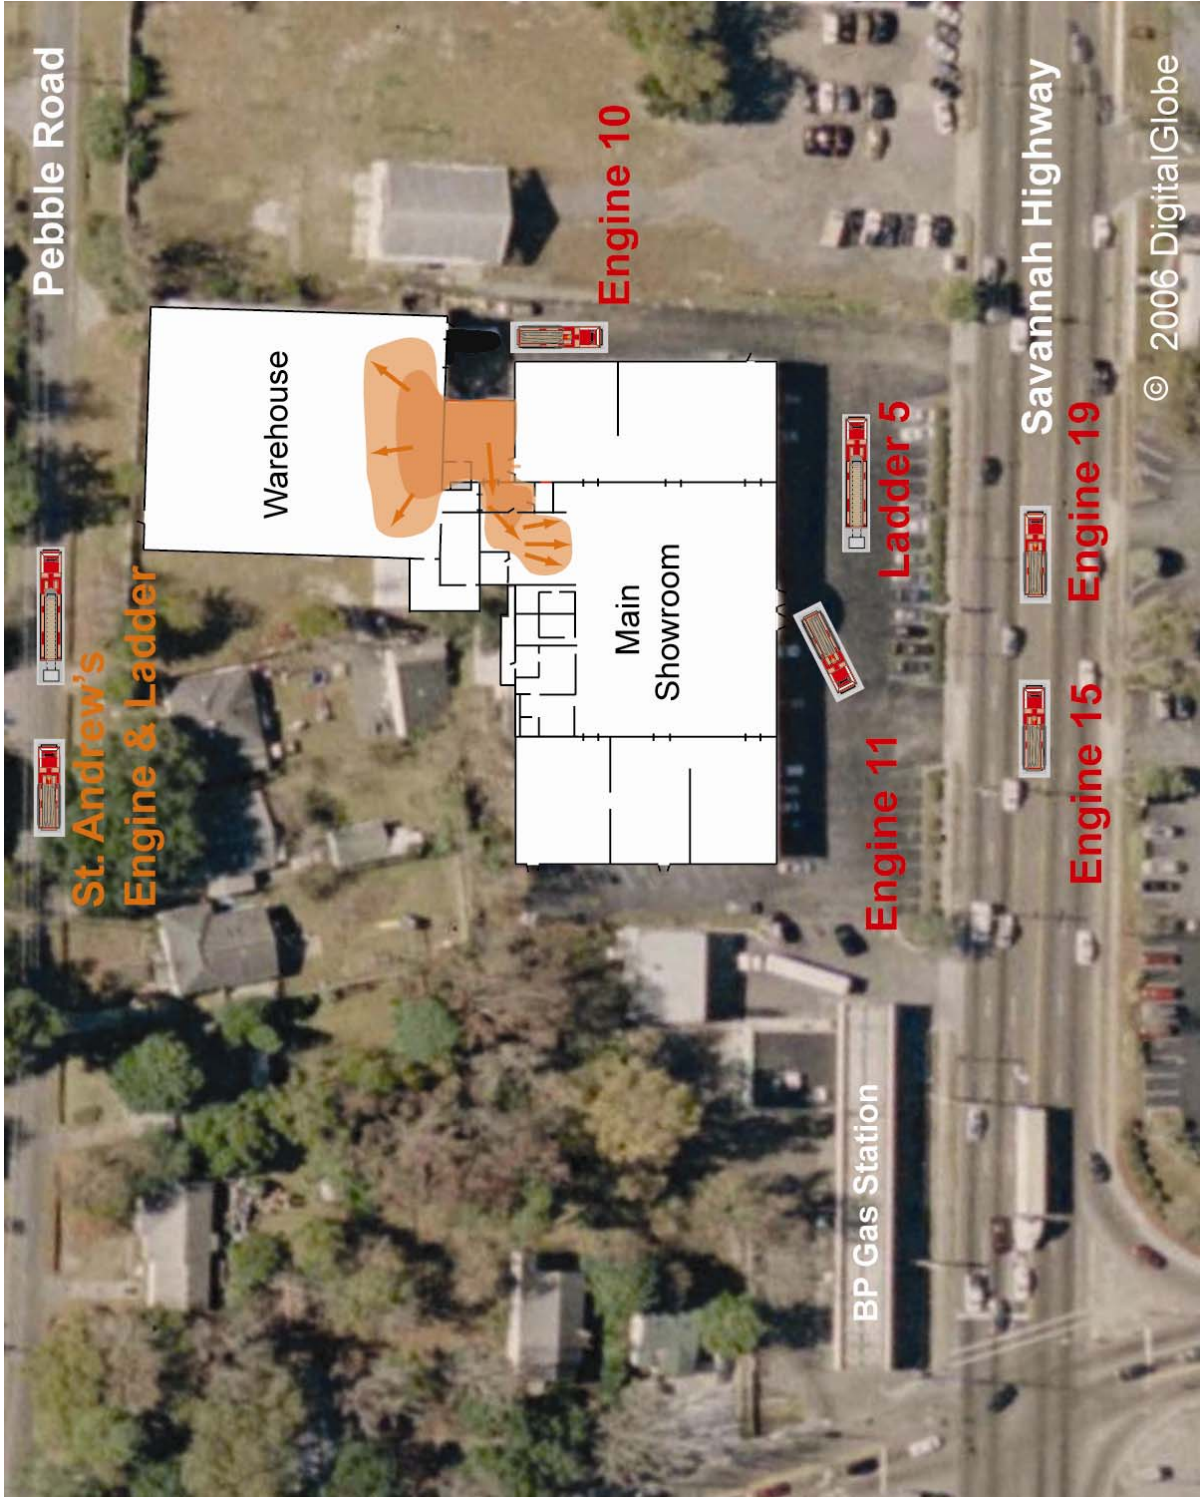
Figure 2-7. Fire was beginning to spread into the rear of the main showroom through the holding area and through the shared metal wall of the warehouse. This was estimated to occur at about 7:31 p.m. Background image used with permission of DigitalGlobe. Enhancements by NIST.

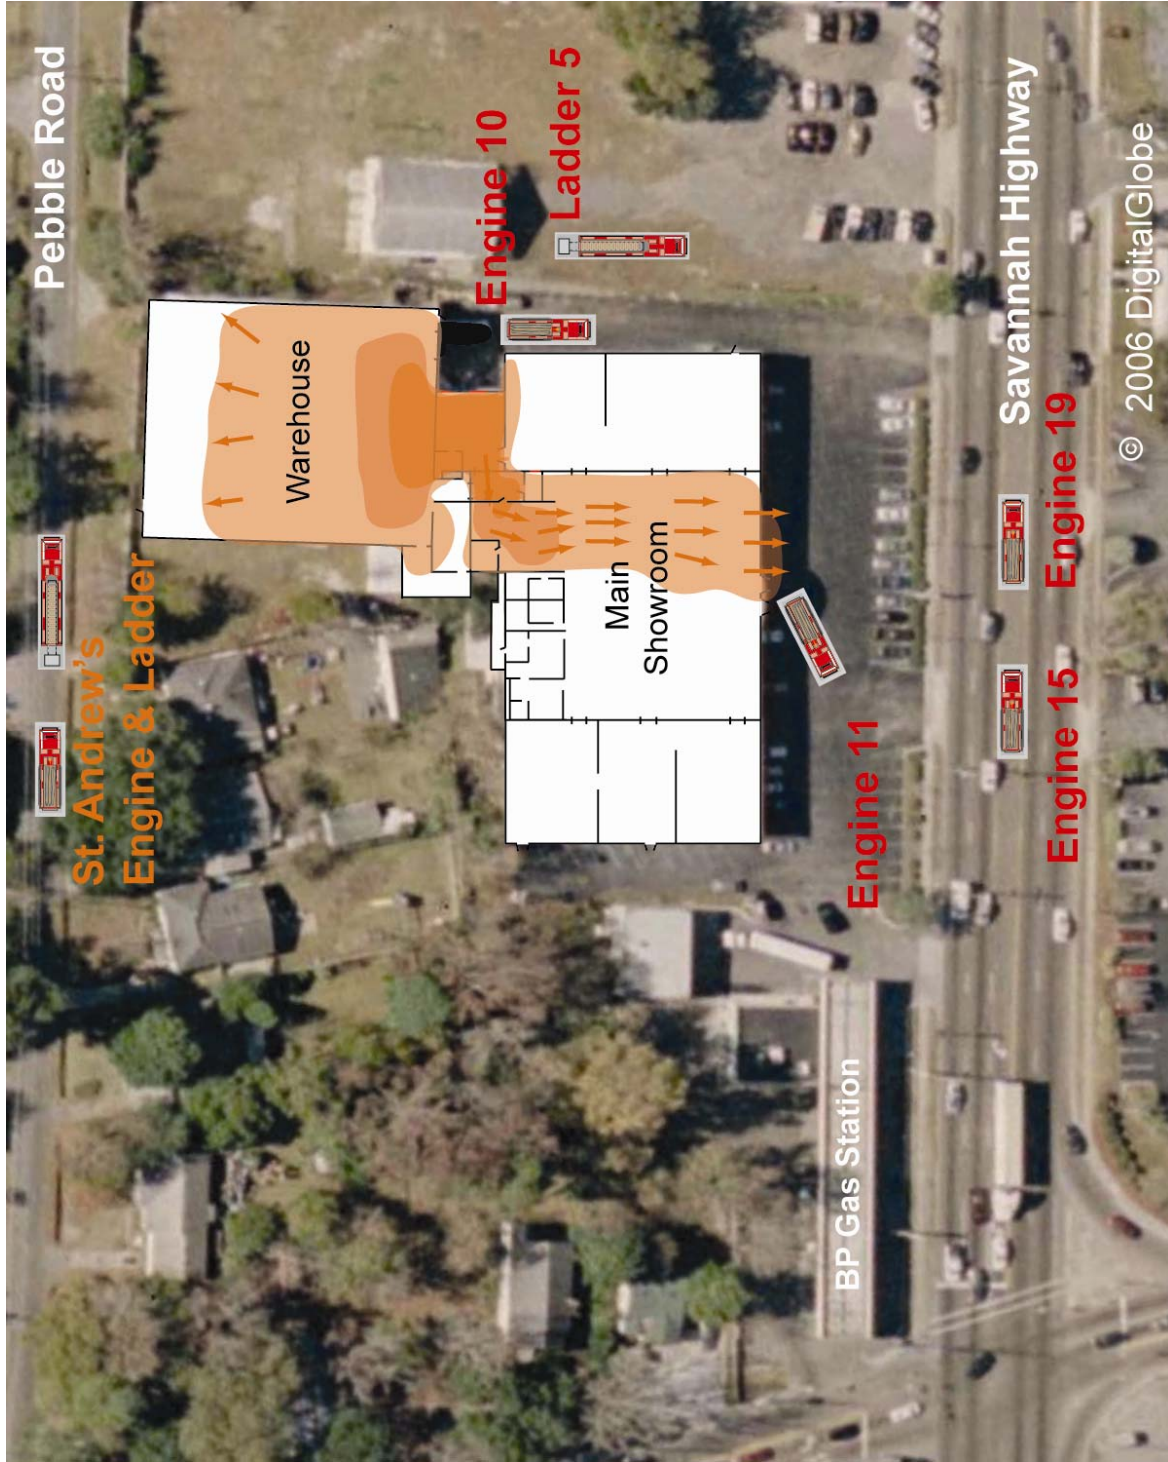
Figure 2-8. Fire spread rapidly from rear of main showroom to the front of the main showroom. Fire continued to spread towards rear of warehouse. This occurred by about 7:36 p.m. Background image used with permission of DigitalGlobe. Enhancements by NIST.

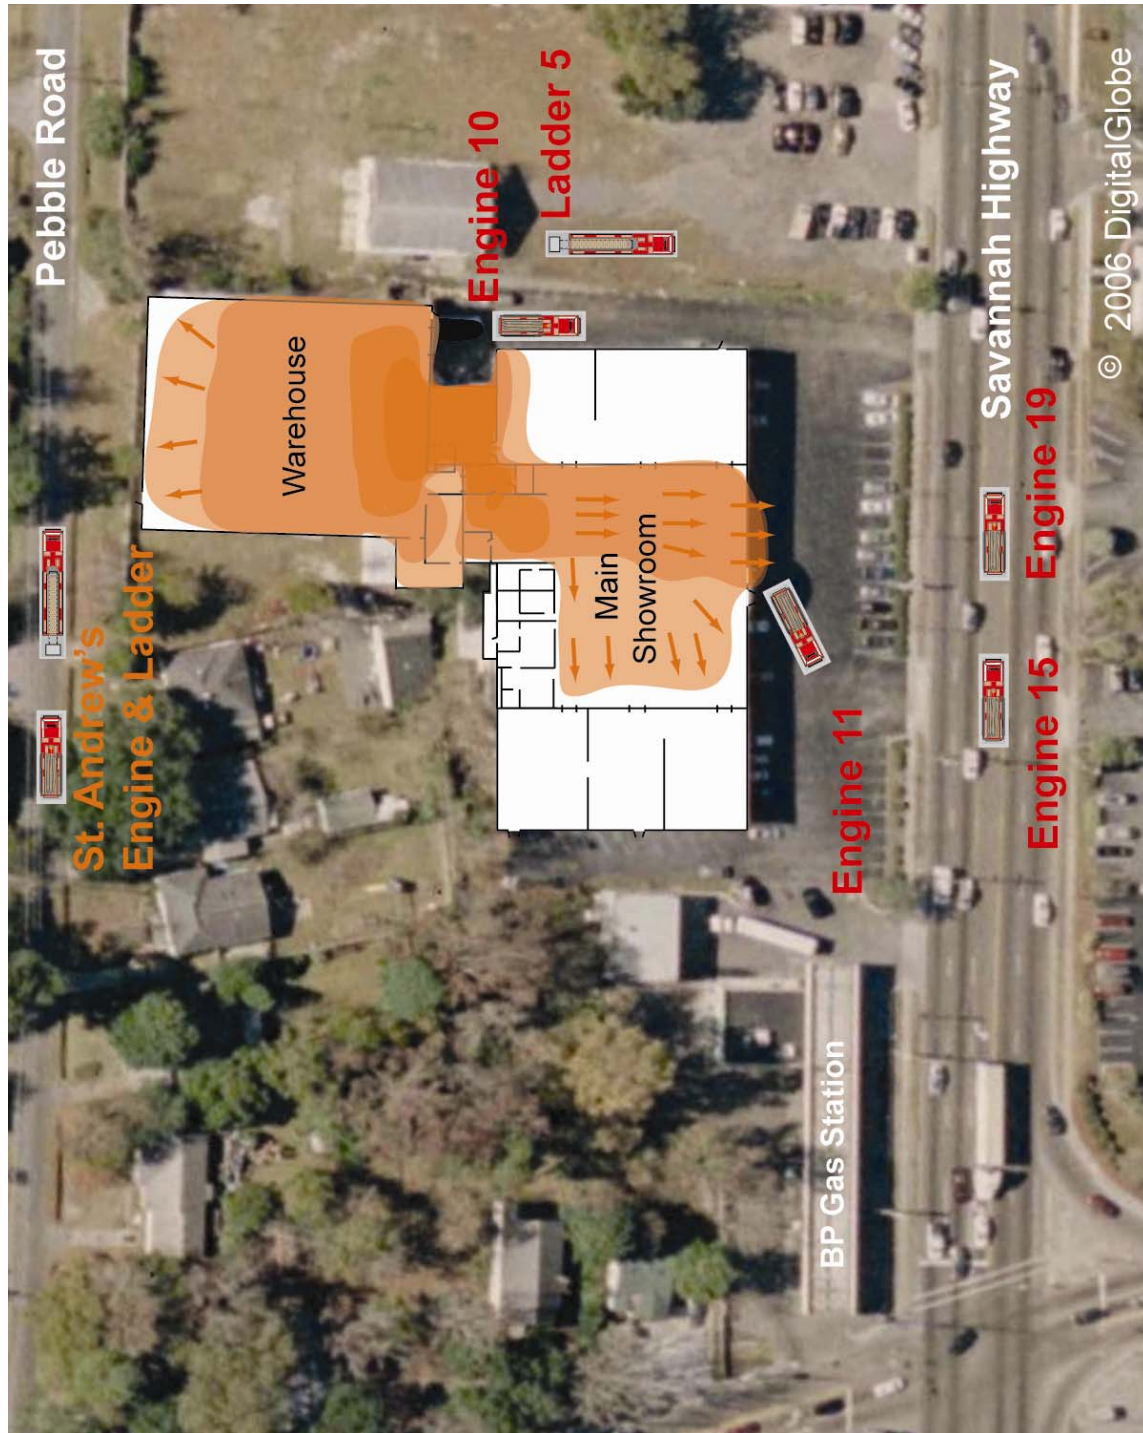
Figure 2-9. Fire spreading to east side of main showroom. This occurred by about 7:37 p.m. Background image used with permission of DigitalGlobe. Enhancements by NIST.

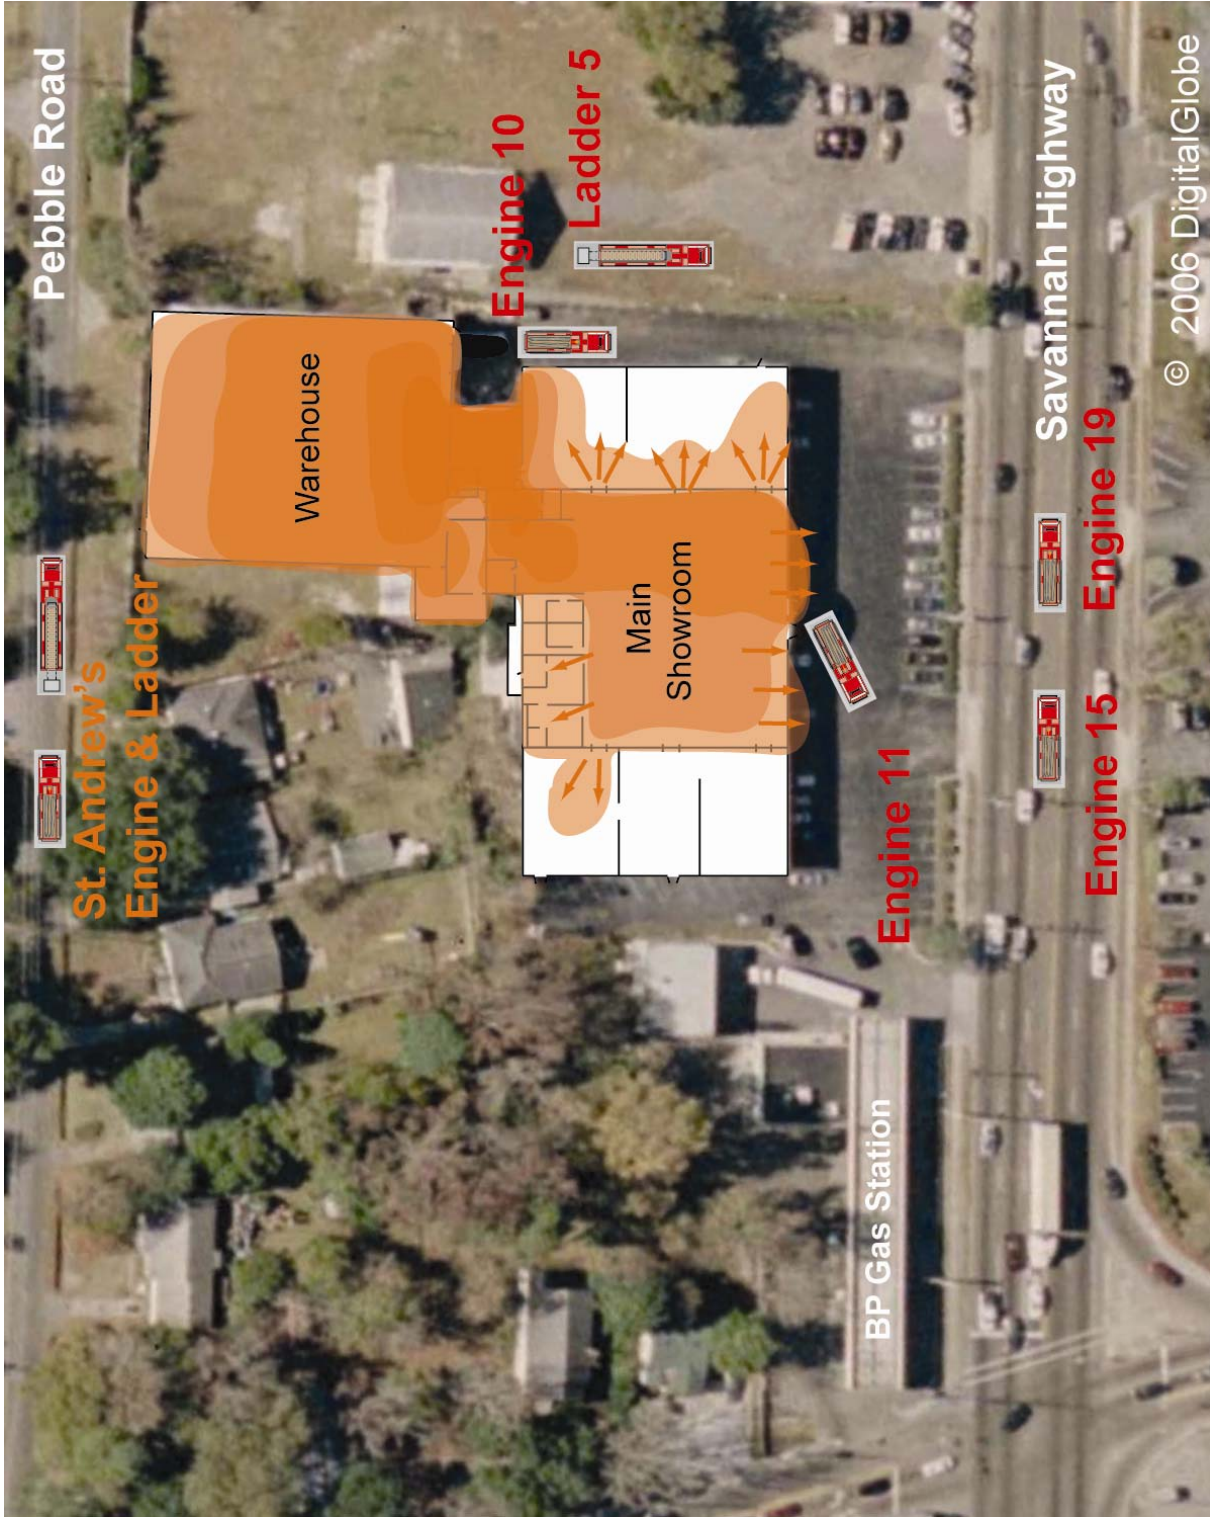
Figure 2-10. Fire spreading to west showroom and the rear of east showroom. This occurred by about 7:38 p.m. Background image used with permission of DigitalGlobe. Enhancements by NIST.

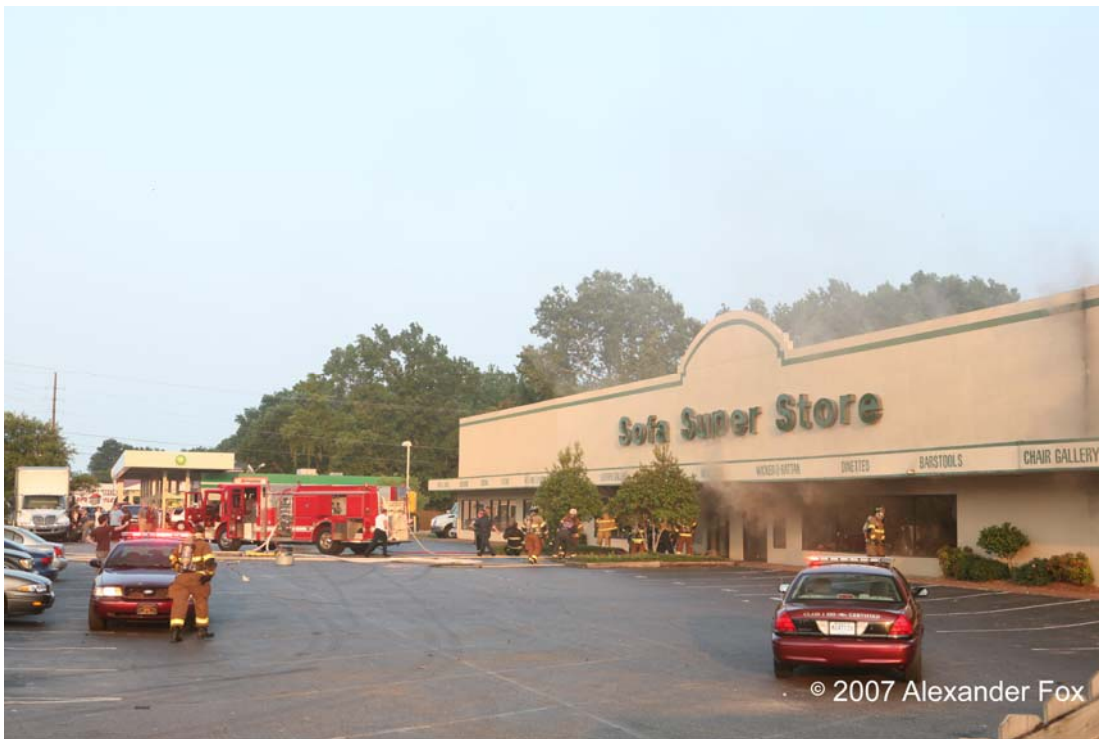
Figure 3-7. Light brown smoke began to flow out of broken front windows. Photo taken at approximately 7:35 p.m. Photo used with permission of Alexander Fox.

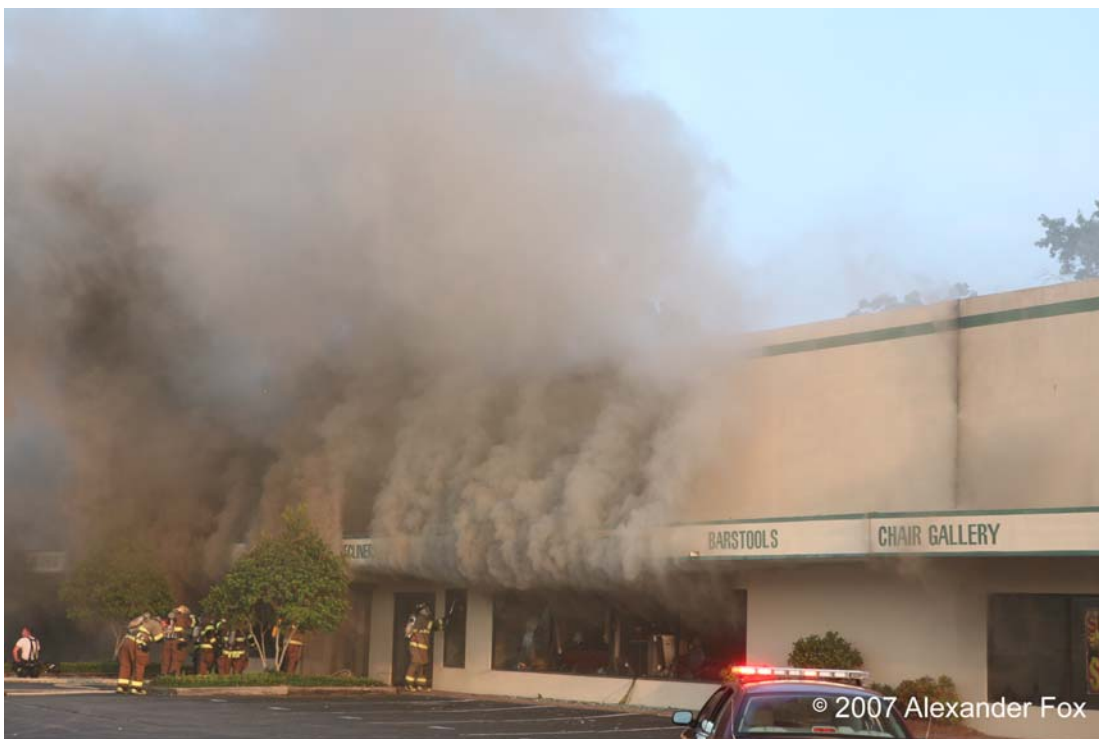
Figure 3-8. Additional smoke moved out of broken windows. Photo taken at approximately 7:36 p.m. Photo used with permission of Alexander Fox.

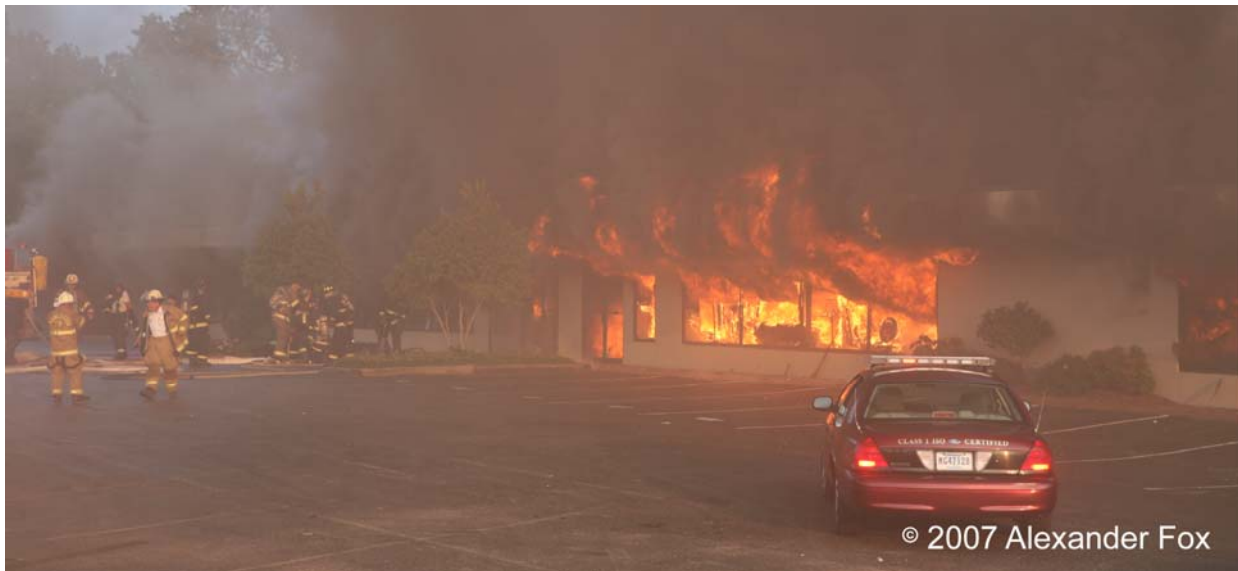
Figure 3-9. Black smoke and flames flowed out of front windows as fire spread to the main showroom. Photo taken at approximately 7:38 p.m. Photo used with permission of Alexander Fox.

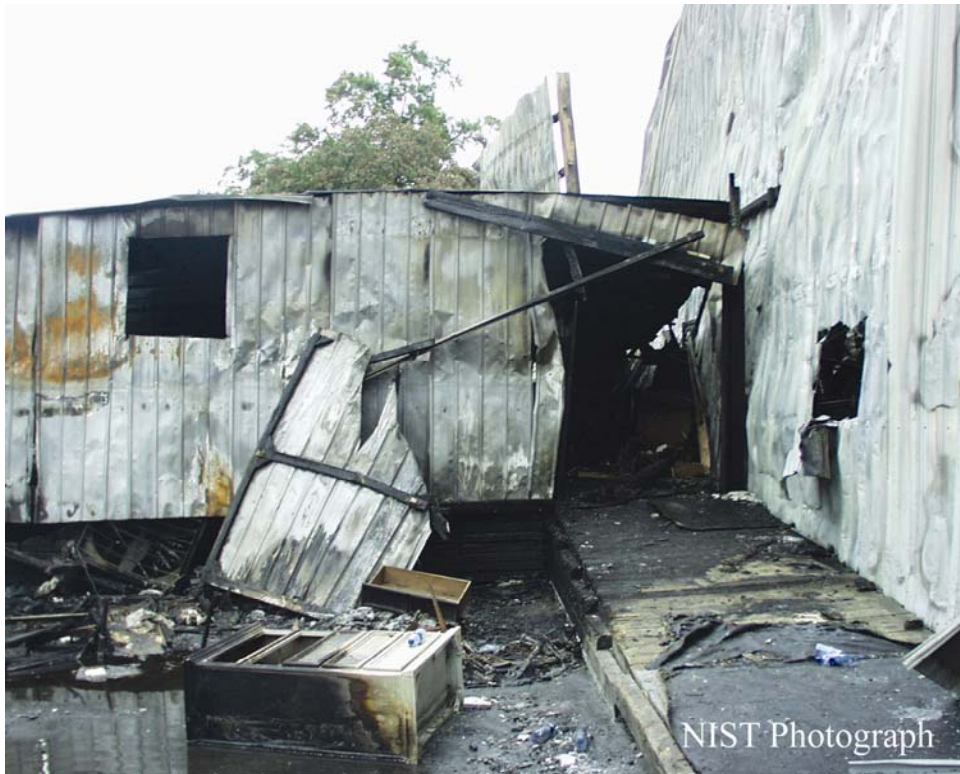
Figure 4-7. Photograph showing the outside of the loading dock. This was identified as the area of fire origin.
