# DEGRADATION STUDY OF FIELDDED PV MODULES FROM DIFFERENT CLIMATES IN CHINA

Dec 8<sup>th</sup>, 2015

Xian Dong

Shunde SYSU Institute for Solar Energy

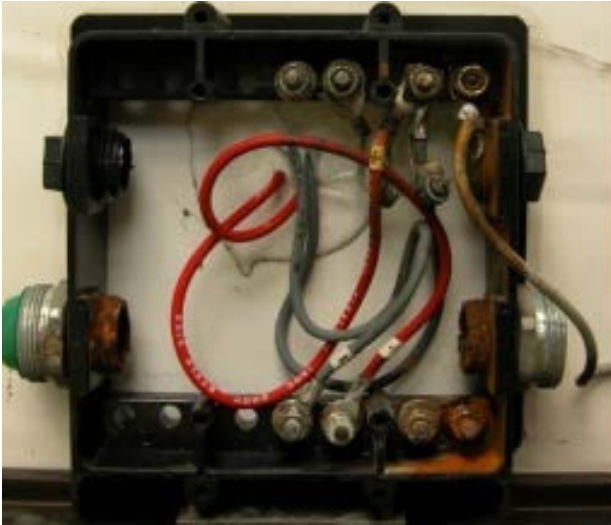
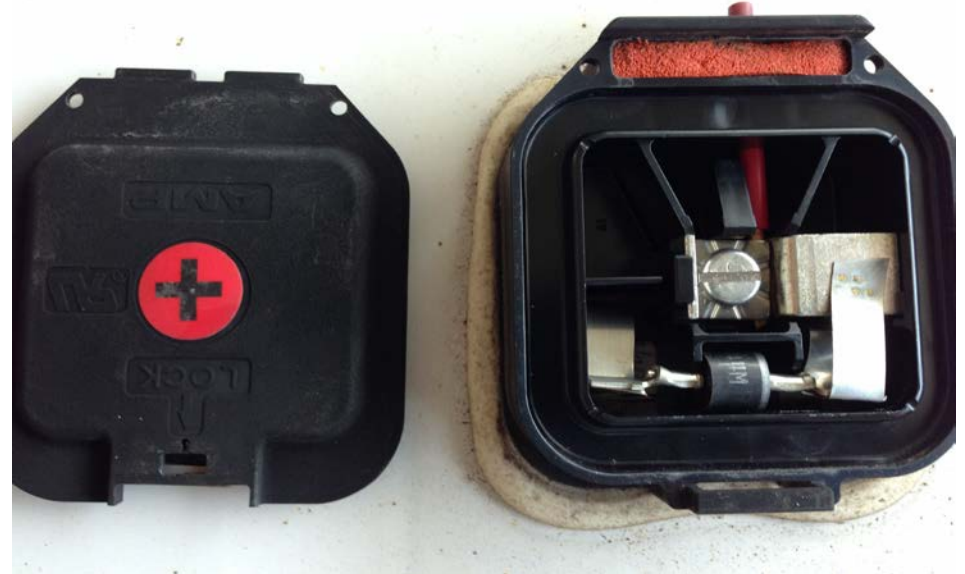
**Degradation of encapsulant material**  
**Sealability of J-box**

6/177 modules failed for bad terminal connection-Solarex module produced in 1982

Improvement of quality and process for J-box after 1990s.

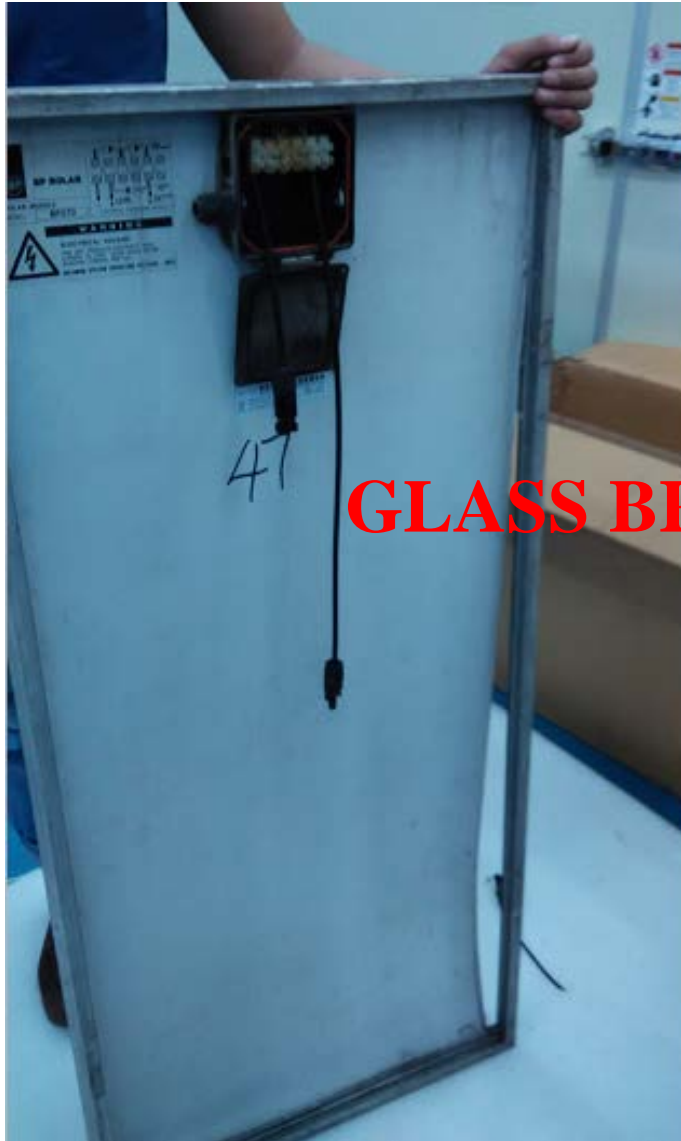
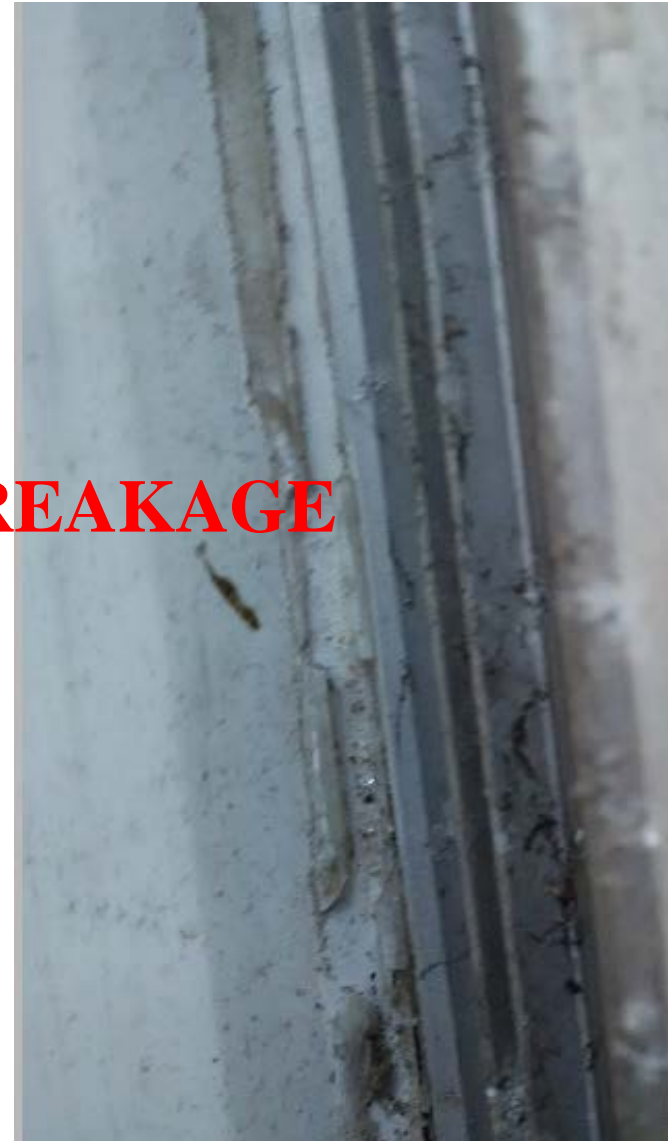
**GLASS BREAKAGE**

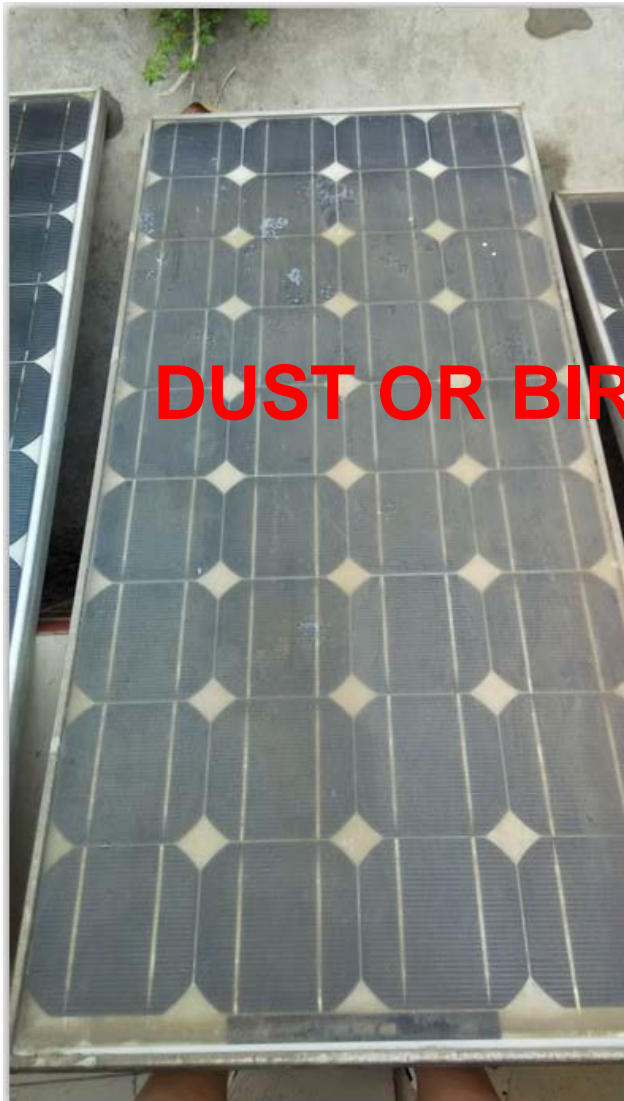
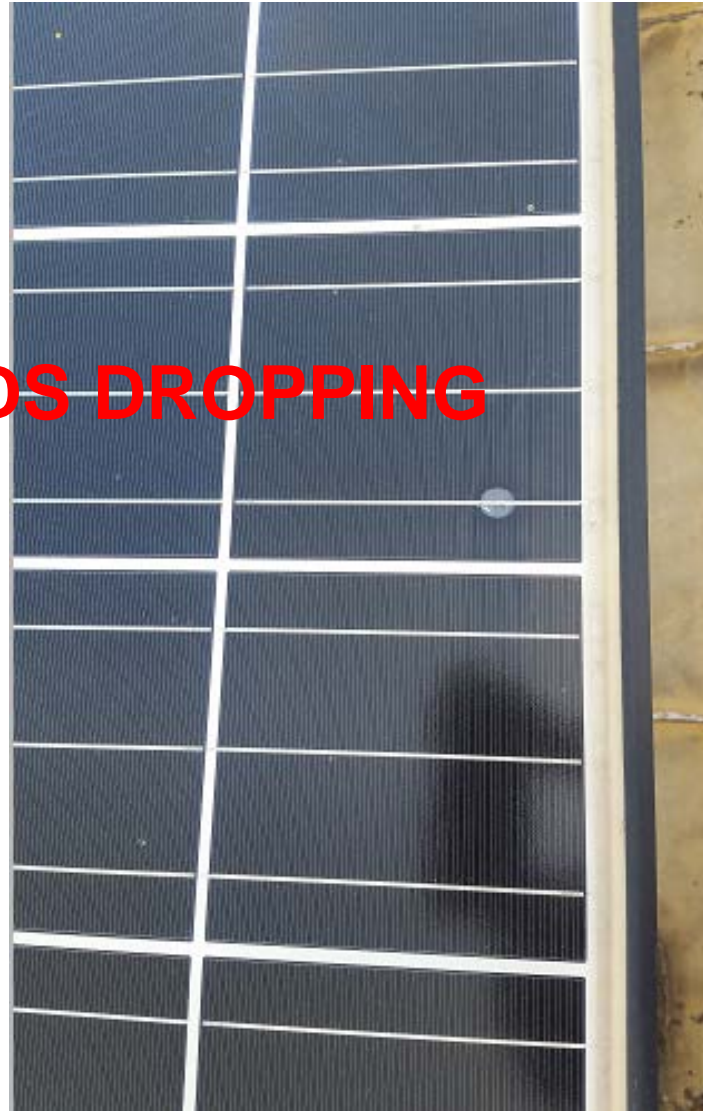
**DUST OR BIRDS DROPPING**

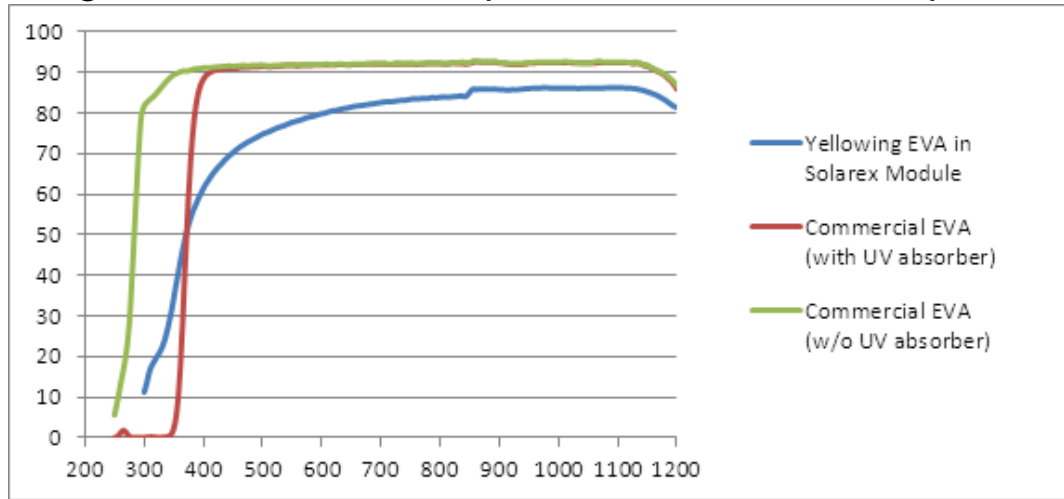
Light transmittance comparison of surface encapsulant

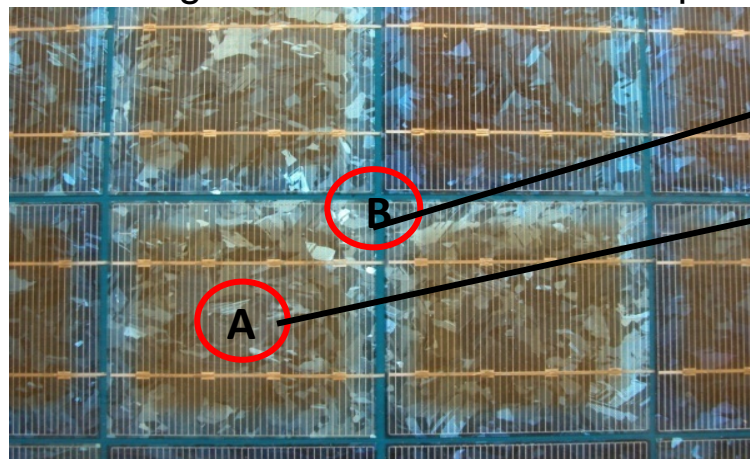
Crosslink degree of EVA from different parts in the module

73.43%

94.86%

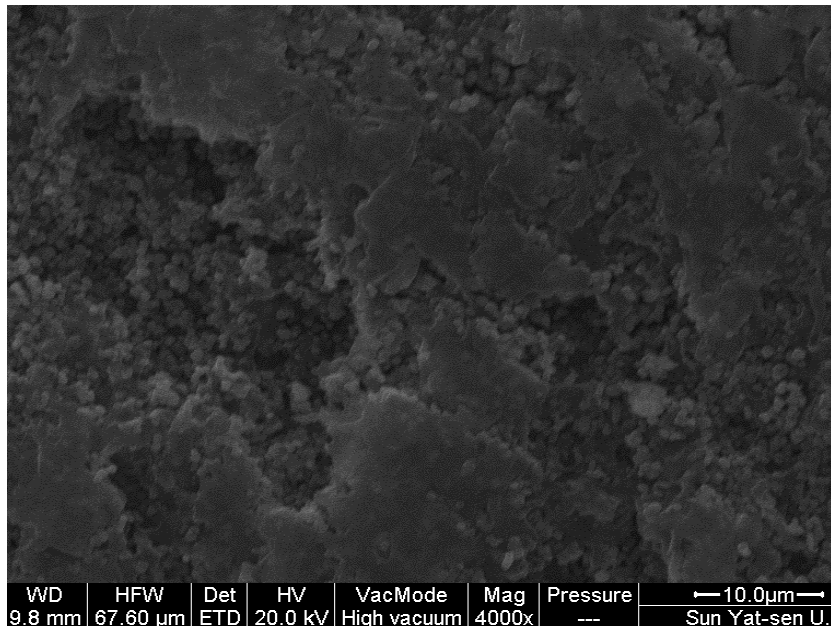
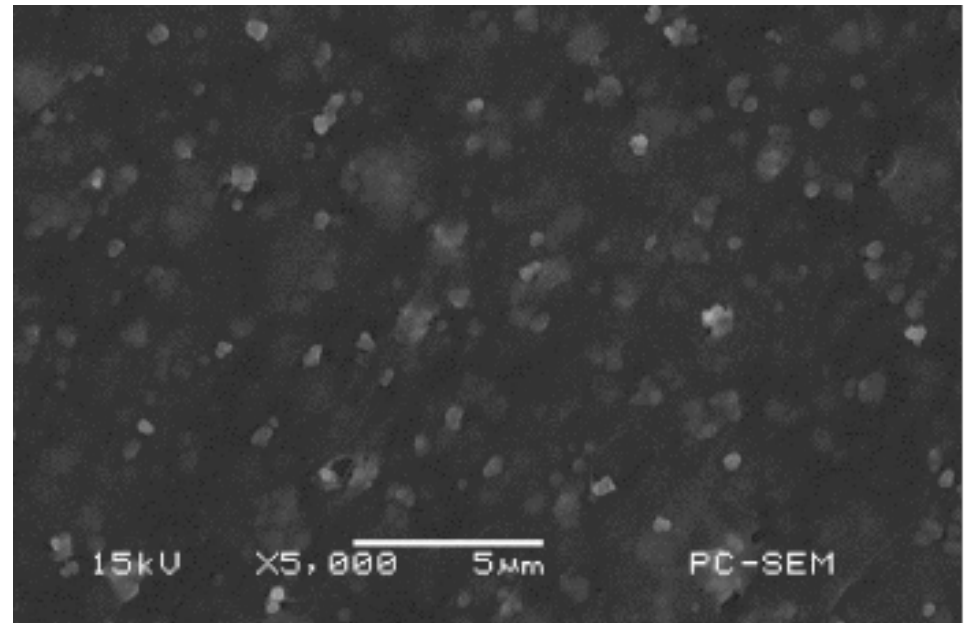
## Backsheet pulverization

Sample from Solarex module

New backsheet-Tedalar PV2001

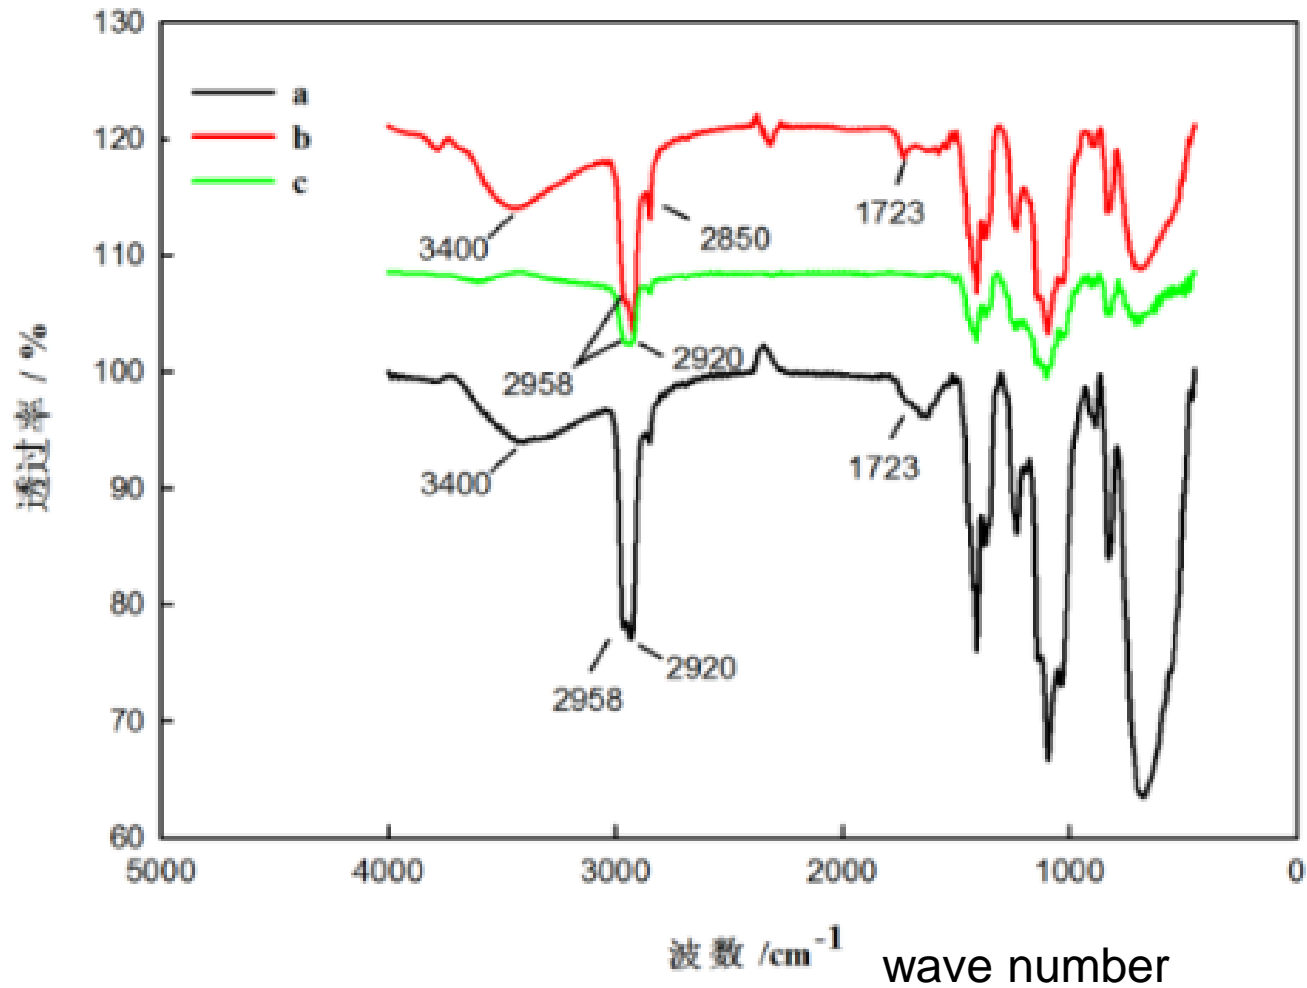
2920-2960: -CH<sub>2</sub>-  
 1400-1000: C-F  
 1723: C=O  
 3400: hydroperoxide  
 580: Ti-O

- (a) Sample from Solarex module
- (b) Sample from Solarex module-covered by the label
- (c) Tedlar PV2001

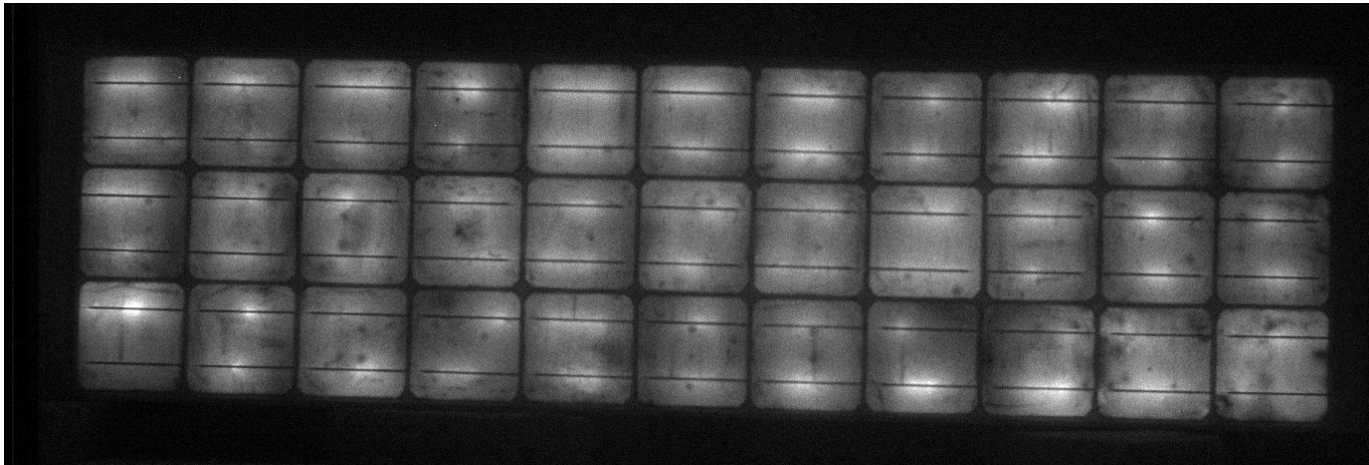
M75

**Deviation: 30%**

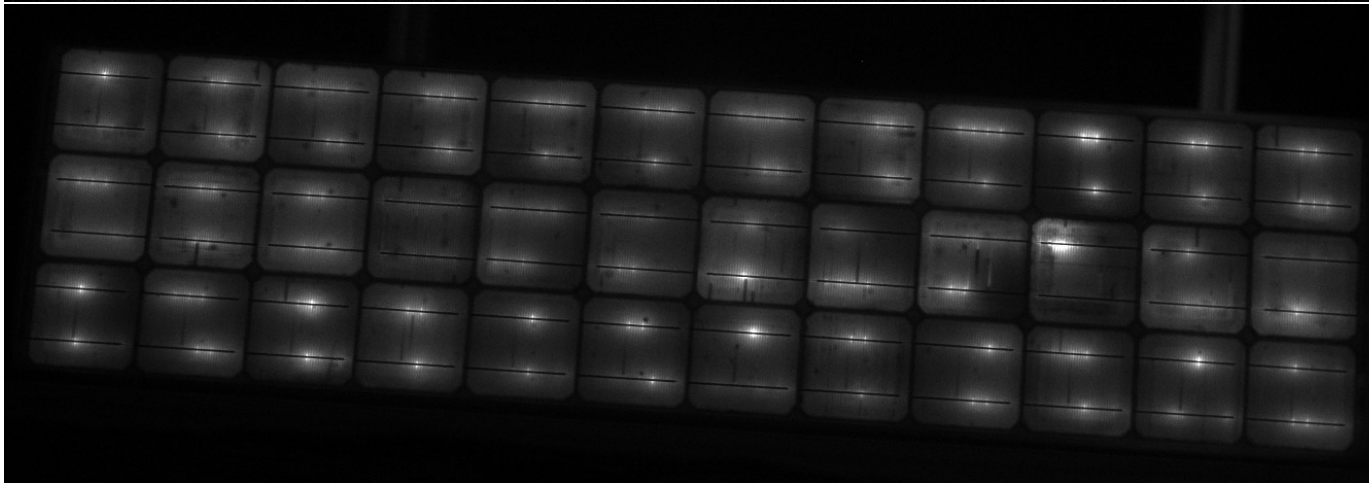
SM55

Why high series resistance?

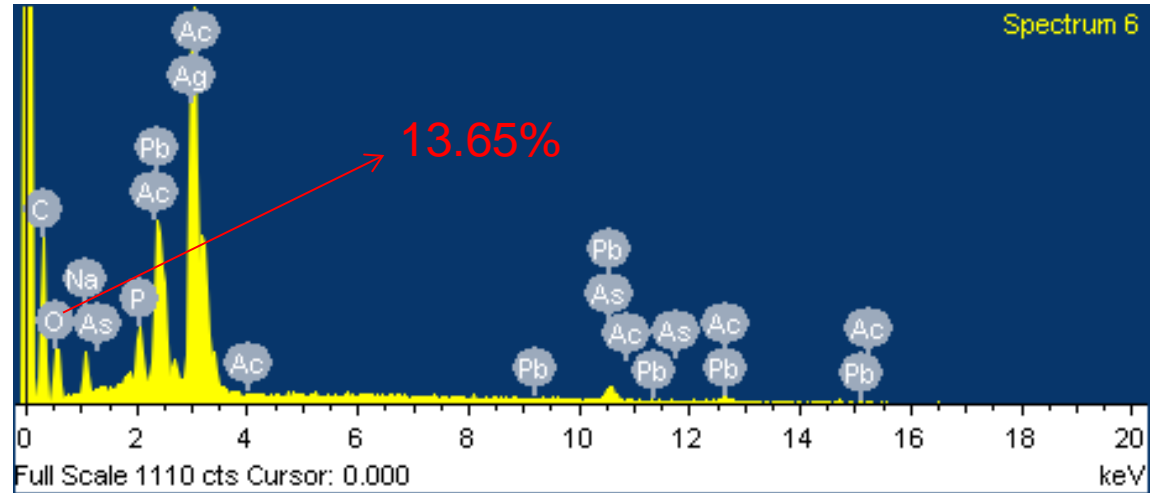
Ag fingers on the front surface of solar cell

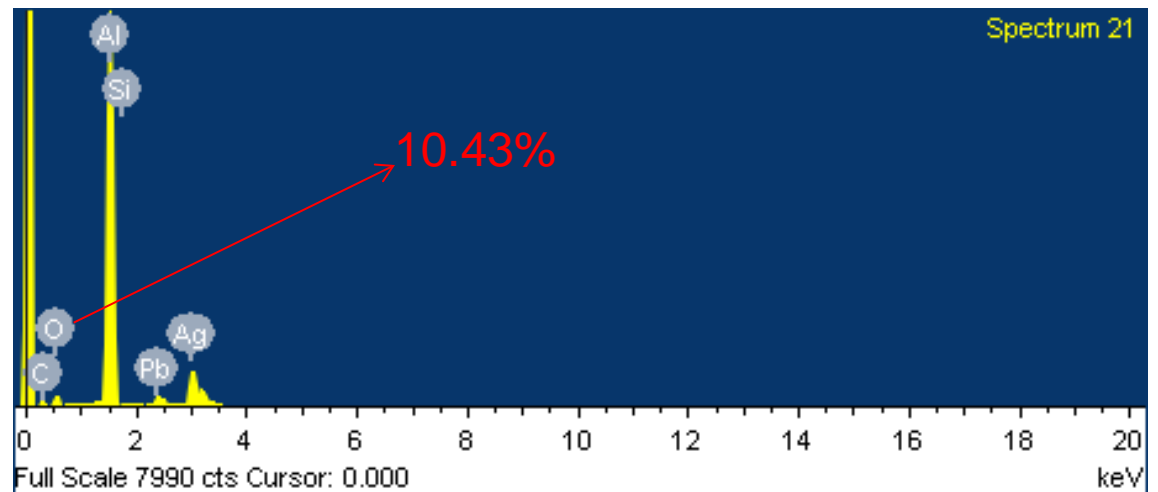
Fingers on the back surface of solar cell

Bad contact between solar cell and ribbon

Al-Ag paste/Soldering process/severe climate
