# Update on NIST's Investigation of the Partial Collapse of Champlain Towers South in Surfside, Florida

Judith Mitrani-Reiser  
*Lead Investigator*

**STRUCTURES CONGRESS 2025** | [structurescongress.org](https://structurescongress.org)

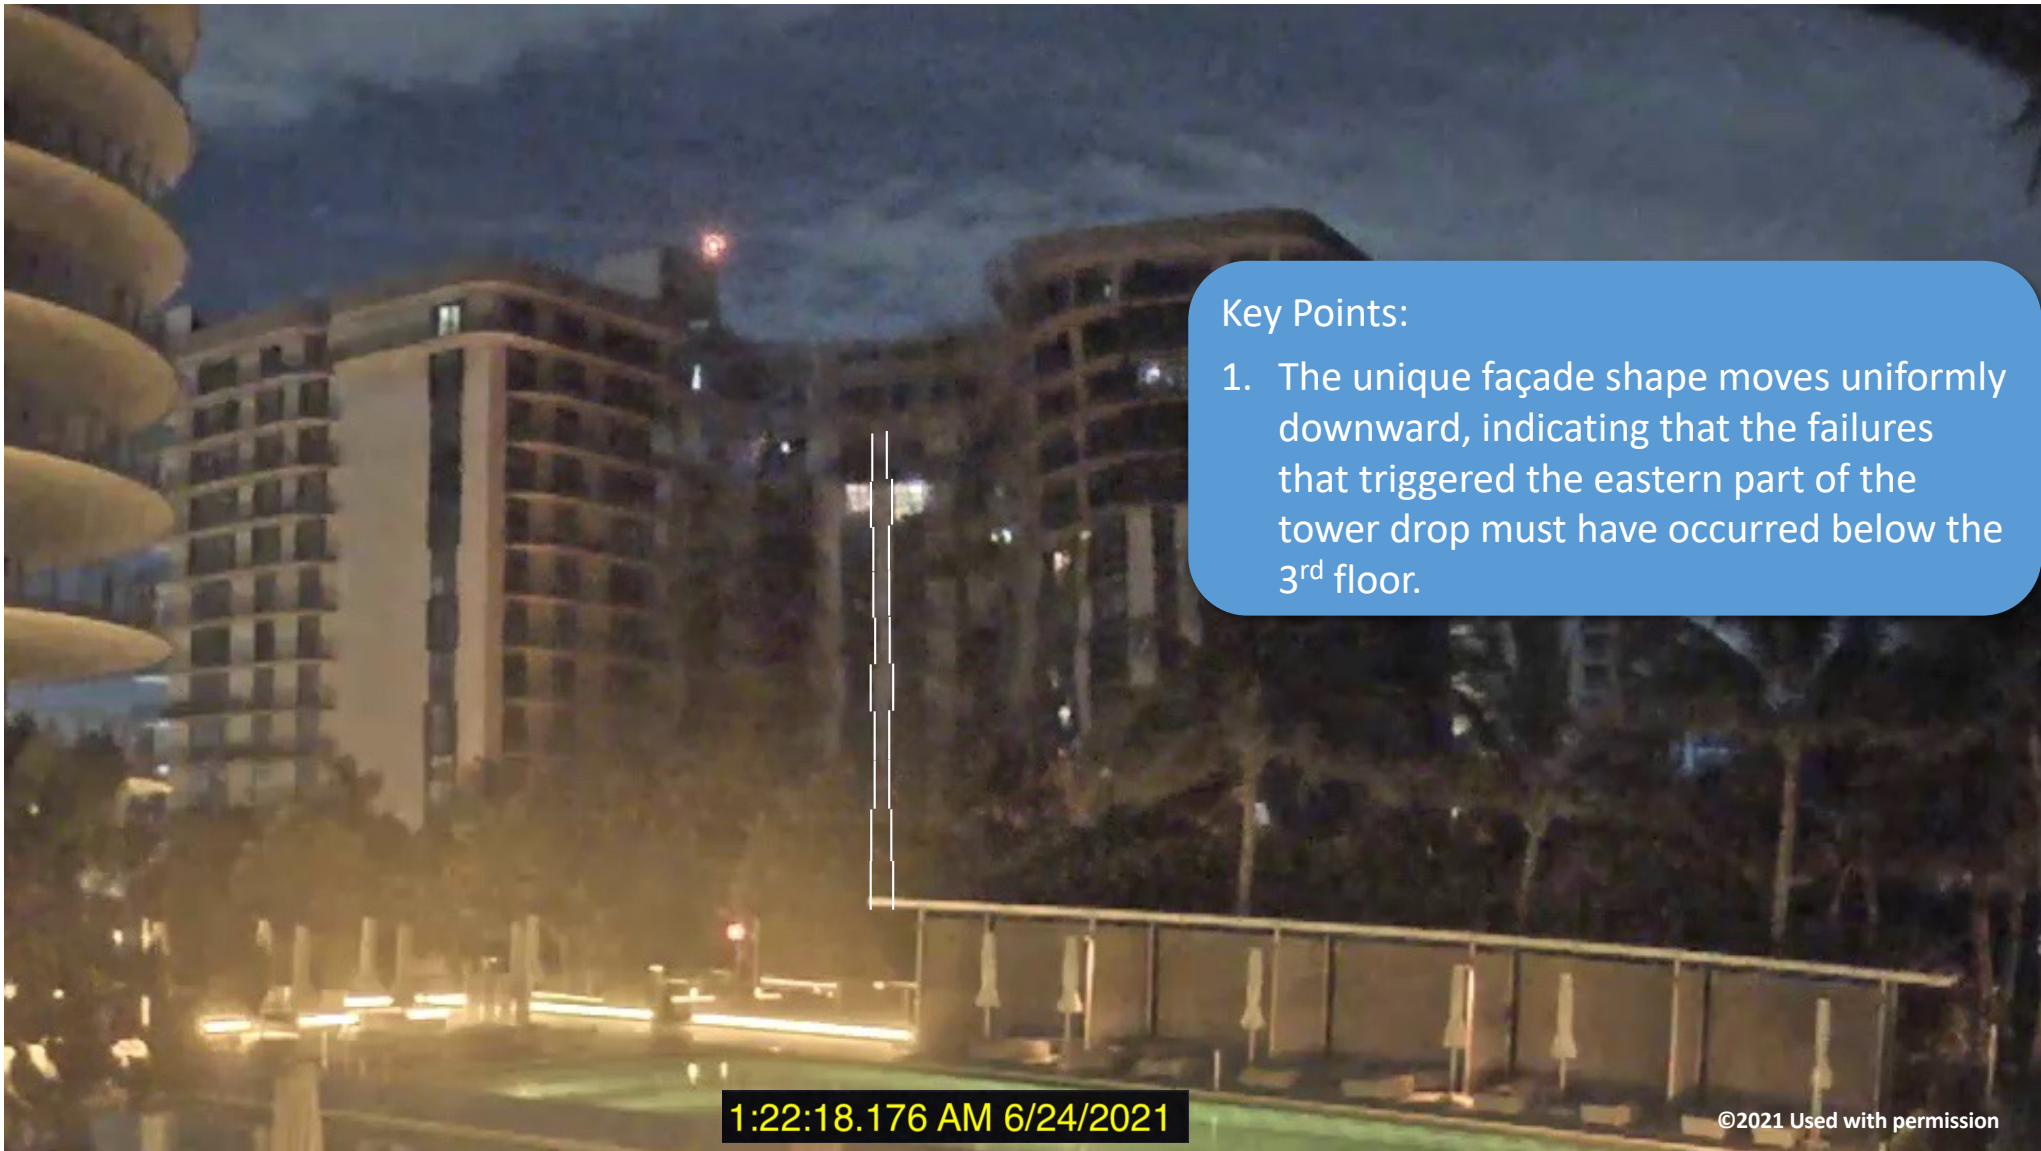
1:22:18.043+ AM 6/24/2021

1. The unique façade shape moves uniformly downward, indicating that the failures that triggered the eastern part of the tower drop must have occurred below the 3<sup>rd</sup> floor.

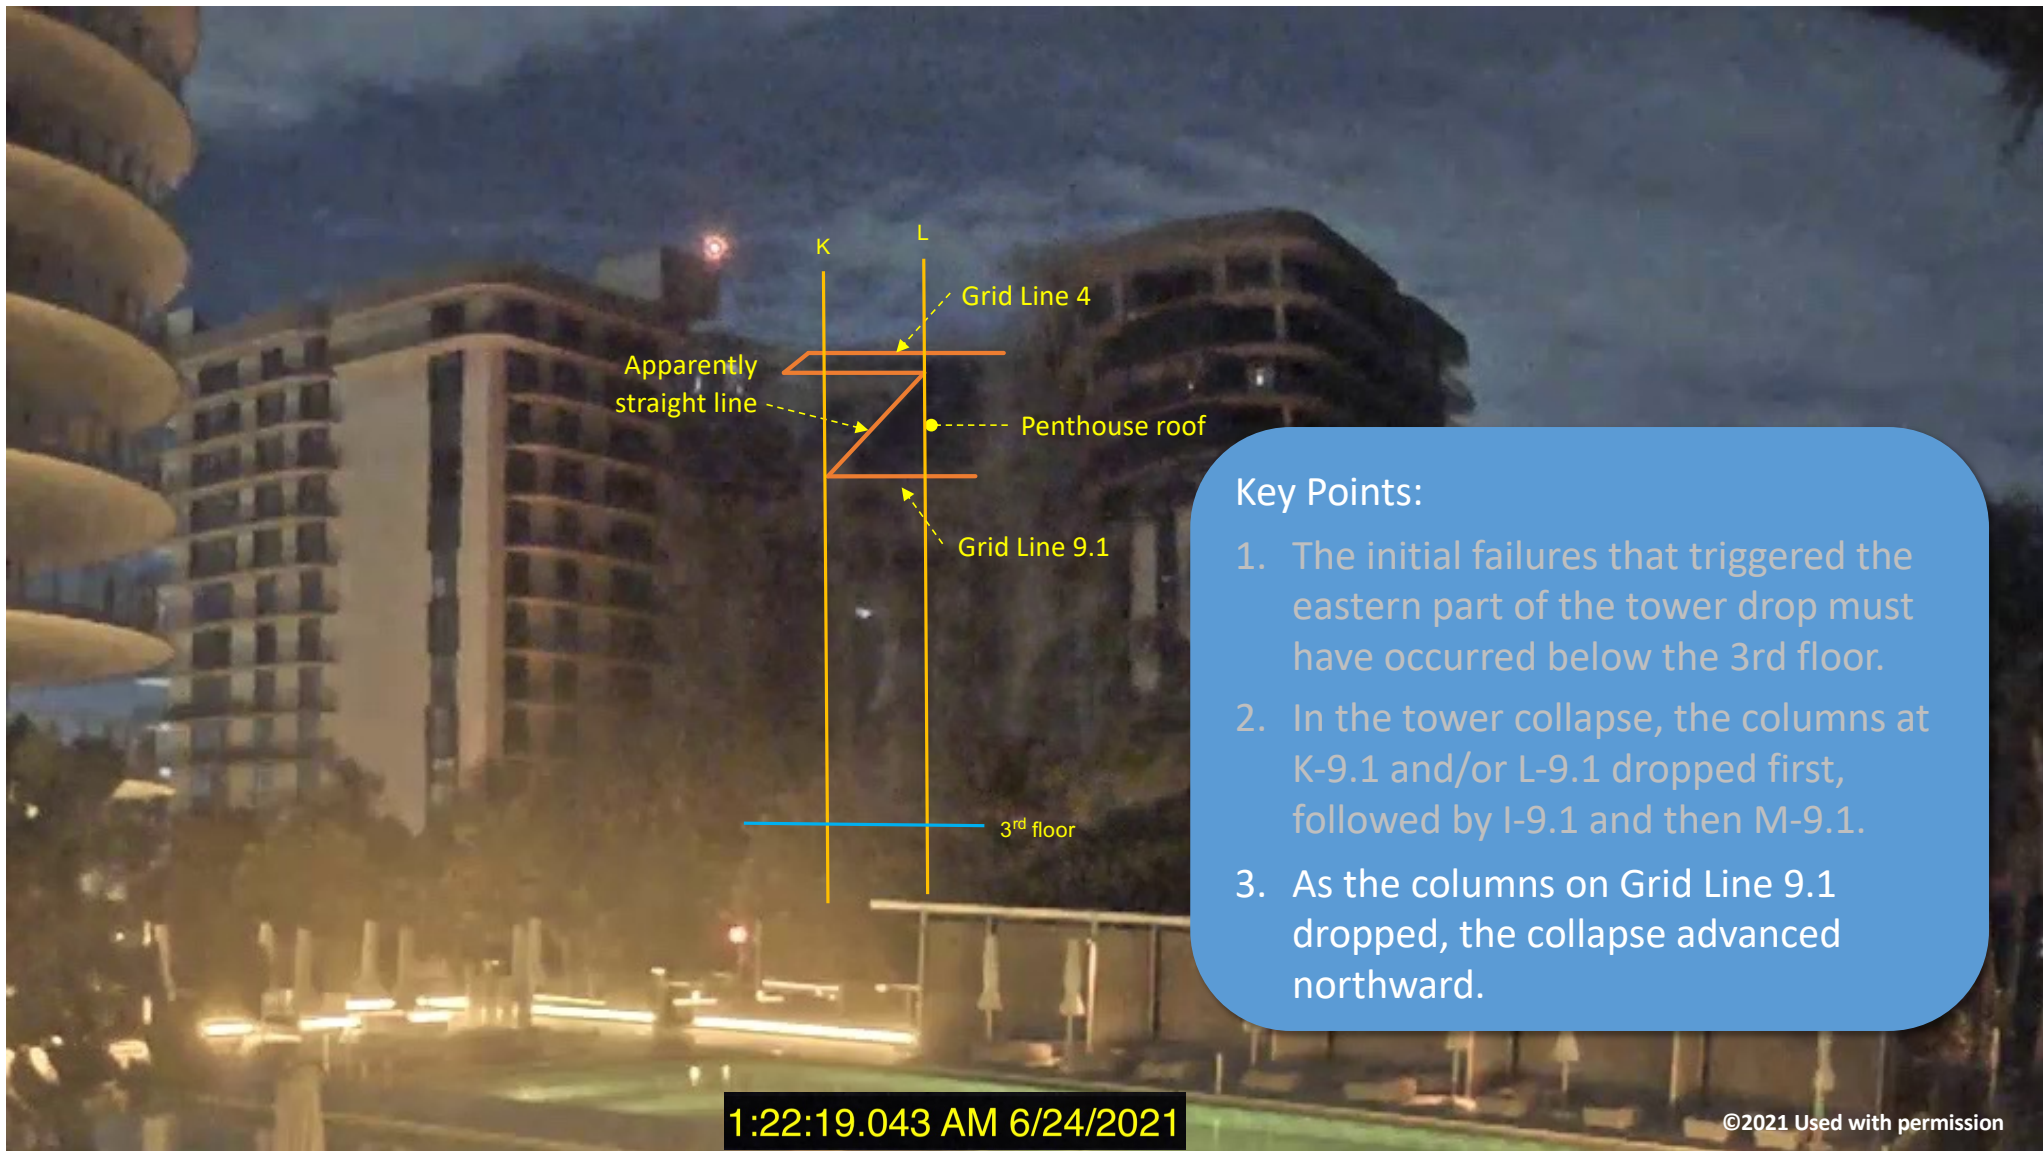
1:22:18.876 AM 6/24/2021

1. The initial failures that triggered the eastern part of the tower drop must have occurred below the 3rd floor.
2. In the tower collapse, the columns at K-9.1 and/or L-9.1 dropped first, followed by I-9.1 and then M-9.1.
3. As the columns on Grid Line 9.1 dropped, the collapse advanced northward.

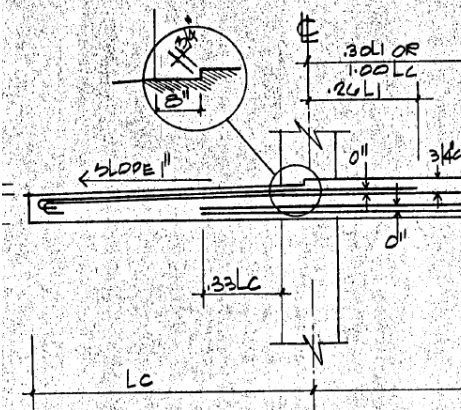
## Congestion:

9.75 % vertical reinforcement in column at this splice, vs. 8 % maximum permitted (worst case at another column is 12.2 %)

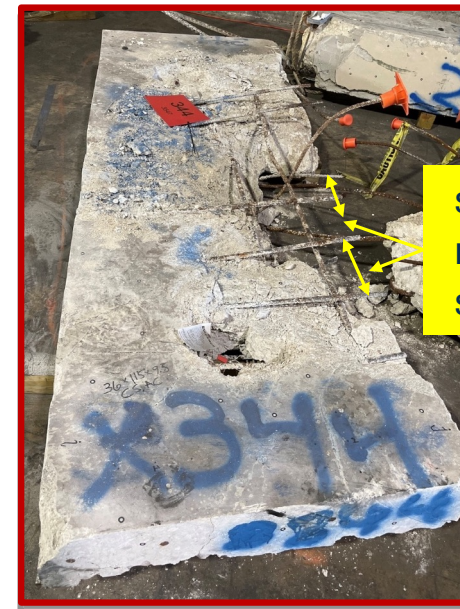
2 slab top reinforcement bars

The measured spacing of the top reinforcing bars in the column strips of the pool deck slab specimens commonly ranges from about 20 % to 40 % wider than required by the structural design drawings, resulting in less reinforcing in the column strips than required by the design.

slab top reinforcement spacing

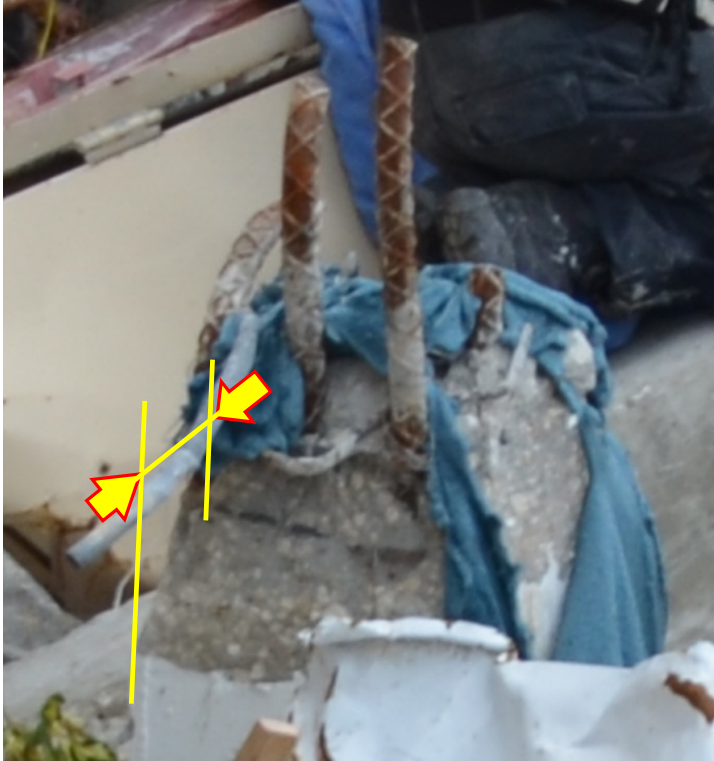
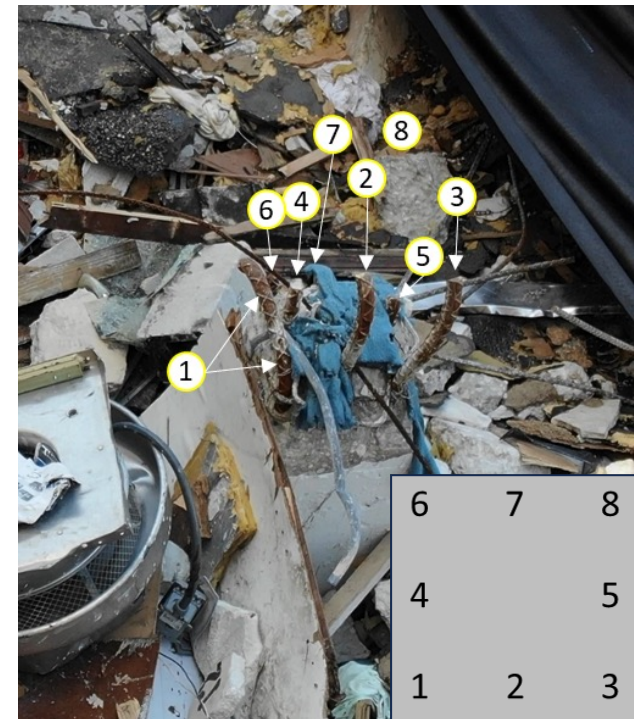
## Position of reinforcing cage within columns:

Photos of top of basement column at Grid Line K on south face of tower: bars shifted to the north (excessive cover on near face, but ties against form on far side of column)

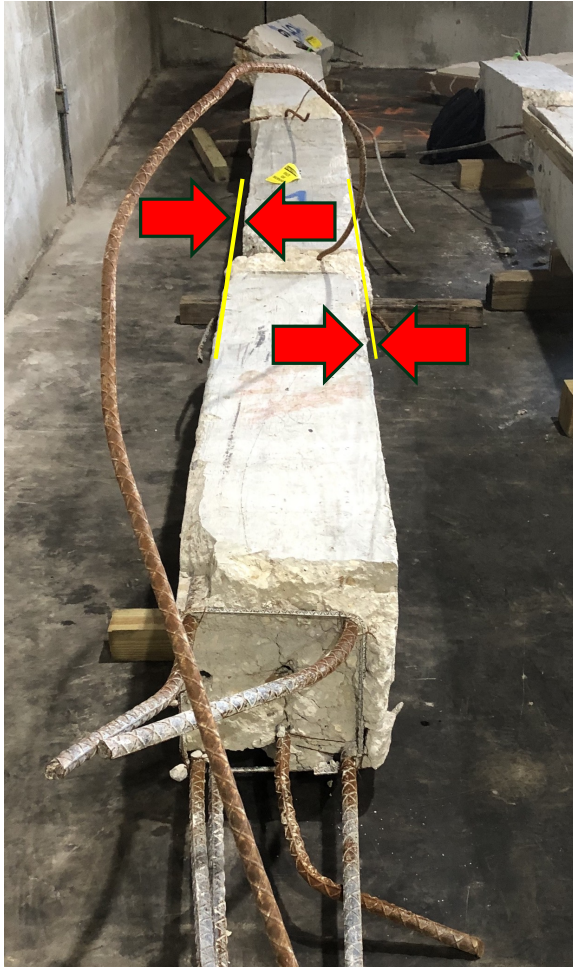
**Alignment of concrete:** Offset in column from story to story exceeds standard tolerances.

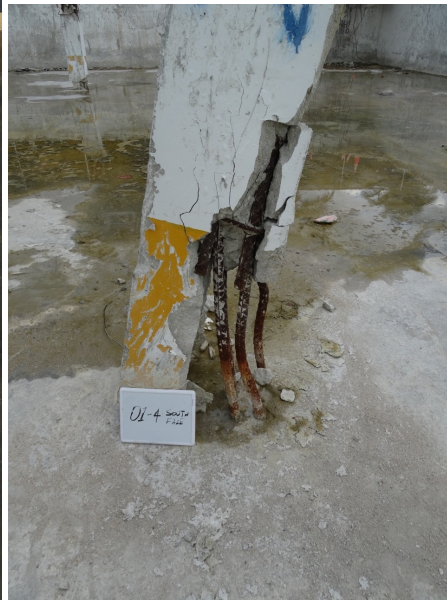
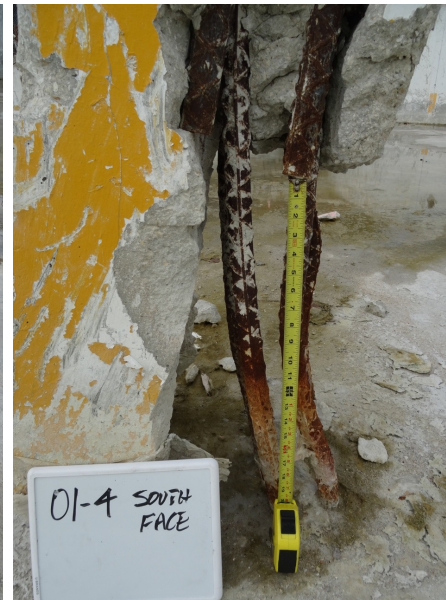
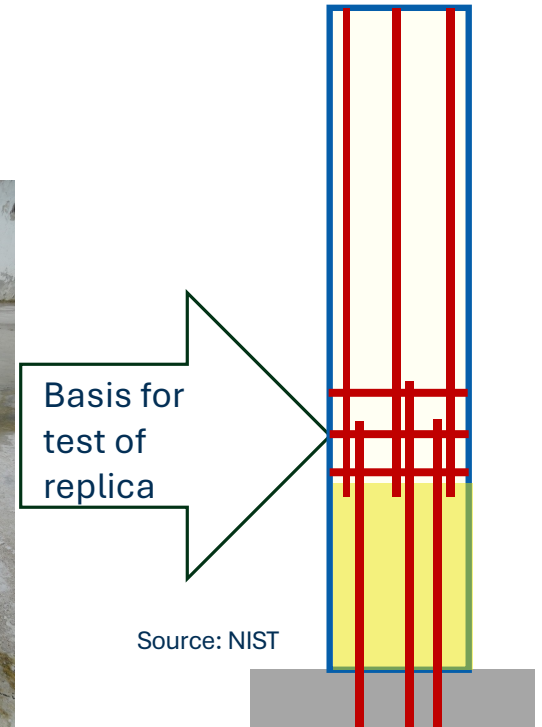
**Misplaced/short splice:**

Several columns found with longitudinal bars where the lap splice is shorter than specified.

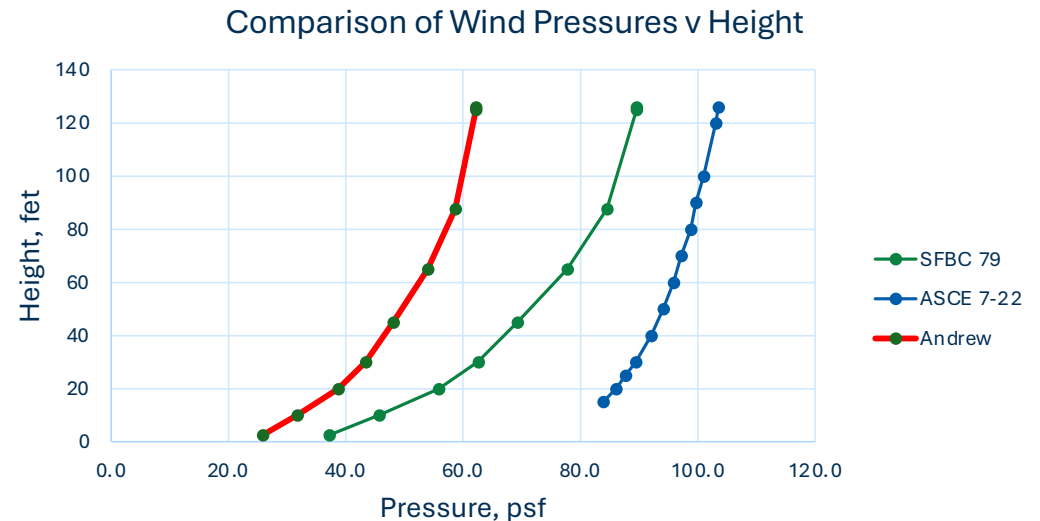
Historical wind study found highest velocity winds at the building were from Hurricane Andrew, 1992. The pressures were less than required by the 1979 SFBC or by ASCE 7-22.

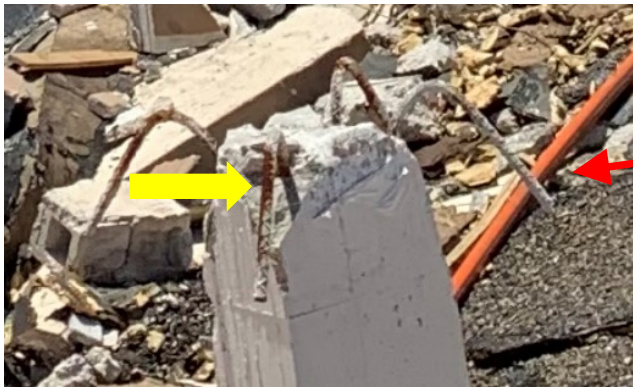
Corrosion of Pool Deck Hooked Column Reinforcement Bars that Were Embedded into Pool Deck Slab

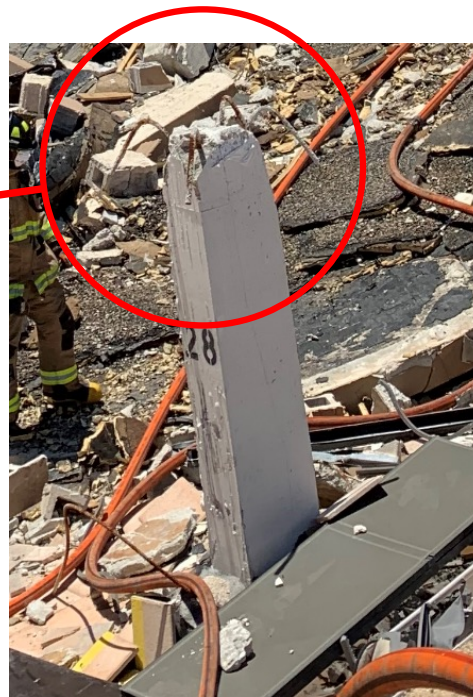
Enlargement of Column Top Showing Hooked Reinforcement Bars with Corrosion

Pool Deck Column Post-Collapse

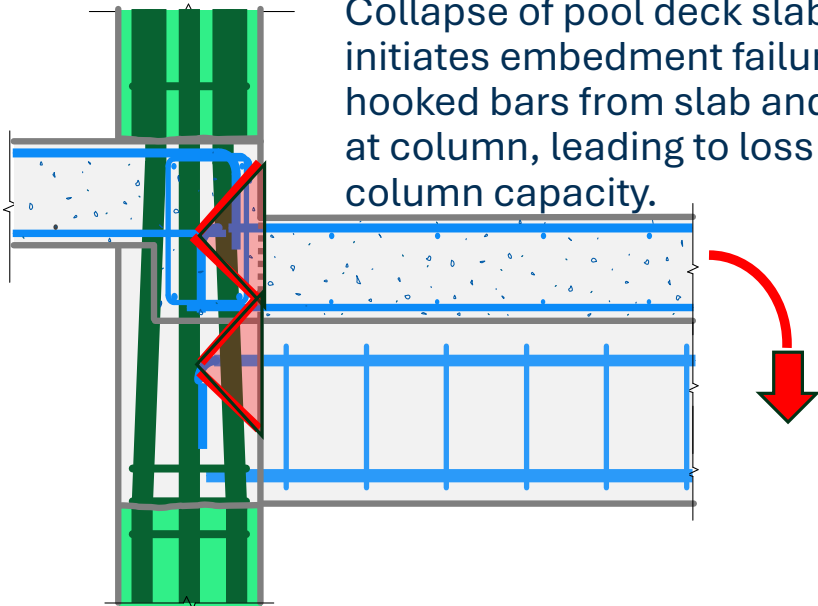
Collapse of pool deck slab initiates embedment failure of hooked bars from slab and beam at column, leading to loss of column capacity.

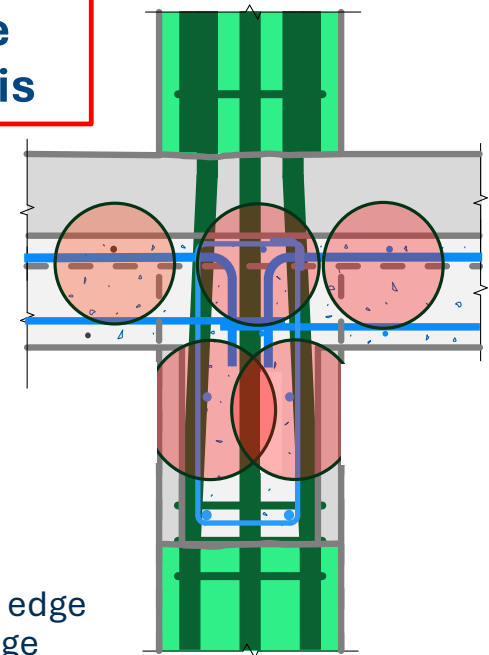
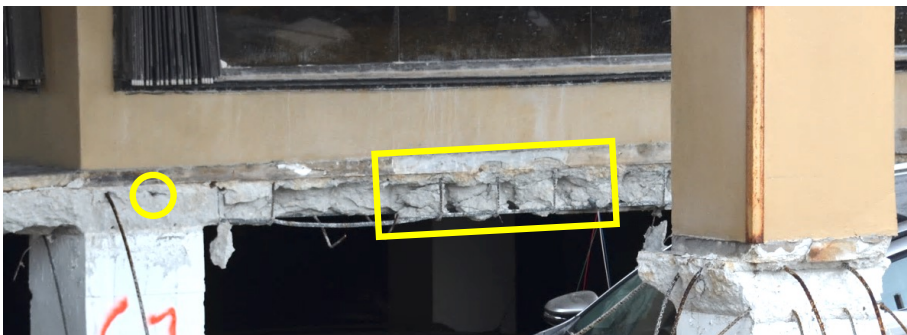
Image (at left) of similar condition at edge of portion that did not collapse. Image analysis of area in yellow box led to the profile (below) of concrete left after bars pulled out.

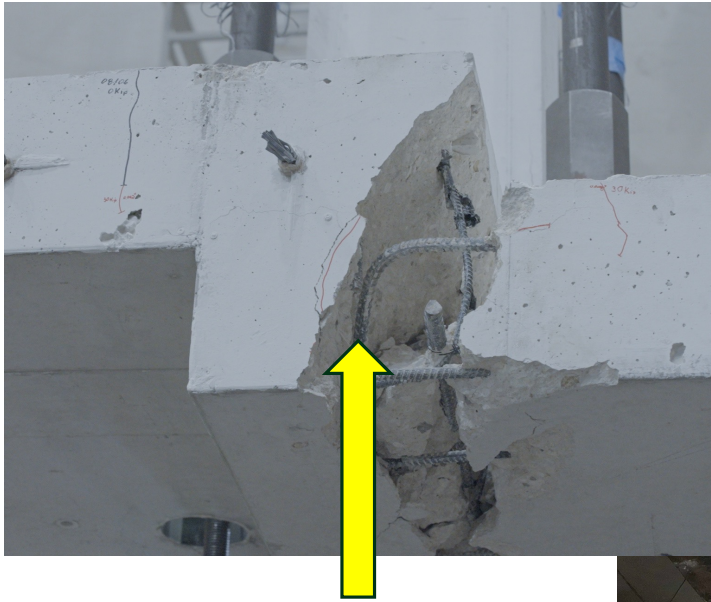
Hooked #5 top bars in lower slab broke out of drop beam

Test #2: column bars at south face lose cover and buckle

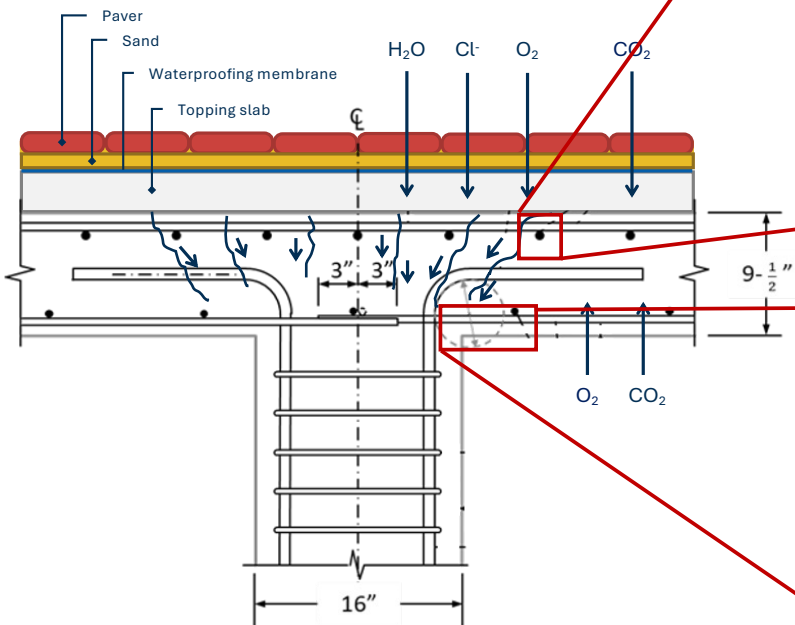
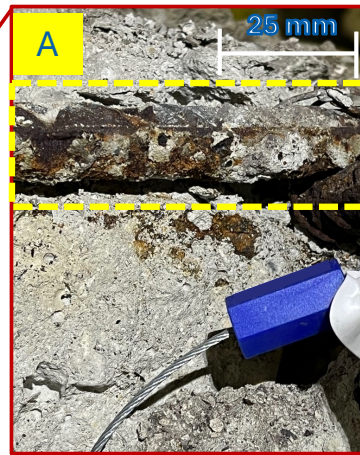
### 1. Reinforcing bar corrosion

- Corroded reinforcement in slab (A)
- Reinforcement before (B) and after (C) cleaning

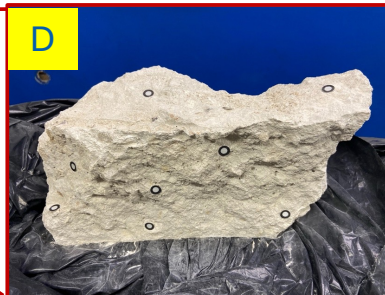
### 2. Concrete degradation

- Specimen extracted from slab near column (D)
- Microstructure characterized by high porosity (black regions at E)

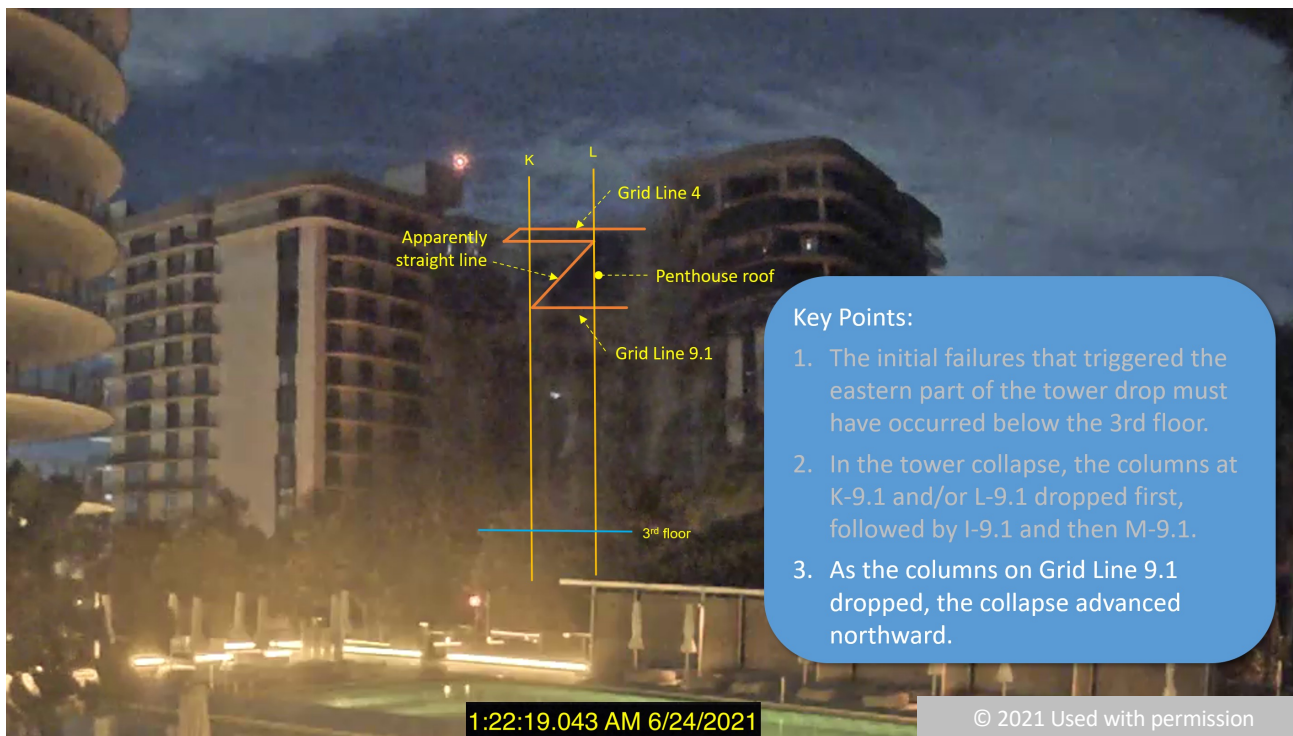
4. As the columns on Grid Line 9.1 dropped, the collapse advanced northward.

1. The initial failures that triggered the eastern part of the tower drop must have occurred below the 3rd floor.
2. In the tower collapse, the columns at K-9.1 and/or L-9.1 dropped first, followed by I-9.1 and then M-9.1.
3. As the columns on Grid Line 9.1 dropped, the collapse advanced northward.

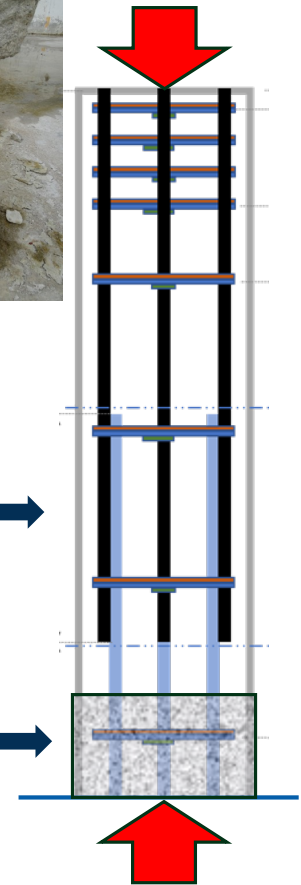
### Failure Initiation Possibility #3:

crushing in deteriorated concrete at bottom of column in basement
