# Some Enlightening Case Histories on Lightning Damage

Thomas Key, Doni Nastasi and Kermit Phipps  
EPRI PEAC Corporation  
Knoxville TN

François D. Martzloff  
National Institute of Standards and Technology  
Gaithersburg MD

Reprinted from *Proceedings, 25<sup>th</sup> International Conference on Lightning Protection - Rhodes, September 2000*

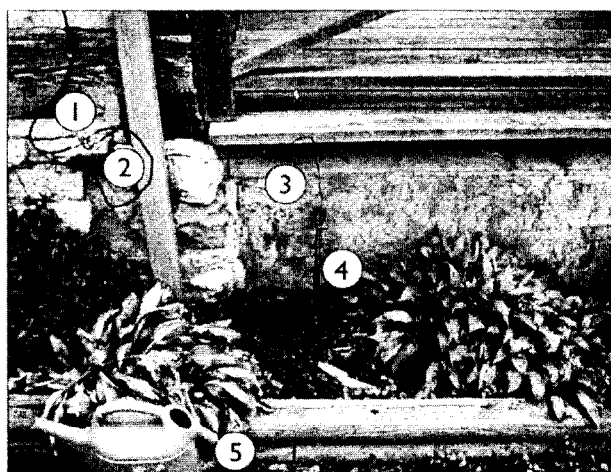
Figure 2 — Cable TV entrance

In the Cozy Cabin installation, the power service entrance was located at one end of the house, while the cable TV service entrance was located at the opposite end. Furthermore, a visit to the site revealed that the cable TV shield was grounded only by a questionable ground rod next to the house foundation (within the drip line, and thus in dry soil, see Figure 2). This cable TV grounding electrode was not bonded to the grounding electrode of the power service entrance, a clear violation of the U.S. National Electrical Code ("NEC", NFPA 70, 1999) [4].

1. Incoming cable      2. Splitter & discharge unit  
3. Grounding wire      4. Ground rod  
5. Watering can (for plants, not ground rod!)

Following the visit to the site by the authors, the local cable TV company was informed of this situation and took what they believed an appropriate action: the incoming cable was first routed under the house, in the crawl space, to allow bonding the shield to the power service grounding connection. From there, the cable was returned to its original point of entry into the house, at the opposite end. This modification did correct the NEC violation but left the arrangement in the topology shown in Figure 1.

However, the interaction was not pursued further with the cable company. A recommendation was made to the owner, to install a surge reference equalizer [5] for each piece of video equipment. After that was done, no damage occurred during the next lightning season. Of course, it is still too early to declare victory over Zeus and Murphy, but encouraging when compared to a previous history of two incidents within a few months.

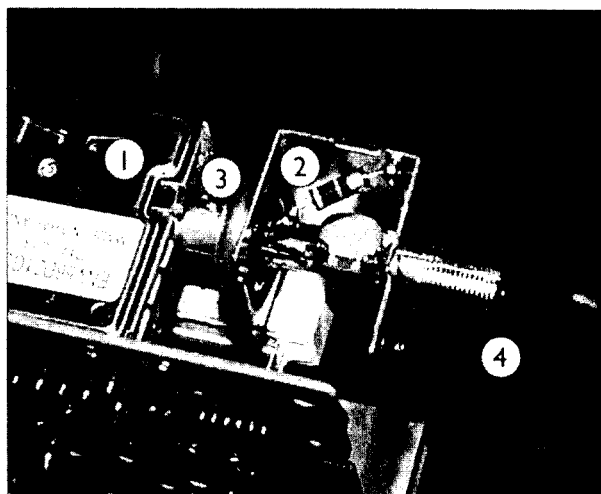
Figure 3 — Insulating gap at signal input

One of the failed TV receivers from the Cozy Cabin was made available to the authors for examination. No evidence of damage was found on the power side of the chassis and the related components, but a clear indication of surface flashover was observed along the insulation of the gap intended to isolate the cable input 'ground' termination (connected to the incoming cable shield) from the shielding can of the tuner (connected to one of the power cord conductors, see Figure 3).

After cleaning the carbonized path of the flashover, a  $0,5 \mu\text{s} - 100 \text{ kHz}$  Ring Wave was applied in incremental steps between the two conductors of the power cord, bonded together, and the shield connector of the cable input: flashover occurred at 2 kV. By removing the material to a greater depth and covering it with epoxy, the gap did withstand a greater level, and failed at 2,5 kV. That flashover occurred at another part of the original insulation, thus providing valid information on the original withstand capability.

1. Tuner box      2. Cable termination box  
3. Insulating gap      4. Incoming cable connection

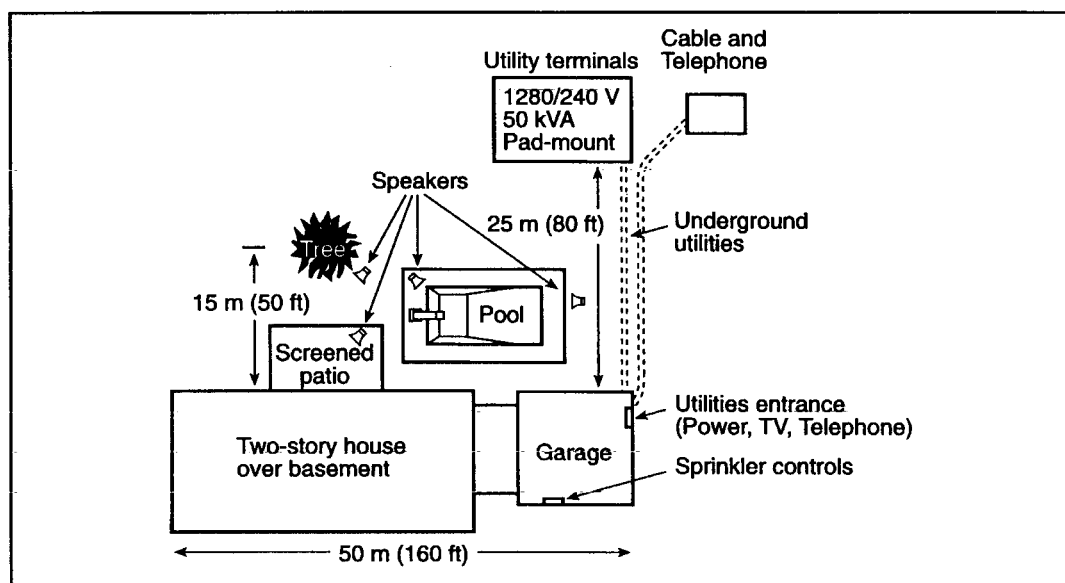
Figure 4  
Schematic configuration of the Rambling Residence

The overall physical layout of the house, damaged tree, and electronic equipment are shown in Figure 4. The tree that was struck is much taller than the house and is the tallest of the trees in the immediate area. The bark was stripped from the tree trunk for most of its height. The tree trunk is only approximately 15 m from the house and even closer to the patio, where some of the audio speakers were installed. Outdoor speakers are also located in the pool area and connecting walkways.

In the audio amplifiers, as noted above, the power supplies of the units were not damaged, but their output transistors that drive the speakers and the speakers themselves were damaged. Thus, it was speculated that the surge energy had been coupled into the speaker wires, which are probably very long and very near to the lightning strike, rather than as a "power-line surge."

The visit to the installation verified this theory. The home entertainment equipment, including amplifiers, is centrally installed in the basement of the house. Speakers are located throughout the house, the patio, and the swimming pool area. The wire length between the outdoor speakers and the central amplifier is about 30 m, and some of the wires run within 10 m of the tree trunk.

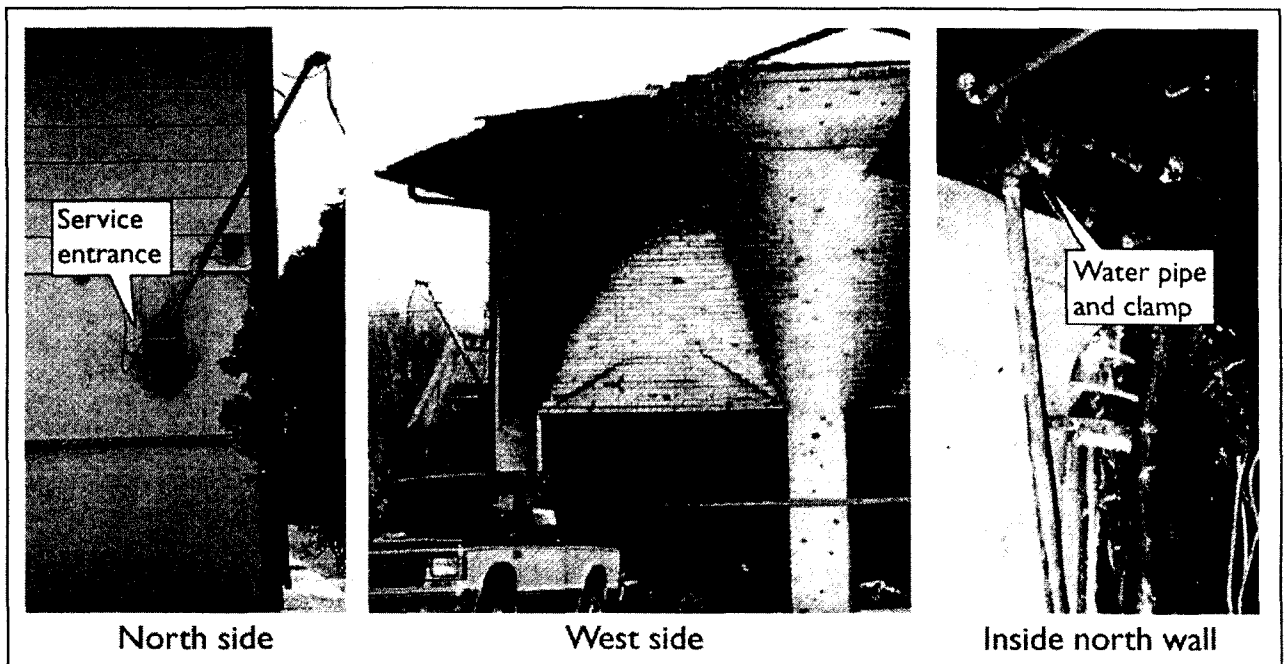
Figure 5 — The Standard Suburban aftermath

In this case, which occurred in a suburban, semi-rural hilly area, the post-strike investigation revealed that the overhead service drop to the house (involving a span of about 20 m across the street) had been severed by melting at the point of strike. From there, the current traveled to the revenue meter (typically on the outside wall in U.S. practice), where a ground conductor is normally installed with a short run to the earthing electrode of the house. Instead, according to the practice when constructed in the 1970s, a cold water pipe was allowed to be the main earthing electrode. In this case, the conductor for the earthing electrode entered the garage and was routed upward near the ceiling with several bends before it was bonded to a copper water pipe. Without any better path to earth, the lightning current had apparently followed the same route, severing the bare conductor while seeking the well-grounded water pipe (see Figure 5).

As shown in the photographs of Figure 5, the service entrances were overhead and without any direct path to earth. This type of installation would not be approved by current US practice, which requires a direct connection to a driven ground rod in addition to any other supplemental electrodes such as the cold water pipe. One of the main reasons that the practice was modified is the growing use of PVC or plastic water pipe.

On a later visit, the engineers who made the first visit were allowed to visit the repaired house. Indeed, the new service grounding point includes not only the electric power but also the telephone and cable company. The new water piping is PVC, and a driven ground rod has been installed as the primary grounding electrode.
