PV Array Differential Backside Exposure Conditions: Backsheet Degradation and Site Design

4th Atlas/NIST Workshop on Photovoltaic Materials Durability

NIST CNST site overview

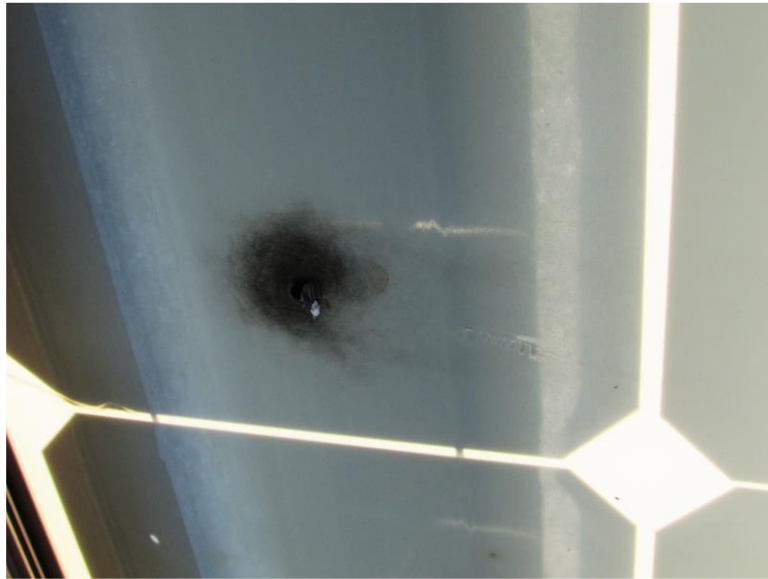
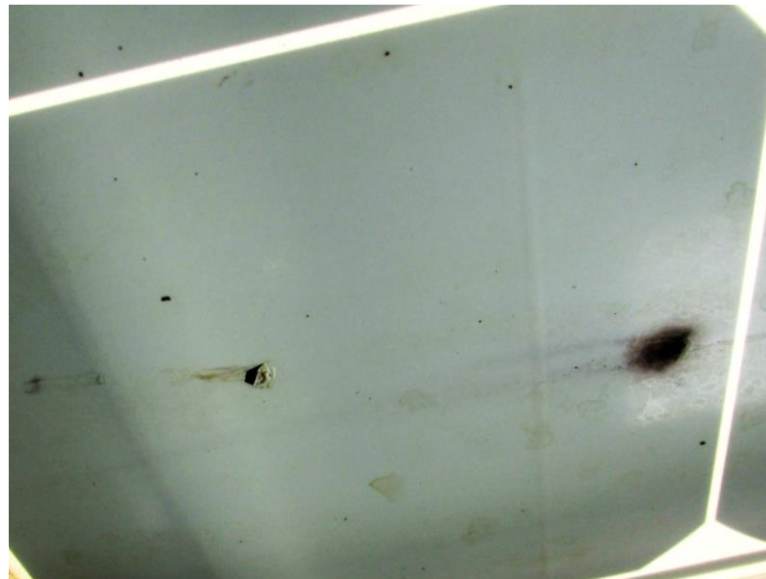
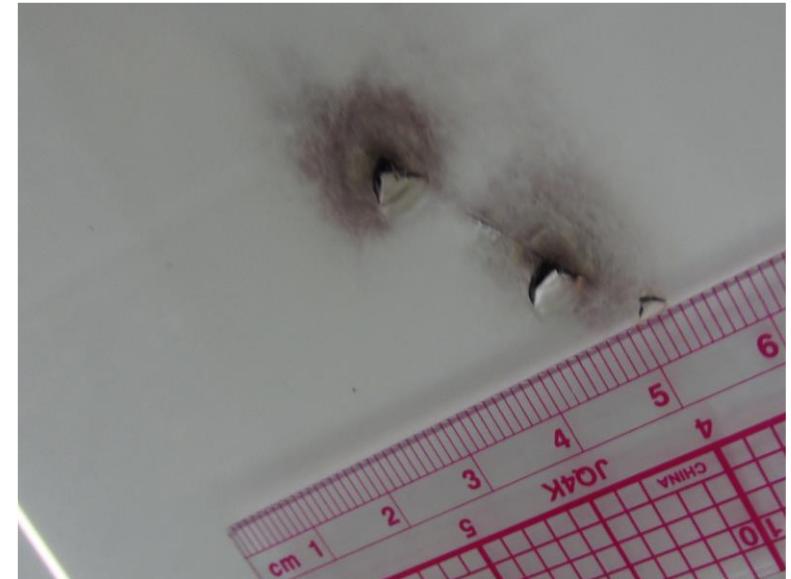
1) Burn-throughs

- Observed in ~3% of modules, less common on bottom row
- Affected modules typically have 1-2 marks

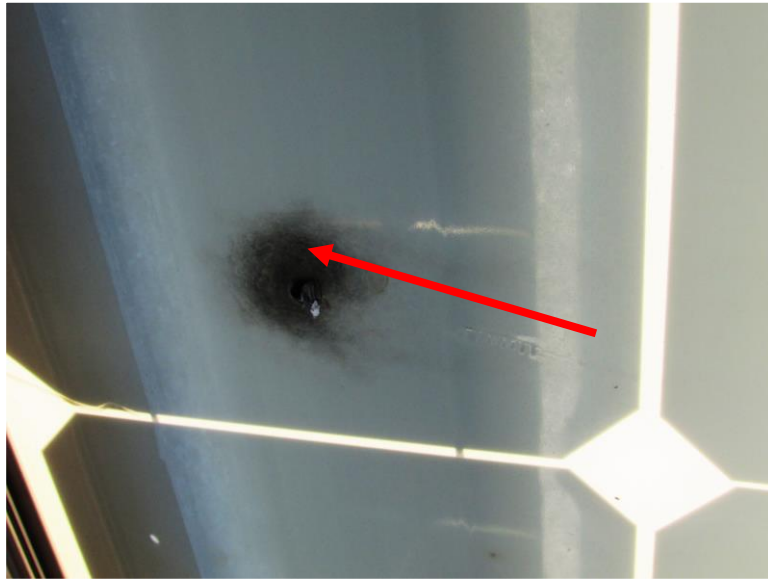
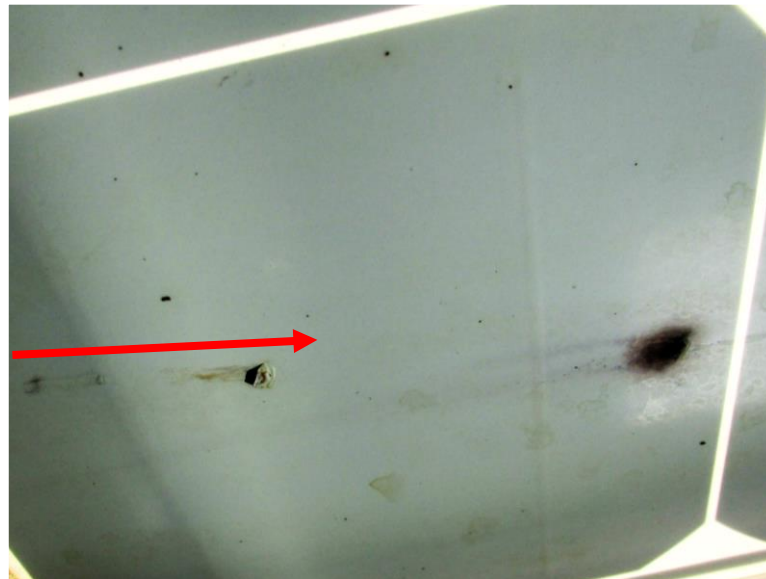
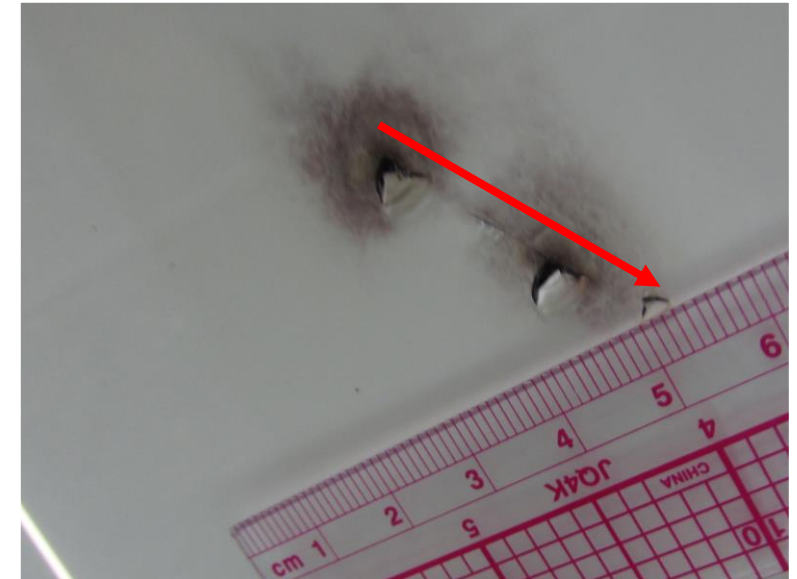
1) Burn-throughs

- Observed in ~3% of modules, less common on bottom row
- Affected modules typically have 1-2 marks
- Many occur near physical damage due to handling (red arrows)

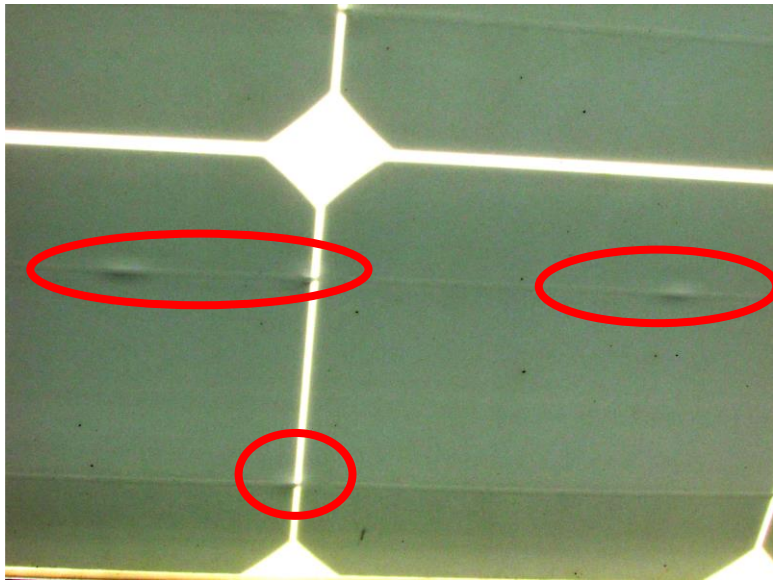
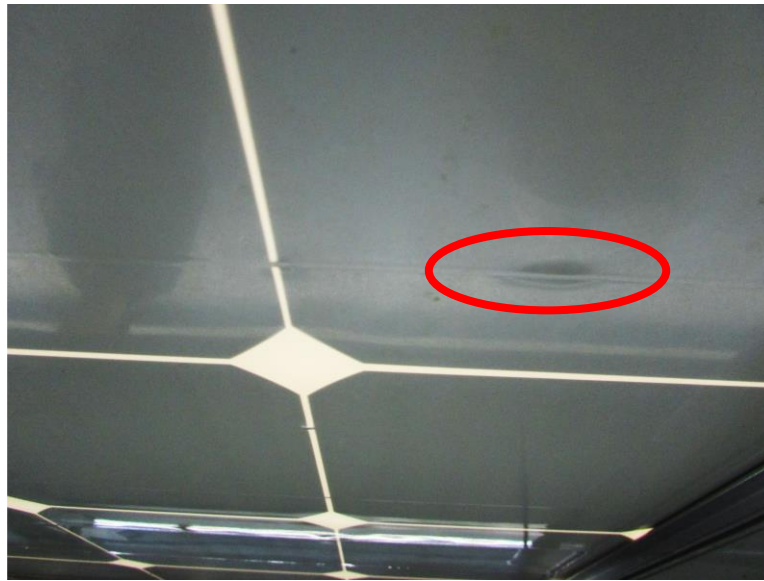
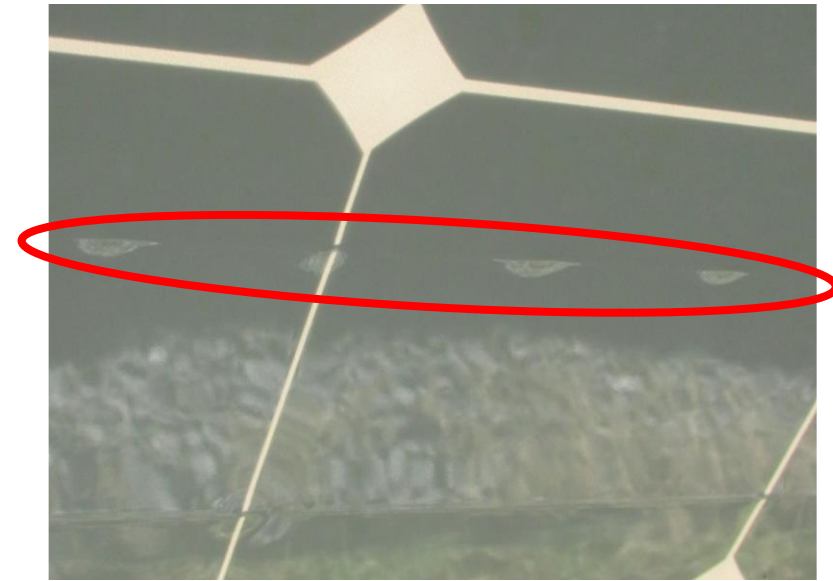
2) Busbar bumps

- Observed in 5-10% of modules, more common on bottom rows
- Affected modules typically have multiple bumps
- Occur along busbars and at interconnects

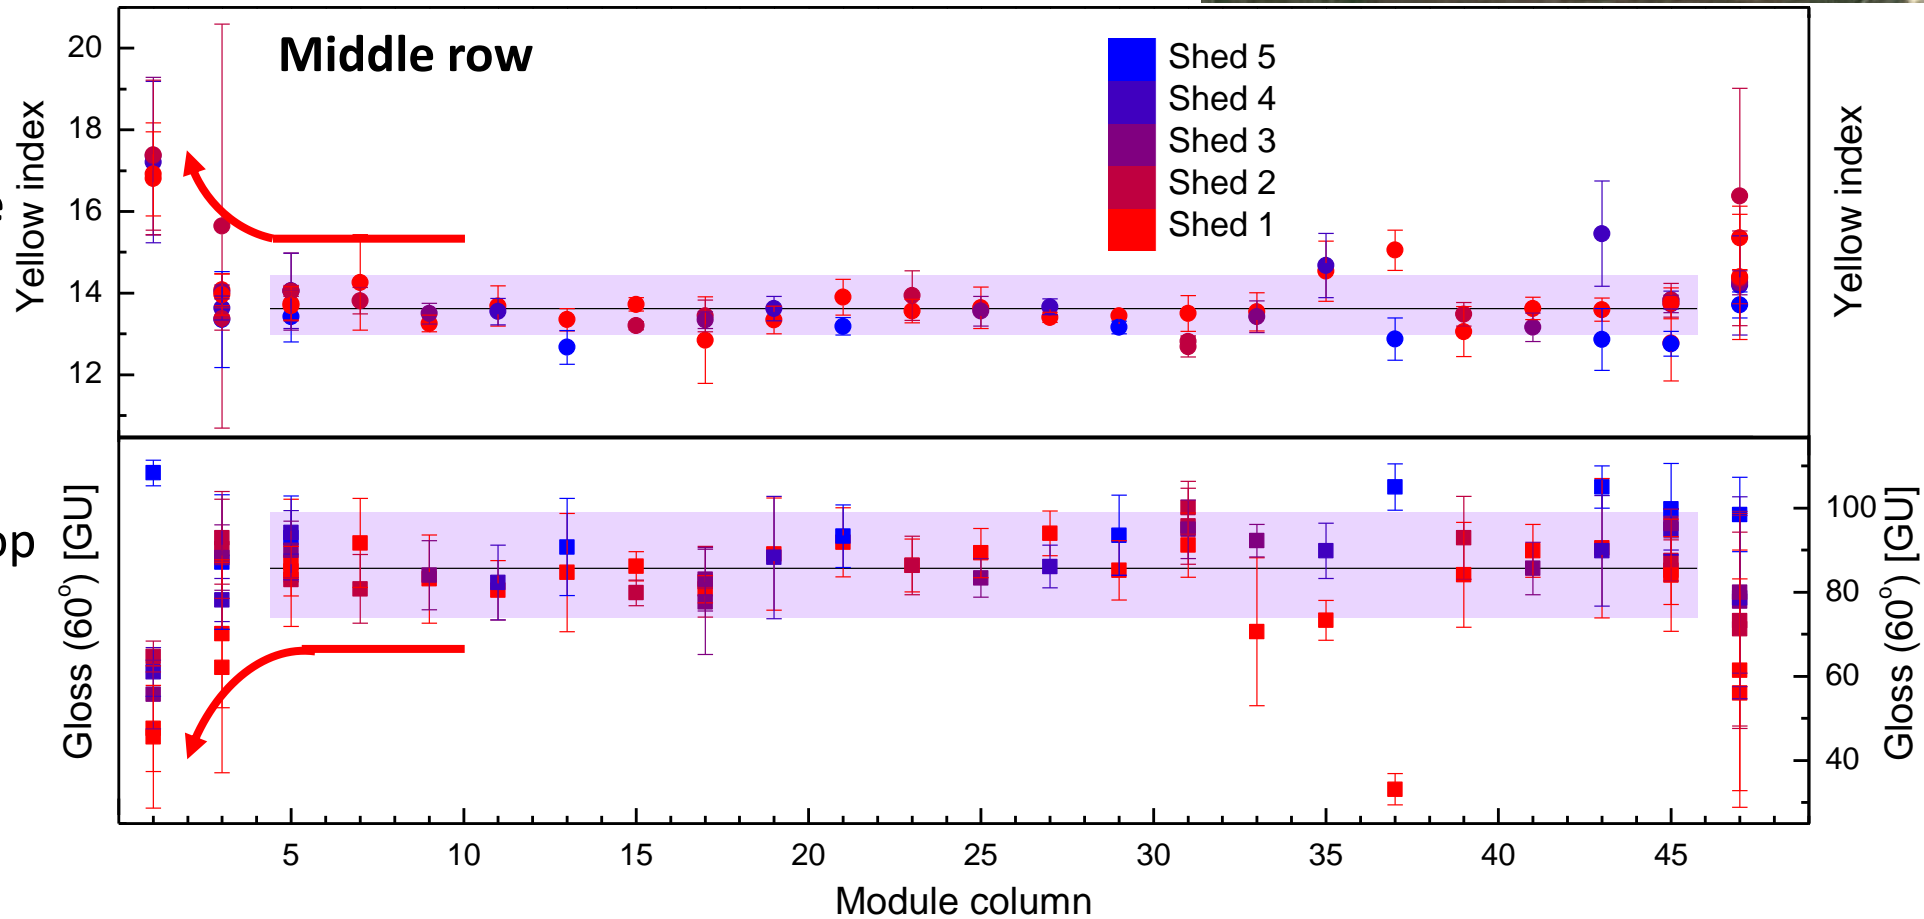
Proximity to array edge (<6 m) also influences YI and gloss

Center col. → edge
YI: 13.6 → 19.6
Gloss: 87 → 28

Effect is weaker in top row

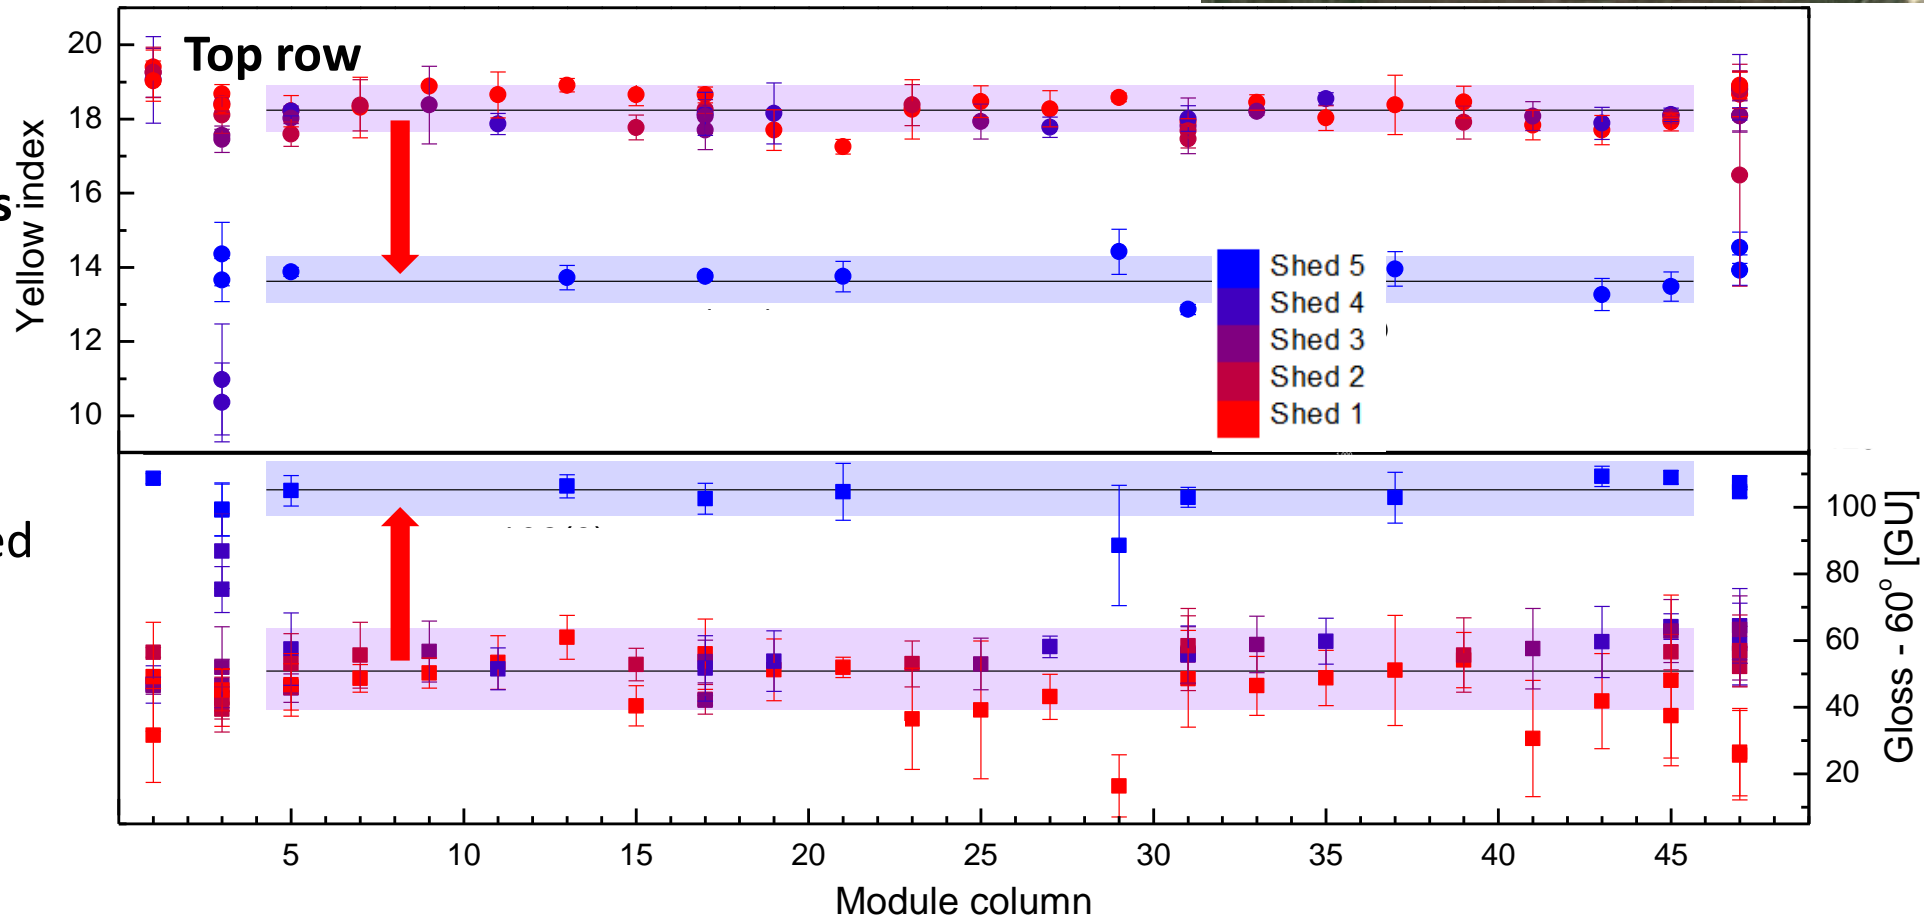
Ground albedo (rock v. grass) influences YI and gloss

Rock shed → grass

YI: 18.1 → 13.7

Gloss: 50 → 103

Also observed in shed 1 bottom row

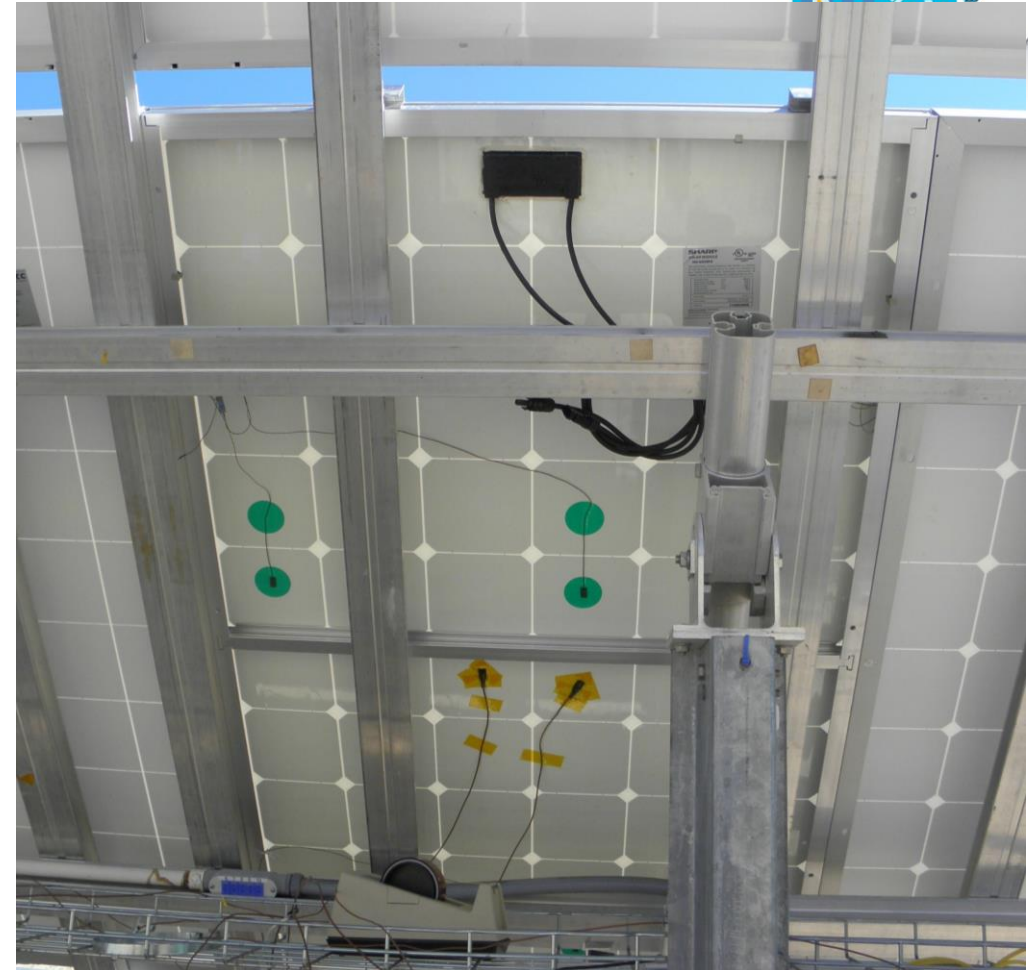
Non-uniform yellowing and gloss-loss (typ. >100 GU)

Yellowing as advanced as NIST field array modules:

- Sandy vs rocky ground cover (higher UV albedo)
- Higher ambient temp. and global irradiance

Whitest region:
YI = -1.1
Gloss (60°) = 122 GU

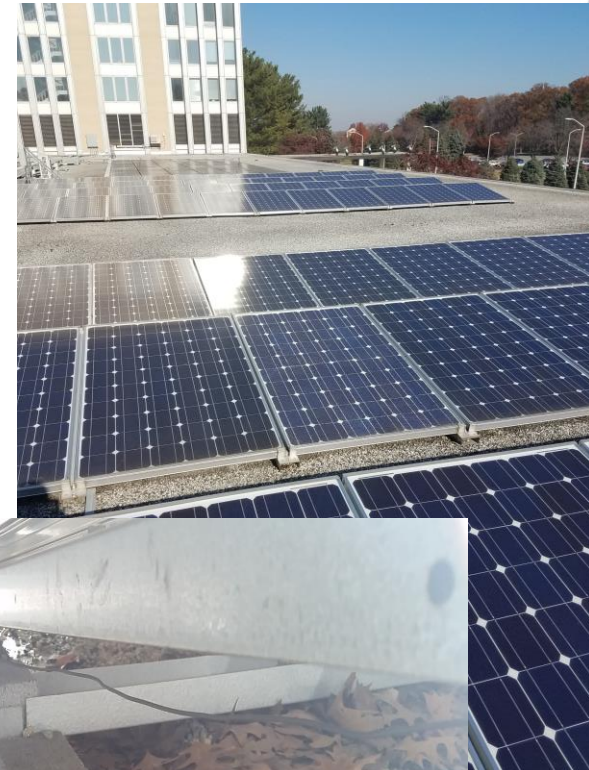
Also exhibits non-uniform yellowing and gloss-loss (typ. >110 GU)

Yellowing is less advanced than NIST field array modules:

- Much less light hitting the back
- Higher summer time max temperatures (high 60's vs low 50's)

Whitest region:
YI = -0.2
Gloss (60°) = 131 GU

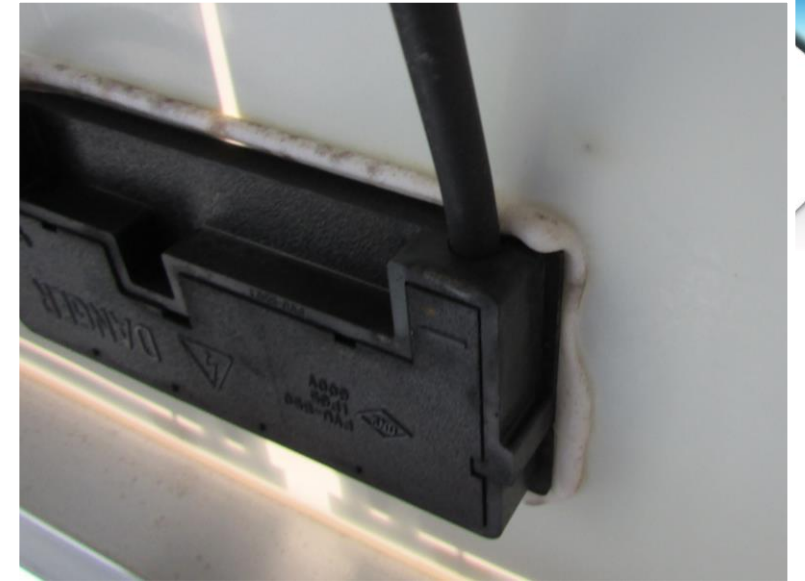
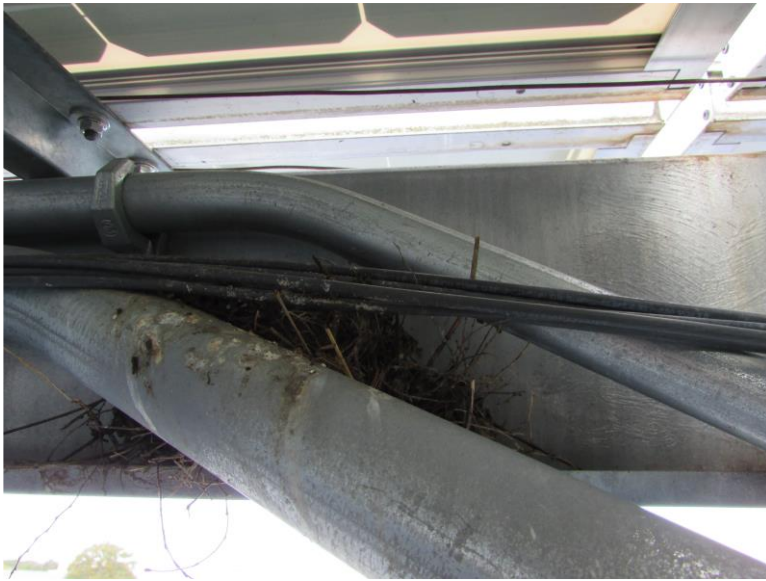
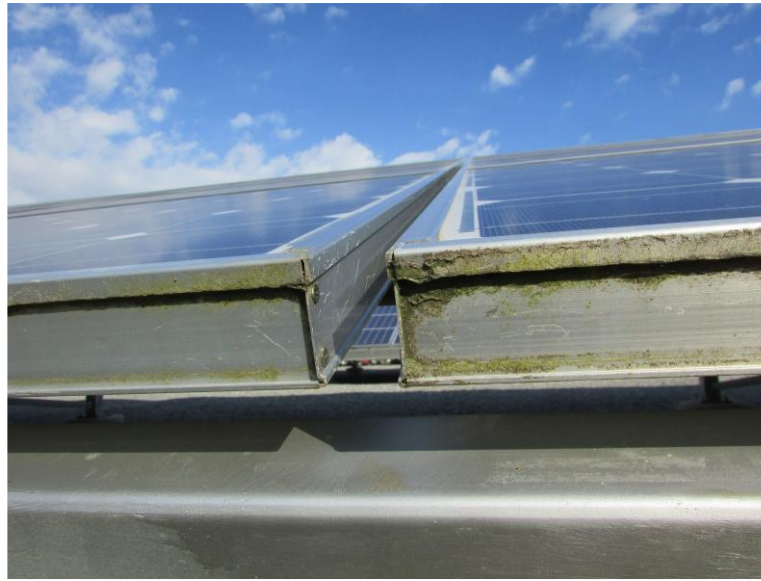
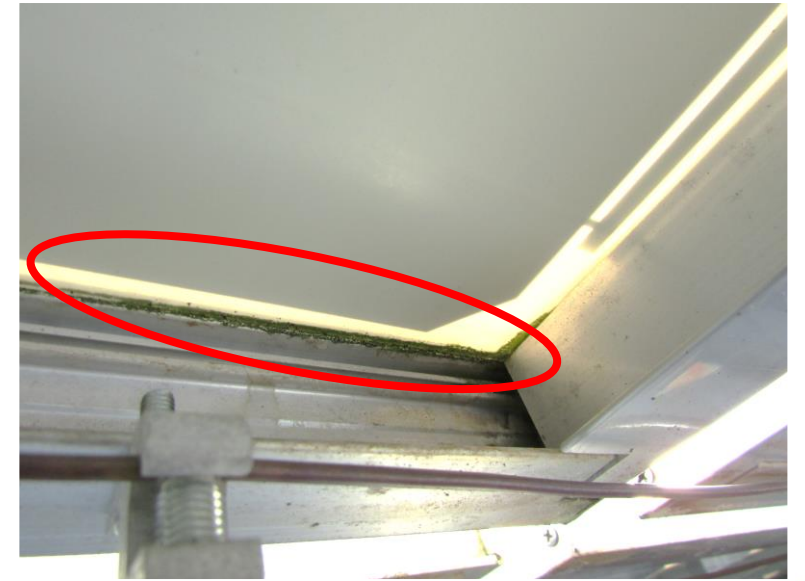
3) Miscellaneous:

- Junction boxes appear okay, some have dirt buildup
- Organic growth on frame (bottom) and backsheet near frame
- Birds, wasps...
- Dirt, scratches, tape, epoxy, etc...

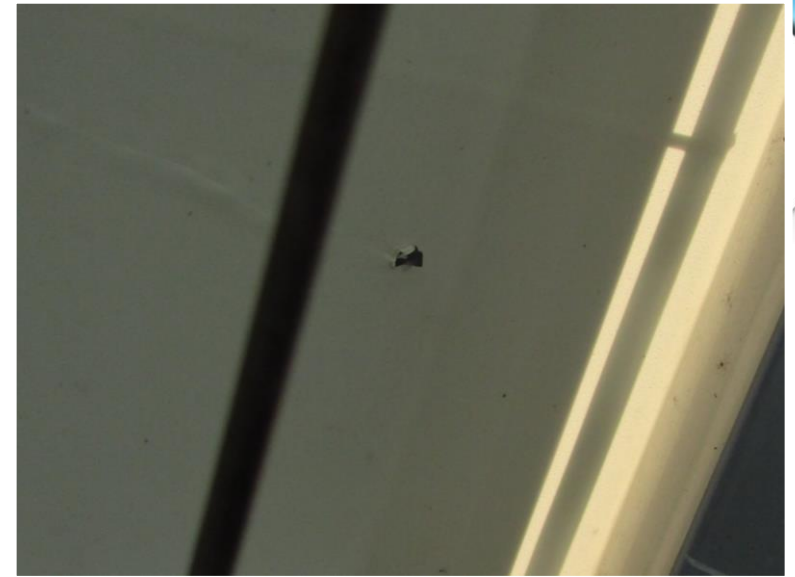
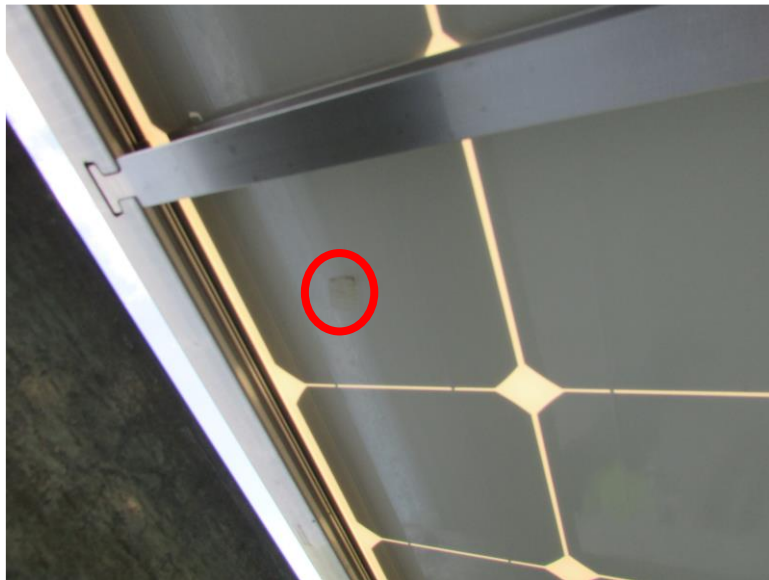
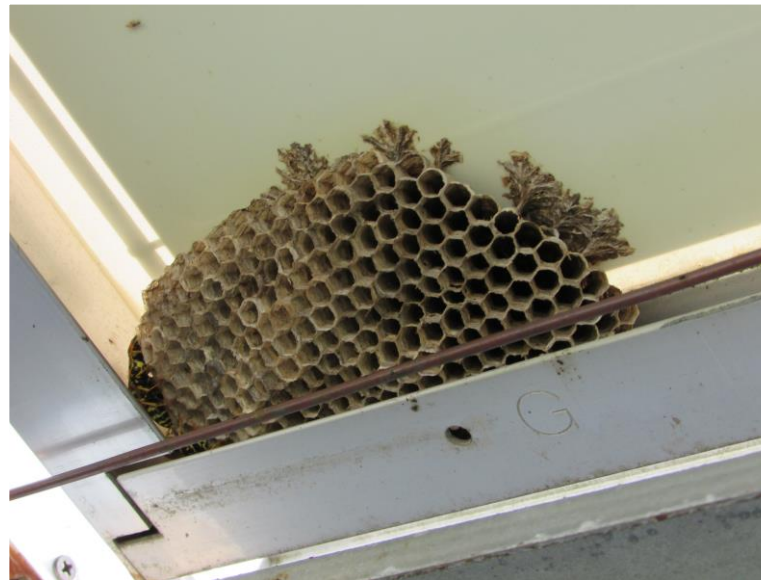
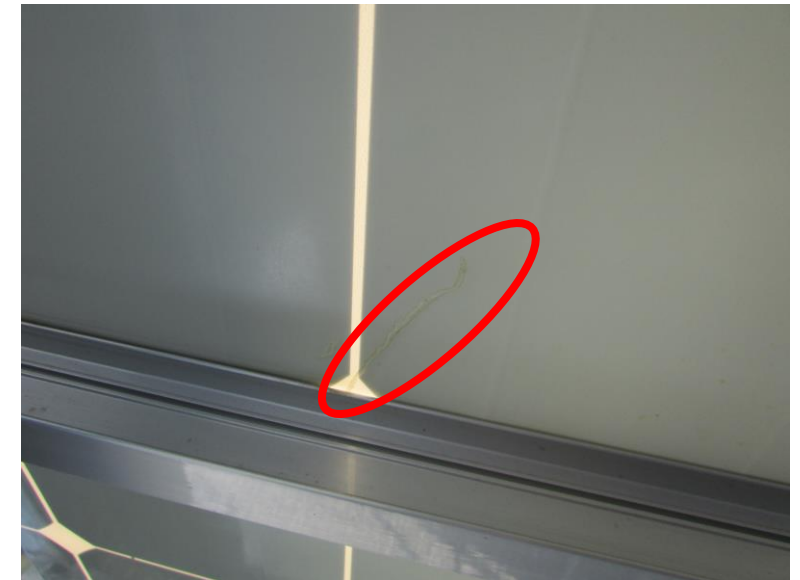
3) Miscellaneous:

- Junction boxes appear okay, some have dirt buildup
- Organic growth on frame (bottom) and backsheet near frame
- Birds, wasps...
- Dirt, scratches, tape, epoxy, etc...

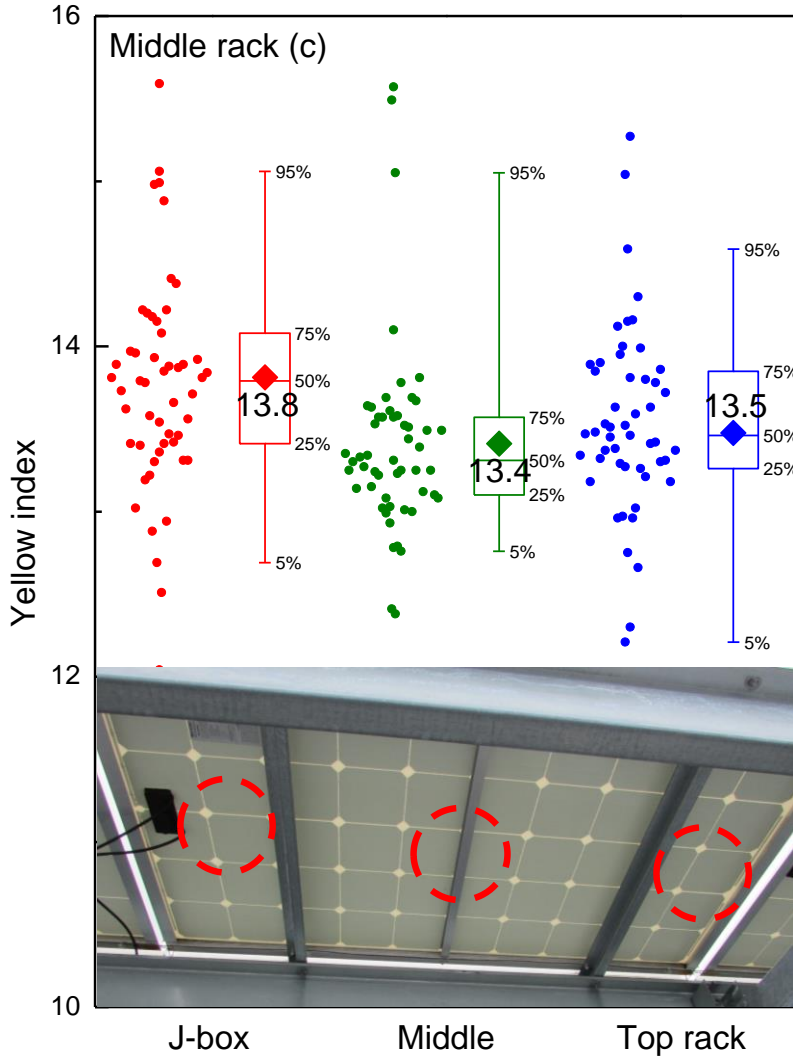
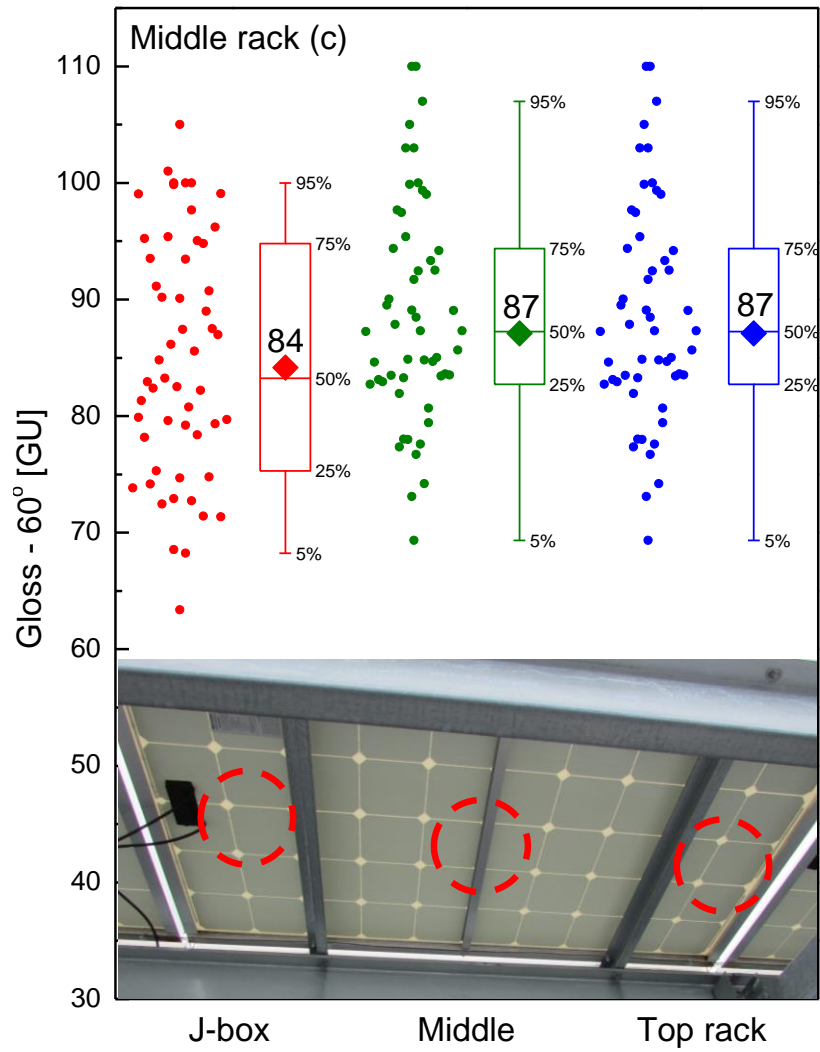
Junction box region often contains by-pass diodes, which can lead to locally higher temperatures

Yellow index: j-box region higher than middle or opposite end ($p < 0.005$)

Gloss: high standard deviation, statistically insignificant difference within modules
