Field study and analysis of backsheet degradation in 450MW+ PV installations

Atlas-NIST Workshop 2017 December 4-6, 2017

DuPont Photovoltaic Solutions

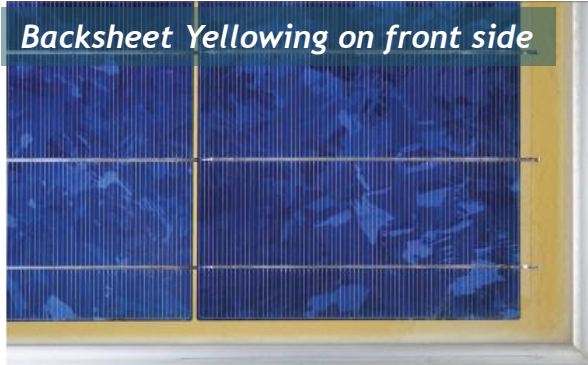
2 year old fielded module in a desert in USA- PVDF-based backsheet

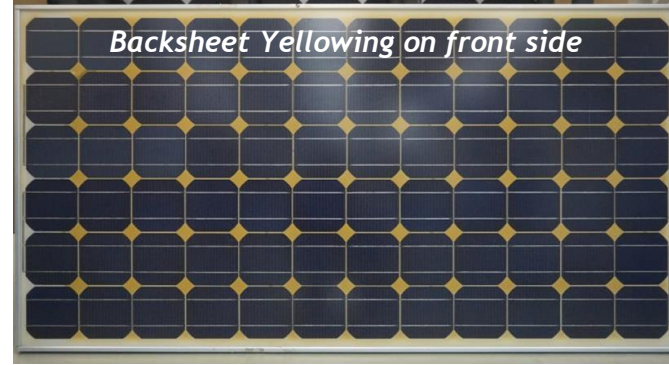
9 year old fielded module in Tibet- PET-based backsheet-100% modules yellowed in 10kW field

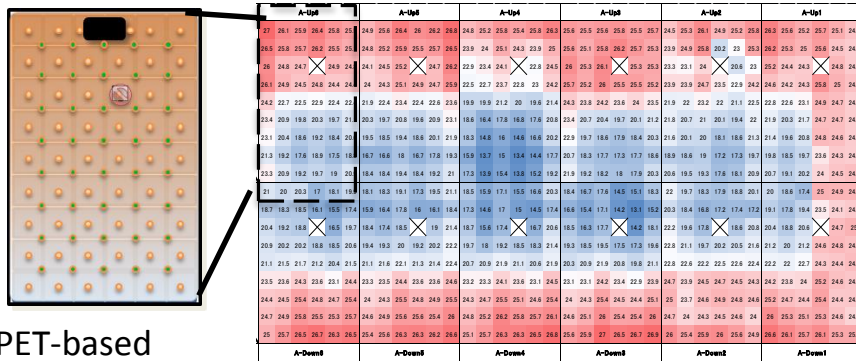
Yellowness measured on 12 rooftop modules deployed 15 years in Japan.
 Significant yellowing even on the interior of array (b* of 13-20)
 Highest yellowing is along edges with highest UV exposure (b* up to 27)

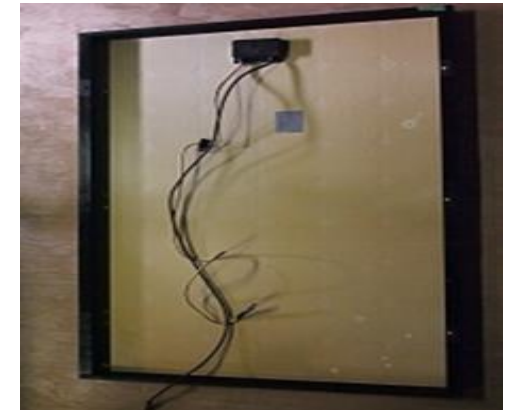
Detail of module from the installation shown on left

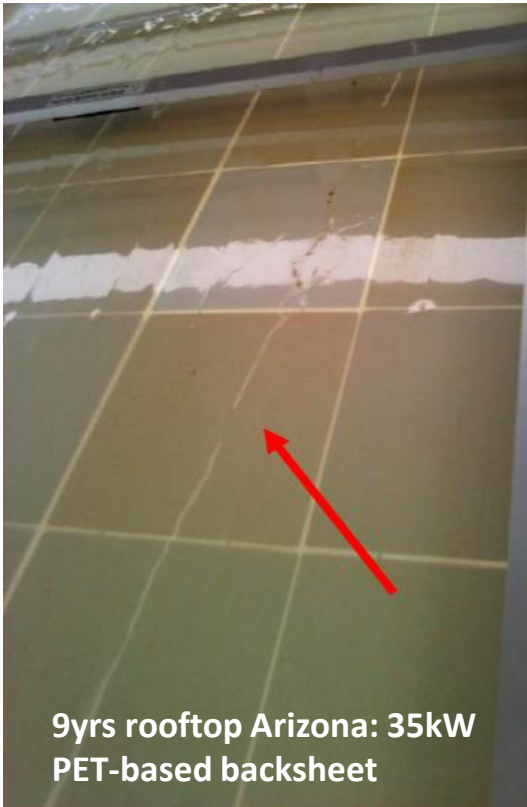
PET-based Backsheet cracking with ~15-20% of modules cracked. 80% power loss

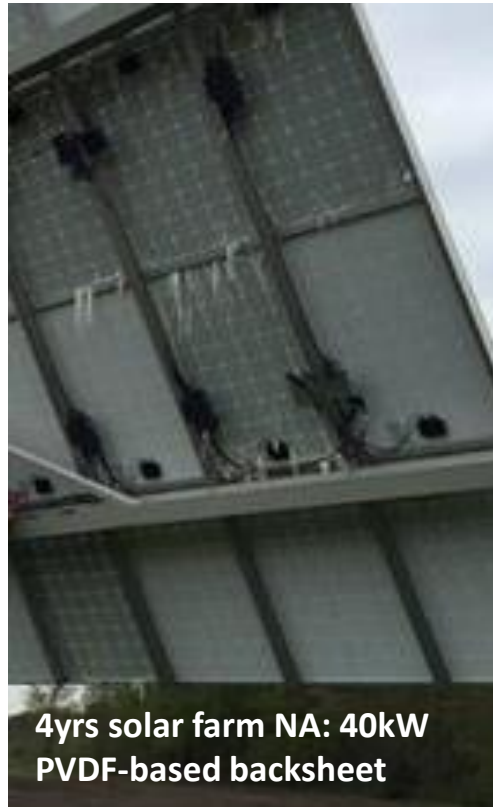
PVDF-based Backsheet cracking & delamination 57% of modules cracked

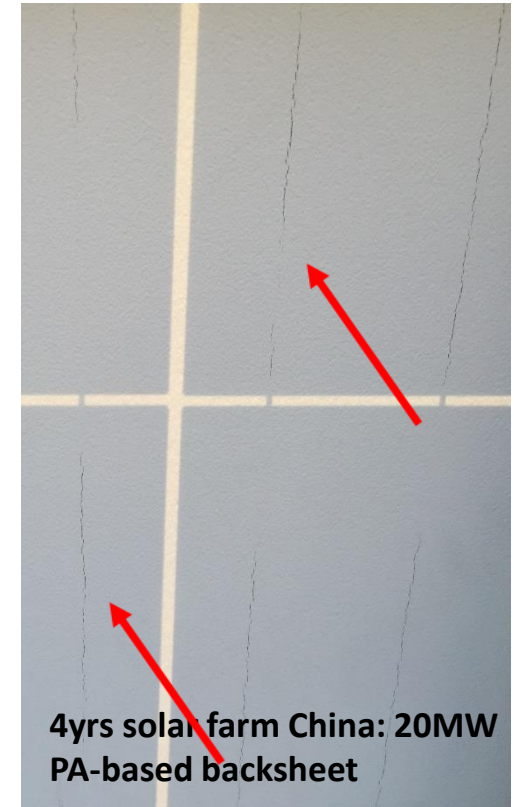
PA-based Backsheet large amount of cracking with ~40% of modules cracked.

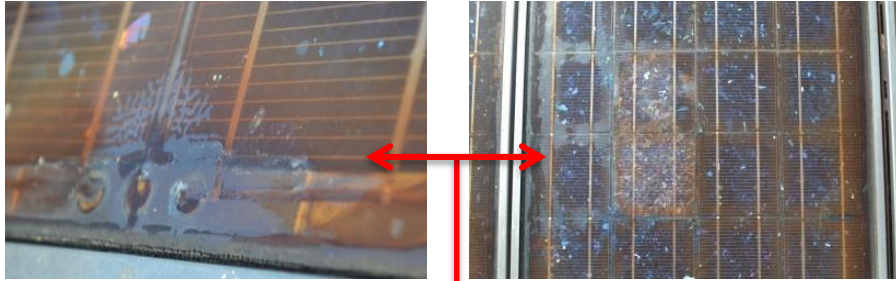
Location: Danzhou (China), Time: 15 years

Observation: Bus bar Corrosion, EVA browning
Power loss

- Multiple failures: Power Loss & Breakages across regions, applications (roof+ground)
- Believed higher corrosion rates are due to trapping of acetic acid by the glass backsheets

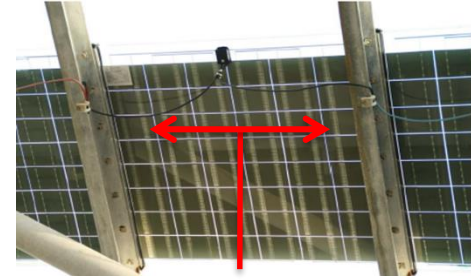
Location: Okinawa (Japan), Time: 11 years

Observation: Bus Bar Corrosion,
Power loss

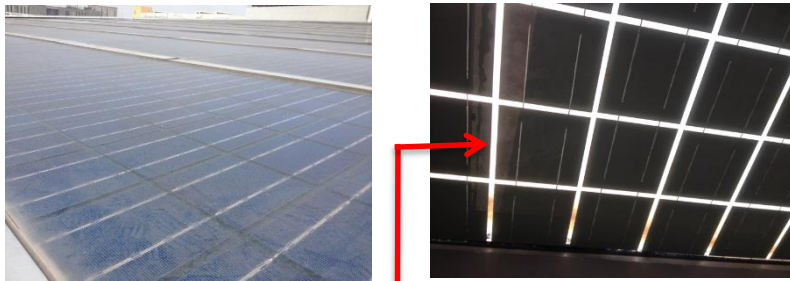
Location: Shanghai (China), Time: 5 years

Observation: Bus bar Corrosion
Power loss

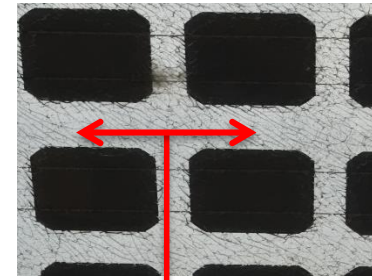
Location: Yannan (China), Time: 10 years

Observation: Extensive breakage
