**Photo C-1. NIST Nain Entrance – Front of the House shown with library on the left side and auditorium on the right side of entrance (view southwest)**

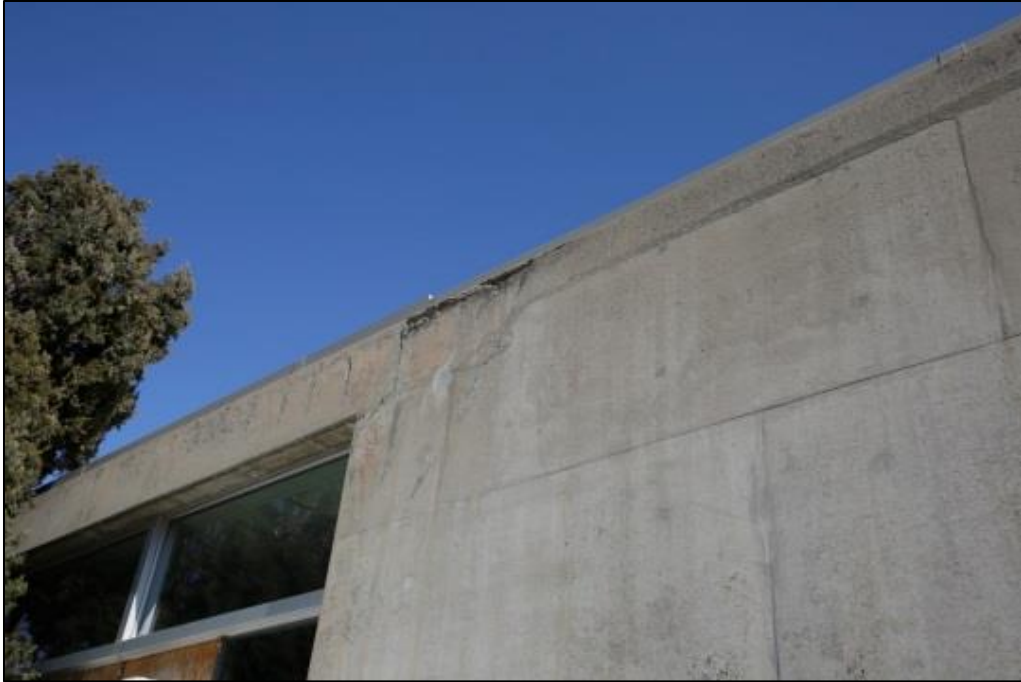
**Figure C-2. Exposed Concrete Wall on West Elevation of Auditorium (view southeast)**

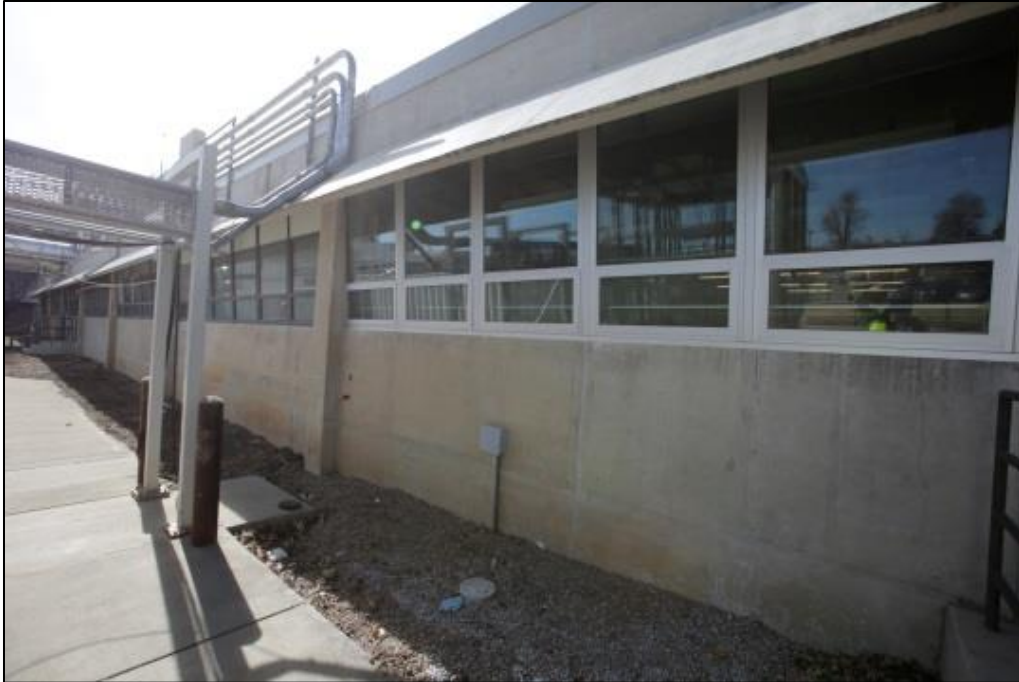
**Photo C-34. Orange Staining on Concrete and Replacement Windows on North Elevation of Wing 1 (view southeast)**

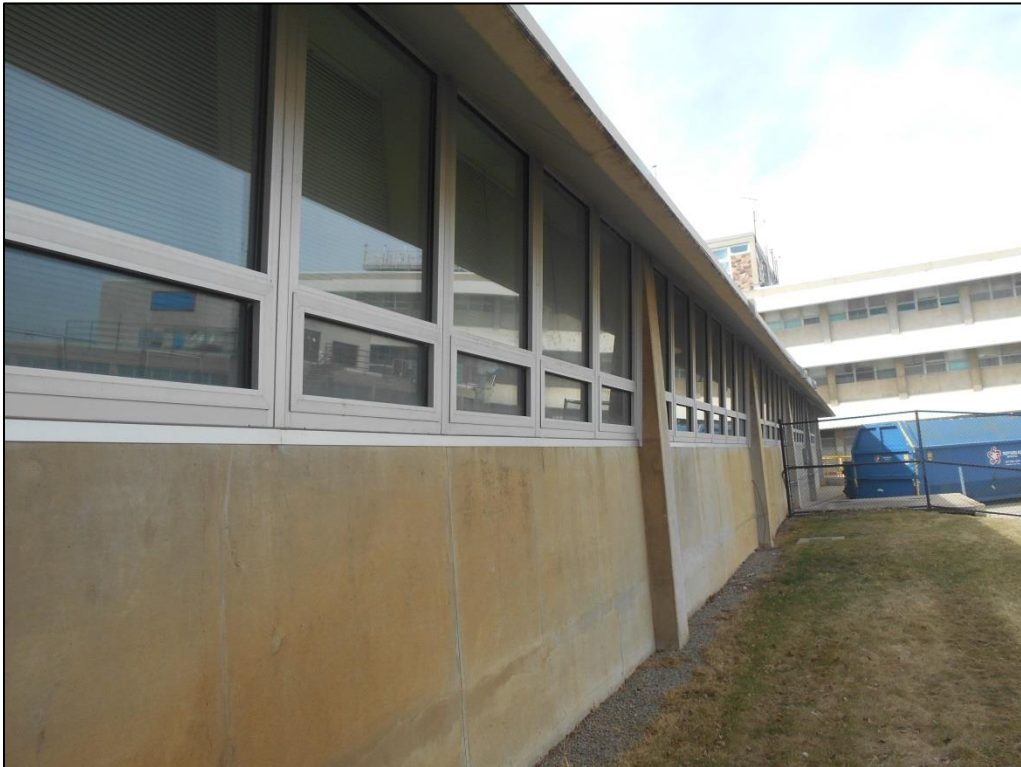
**Photo C-49. Concrete Wall Detail with Horizontal Pour Line, Vertical Control Joint, and Orange Concrete Stains; Typical of Wings 1, 2, and 4.**

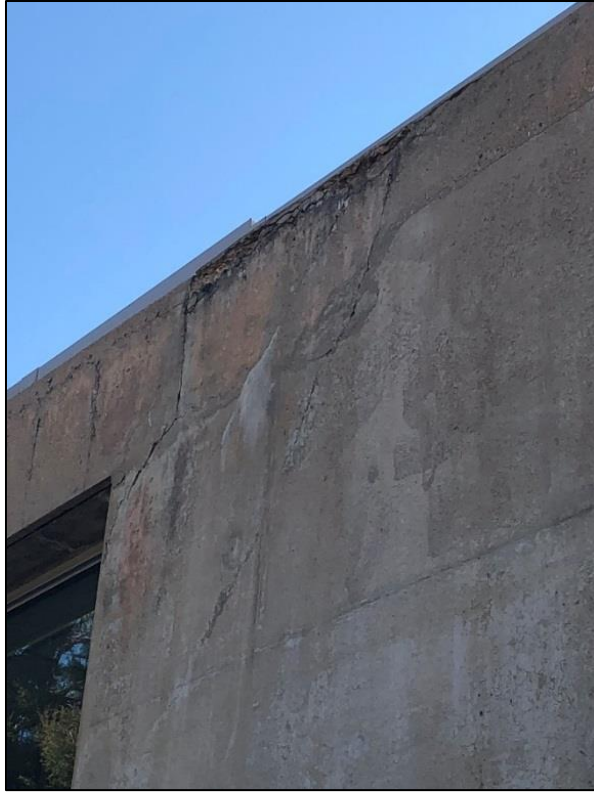
**Photo C-154. Spalls at Steel Embed**

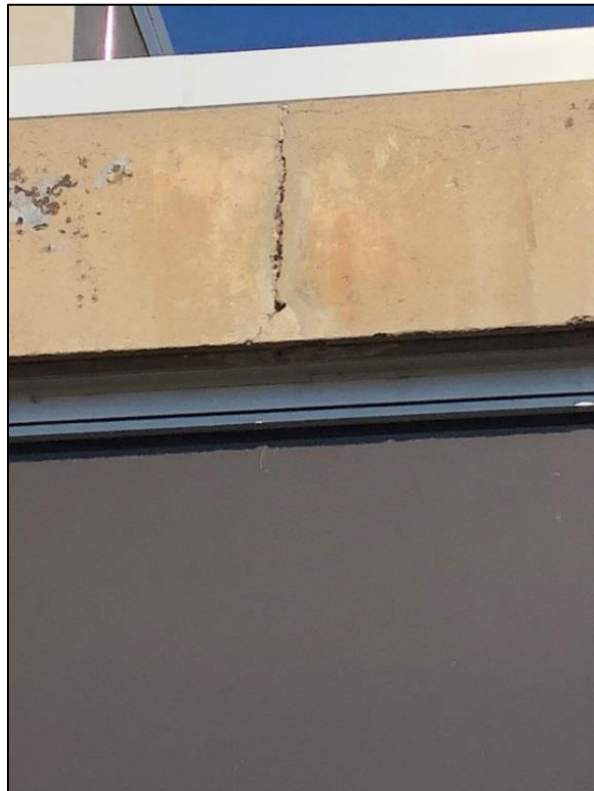
**Photo C-155. Water Exposure and Cracks**

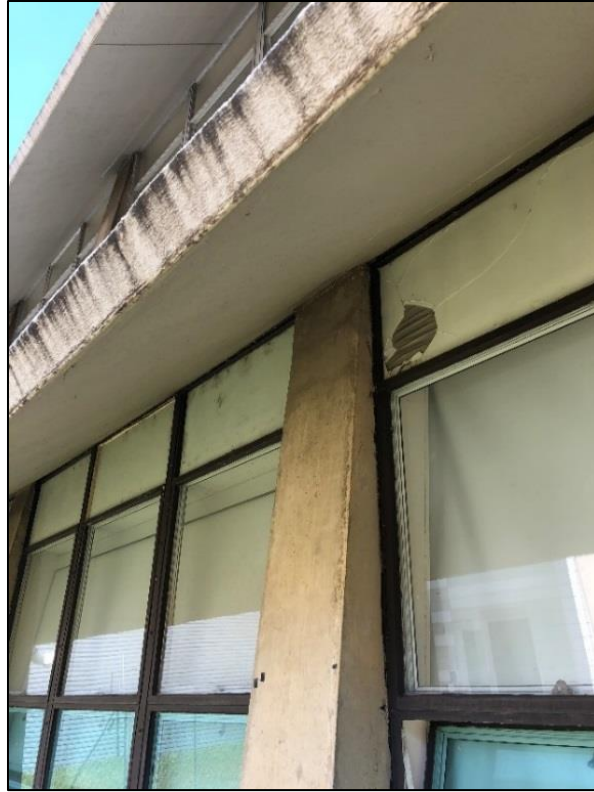
**Photo C-156. Cracks**

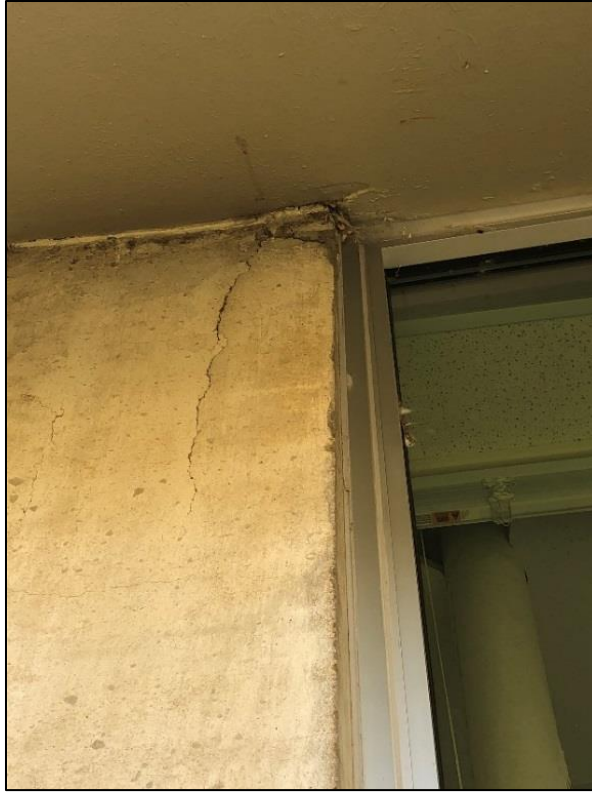
**Photo C-158. Column Cracks and Stains**

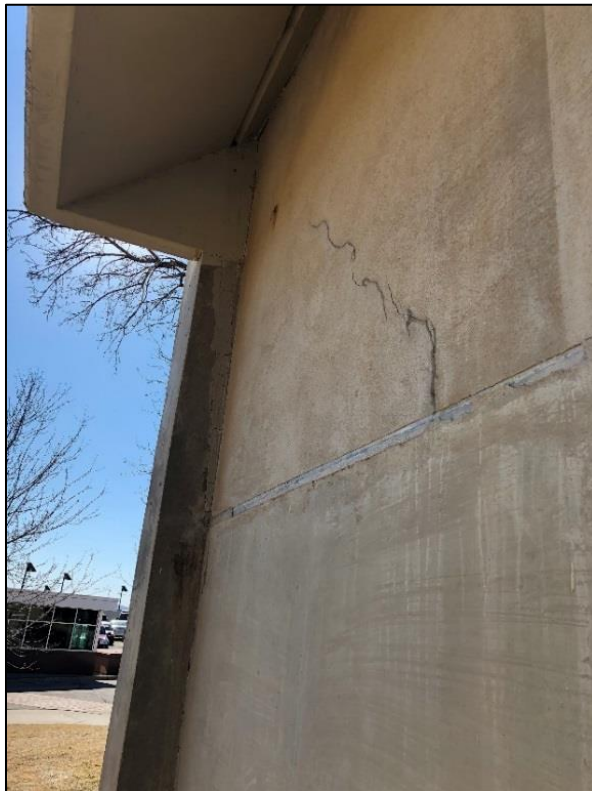
**Photo C-159. Cracking at Top of Column**

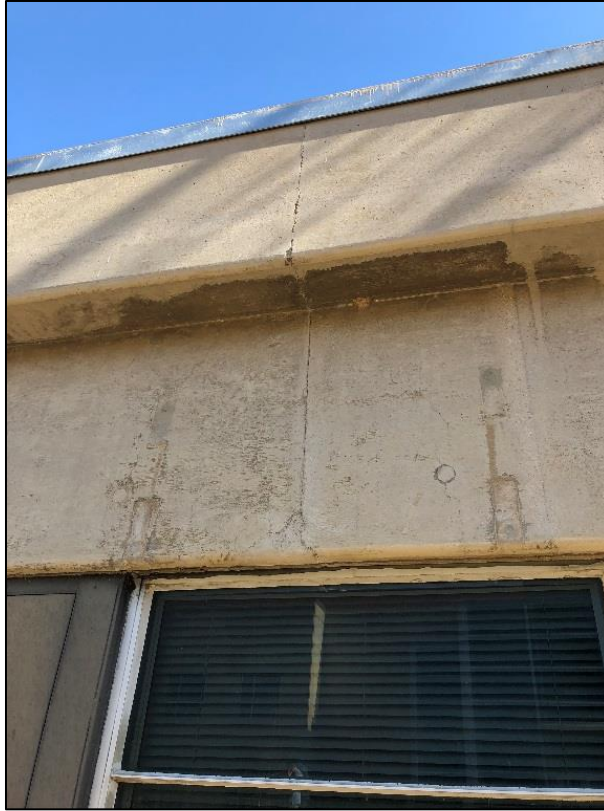
**Photo C-160. Cracks in Wall**
