HISTORIC STRUCTURE REPORT

NATIONAL BUREAU OF STANDARDS RADIO BUILDING (BUILDING 1)

U.S. Department of Commerce Boulder Laboratories
Boulder, Colorado

July 2018

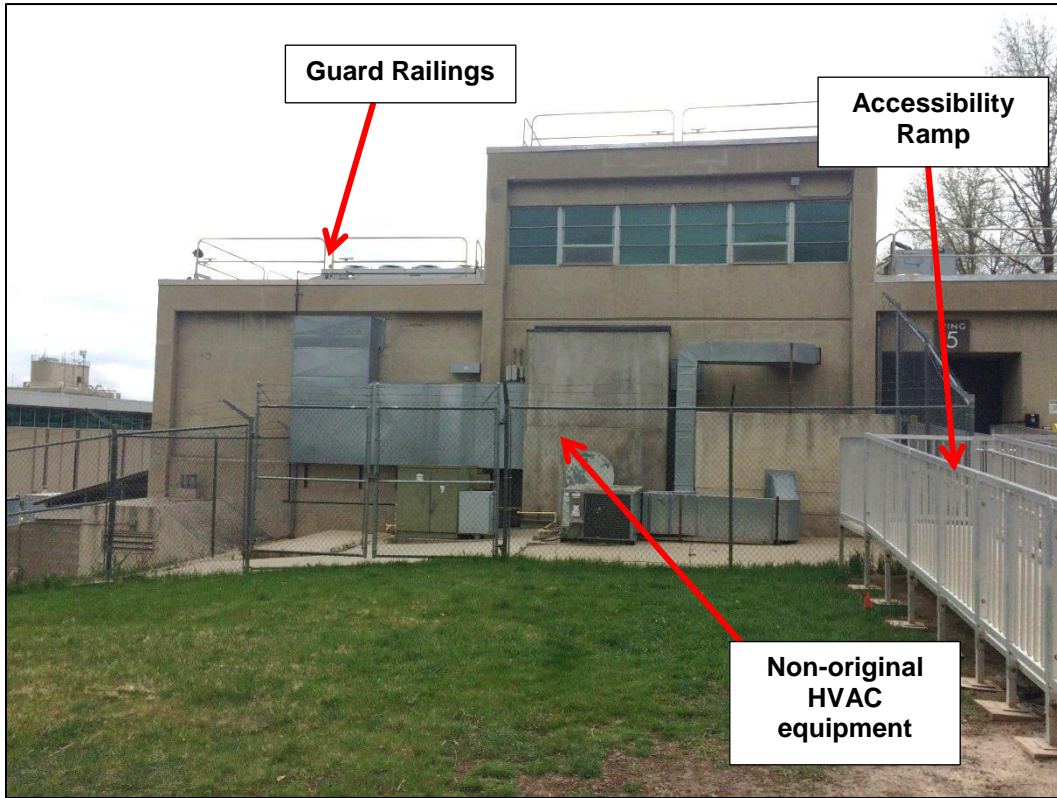
Figure 3-3. Wing 5, Looking Southwest – Mechanical Systems Additions

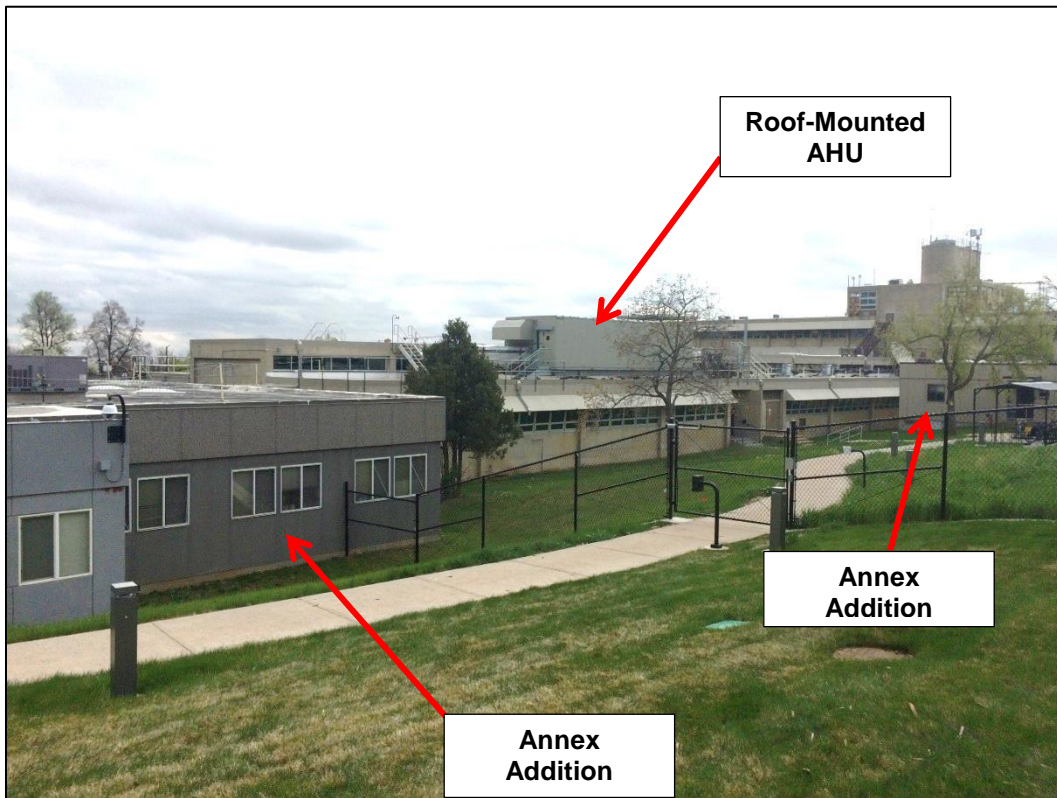
Figure 3-4. Wing 1, Looking Southeast – Mechanical Systems Additions

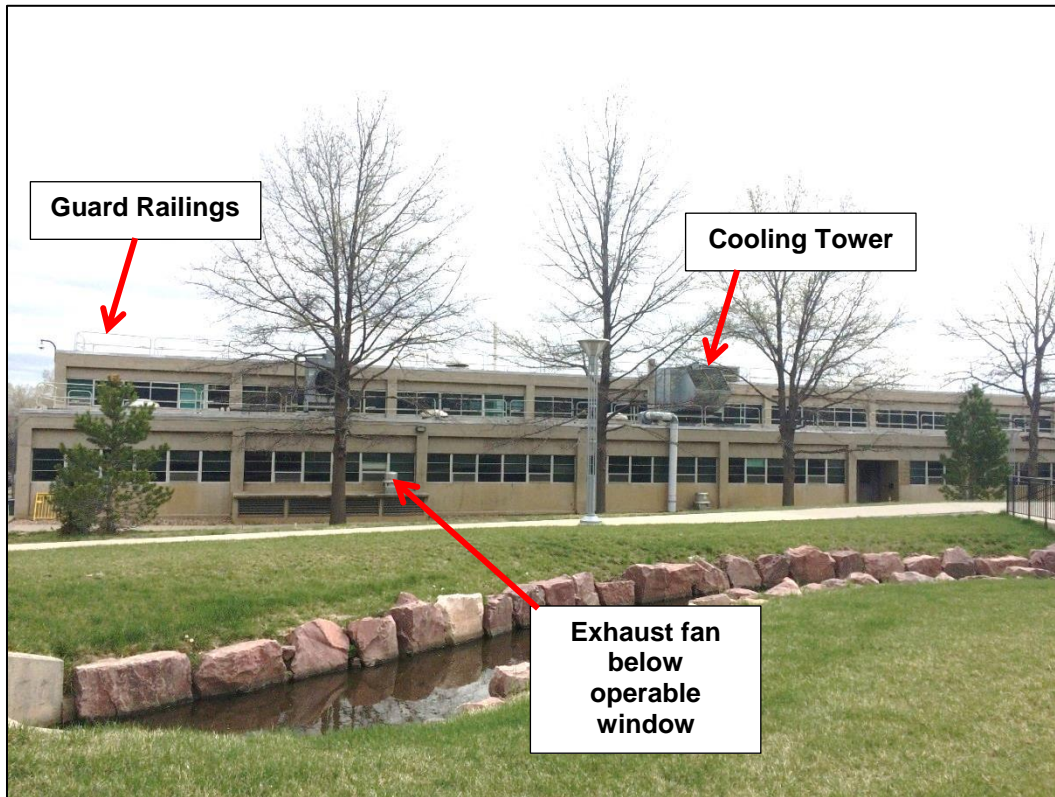
Figure 3-5. Wing 5, Looking East – Mechanical Systems Additions
