Federal Building and Fire Safety Investigation  
of the World Trade Center Disaster

**Project #3: Analysis of Structural Steel**  
*Update*

June 22, 2004

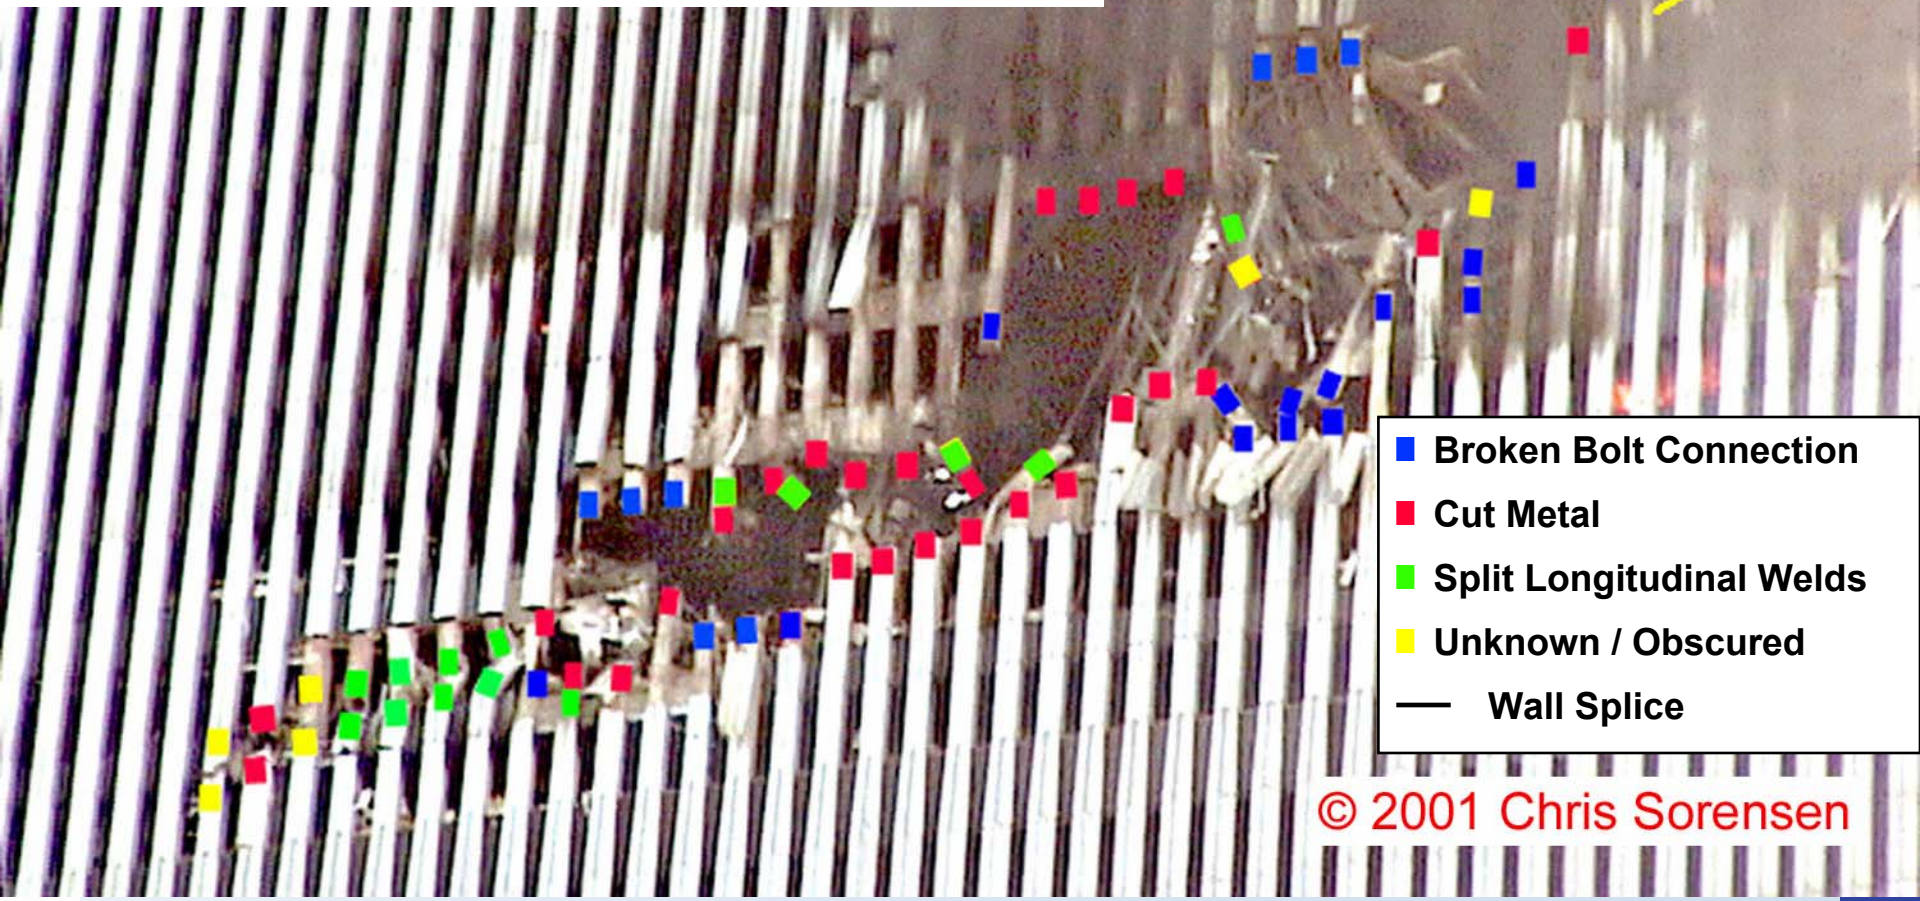
- Collapse did not significantly damage many impacted panels
- Impact area: bolt fractures dominate column connection failure
- Columns severed at stiffener plates
- Weld unzipping common in impacted panels
- Inner webs buckled from fire
- Above impact zone: spandrels fail by bolt tear-out
- Below impact zone: spandrels fail by tearing off column

■	Broken Bolt Connection
■	Cut Metal
■	Split Longitudinal Welds
■	Unknown / Obscured
—	Wall Splice

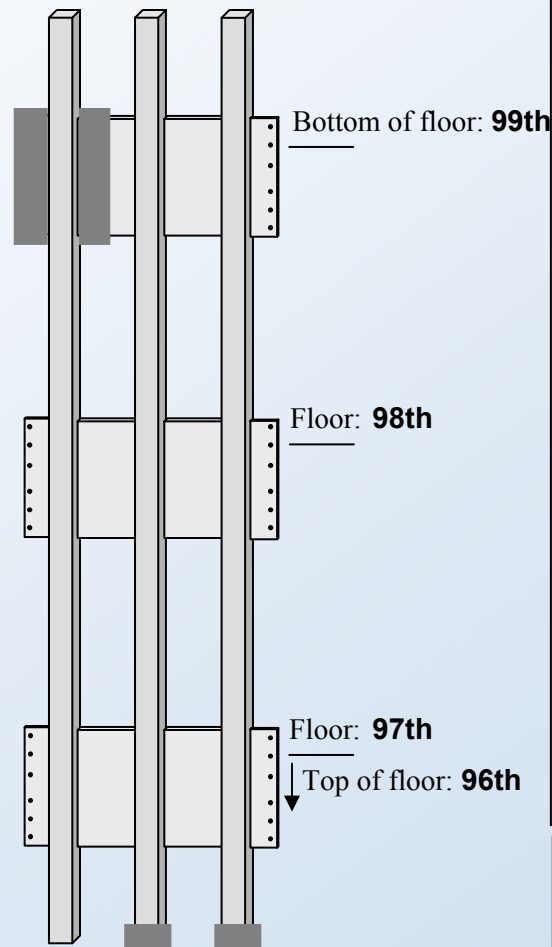
**NIST Name:** M-2  
**Panel ID:** A130: 96-99  
**Panel location:** WTC 1, North face  
**Window lines:** 28-31

■ **Un-recovered portion of panel**

External flaming	3
Fire inside	2
Spot fire	1
No fire evident	0
No determination	9
Unrecovered portion of panel	#

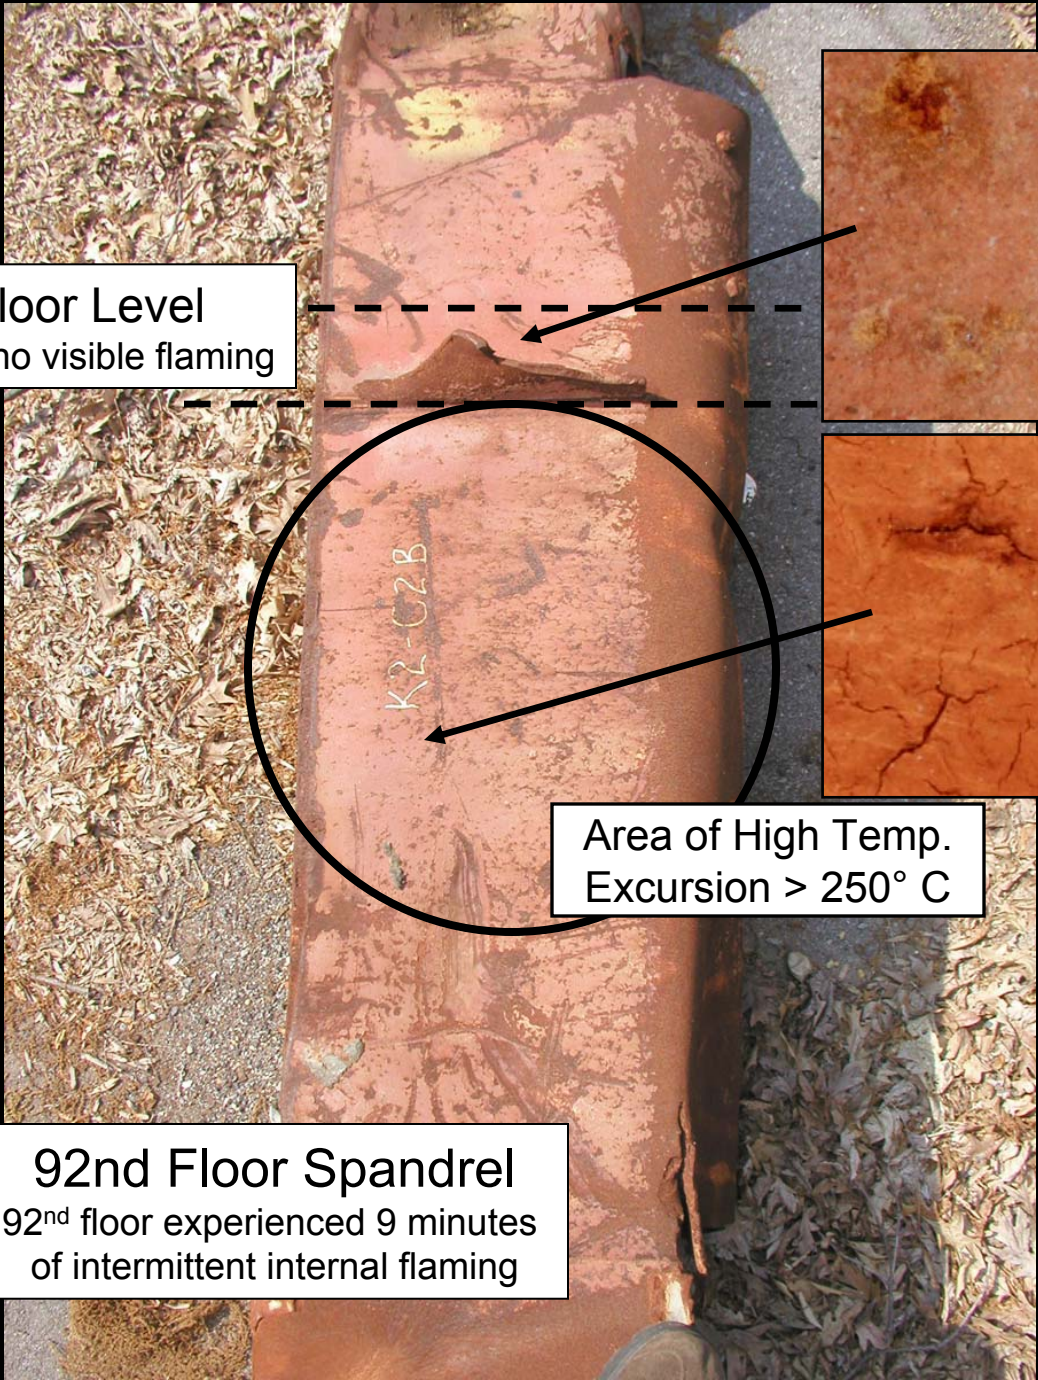
# WTC 1

93<sup>rd</sup> Floor Level  
93<sup>rd</sup> floor – no visible flaming

Area of High Temp. Excursion > 250° C

92<sup>nd</sup> Floor Spandrel  
92<sup>nd</sup> floor experienced 9 minutes of intermittent internal flaming

**Conclusion:**  
Area protected by floor slab stayed under 250° C
