PV modules' reliability deployed in Japanese PV power plant from viewpoint of encapsulant

December 8th 2015

Tsuyoshi Shioda
Mitsui Chemicals, Inc.

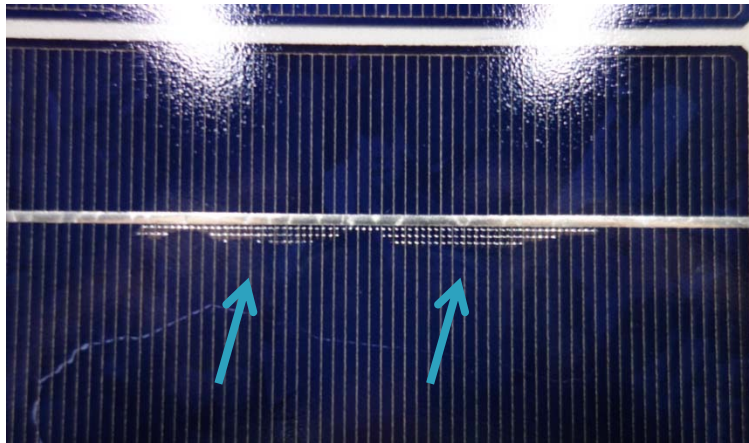
delamination between Si and EVA
during storage (~1y) in our warehouse

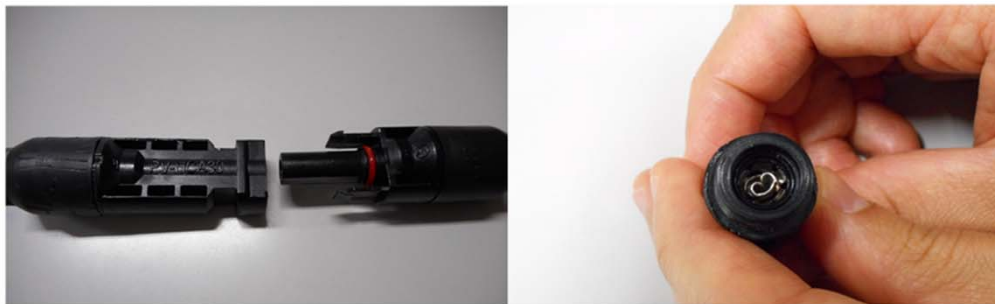
MC4 compatible connector

pulling cable off “easily” from connector

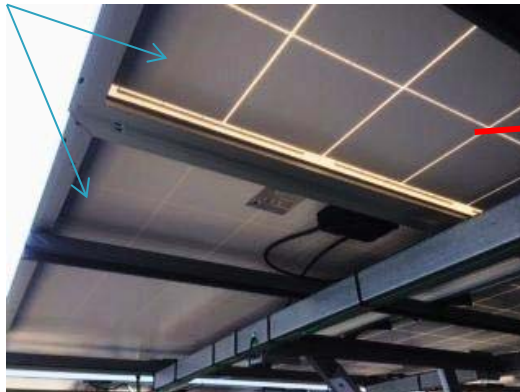
Same type of a PV module

Different backsheet

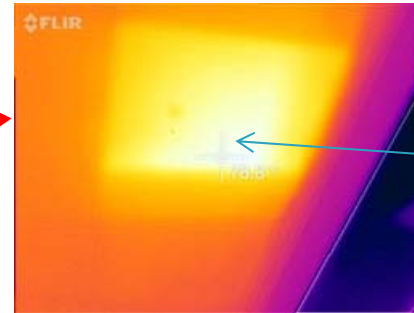
Infra-red observation

Hotspot

Solder joint failure

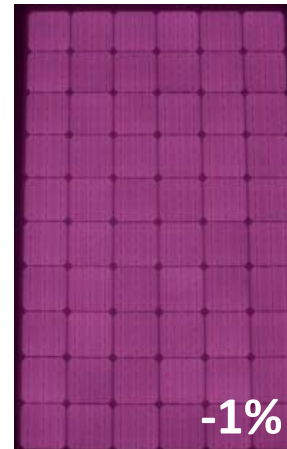
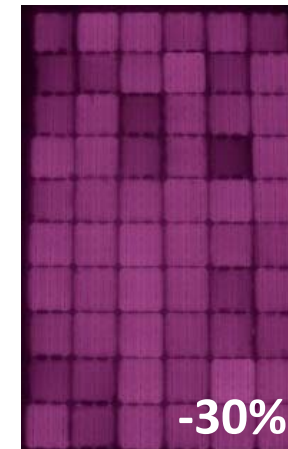
Electroluminescence (EL) images after PID test

Different encapsulant

Same type of a PV module

- ✓ We have seen some troubles and failures of PV modules and PV plants in Japan.
- ✓ According to our services' results, there were some cases that use of different PV materials for same type PV modules led to different durability and reliability of the PV modules.

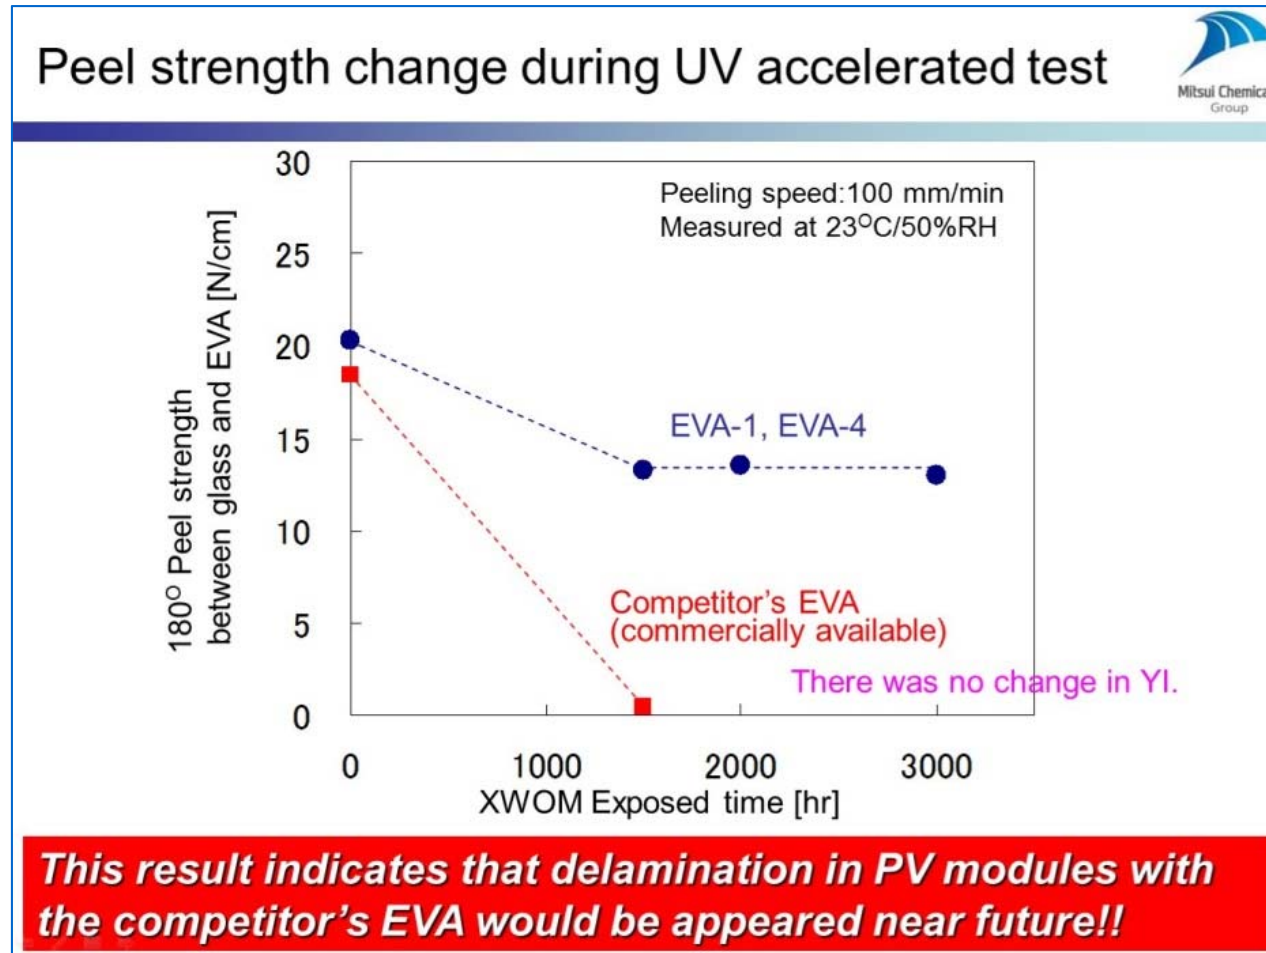
Importance of formulation of EVA encapsulant

This phenomenon is due to **lack of “additive” related to durability of light exposure.**
(not UV absorber)

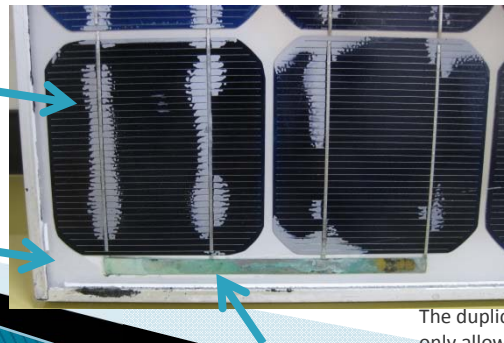
- ✓ Some PV modules evaluated on 2014 have high risk of delamination according to our additive analysis.
- ✓ However the risk for those evaluated on 2015 would be low and not zero.
- ✓ We have to beware that function of UV absorber in EVA is mainly to protect backsheet against UV damage and completely differs from that of additive "A".

15 years field aged PV module with delamination and corrosion
(Both EVA has two additives shown in the table...)
