# Challenges for Fuel debris retrieval with Robotics technologies at Fukushima Daiichi NPS

*February 3, 2016*

*Fukushima Daiichi Decontamination & Decommissioning Engineering Company,  
Tokyo Electric Power Company*

## *2. PCV Surveys with Robotics*

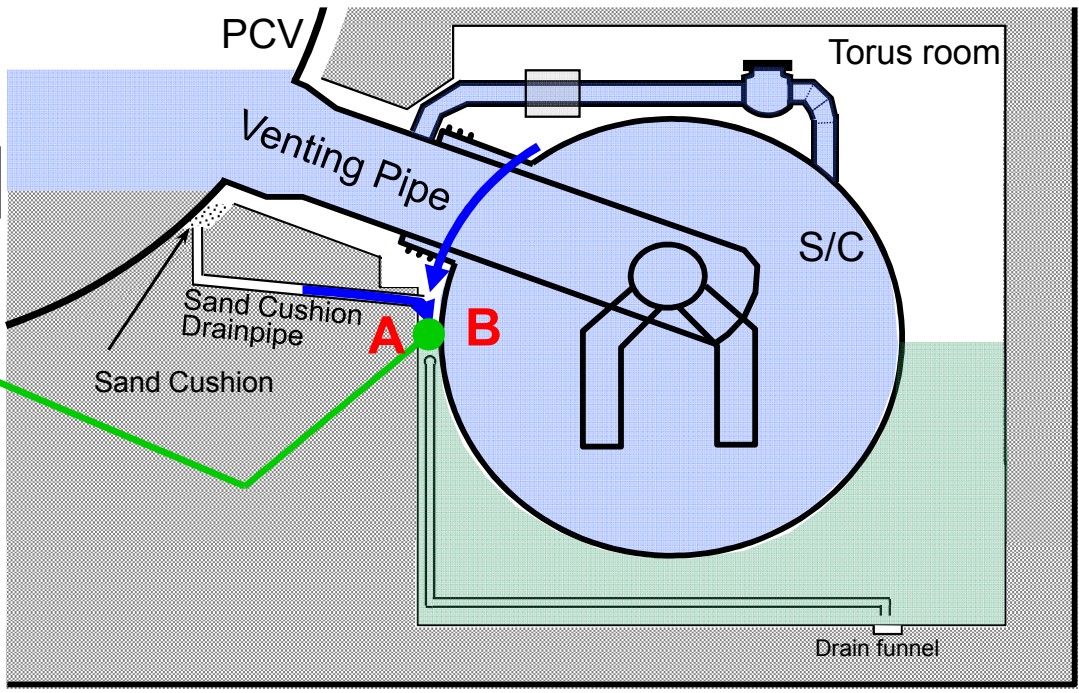
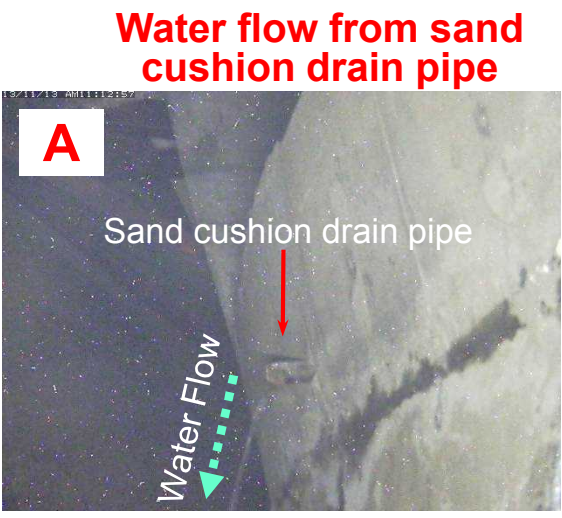
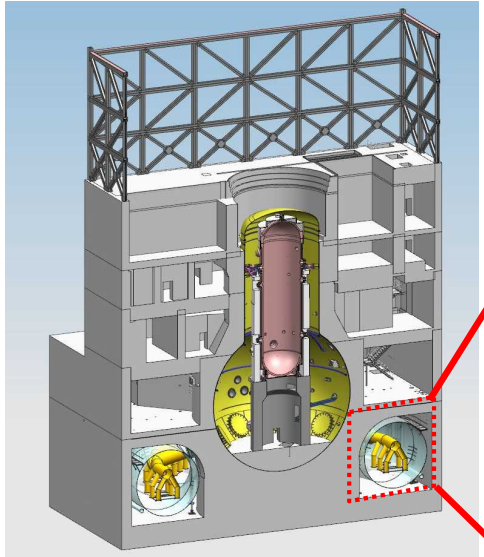
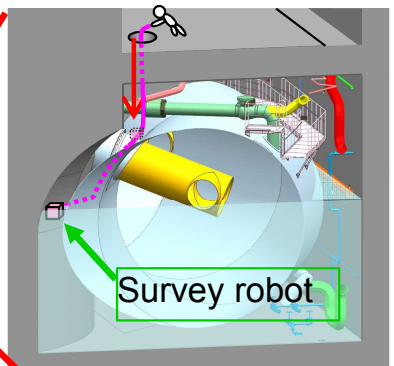
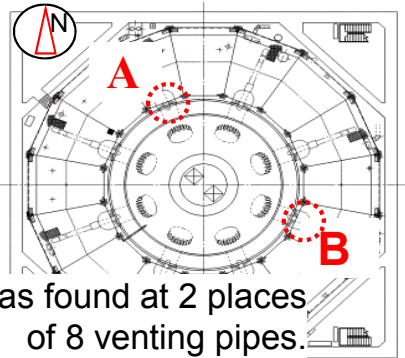
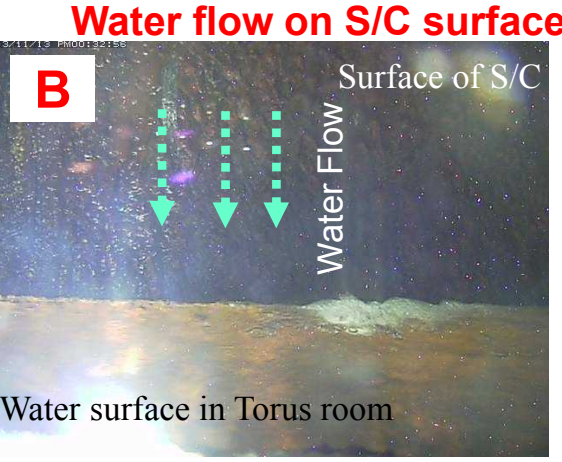
- Water leakage was found in sand cushion drain pipe. (November 2013)
- It indicates the possibility of D/W shell damaged.

Leakage was found at 2 places of 8 venting pipes.

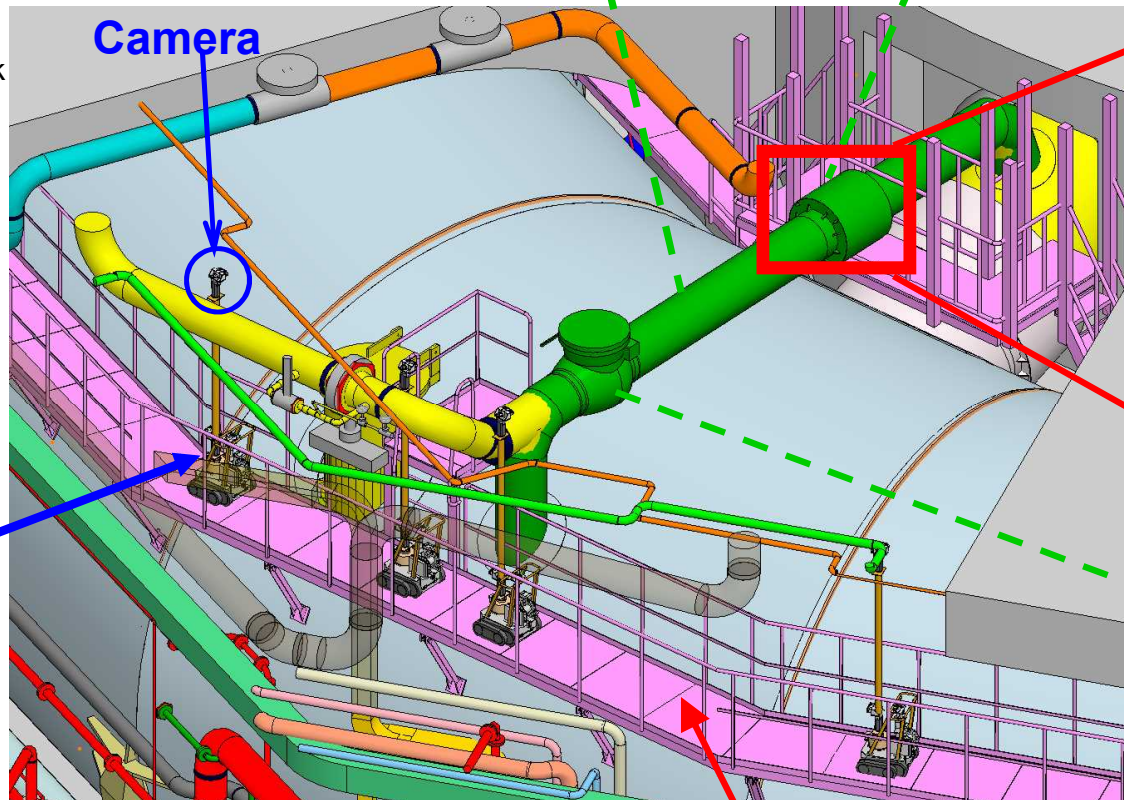
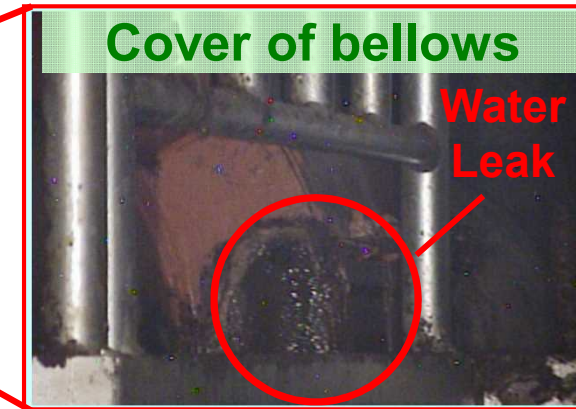
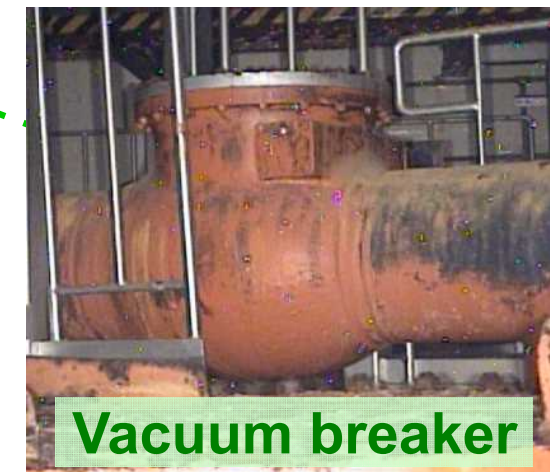
- Water leakage was found at the bellows cover on the vacuum breaker.
- No other leaks were found. line (May 2014)

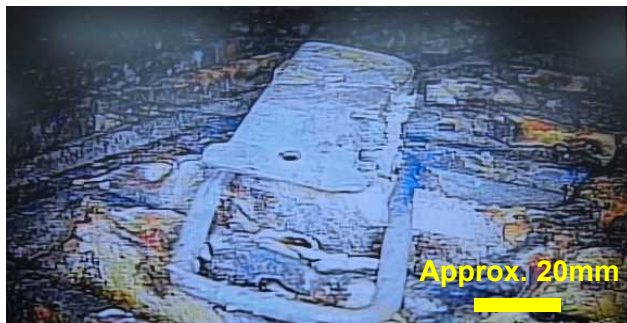
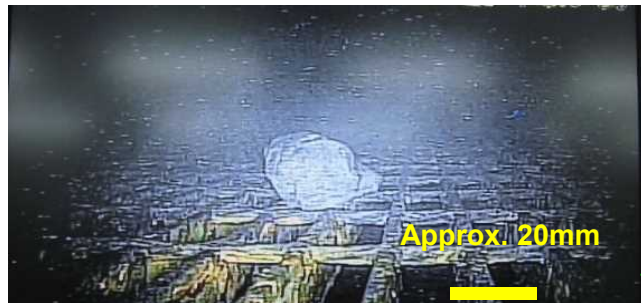
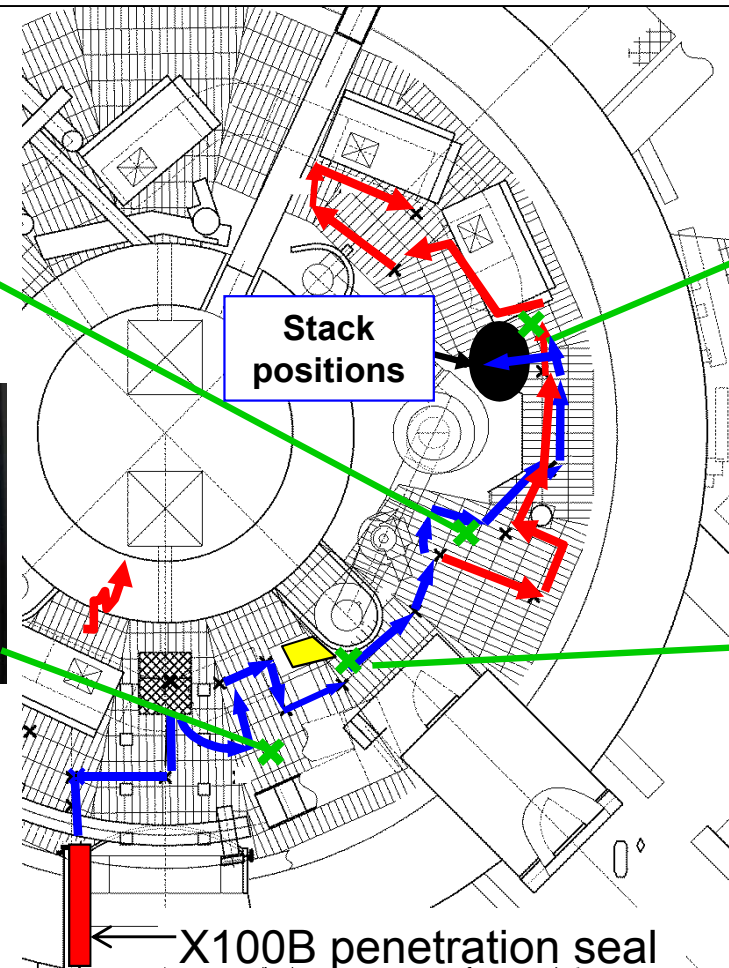
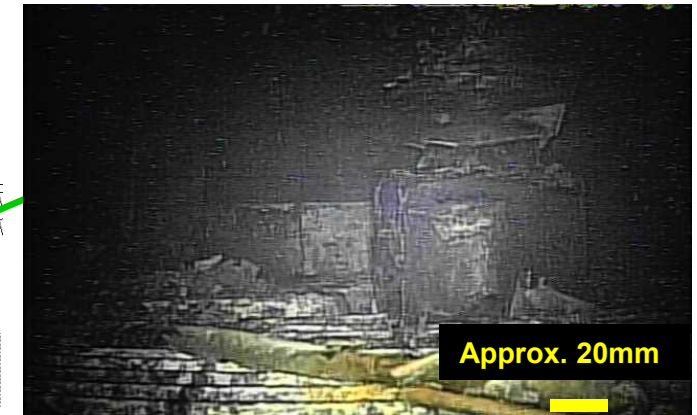
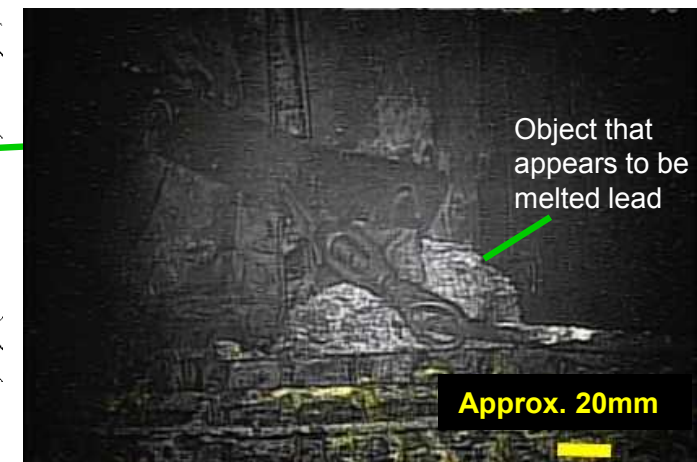
- Detected Dose rate: Approx. 5-10Sv/h and Temp. Approx. 18-21 degree C.
  - Does not appear to be dependent upon a specific location.
- No apparent damage was found
  - On the equipment above the grating on the first floor of the PCV.
- Melted lead was found a lot. (Melting point 328 degree C)

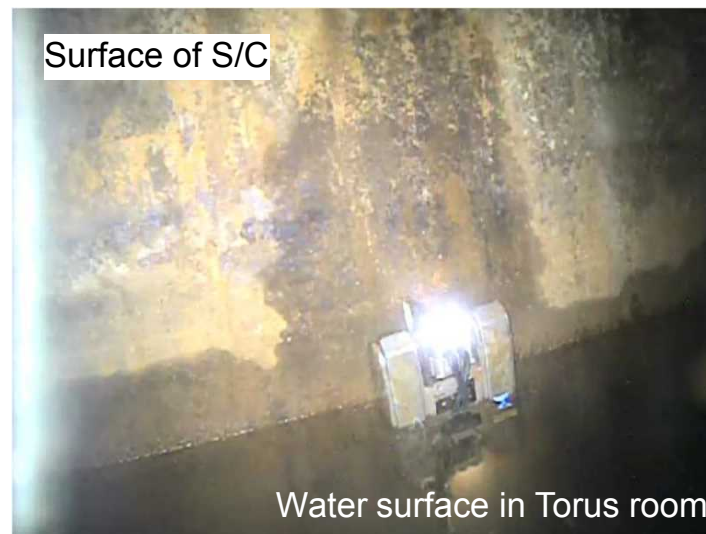
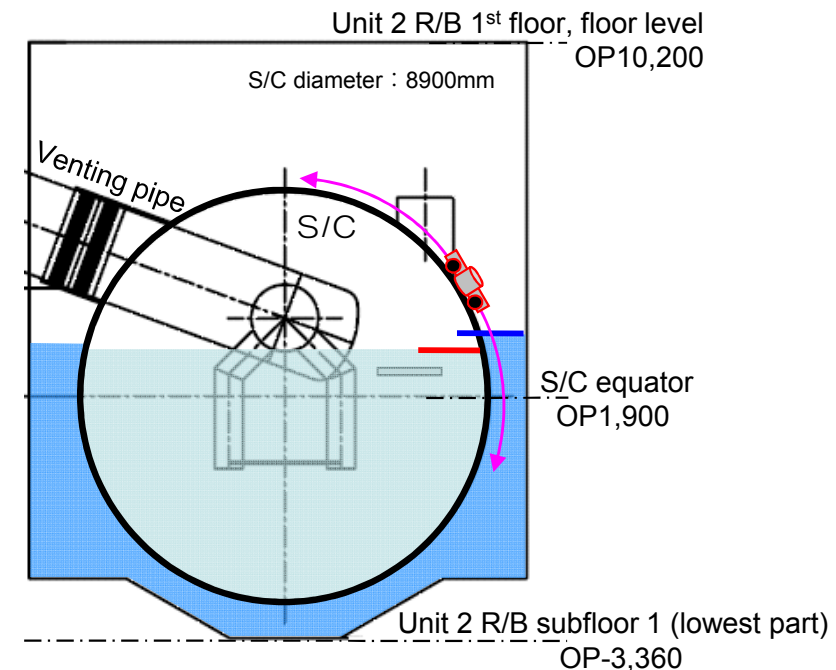
- Water level in S/C was same as in Torus room. (January 2014)
- It suggests a leakage at submerged parts of S/C or connecting pipes.

[Addendum] It is assumed that water levels inside the S/C are being affected by the level of accumulated water in the torus

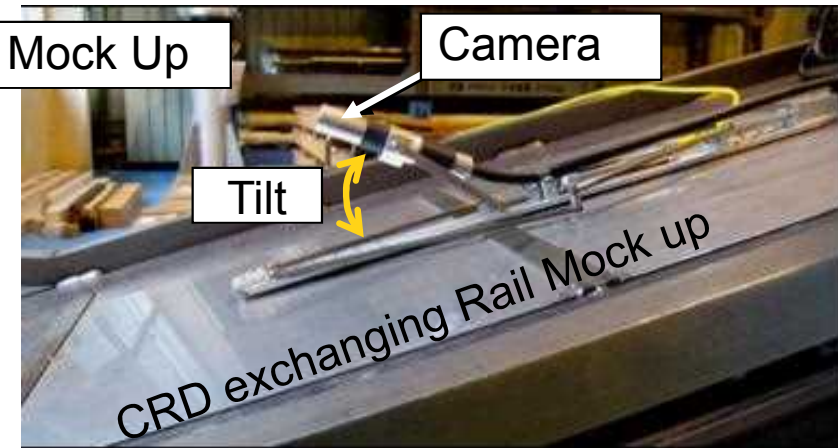
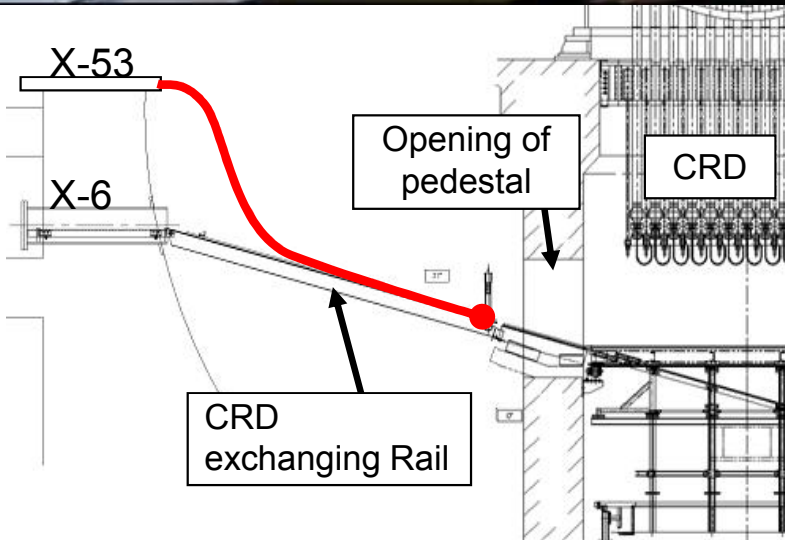
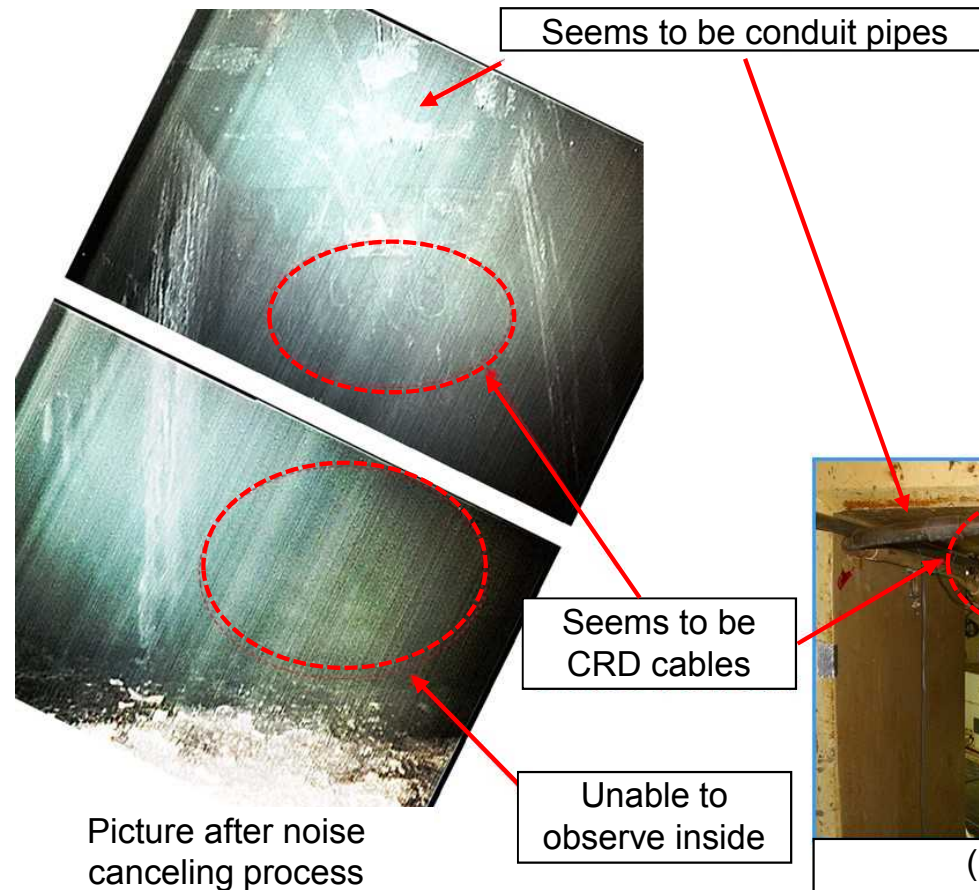
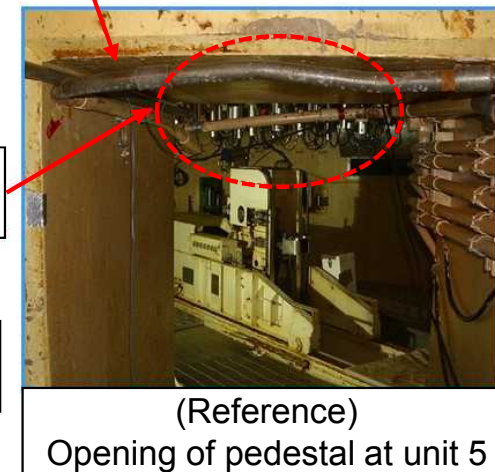
- Cables were identified at bottom of the RPV and suggested that huge collapse doesn't happen at bottom and under the RPV.
- Detected dose rate on the CRD rail was 24-36 Sv/h.
  - Significant increase doesn't appear at near the opening of pedestal.

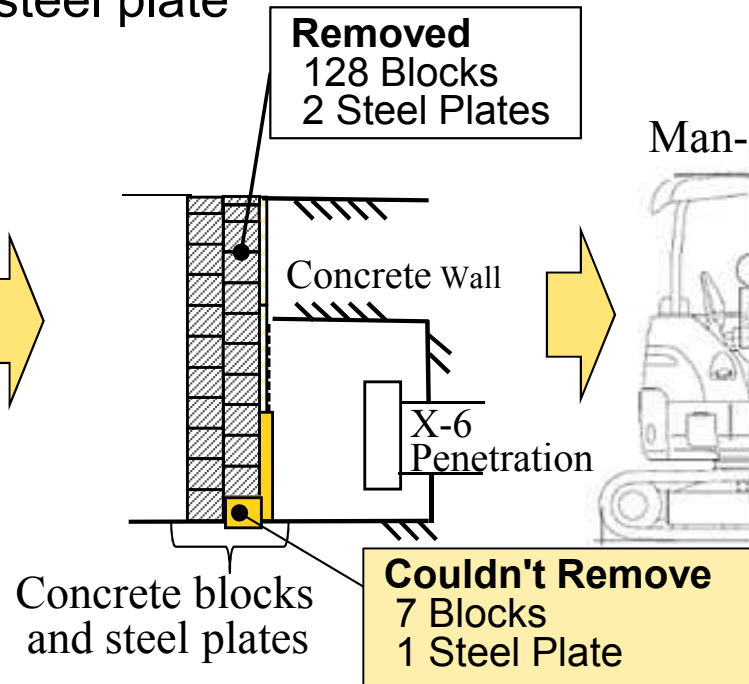
[result]  
Some Block Remained  
By block stuck and unexpected steel plate

- Unexpected stack of concrete blocks. Rust condition was difficult to predict.
- Unexpected steel plates.
- Unexpected structure of floor groove under the blocks.

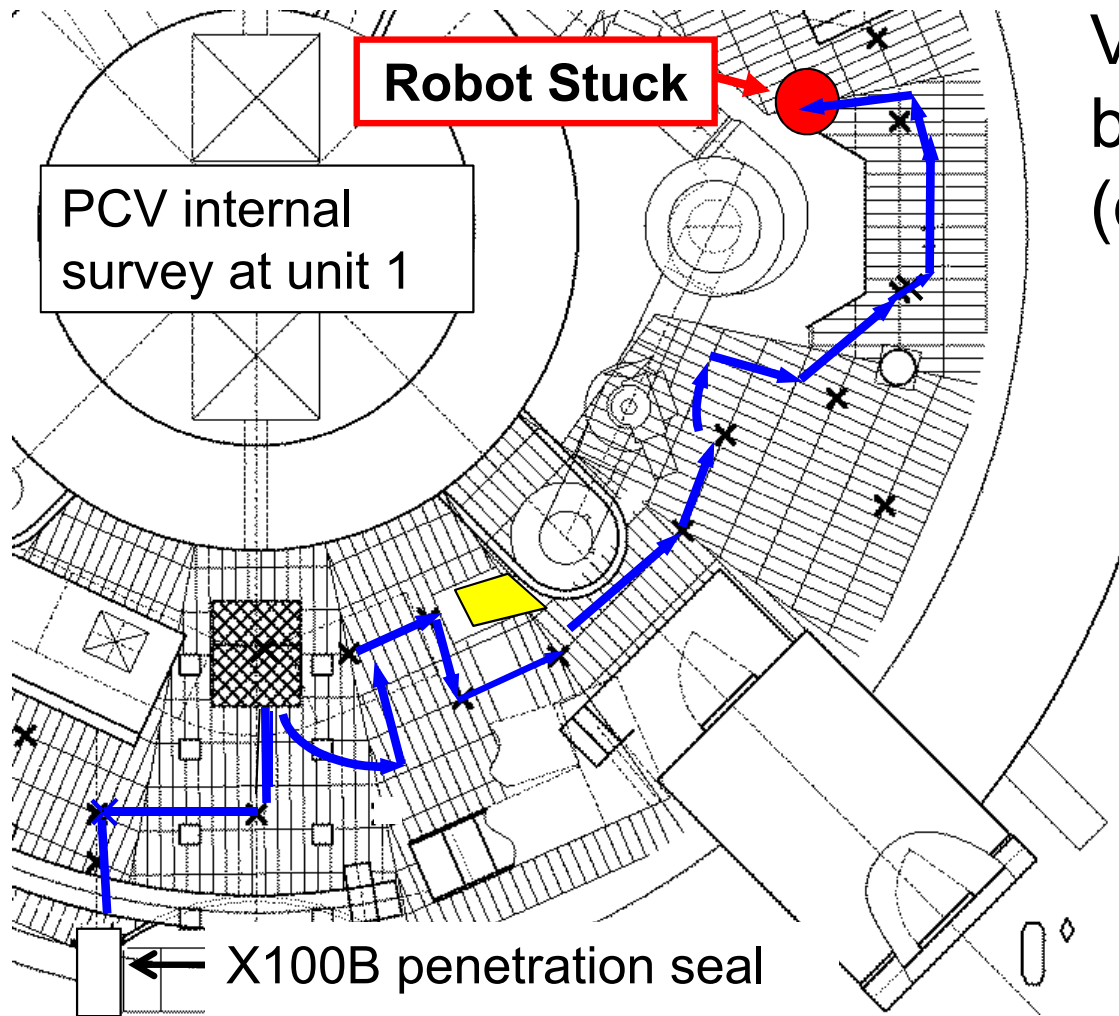
Vehicle robot stuck at the gap between the floor grating plates.  
(doesn't mean project failed)

- Floor gap of grating plates (height and width) was expected with margin and operation training done, but actual gap was greater than simulated.
- No detailed engineering drawing exists for existing grating floor plates.
