4<sup>th</sup> Atlas/NIST Workshop on Photovoltaic Materials Durability  
December 5 – 6  
Session 4

# Short-term and long-term field experiences in Japan in terms of PV encapsulant

*Tsuyoshi Shioda*  
*Mitsui Chemicals, Inc.*

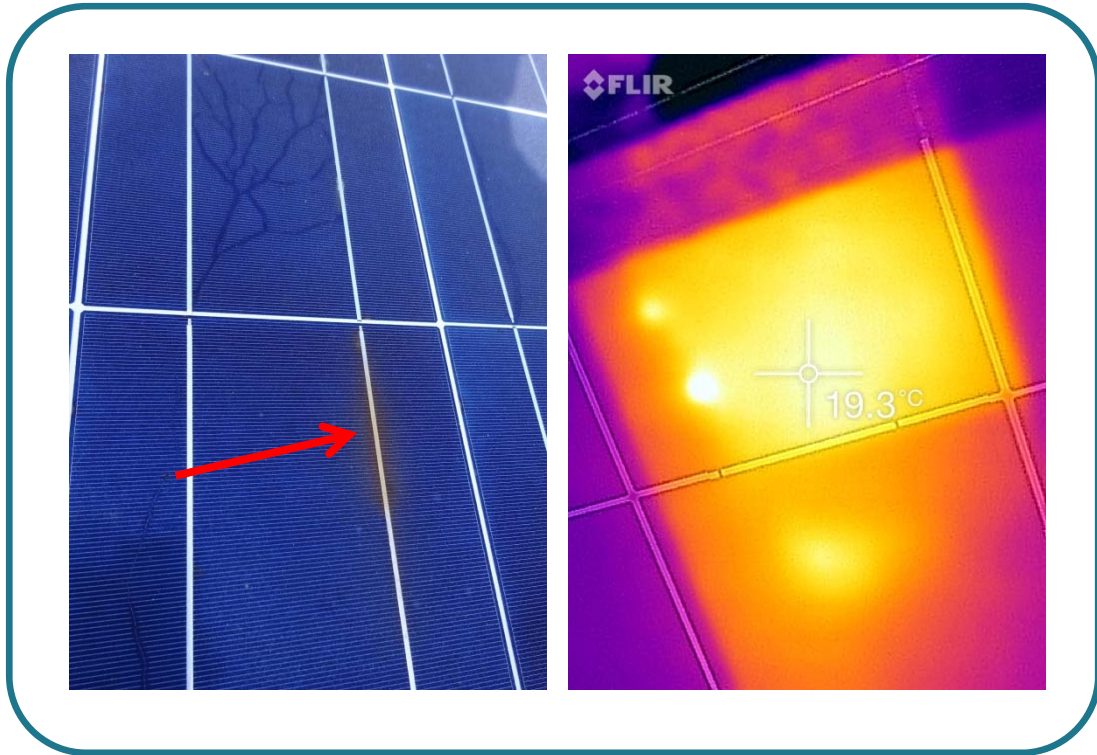
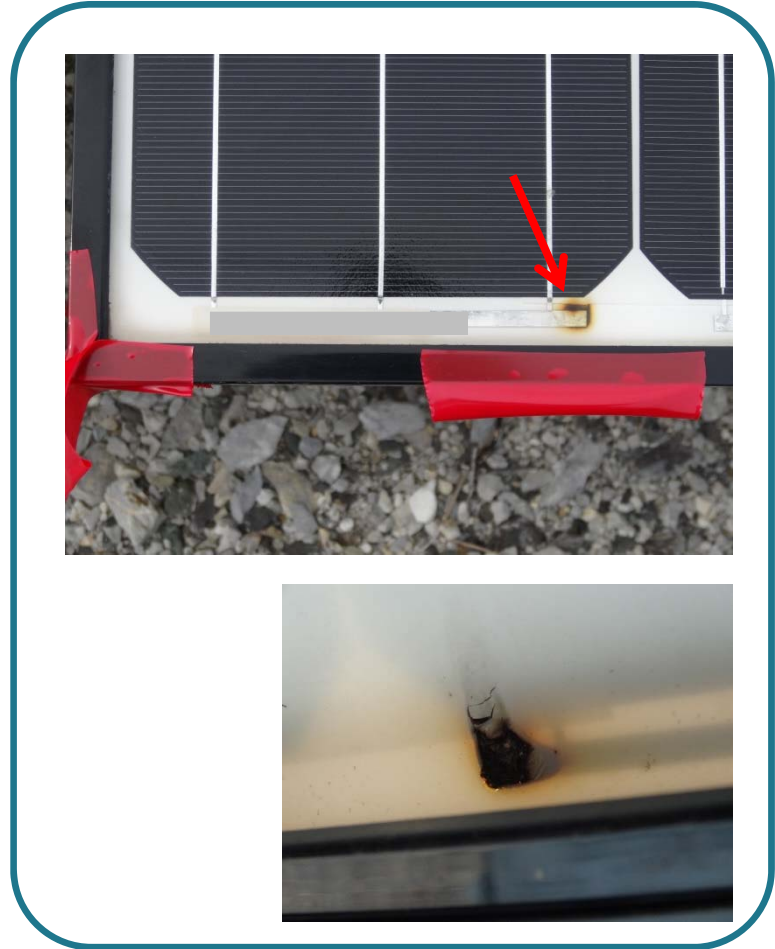
# ◆ Failures related to solder bonding

cell string

~2y operation

busbar

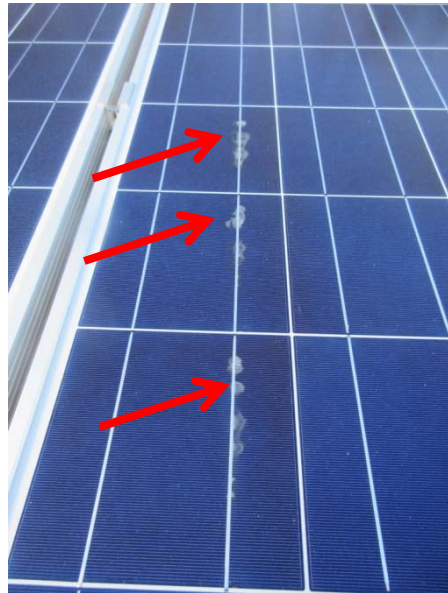
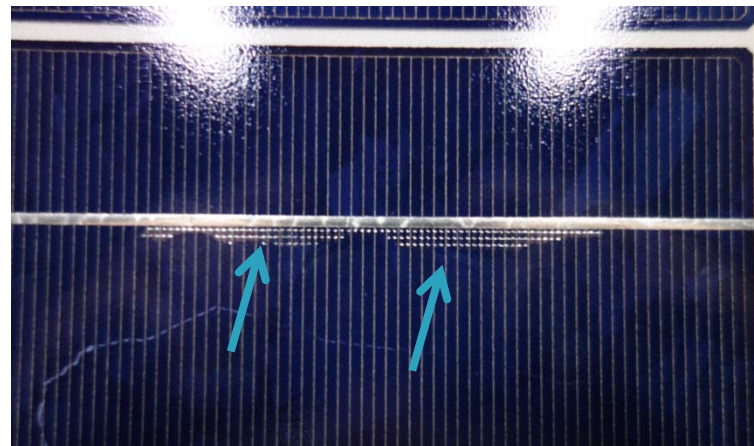
## delamination

glass

*during storage (~1y) in  
our temperature  
controlled warehouse*

interconnector

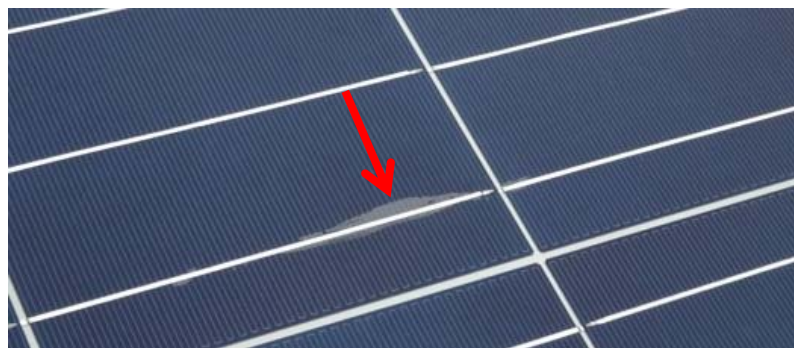
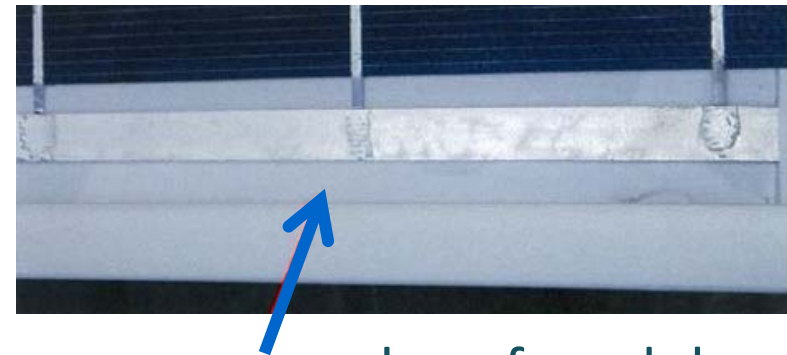
*~2y operation*

edge of module

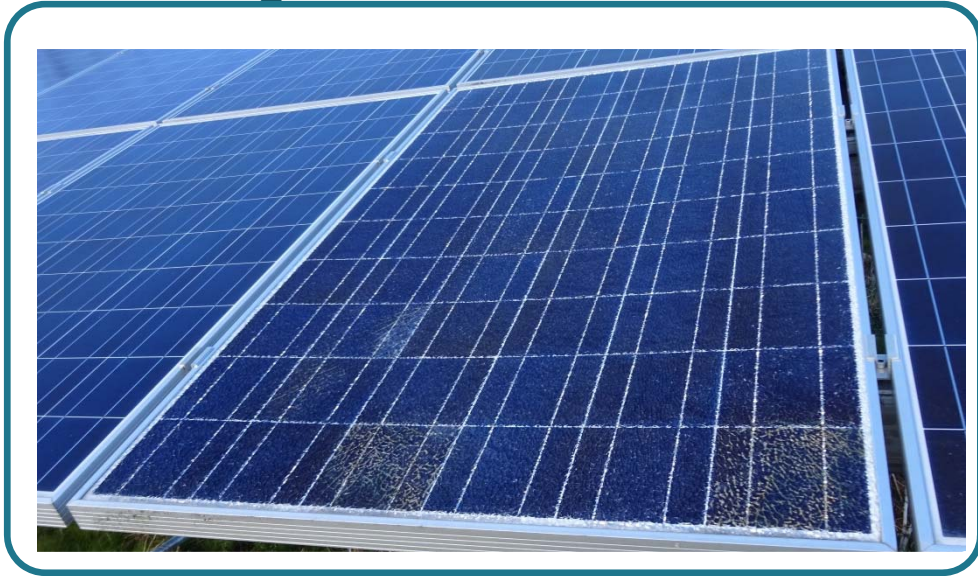
## Broken glass and corrosion

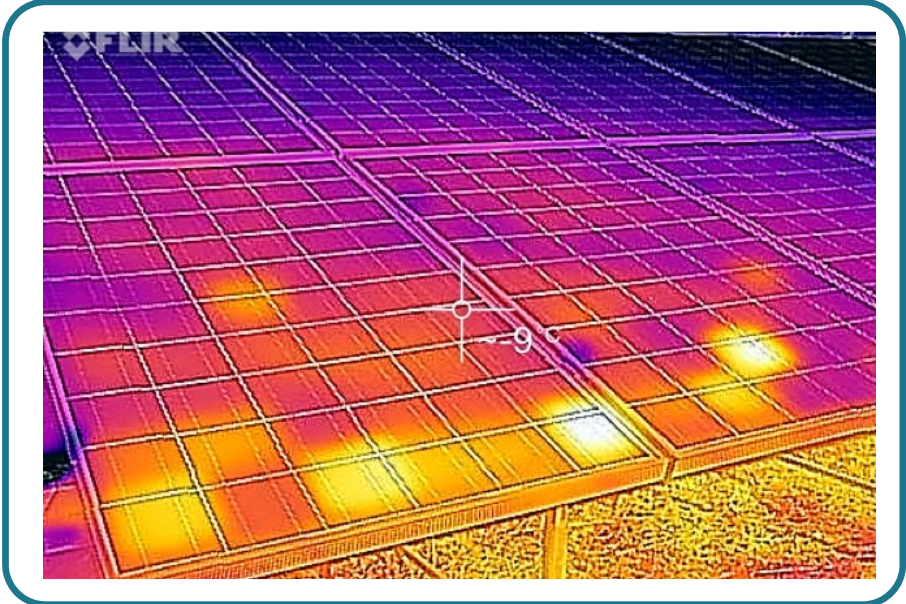
## PID?

*~2y operation*

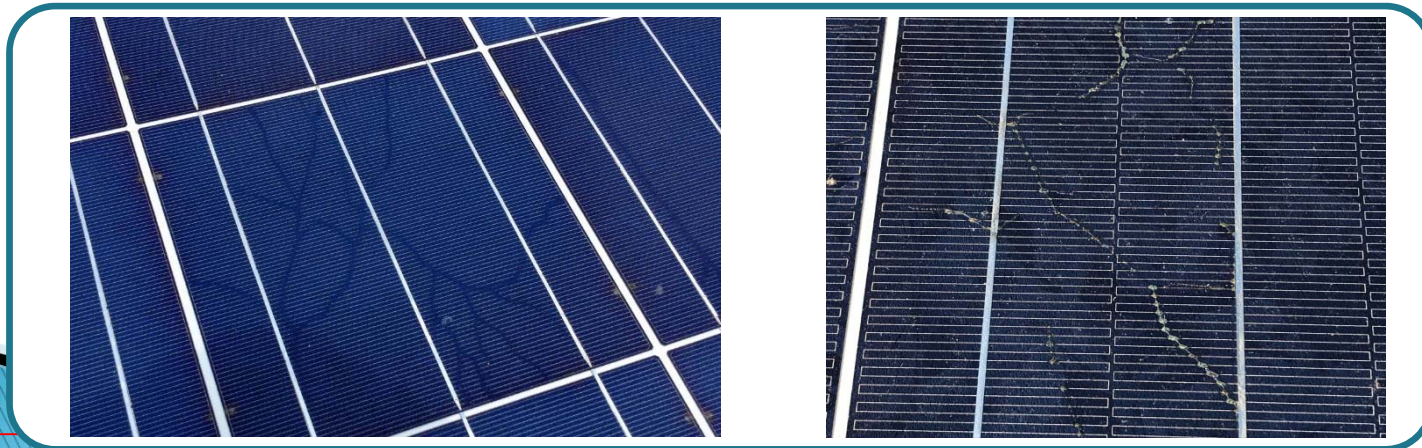
## Snail trail and delamination

*~2y operation*

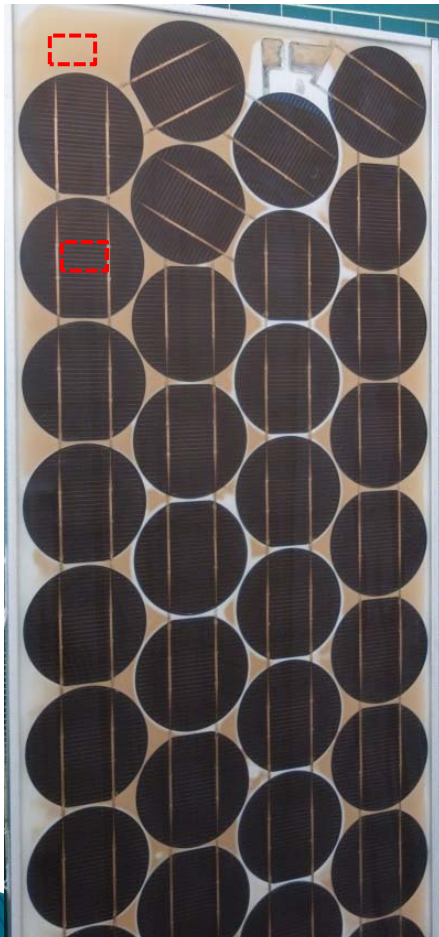
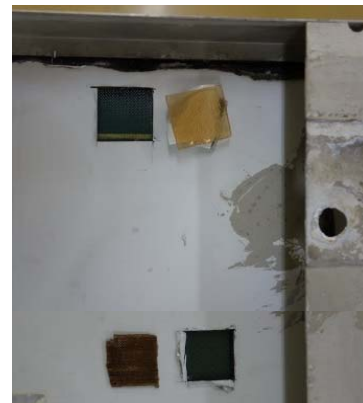
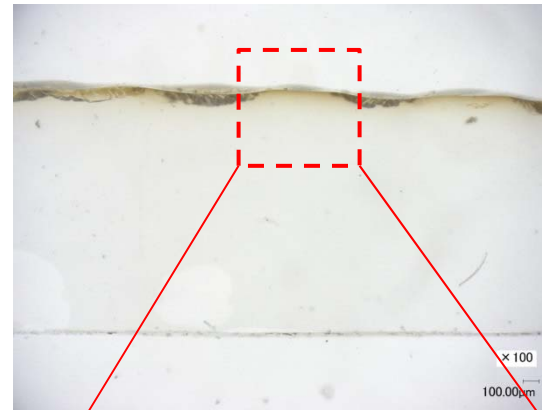
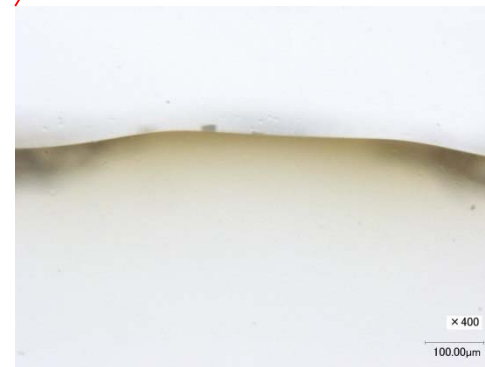
17 years field aged PV module

T-peel strength to glass or backsheet was low. It would be around 1~5N/cm (initial ~15N/cm).

**Yellowness Index**

← ~20  
← ~4  
← ~2

There are no delamination failures.

**Browning led by additive degradation has been happened at a thin layer of EVA.**

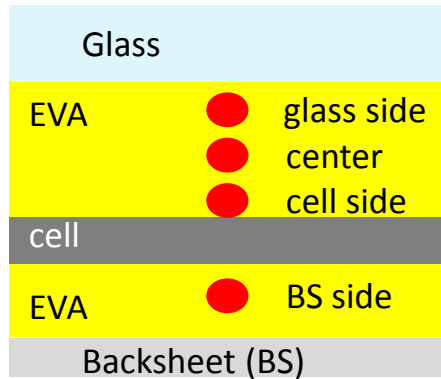
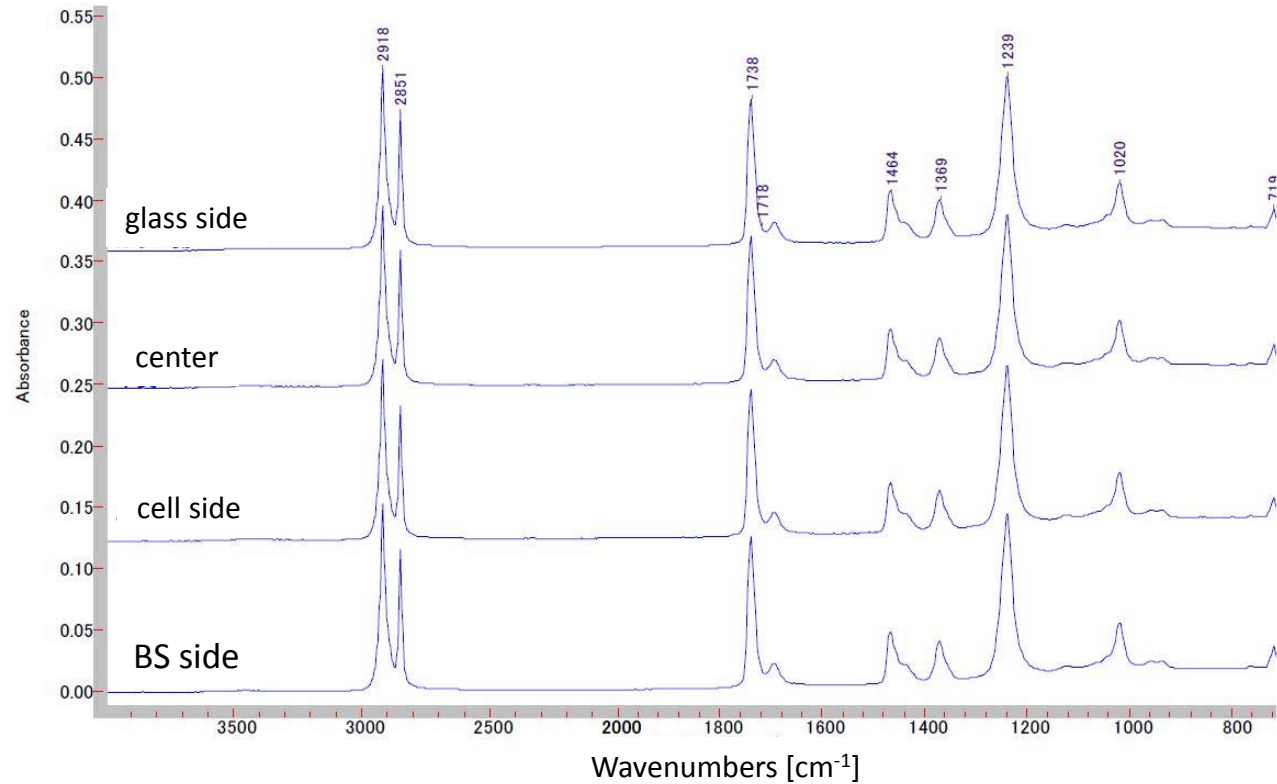
IR Spectra of field aged EVA – microscopic FT-IR/ATR

There were no differences in IR spectra of EVA in thickness direction.

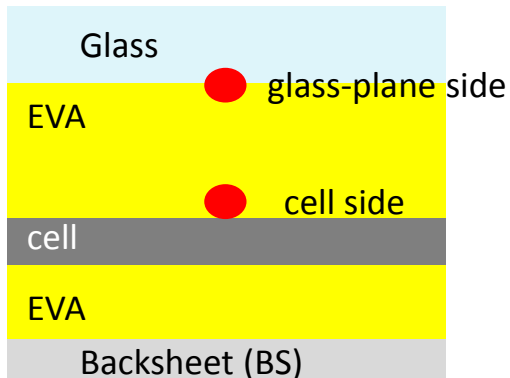
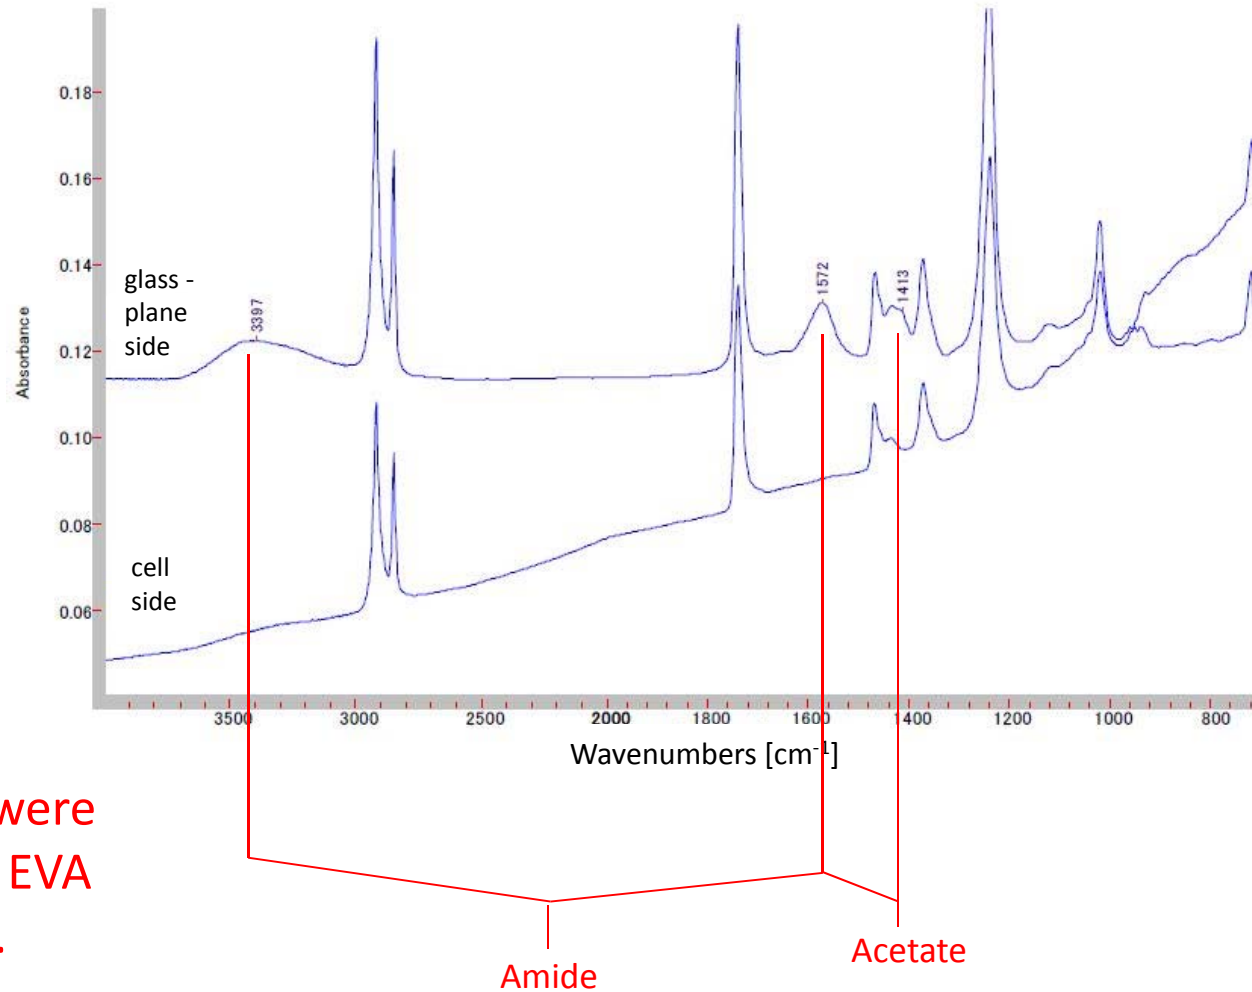
IR spectra of glass-face side EVA compared to that of cell side EVA

Chemical changes of EVA were observed in the vicinity of EVA layer contacted with glass.

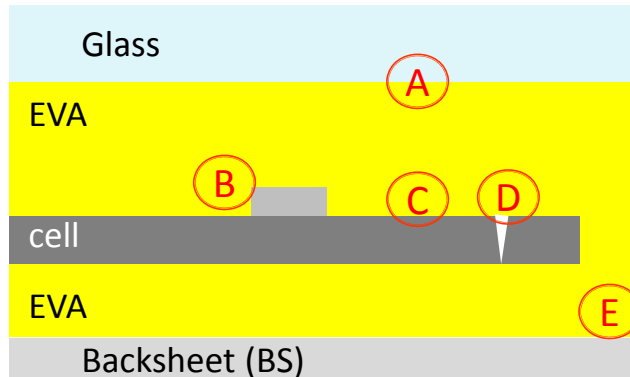
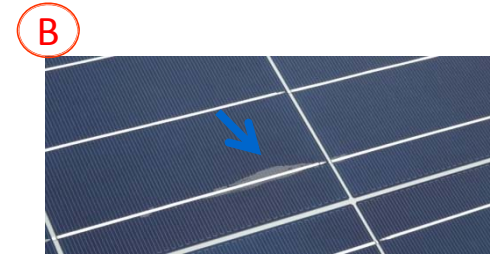
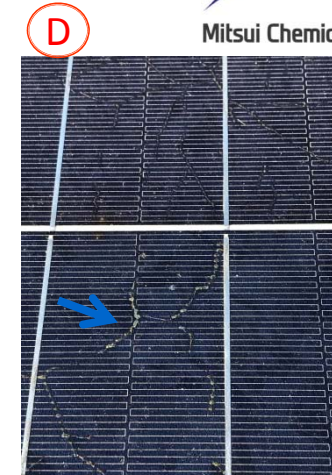
Interface	Potential Causes	Frequency (in Japan)	Risk (safety)
A	Glass/EVA	<b>inadequate lamination</b> , formulation of EVA	Rare case?	<b>high</b>
B	EVA/interconnector	<b>Inadequate lamination</b> , flux, formulation of EVA	Often	low
C	EVA/cell	<b>inadequate lamination</b> , AR coating, formulation of EVA	Aged specific PV modules	low
D	EVA/cell, finger electrode Snail trail (micro crack)	Ag paste for finger electrode, formulation of EVA	Often (specific types)	low
E	EVA/Backsheet	<b>inadequate lamination</b> , adhesiveness of Inner layer of backsheet, formulation of EVA	Rare case?	<b>high</b>

- ✓ **Inadequate lamination**, which means that inadequate lamination condition and/or quality control issue lead to insufficient thermal history for EVA including additives, causes **delamination** as an infant mortality.

- ✓ **Originally durable adhesion** of EVA has been designed for interface between **glass and EVA** with a silane coupling agent. Further its durability, which means that no delamination on glass was happened, has been proven by many long-term field aged PV modules with EVA having certain silane coupling agent.

- ✓ **Adhesion of EVA/backsheet** has sometimes become **issues for long-term** reliability. These days, UV absorber has been removed from glass side EVA. Thus inner layer of backsheet would be suffered by UV light compared to older type of PV module.

- ✓ PV module manufacturer shall conduct **long-term UV exposure test** using a PV module with EVA encapsulant with its lower limit or less of gel content, certain backsheet and interconnector to be used.
