Understanding the Mechanisms of Surface Cracking of Multilayer Photovoltaic Backsheets after Accelerated Aging

Chiao-Chi Lin¹, Yadong Lyu¹, Deborah L. Stanley¹, Jae Hyun Kim¹, Kai-Tak Wan², Donald L. Hunston¹, Xiaohong Gu¹

¹Polymeric Materials Group, National Institute of Standards and Technology, Gaithersburg, MD 20899, USA
²Department of Mechanical and Industrial Engineering, Northeastern University, Boston, MA 02115, USA

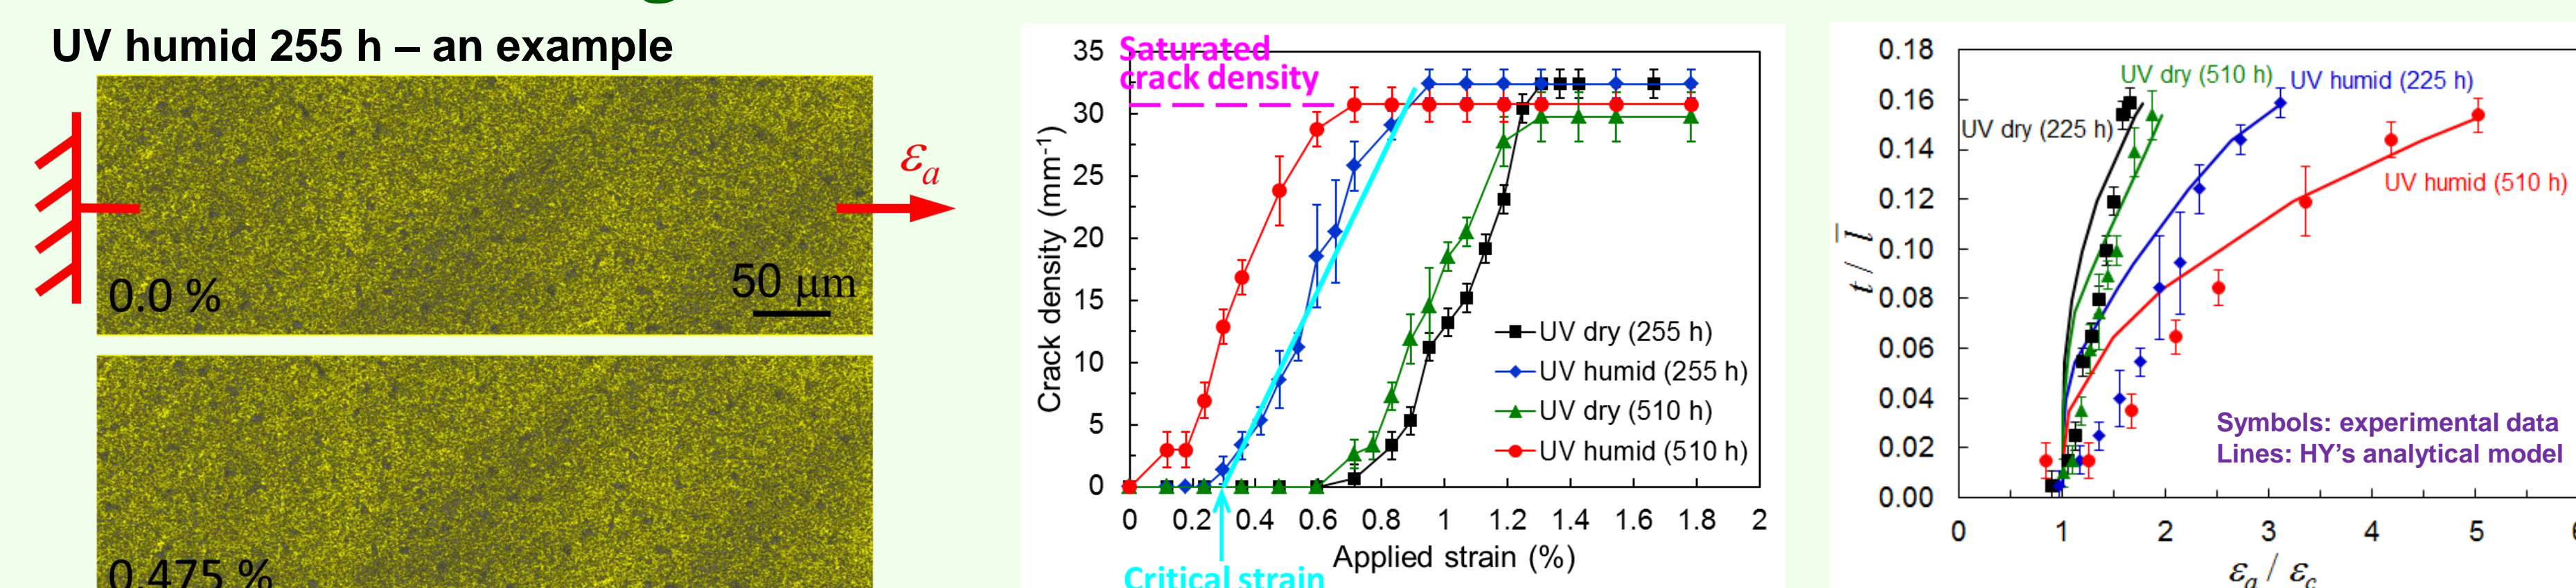
Surface Cracking Behaviors

- RH levels and aging times influence **critical strain** (ϵ_c) only.
- Similar **saturated crack density** was reached despite of RH levels and aging times.
- There was no surface cracking occurred on the unaged sample and samples aged without UV!**
- A nominal 5 μm crack depth into the surface is taken for the analytical model.

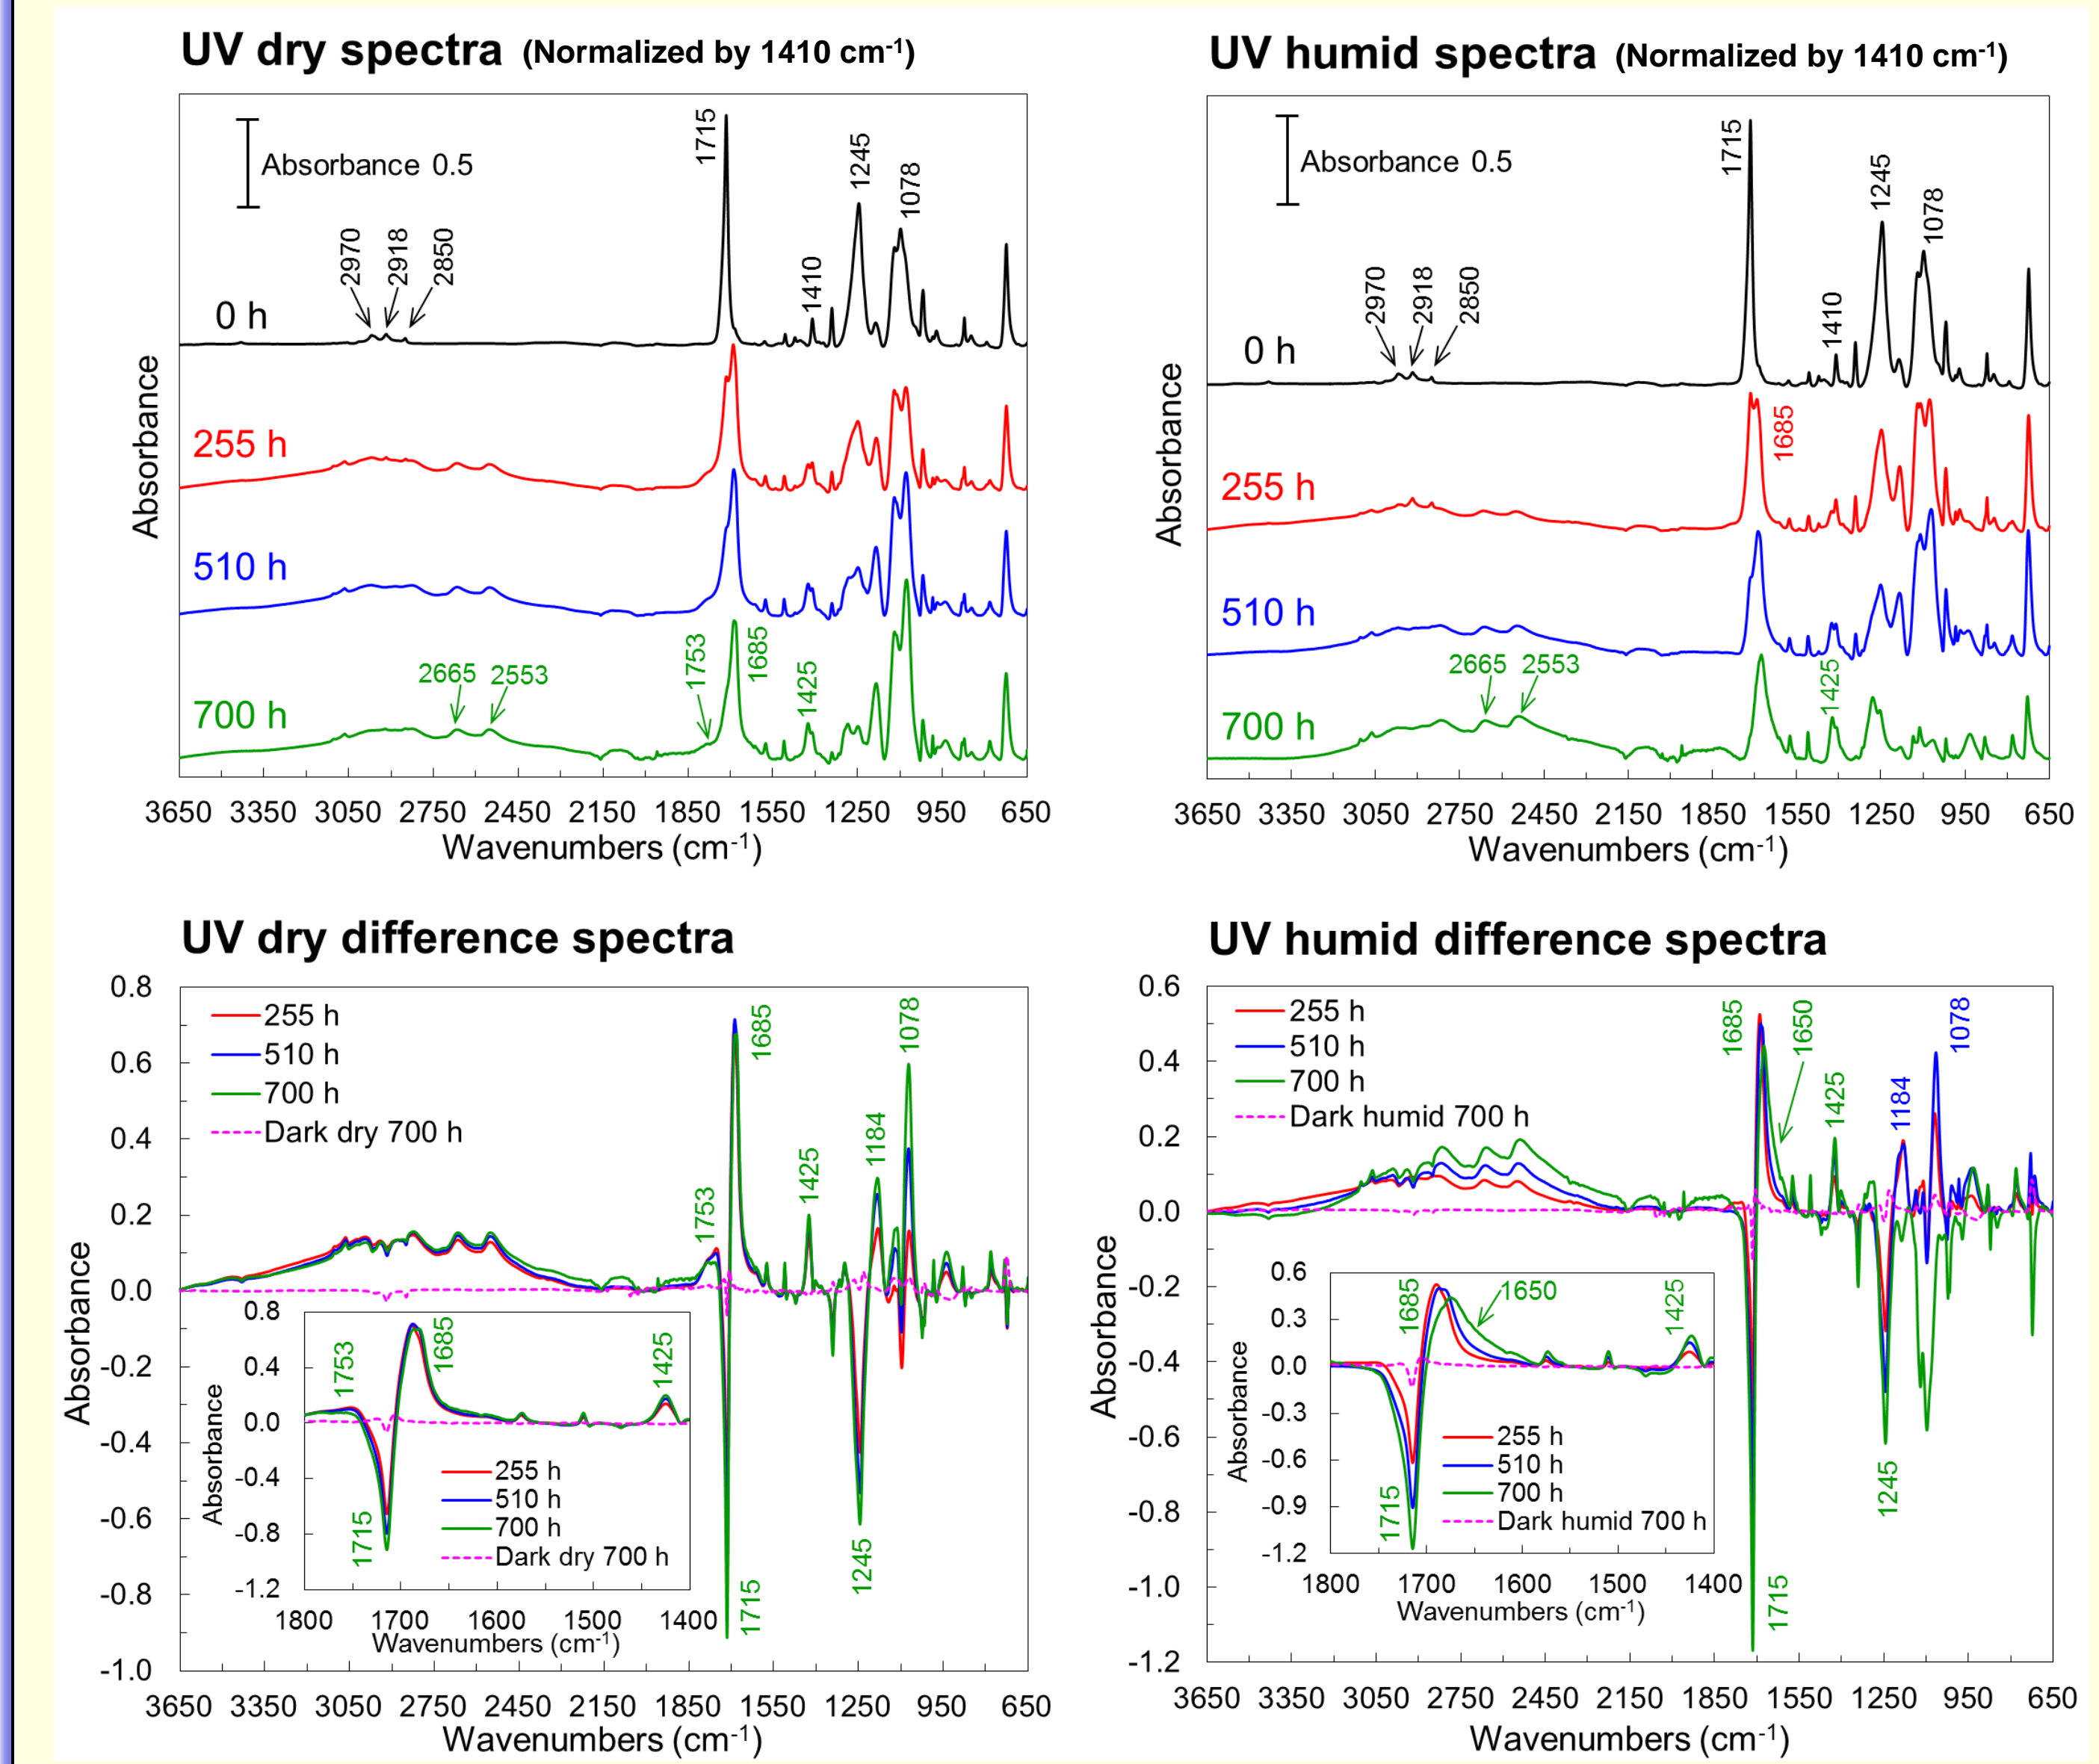
ATR-FTIR Results

- The embrittled surface layer resulting from the UV photo-degradation is responsible for surface cracking. Moisture plays a synergistic effect in the degradation mechanism.
- The mode I fracture toughness (K_{IC}) of the embrittled surface layer aged under UV humid conditions is lower than that under the UV dry conditions, which is consistent with their chemical and morphological degradation.
- The channel cracking fragmentation testing approach is possibly used to assess the tendency of cracking formation for PV backsheet after weathering.
