National Construction Safety Team Investigation

**Press Briefing: Draft Report on
The Station Nightclub Fire**

Providence, Rhode Island
March 3, 2005

**National Institute of Standards and Technology
Technology Administration
U.S. Department of Commerce**

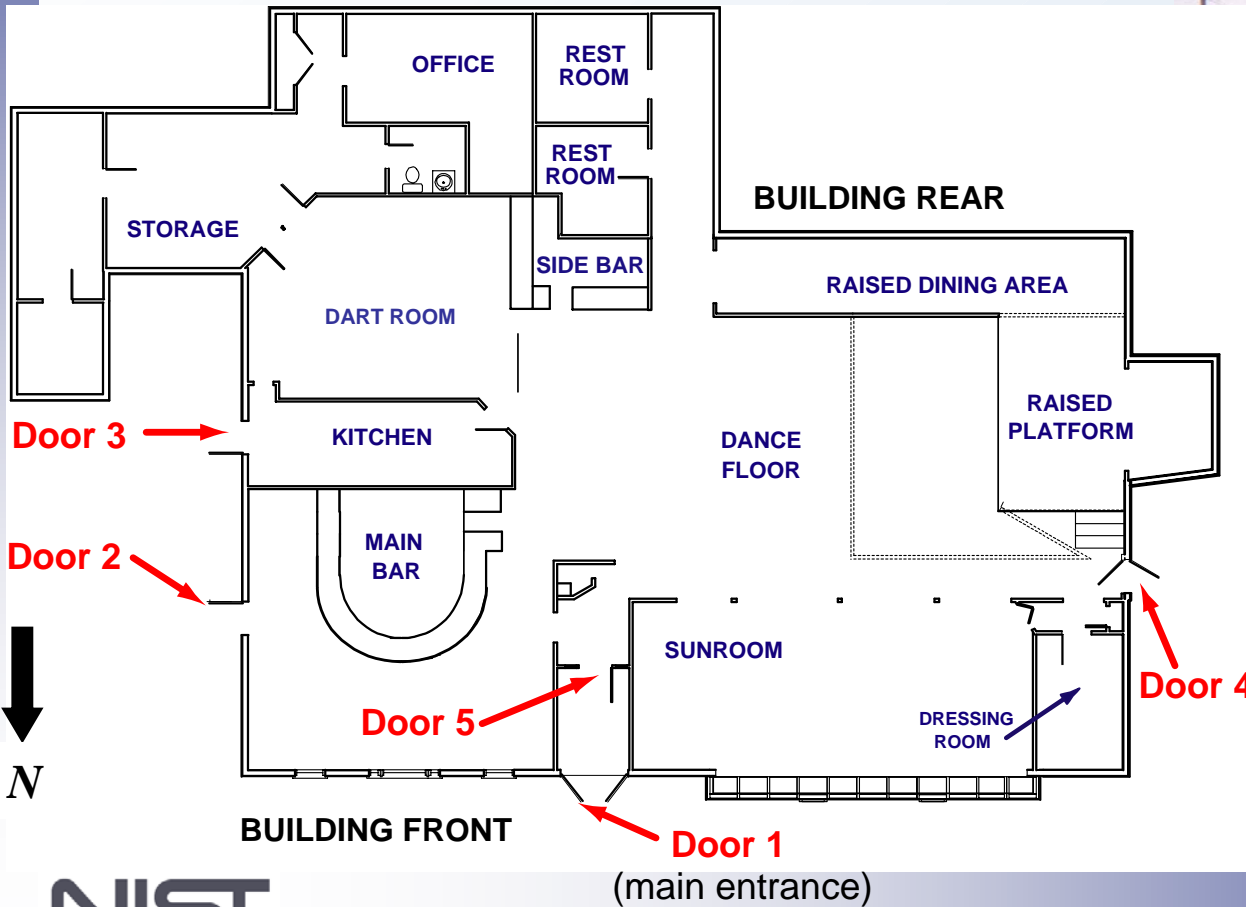
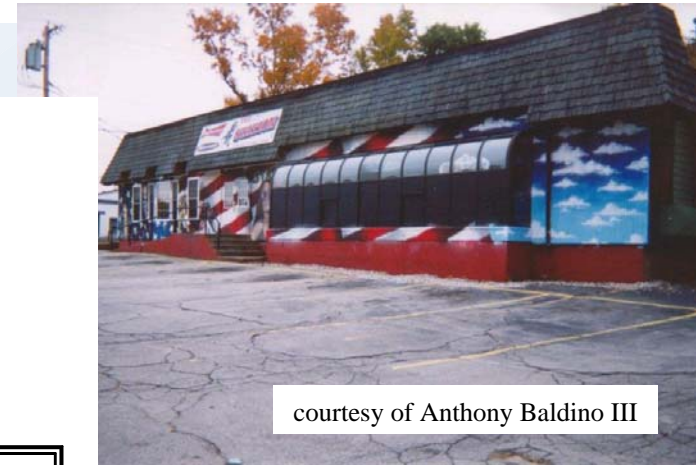
Views of Building

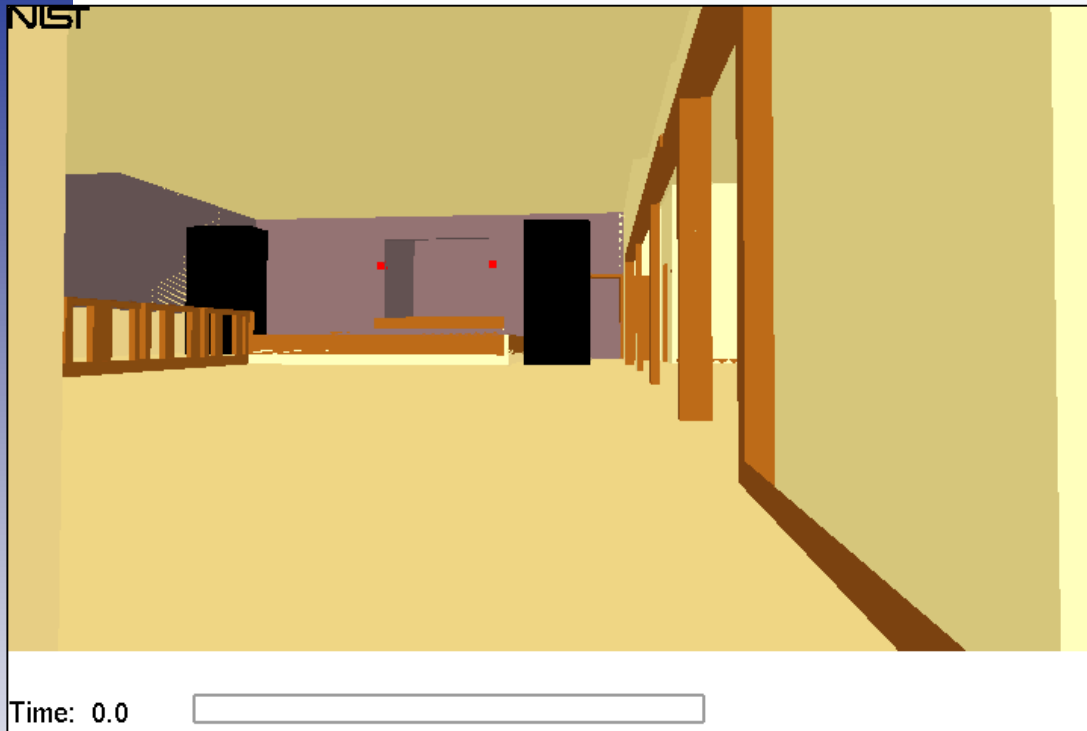
← View of fire from near entrance to front vestibule (near floor)

View of fire from far side of main bar (head height)

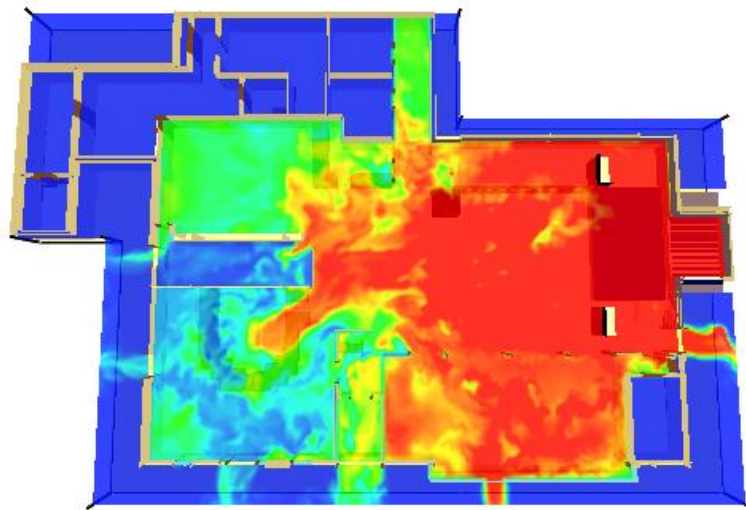
Temperatures in The Station at 90 seconds

5 ft above floor

Peak temperatures in red exceed 1000 °C (1832 °F)

Light blue indicates temperatures around the boiling point of water (100 °C, or 212 °F)

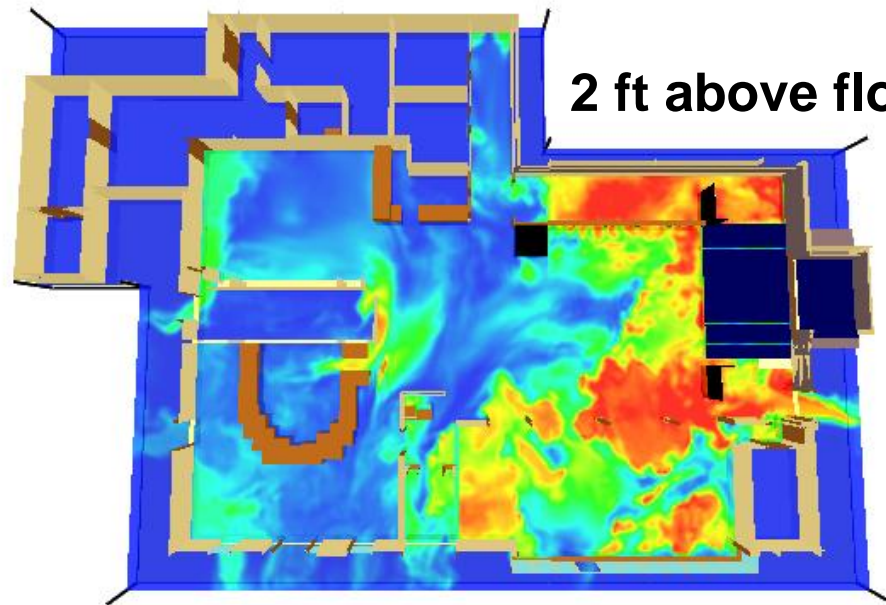
2 ft above floor

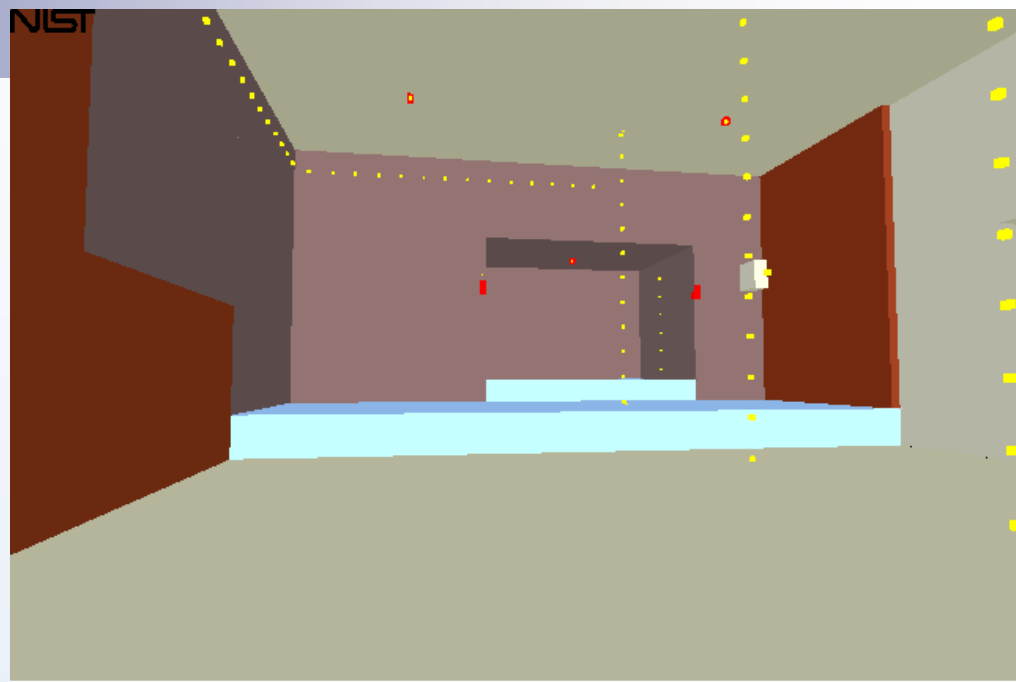
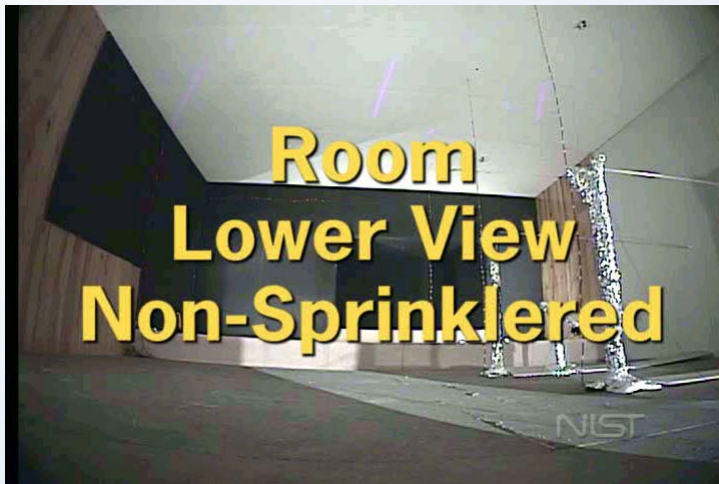
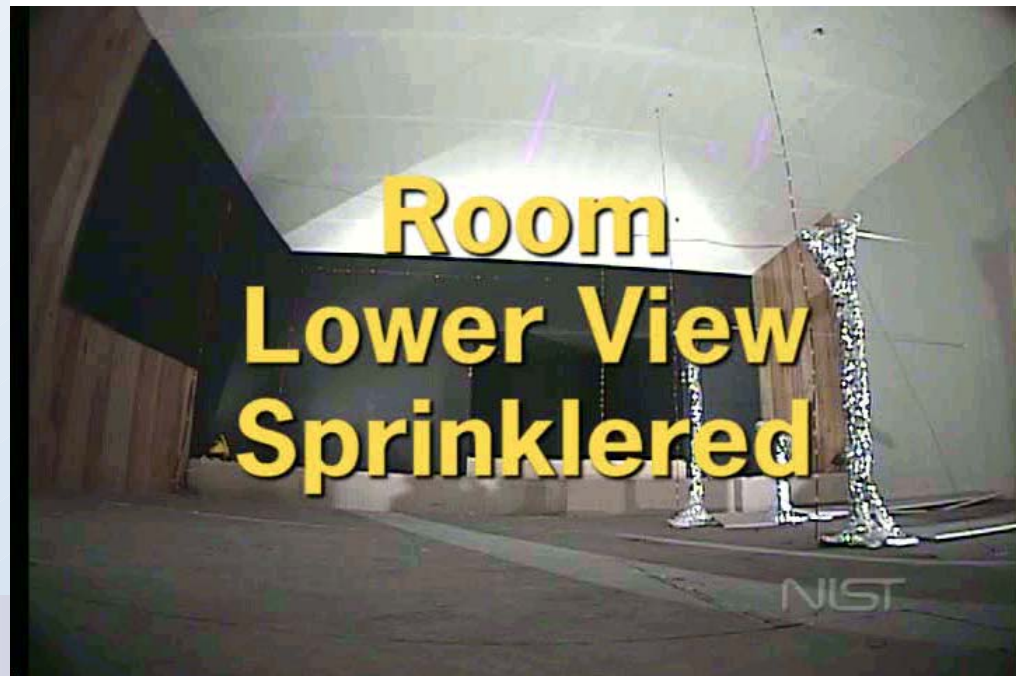
Computer simulation of platform area mock-up with sprinklers

- Experiments conducted at NIST demonstrated that a sprinkler system installed in test room in accordance with NFPA 13 was able to control a fire initiated in non-fire retarded polyurethane foam panels.
- Sprinklers were not installed in The Station, nor would they have been required for such existing structures under 2003 editions of the model codes
- A heat detection/fire alarm system was installed in the building and was activated (sound and strobe) by the fire 41 seconds after the fire started.
