### **NIST Special Publication 1129**

# Summary of the 2011 Workshop on Research Needs for Full Scale Testing to Determine Vulnerabilities of Decking Assemblies to Ignition by Firebrand Showers

Samuel L. Manzello Sayaka Suzuki Fire Research Division Engineering Laboratory

August 2011

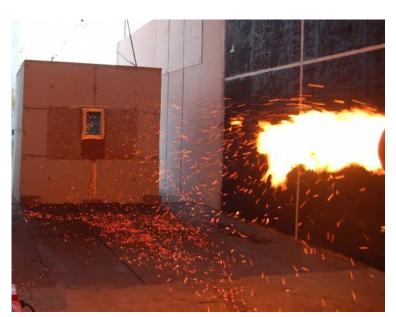
### **BRI/NIST Full Scale Experiments**

20 x 20 mesh (1.04 mm) is shown
