Sifting Through the Debris/Data:

Recovery & Resiliency in Santa Rosa

Tubbs Fire

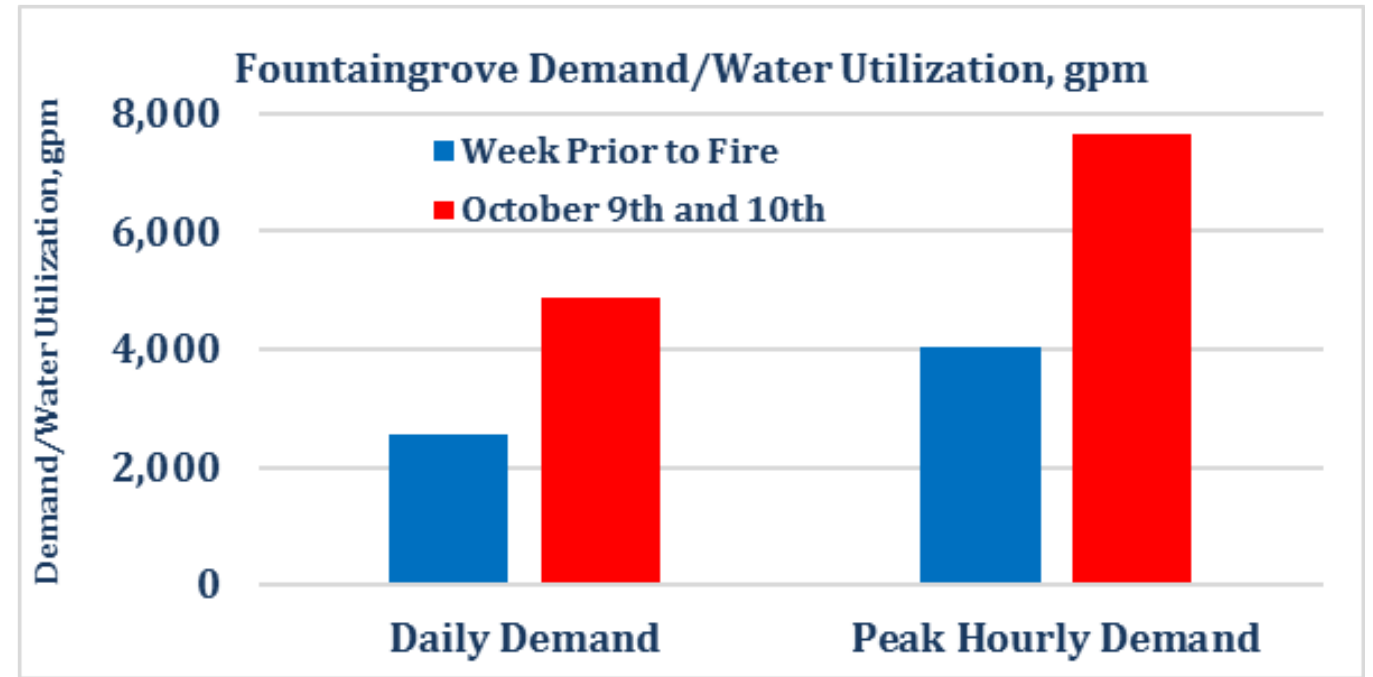
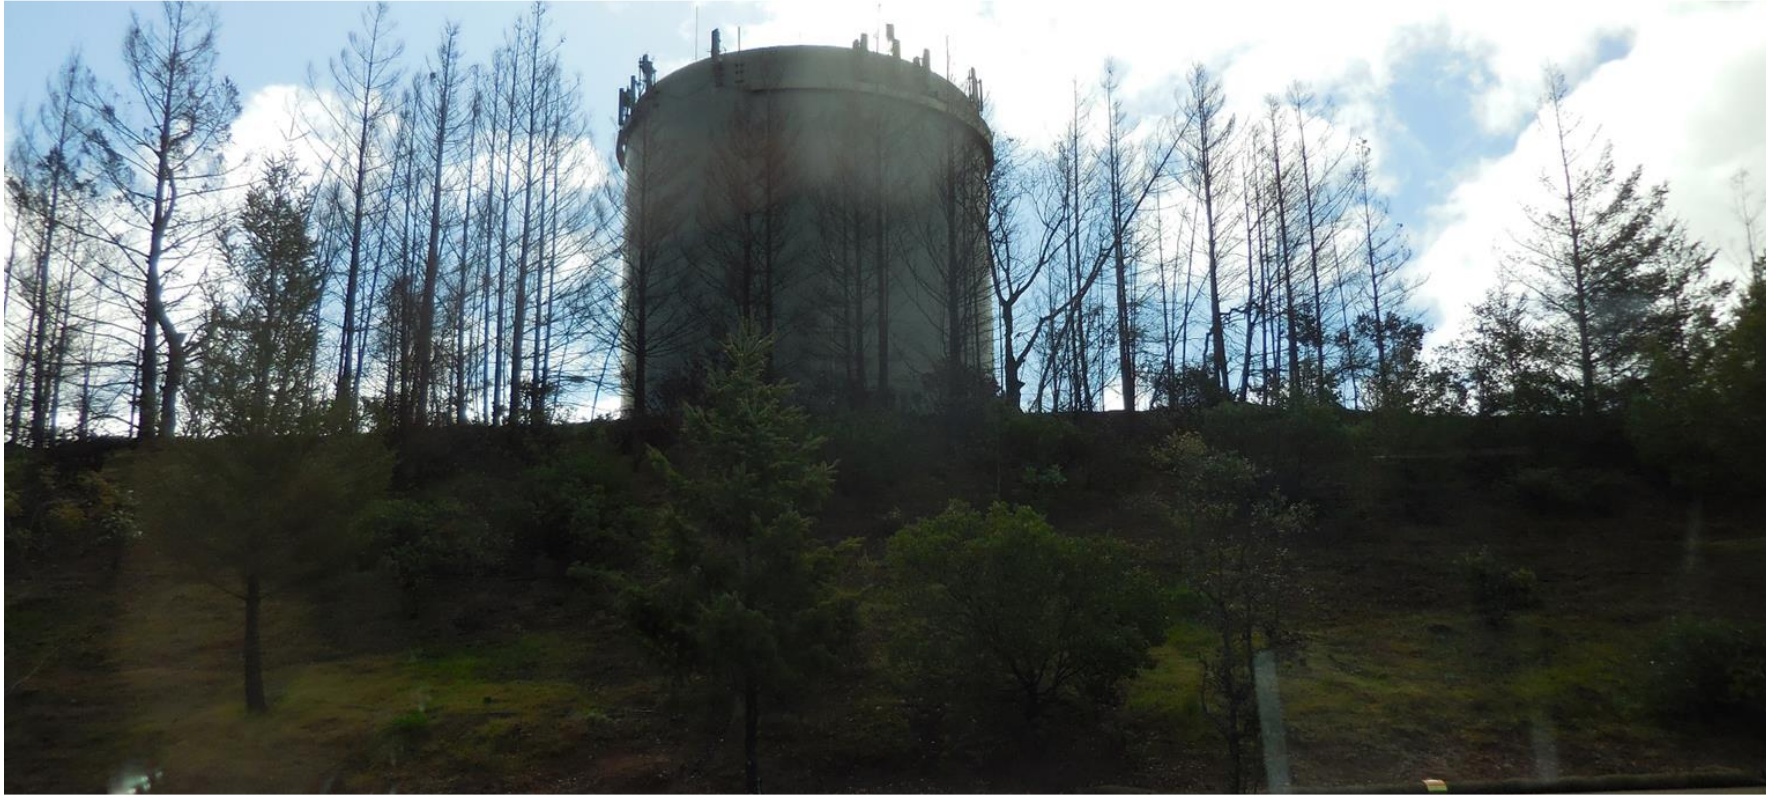
Case Study #1: Impact on Distribution System

- ▶ Demand skyrocketed beyond the normal & continued for hours, causing storage to drain quickly
- ▶ Demand came from firefighting efforts, including from residents, supply flowing freely from damaged lines, taps, etc.
- ▶ In most cases pumps continued to pump but could not maintain normal system pressures
- ▶ Supply could not recover until freely flowing services could be identified and closed

- Water distribution system operated as designed and meets fire flow goals.
- System was pumping, where there was suction head, but could not regain tank levels until flowing pipes were shut-off.
