NWIRP Research Study of Recovery from Hurricane Maria's Impacts on Puerto Rico

Evaluation of Infrastructure Support of Critical Buildings and Emergency Communications

Project Leader: Ken Harrison

Project: Physical Performance of Wireless Communications Systems during Hurricane Maria

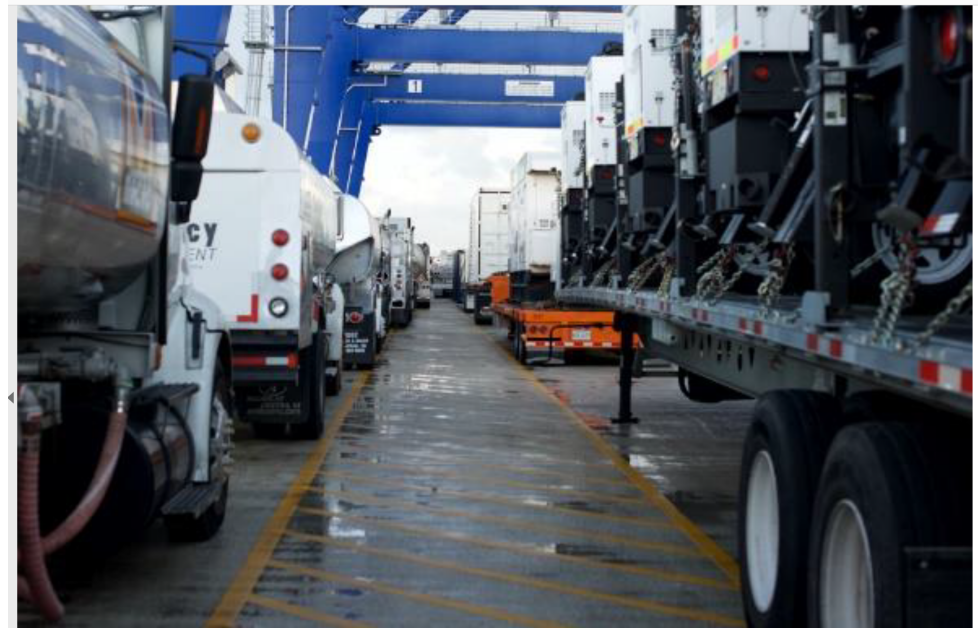
Long line of power generators and fuel tankers on parked trucks with container cranes overhead, arriving to the port of San Juan, Puerto Rico. Source: FEMA

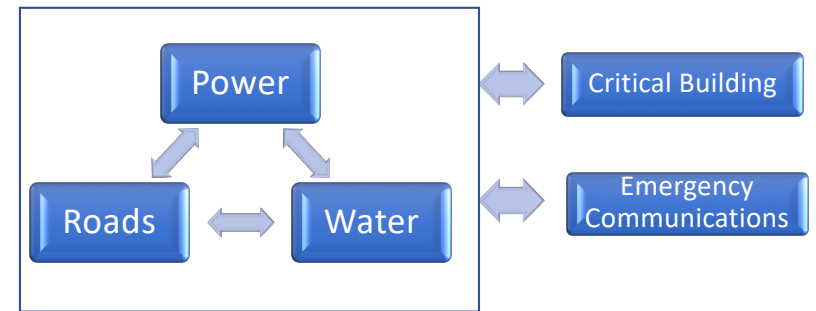
3. Extend NIST Alternatives for Resilient Communities (ARC) tool

NIST-ARC is a new (alpha) interactive tool for developing alternative sets of actions meeting community resilience and cost goals, given hazard and interdependency information, and socio-economic data.

Assists with the process of developing viable alternatives for stakeholder consideration.

- Changes made that improve recovery model validity:
 - Use of generators (delivery, fuel, backup capacity)
 - Startup time (e.g., flushing water distribution systems)

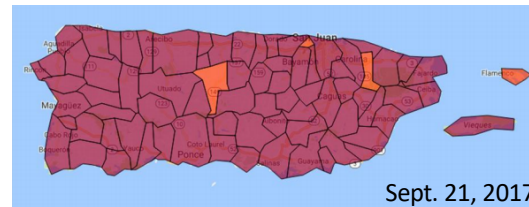
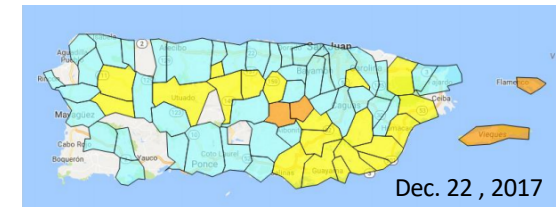
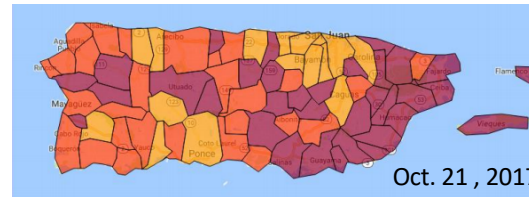
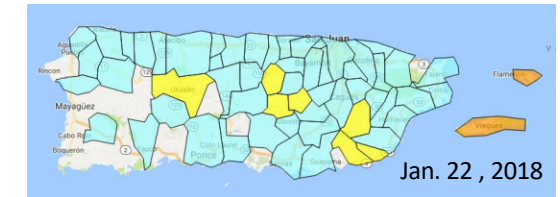
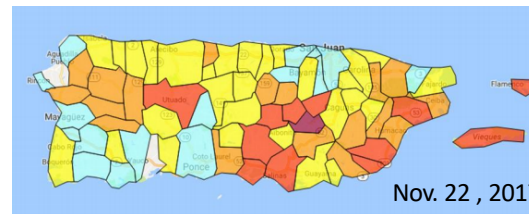
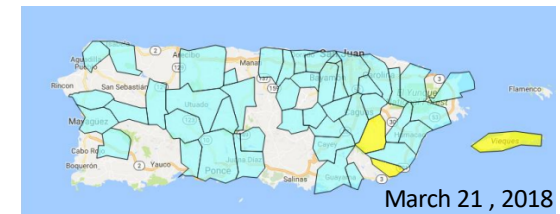
Cell Sites Out-of-Service, by County (%)

1 - 20 21 - 40 41 - 60 61 - 80 81 - 100

Sept. 21, 2017

Dec. 22, 2017

Oct. 21, 2017

Jan. 22, 2018

Nov. 22, 2017

March 21, 2018

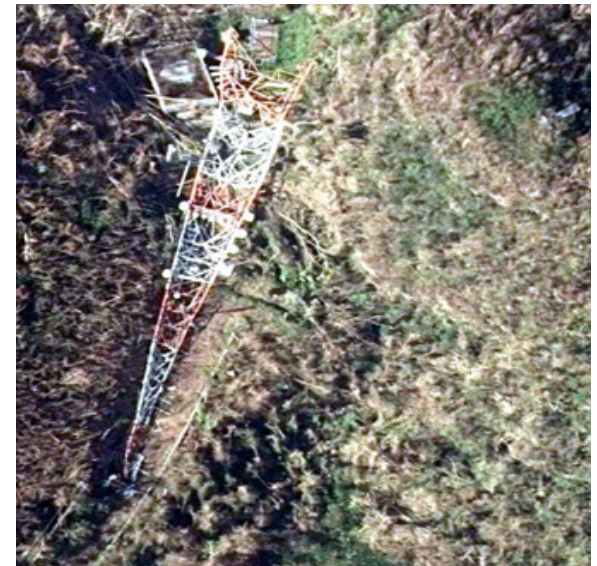
A severely damaged cellular tower remains on a hillside in Puerto Rico after Hurricane Maria October 8, 2017

- Wind loads on cabling and antennas are not fully covered in existing standards
- Confirmed (from the sources above) our preliminary assessment (which were based on media reports, telecommunications company press releases, and NIST analysis of aerial post-storm imagery) that very few towers collapsed
