Response to Building Damage Caused by Tornadoes

Thomas L. Smith, AIA, RRC, F.SEI

TLSmith Consulting Inc.

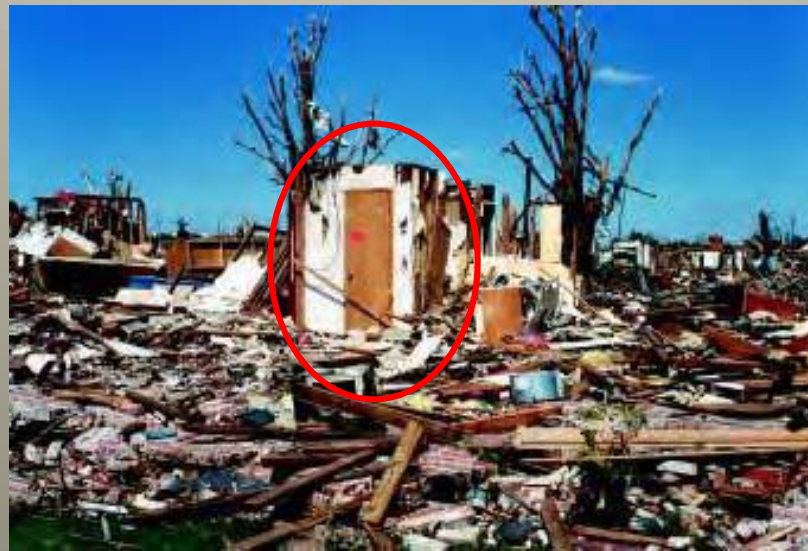
Lubbock F5 Tornado, 1970

- TTU investigated that event and pioneered field research investigations of tornadoes and hurricanes
- Post-tornado observations often revealed that small interior rooms survived
