**Federal Building and Fire Safety Investigation
of the World Trade Center Disaster**

**Project #3: Analysis of Structural Steel
*Update***

December 2, 2003

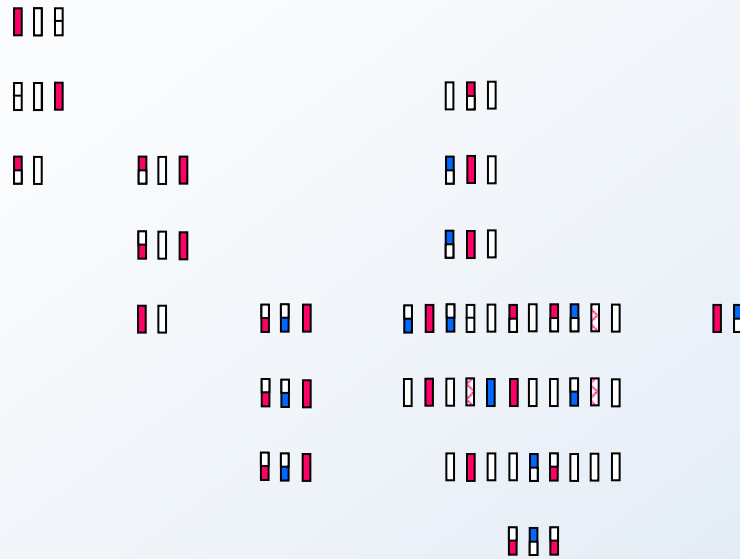
Floor Truss Support: Perimeter Seat Damage

- Seat intact, relatively undeformed
- Seat intact, bent up
- Seat intact, bent down
- Seat intact, bent towards column
- No seat, standoff plate remains
- Seat and standoff plates gone
- Tab plate intact, undeformed
- Tab plate intact, bent up
- Tab plate intact, bent down
- Tab plate gone

95th floor and below:

all attachments bent downwards or missing (components ripped off at welds)

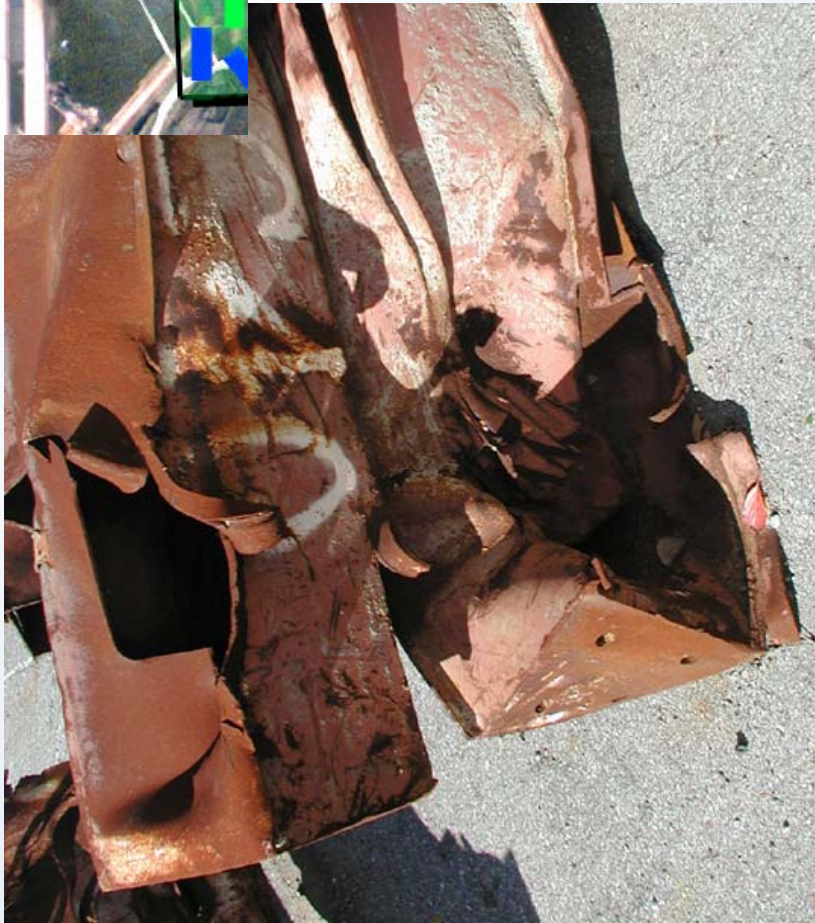
Direct comparison with state of recovered steel

C40 hit by tip of tail?

Closer examination shows collision damage unlikely – damage occurred during fall

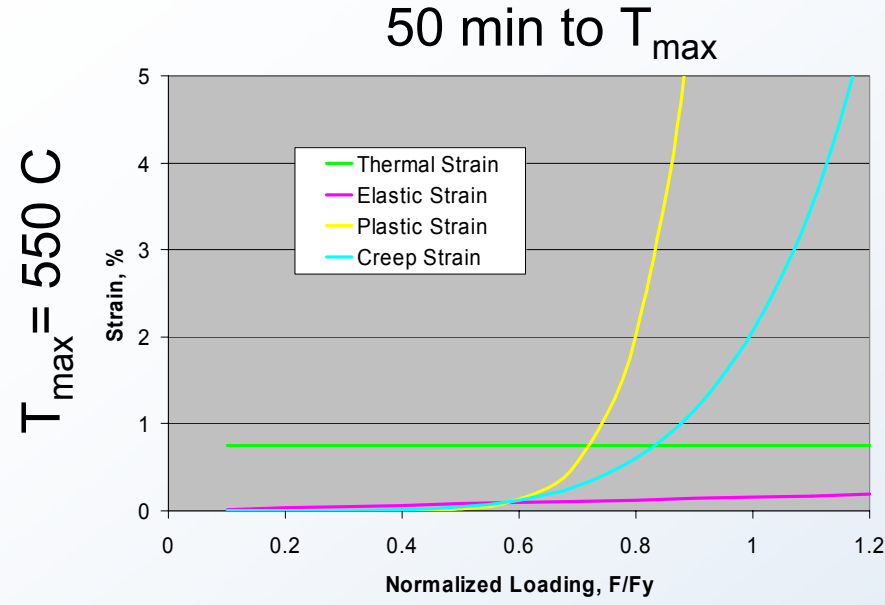
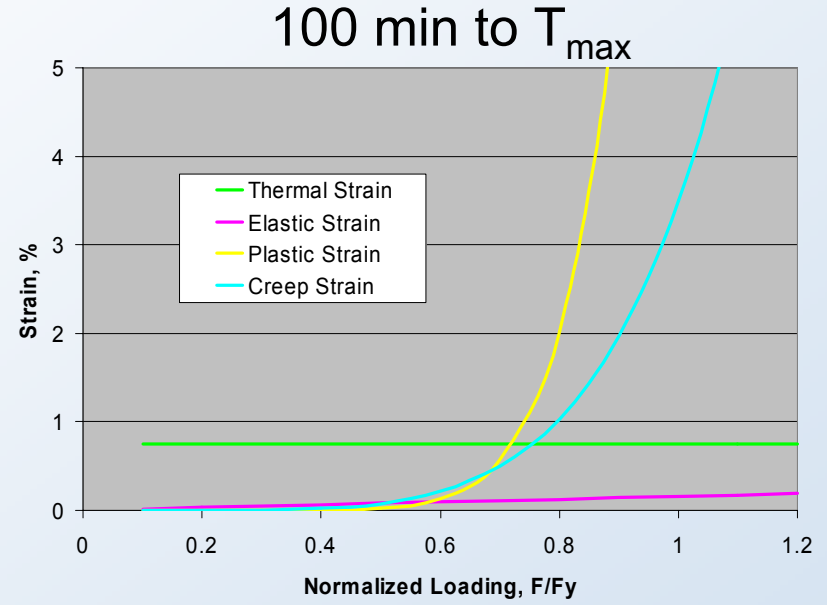
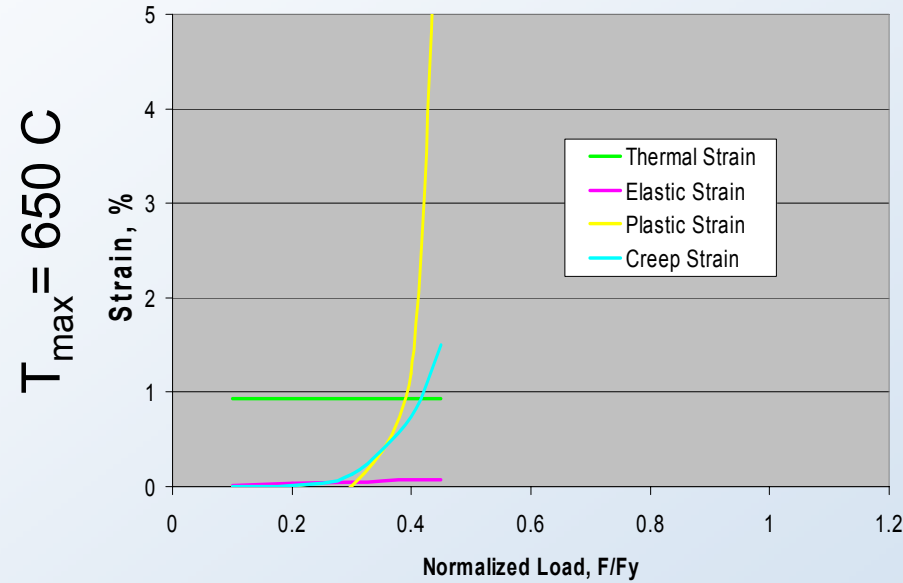
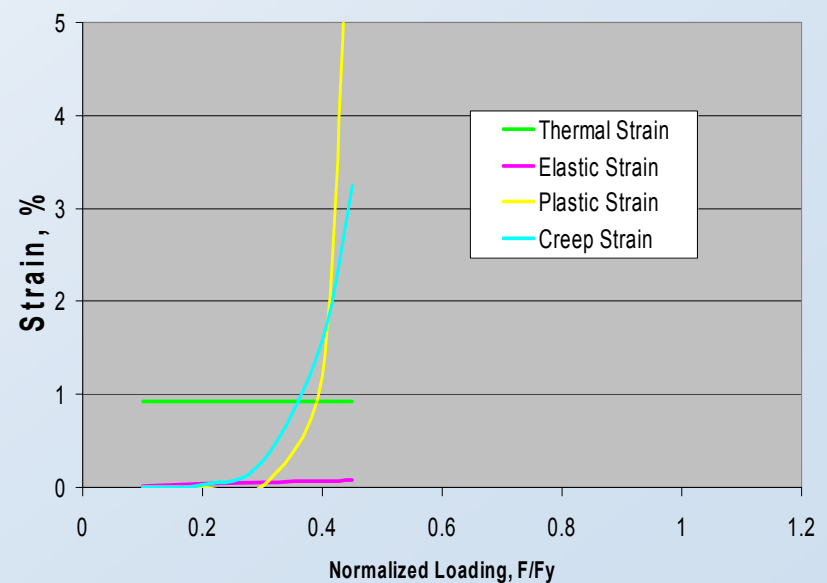
Creep, Plastic, and Thermal Strain – Relative Magnitude

$$\epsilon_{\text{TOTAL}} = \epsilon_{\text{thermal}} + \epsilon_{\text{elastic}} + \epsilon_{\text{plastic}} + \epsilon_{\text{creep}}$$

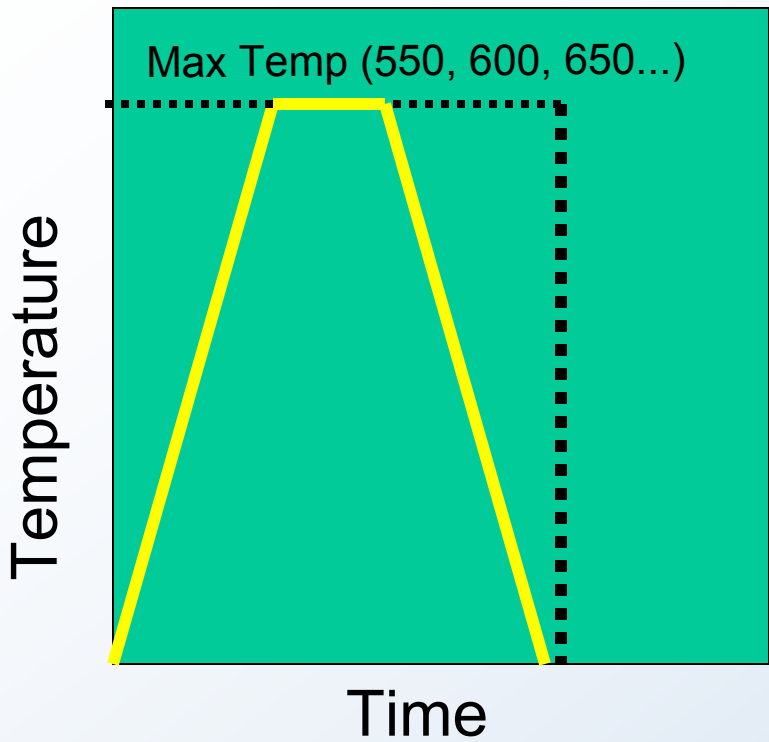
Creep, Plastic, and Thermal Strain – Relative Magnitude

$$\epsilon_{TOTAL} = \epsilon_{thermal} + \epsilon_{elastic} + \epsilon_{plastic} + \epsilon_{creep}$$

For even short hold times at high temperature, *creep strain may dominate total strain.*

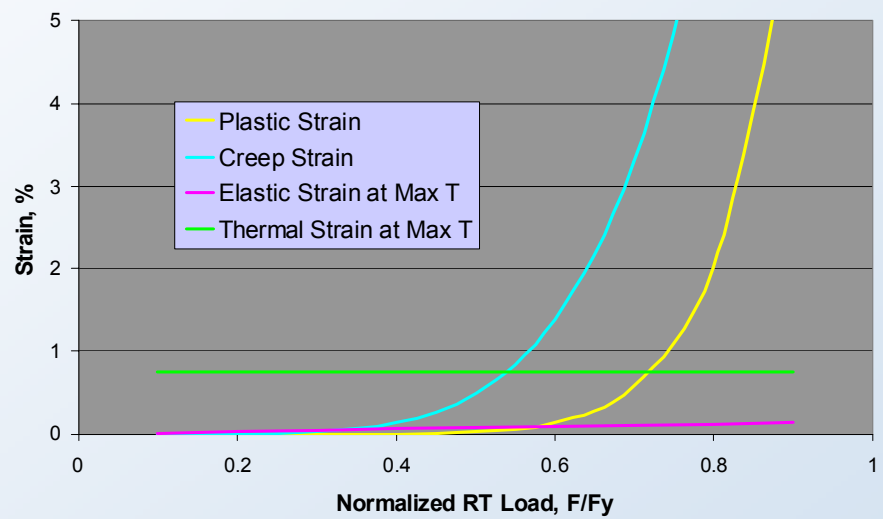
30 min Ramp to 550, Hold 30 min, 30 min Ramp Down

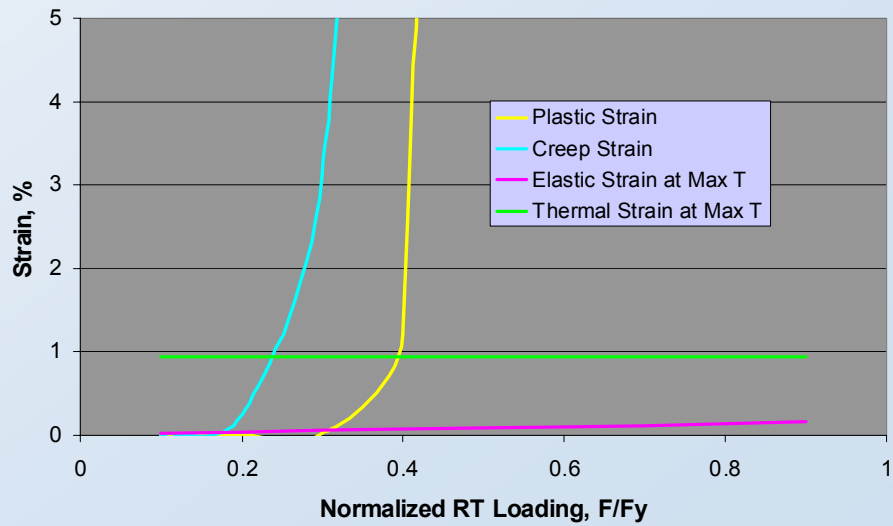
30 min Ramp to 650C, Hold 30 min, 30 min Ramp Down
