# Advancing Reliability Assessments of Photovoltaic Modules and Materials through Combined-Accelerated Stress Testing

NIST/UL Workshop December 2019

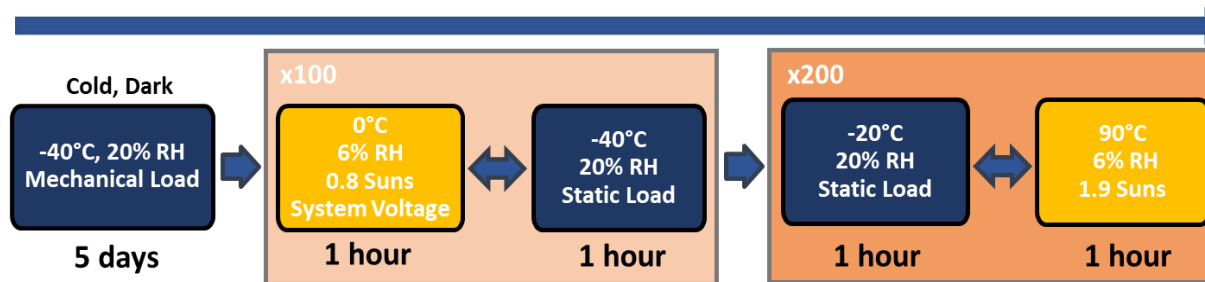
## Phase 2 – Multi-seasonal

6 weeks

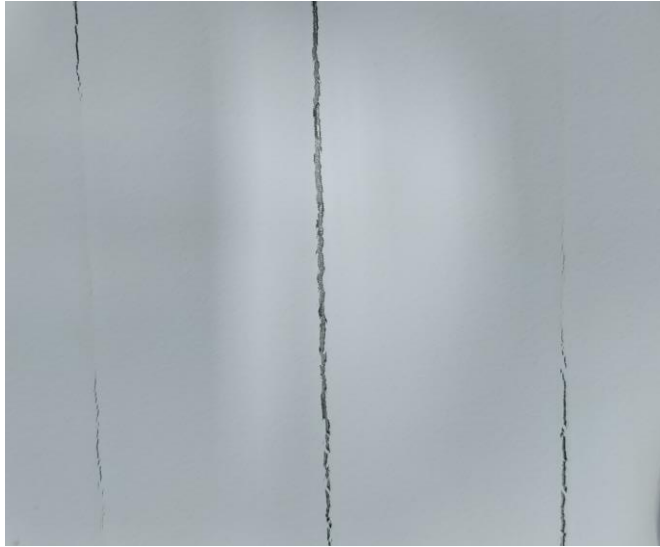
Macro cracking over underlying features (cell tabbing) following phase 1 (tropical) 4.5 months (cumulative)

Important result since AAA cracking could not be reproduced in the standard stress tests

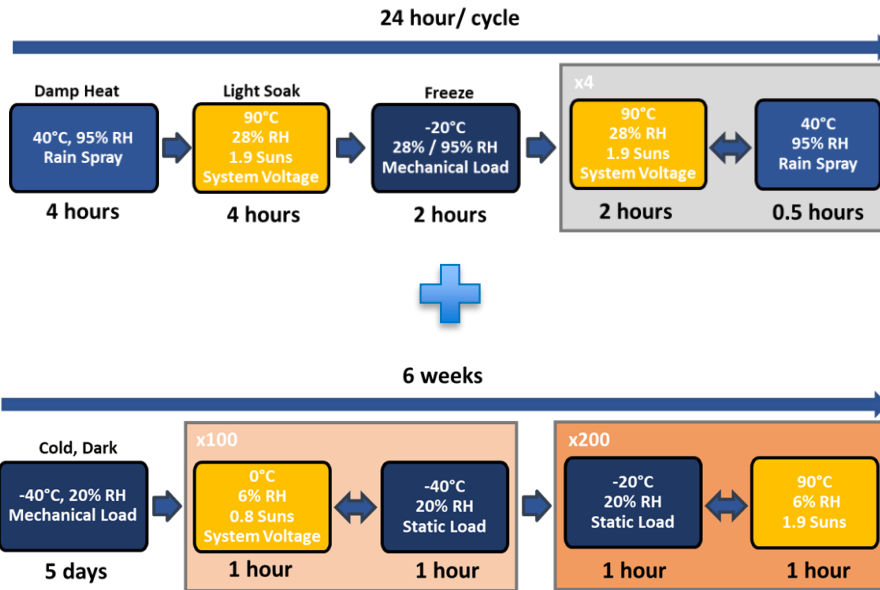
2x KPF samples.

One with **3 months** exposure to tropical and one with **6 months** exposure to tropical. *Without failure.*

Both cracked **simultaneously** after one round of phase 2. Though the 6 month module saw a higher crack density

Phase 1 is predominantly **wet** while phase 2 is predominantly **dry**. Failure to induce cracking in phase 1 suggests some kind of plasticization.

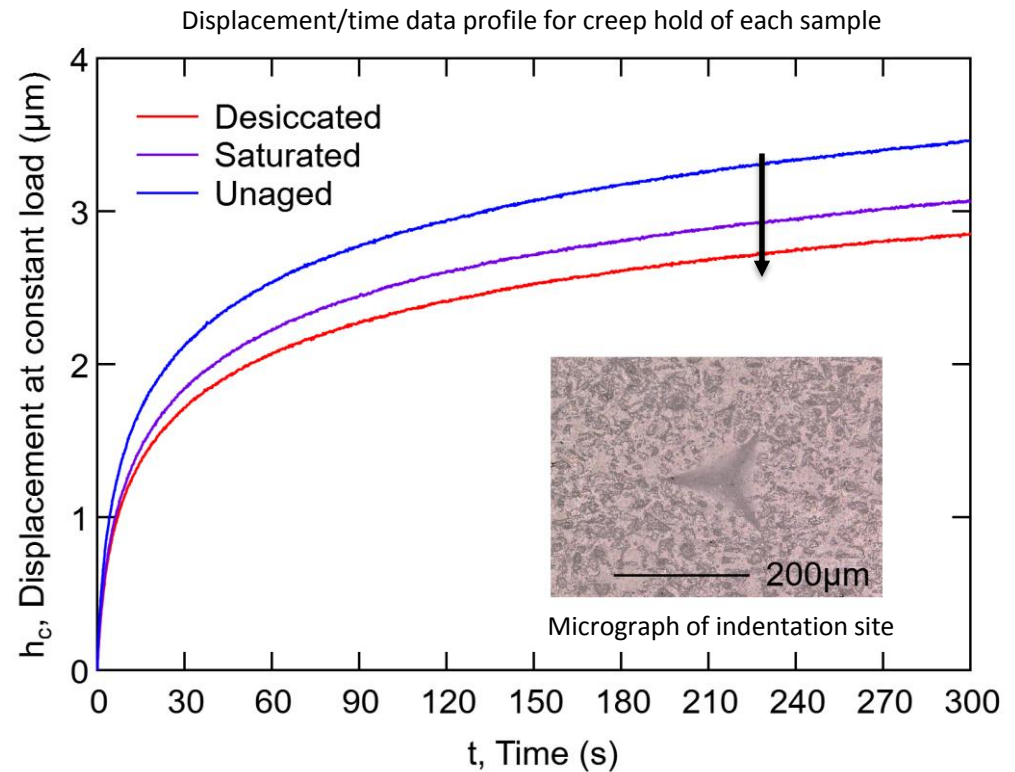
Used to quantify fracture toughness (embrittlement) of a material

- Two KPF samples underwent **6 months of tropical**
- One was saturated at 96% RH/40°C
- One desiccated at 5% RH/40°C,
- Reduced creep displacement in aged materials
- Desiccated sample has greater resistance to creep deformation

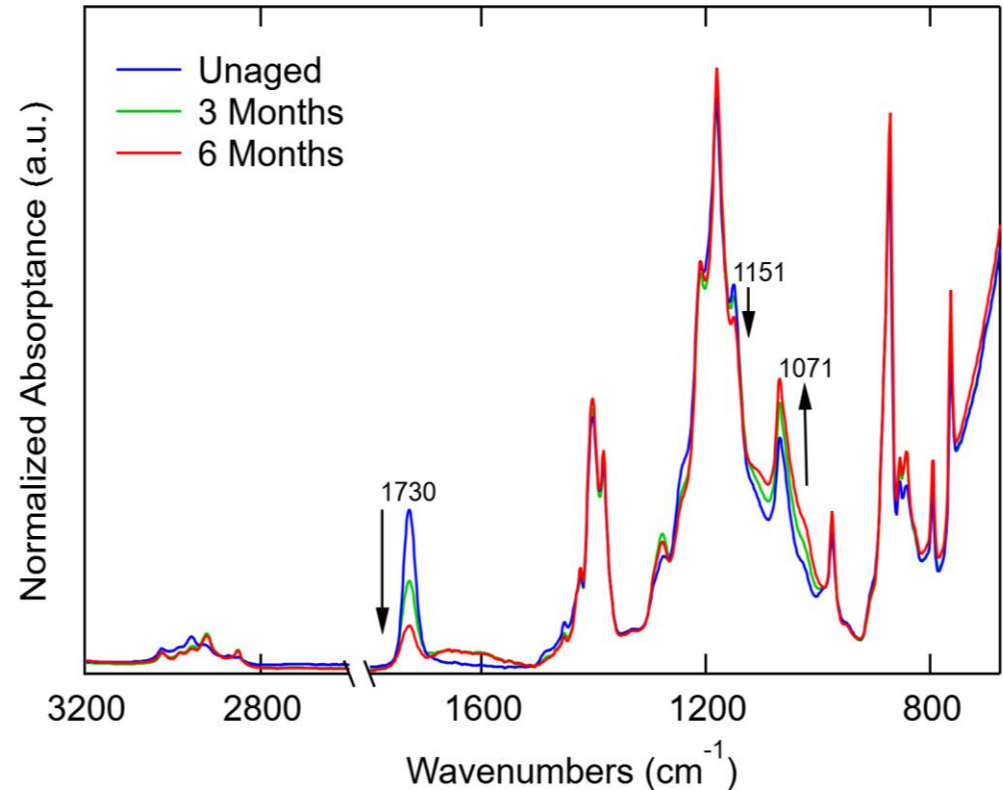
- $1730\text{cm}^{-1}$  carbonyl group and  $1151\text{cm}^{-1}$  ester are associated with PMMA
- Decreasing  $1730\text{cm}^{-1}$  and  $1151\text{cm}^{-1}$  suggests depletion of PMMA
- Increasing  $1071\text{cm}^{-1}$  symmetric stretching of  $\text{CF}_2$  and suggests a crystalline phase change is occurring, however, this could be either  $\alpha$ ,  $\beta$  or  $\gamma$  phase

FTIR-ATR for KPF unaged and C-AST aged samples

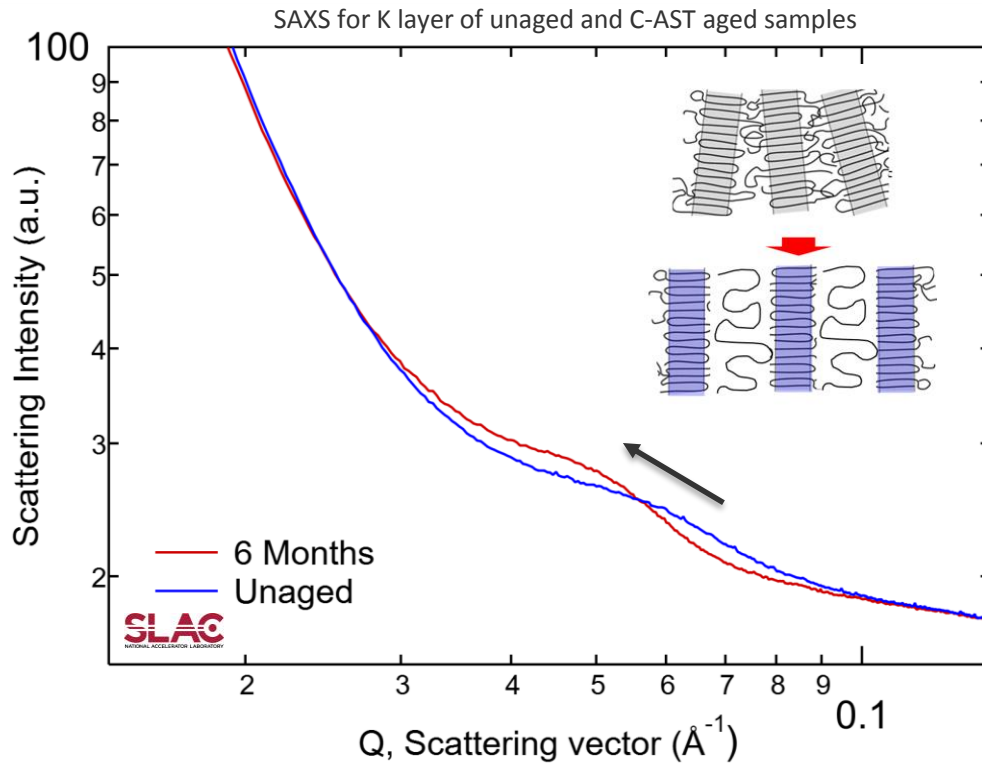
PVDF/PMMA/TiO<sub>2</sub> (K) layer separated  
from rest of the backsheet

- Small-angle X-ray scattering (SAXS) collected at Stanford Synchrotron Radiative Lightsource (SSRL) at SLAC
- SAXS probes the lamellar packing distance between the crystalline and amorphous domains of the polymer
- The lamellar feature of PVDF shifts towards smaller  $Q$  values and becomes slightly more pronounced after aging
- This suggests that the lamellar packing distance becomes larger and more well-defined, consistent with the increased crystallinity observed in WAXS
