Camp Fire – Fire Progression Timeline

International Association of Fire Chiefs

Alexander Maranghides
Eric Link

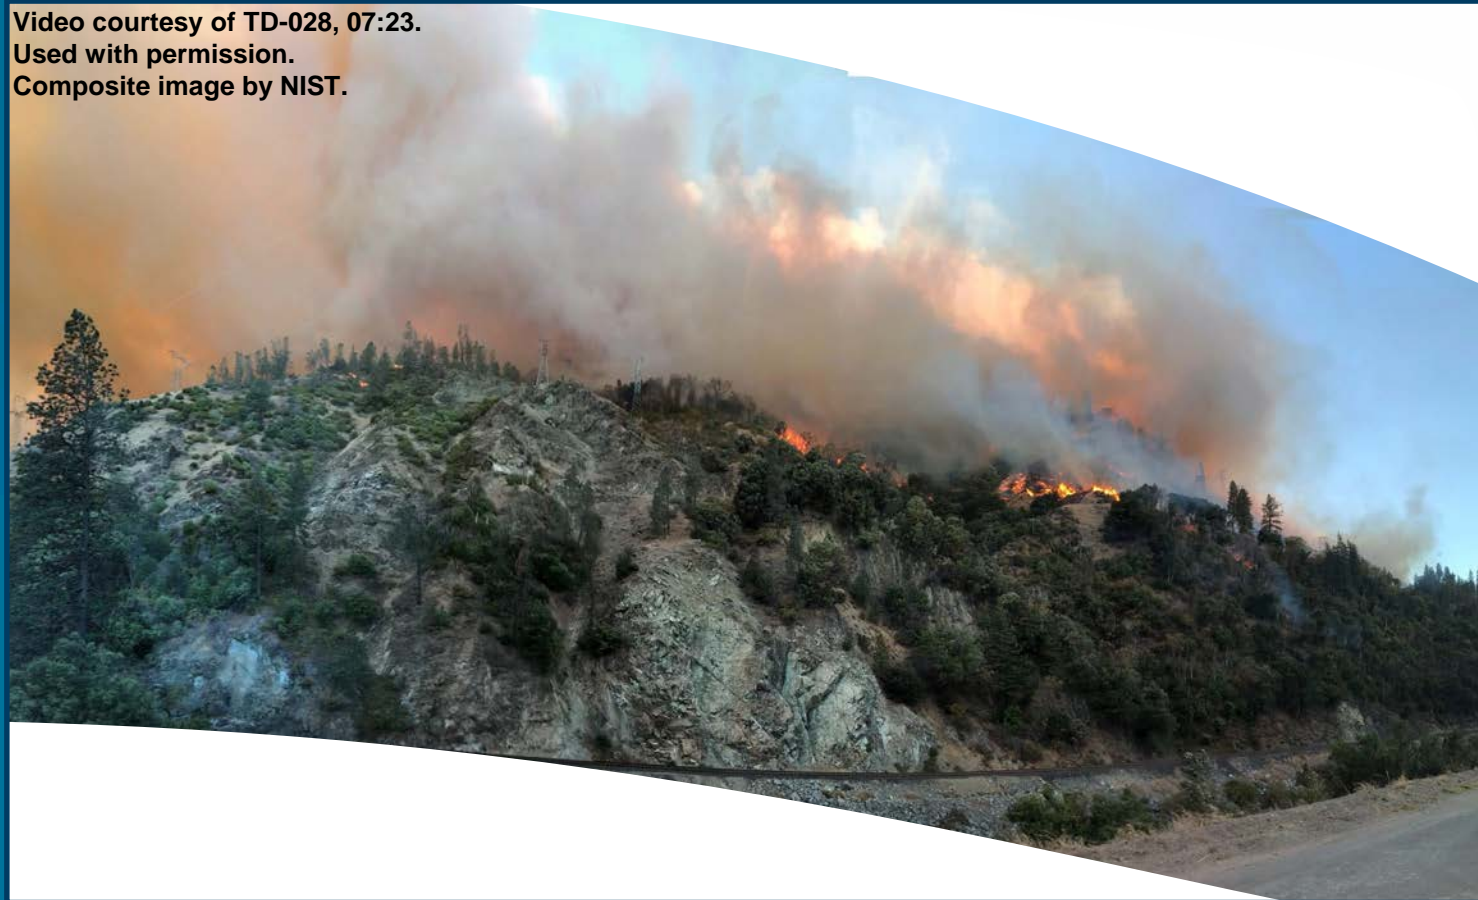
Caltrans Pulga Maintenance Yard, 07:23

- View of the fire looking north from Highway 70.
- Panorama created from video recording.

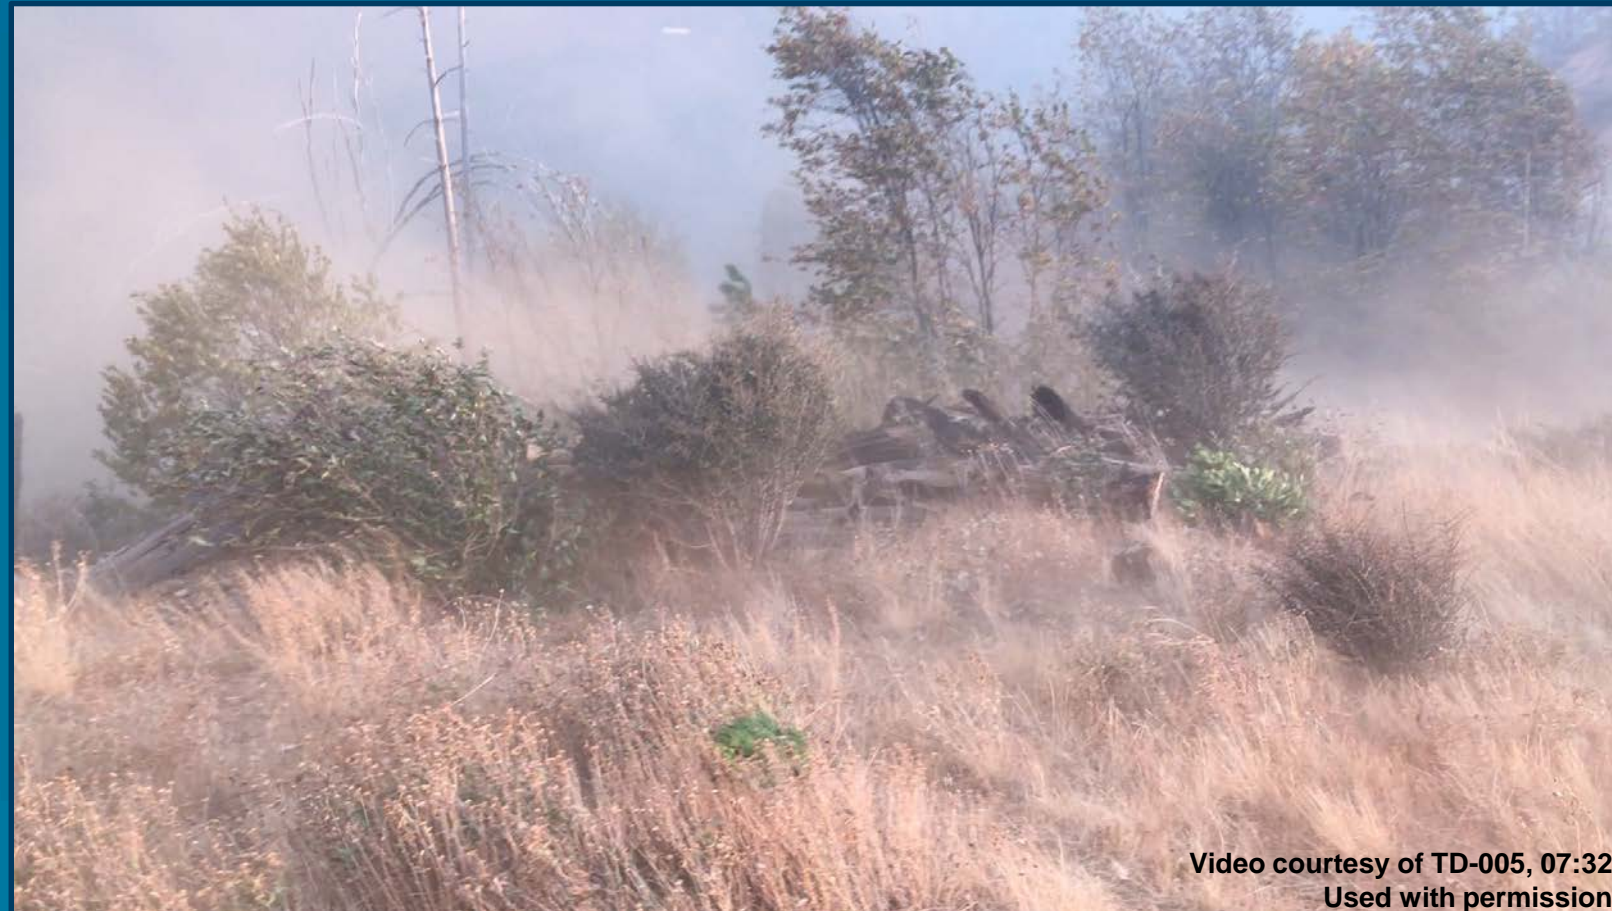
Strong Wind at Rim Road

- Spot fires on ridgetop and into Concow
- Strong east/northeast winds blowing rocks

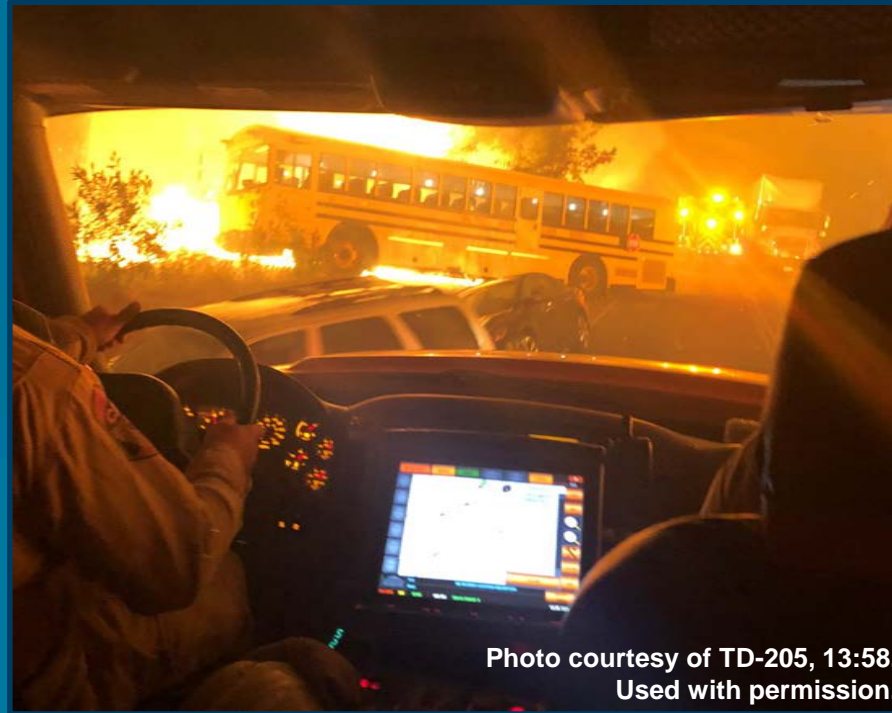
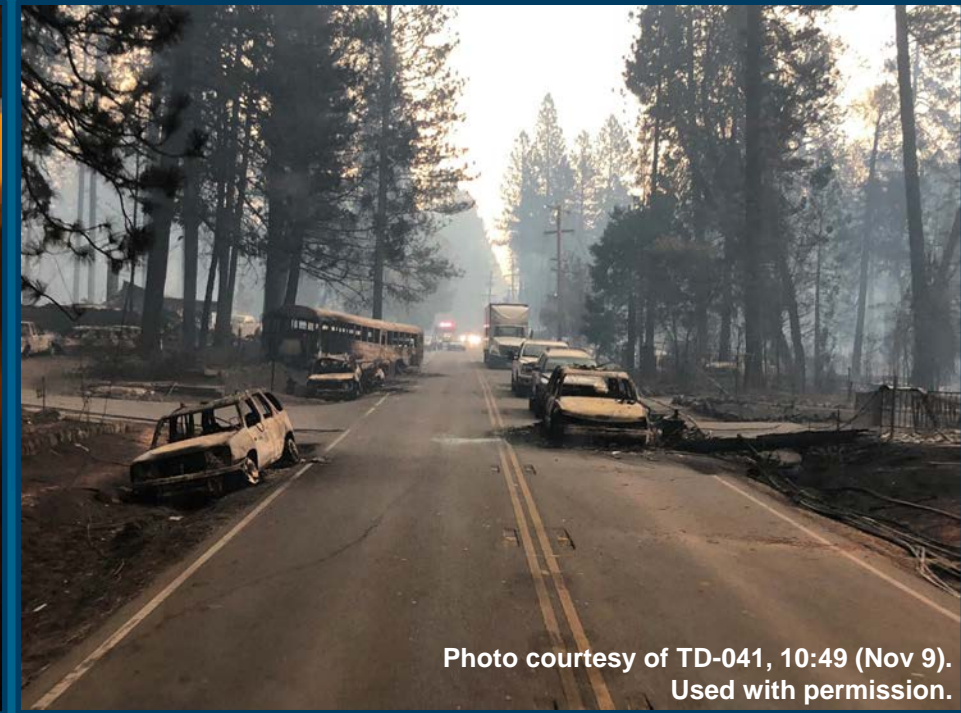
Burnover #4: Upper Skyway

- Prolonged period of hazardous conditions
- Rapid spread of initial spot fires
- Standstill traffic
- Abandoned vehicles burning in roadway
- Prevented evacuation from points north

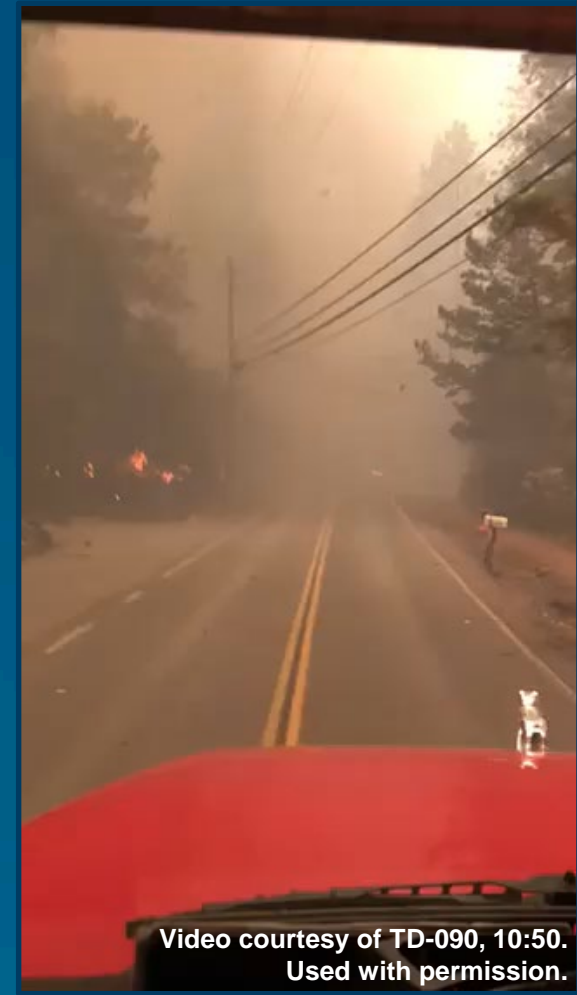
Video courtesy of TD-090, 10:50. Used with permission.

Conditions south of hospital after burnover

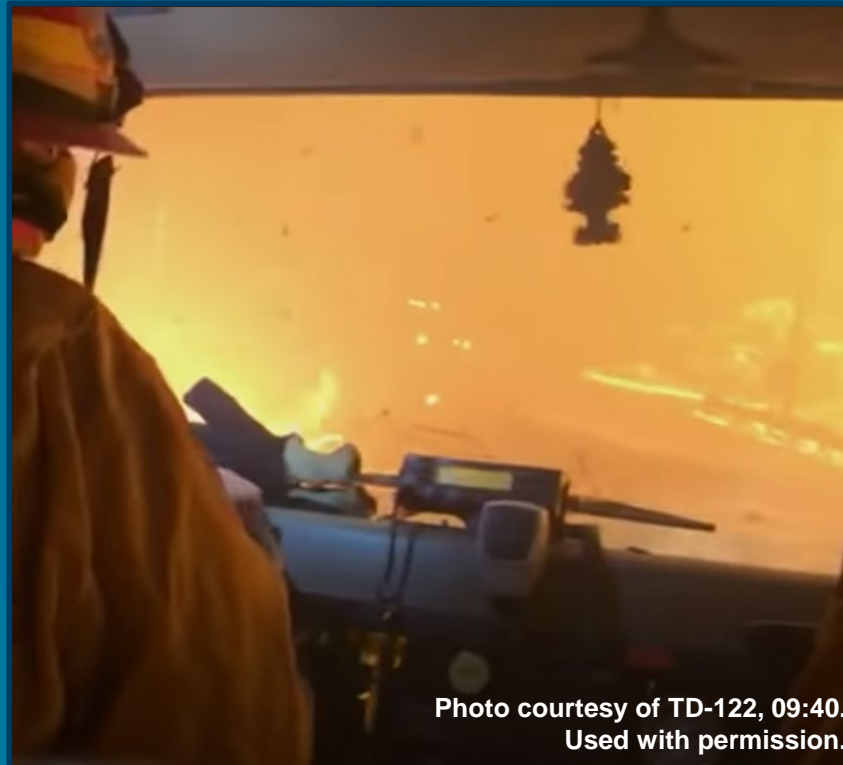
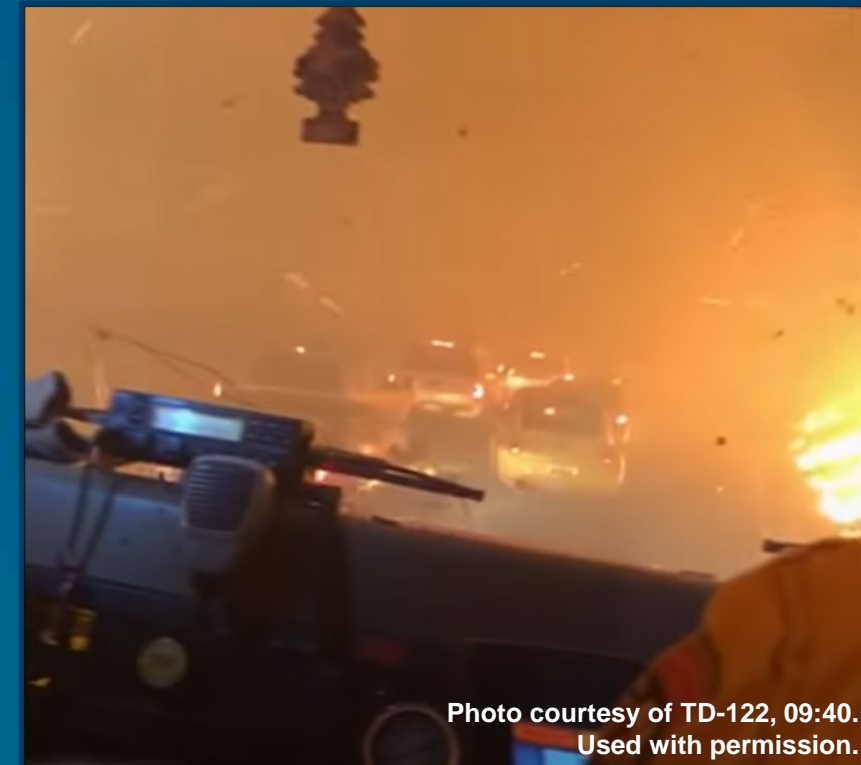
Burnover #7: Pearson Road

- Standstill traffic
- Intense vegetation fire in drainage near Stearns Rd and Hilbe Dr
- Igniting vehicles and structures
- Fire engines and dozers assisted civilians into temporary refuge area

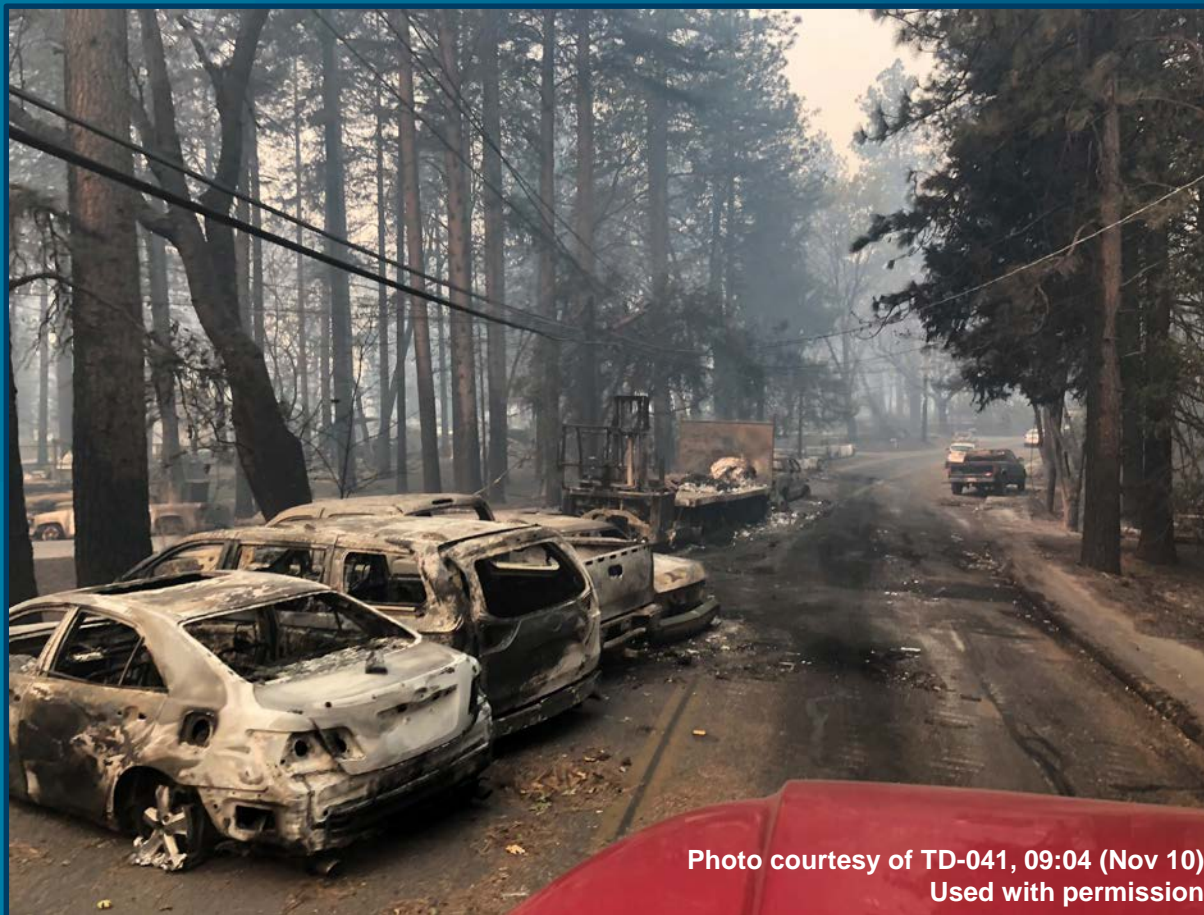
Burnover #8: Bille Road

- Fire impacted standstill traffic
- Evacuees fled on foot, abandoning vehicles
- Fire engine at Pentz Rd and Bille Rd protected temporary refuge area with water spray
- Burning vehicles blocked roadway all day

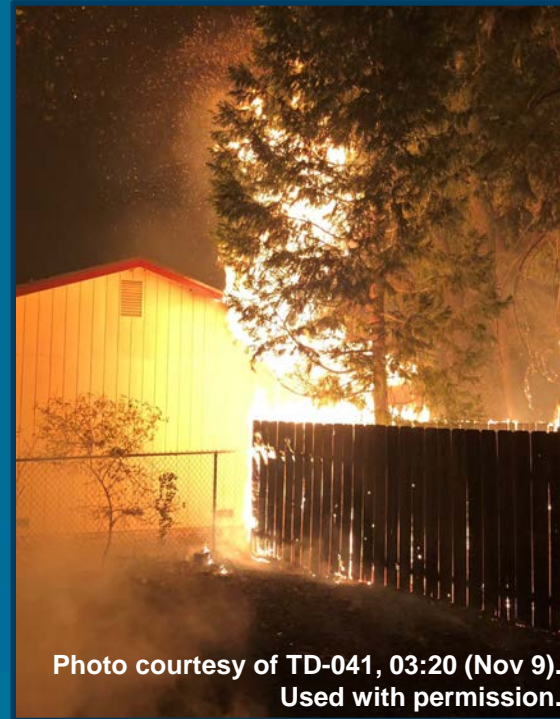
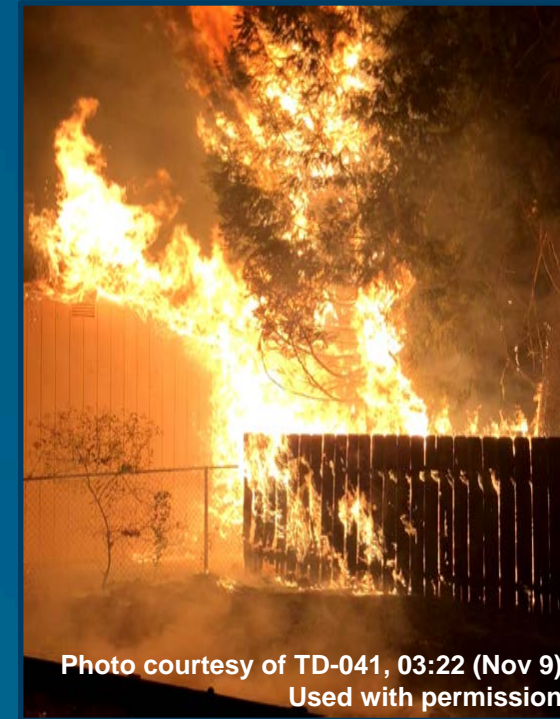
a) $t = 0$ s

Structure ignition on Dade Ct in Magalia. Images are two minutes apart and show fire spread from surface fuels to fence to vegetation to eaves. The combustible fence is estimated to be approximately 1.8 m (6 ft) away from the structure.

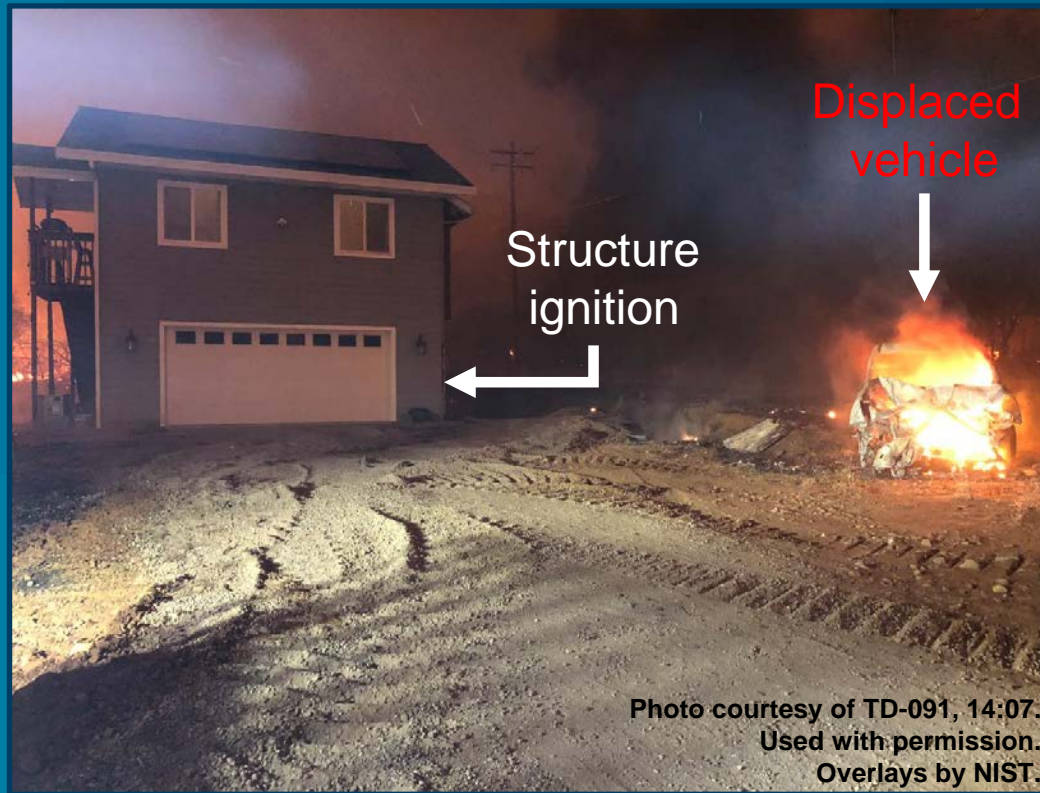
a) A dozer displaced the vehicle to stop fire spread

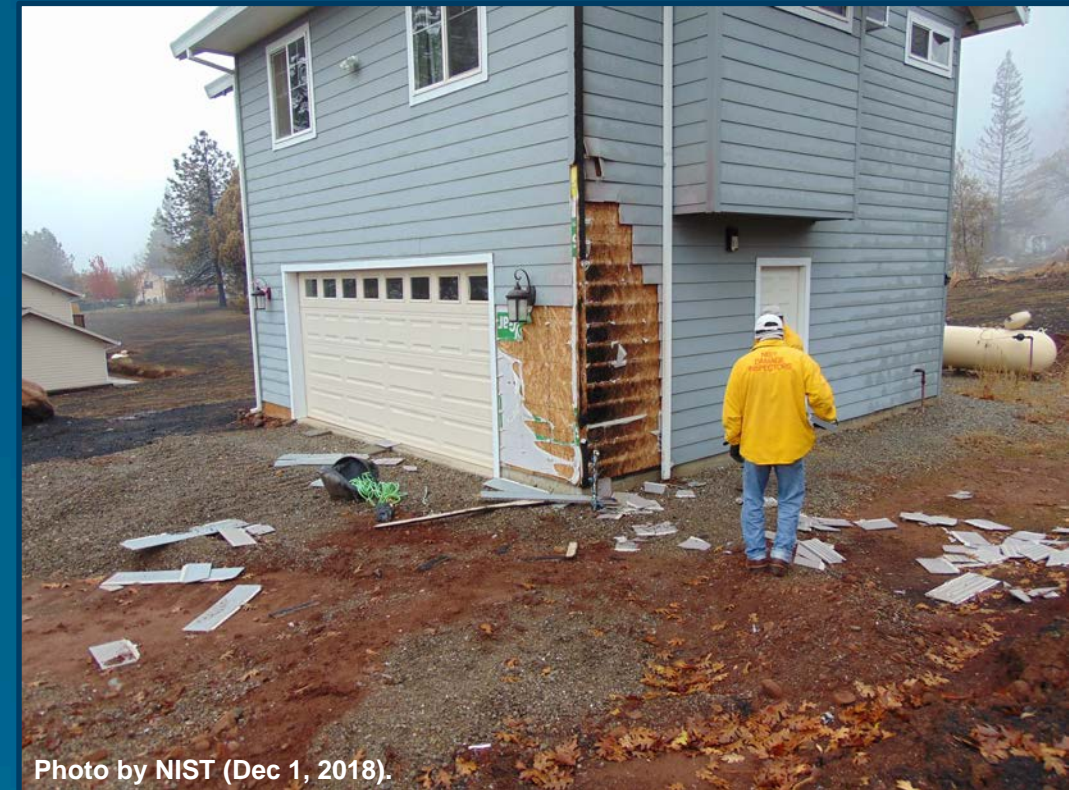
b) Associated evidence of the fire ignition and defensive actions encountered during NIST damage assessments.

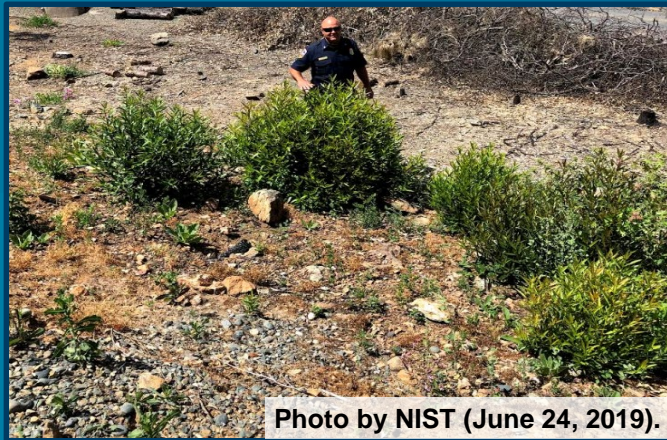
Rapid post-fire vegetative growth in pre-fire fuel treatment areas

Fuel treatments can reduce exposure but must be maintained

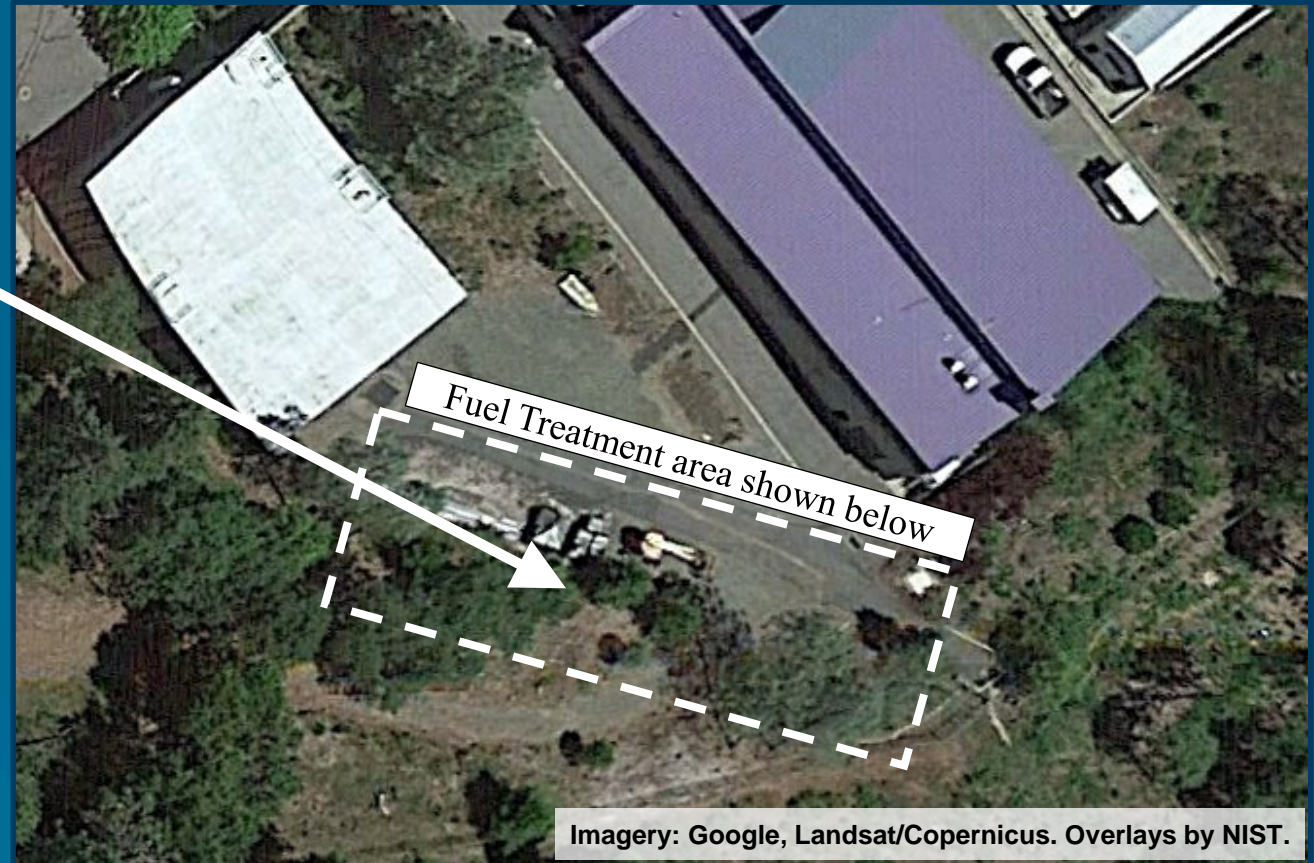
Note: Imagery captured before completion of fuel treatment

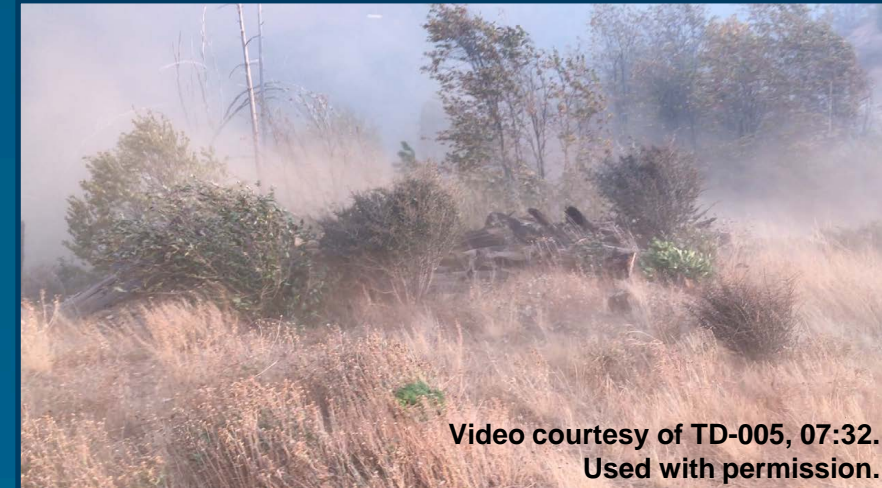
Wind and Terrain

- Jarbo Gap is known for its high winds [TD-003, TD-008]
- Wind* event + topography + dry fuels
 - Rapid fire growth
 - Fire could not be contained soon after ignition

* Wind was not extreme throughout the event (temporally and spatially)
