# Public Comments Received by NIST on DRAFT Reports:

NIST NCSTAR 1A Report on the Collapse of World Trade Center Building 7 - DRAFT for Public Comment

## DRAFTS FOR PUBLIC COMMENTS

August 2008

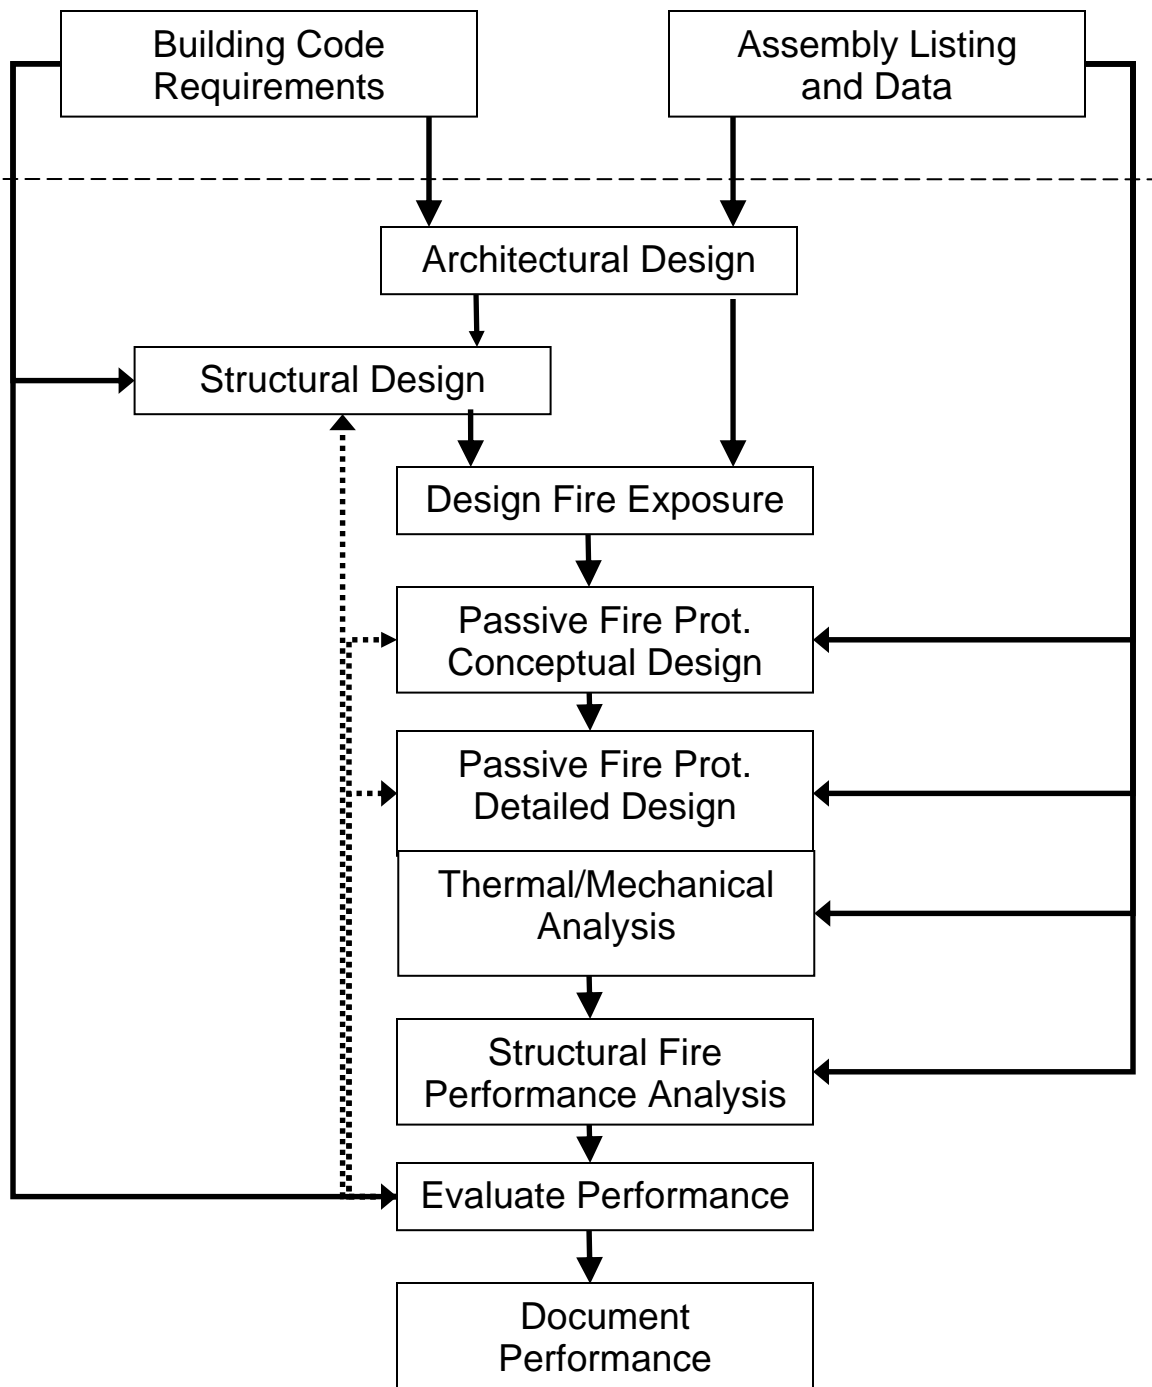
Based upon the architectural and structural designs, the design fire is used to develop the passive fire protection design. This involves the selection of fire resistive assembly constructions for use as walls, columns, and floor/ceiling assemblies. The assemblies are selected to survive the design fire exposure, to be consistent with the architectural/structural design, and to provide cost-effective protection. It would be normal to develop more than one set of conceptual designs for further evaluation.

Figure 1. Performance-based structural fire engineering (PBSFE) design process.

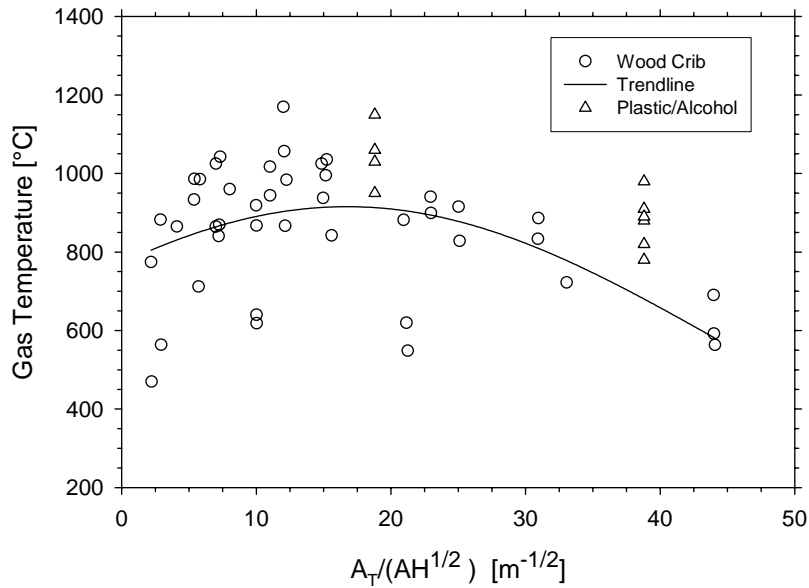
The impact of fire stoichiometry and fuel type can be seen in Figure 6 through the tests on the plastics and alcohol (Bullen and Thomas, 1978). In these tests, the opening factor is constant but the fuel type and stoichiometry of the fire is being varied. As seen in the figure, gas temperatures can vary by 200°C by changing these variables. The highest gas temperatures will be produced by fuels that require less energy to volatilize and when the compartment fire has an equivalence ratio equal to one (i.e., stoichiometric burning).

Figure 6. Compartment fire gas temperatures as a function of opening factor.

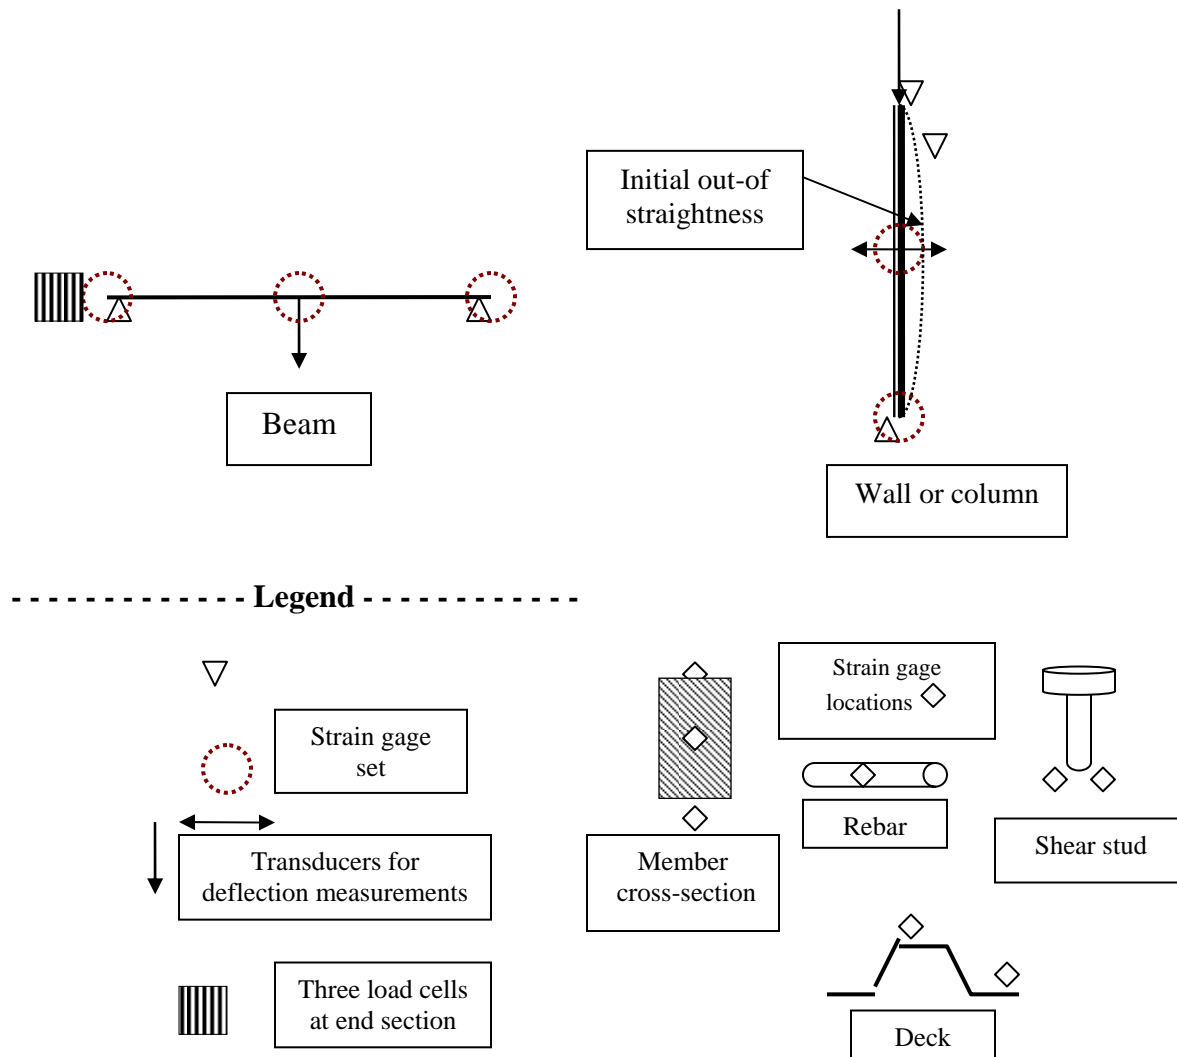
Figure 16. Illustration of recommended additional instrumentation for structural fire performance.

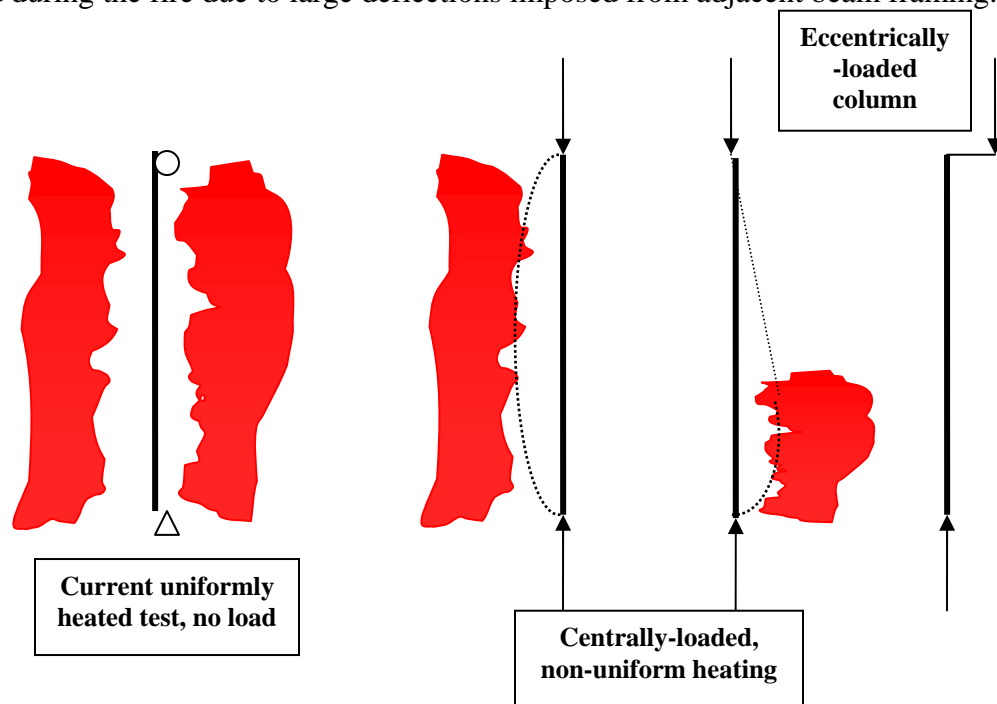
As illustrated in Figure 17, non-uniform heating can be full height, but incomplete fire exposure of entire column section contour or a partial height exposure of some or all the section contour. Loaded column tests with non-uniform heating are expected to show asymmetric structural response and failure mechanisms that are not obviated from the currently unloaded, uniformly-critical E 119 temperature tests with their idealized conditions. Similar performance differences can exist for some wall assemblies due to non-uniform heating, applied load and deformation, even for non-loadbearing elements such as those that may be used as fire separations for large record storage compartments (Beyler and Iwankiw, 2005). Bailey (2004) reported that during the Cardington building tests in the UK, a non-loadbearing compartment wall failed during the fire due to large deflections imposed from adjacent beam framing.

Figure 17. Column fire-testing alternatives.

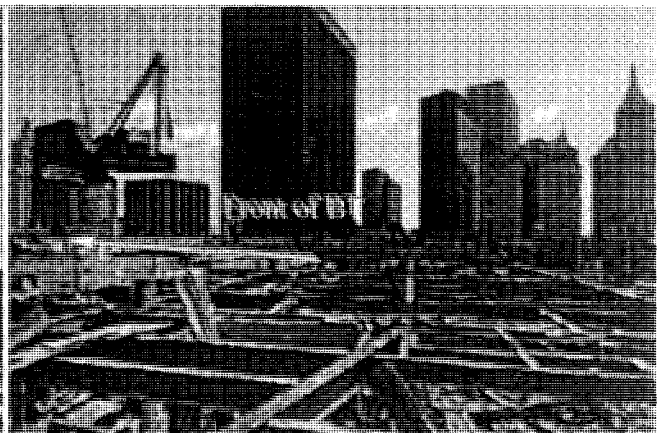
**Figure 64.** Once the concrete slab and metal decking are removed, what remains is a steel skeleton of each floor. There is little rust in the southwest corner of the building, even though it is open during the deconstruction from the top down.  
17bank\_CA06.jpg

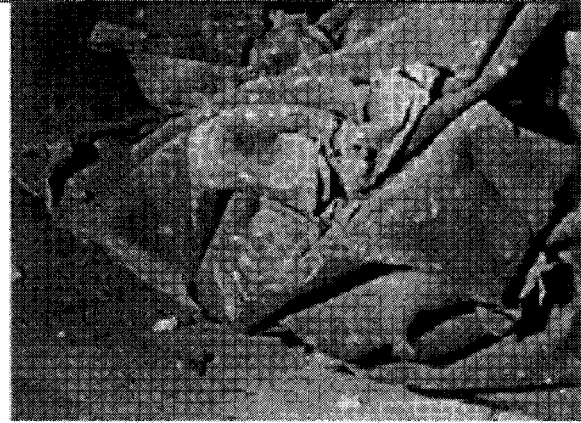
<p>Figure F-A-2c: Collapsed part of Column 210.</p>		<p>The lower portion of this piece is somewhat intact below the distorted portions of the columns. There are no significant visual indications of fire effects on the lower portion of this piece. However, given the sharp curvature of much of the bent steel in the collapsed portion of Column 3, there is the chance that that portion of Column 3 has been fire affected. Metallurgical examination can be used to determine whether or not the collapsed portion of Column 210 has been fire affected.</p>

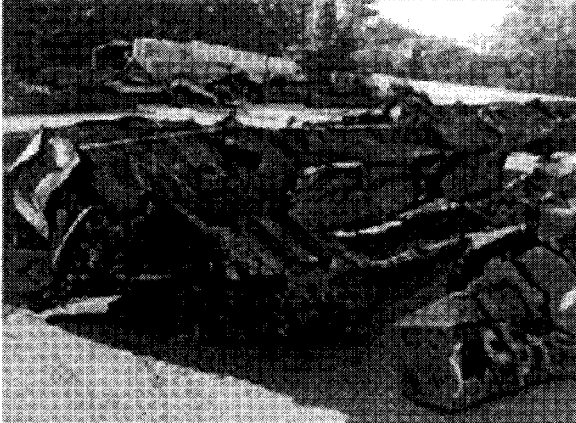
<p><b>Figure F-B-9a:</b> Overall view of piece M-4.</p>		<p>This is an unidentified exterior column panel from WTC 1 or WTC 2. The recovered piece is a partial panel, consisting of approximately the upper one-half to two-thirds of the panel.</p> <p>This panel exhibits possible fire effects on the inside faces of all three columns at some window locations, as exhibited by loss of most paint and the presence of local buckling or "dishing" of the inside faces of the columns. The side faces and outside face of the columns exhibit little or none of these fire effects.</p> <p>Zones of interest were identified on the inside faces of two of the columns as follows:</p>
