# Development of Accelerated Tests Based On Analysis of Fielded Modules

**Atlas/NIST Workshop on Photovoltaic Materials Durability**

# DuPont Field Module Program

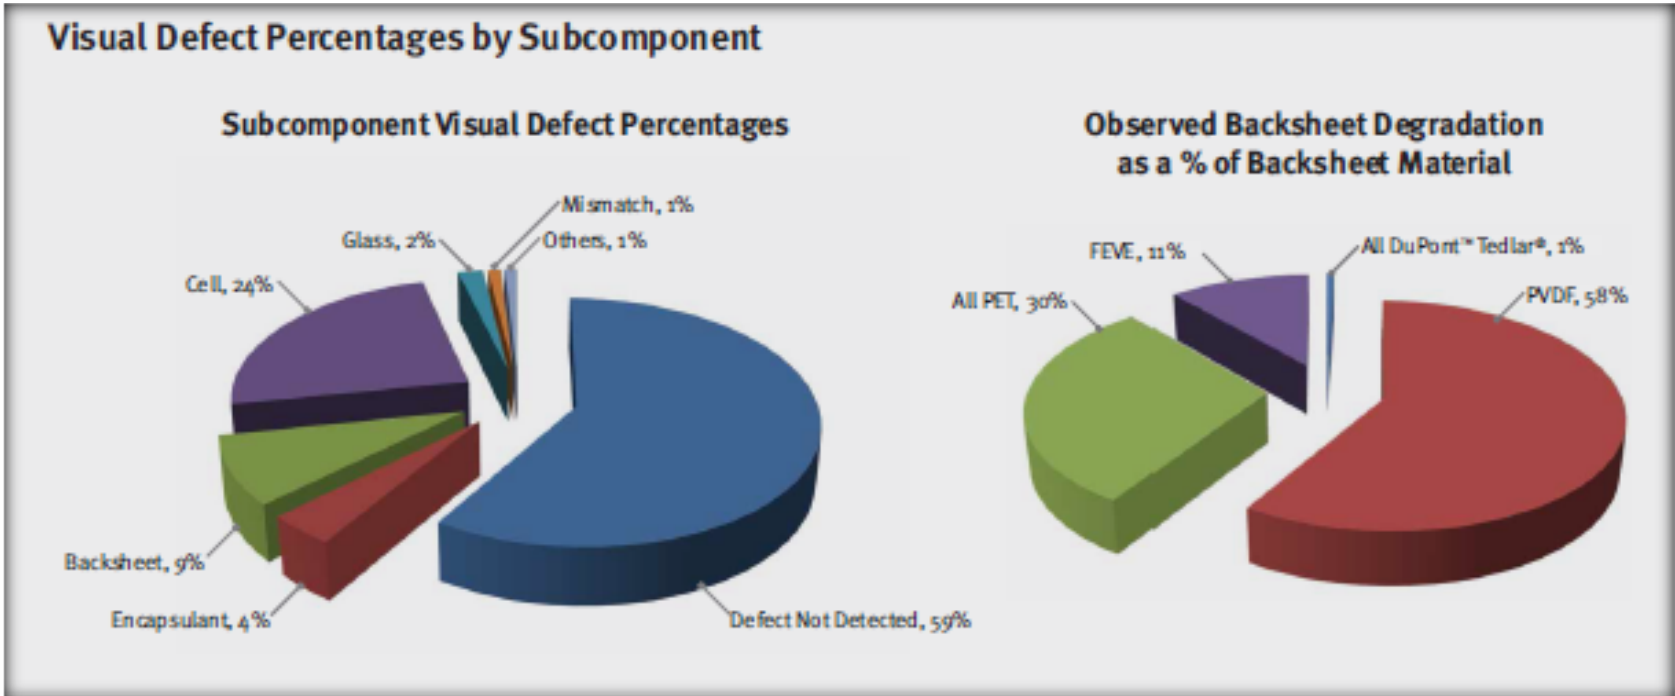
**Field Studies Reveal Quality Issues**  
**41% of surveyed modules exhibited some visual defect**

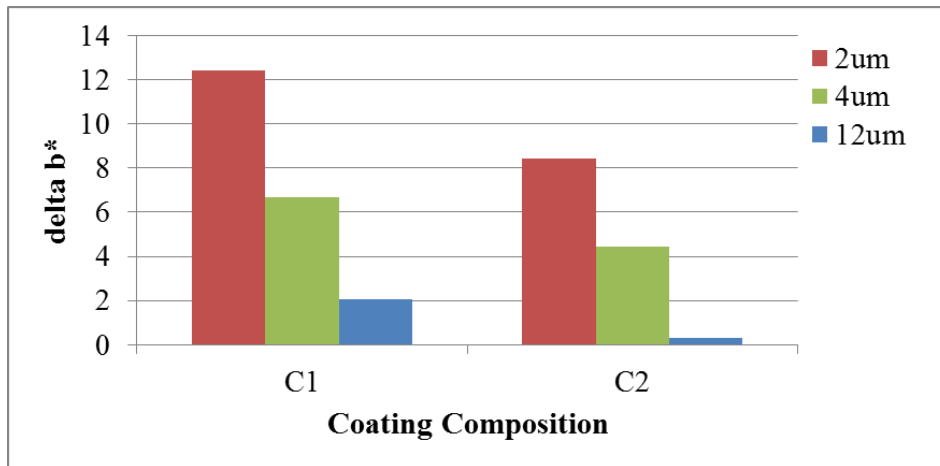
Yellowing vs protection layer thickness for two different compositions

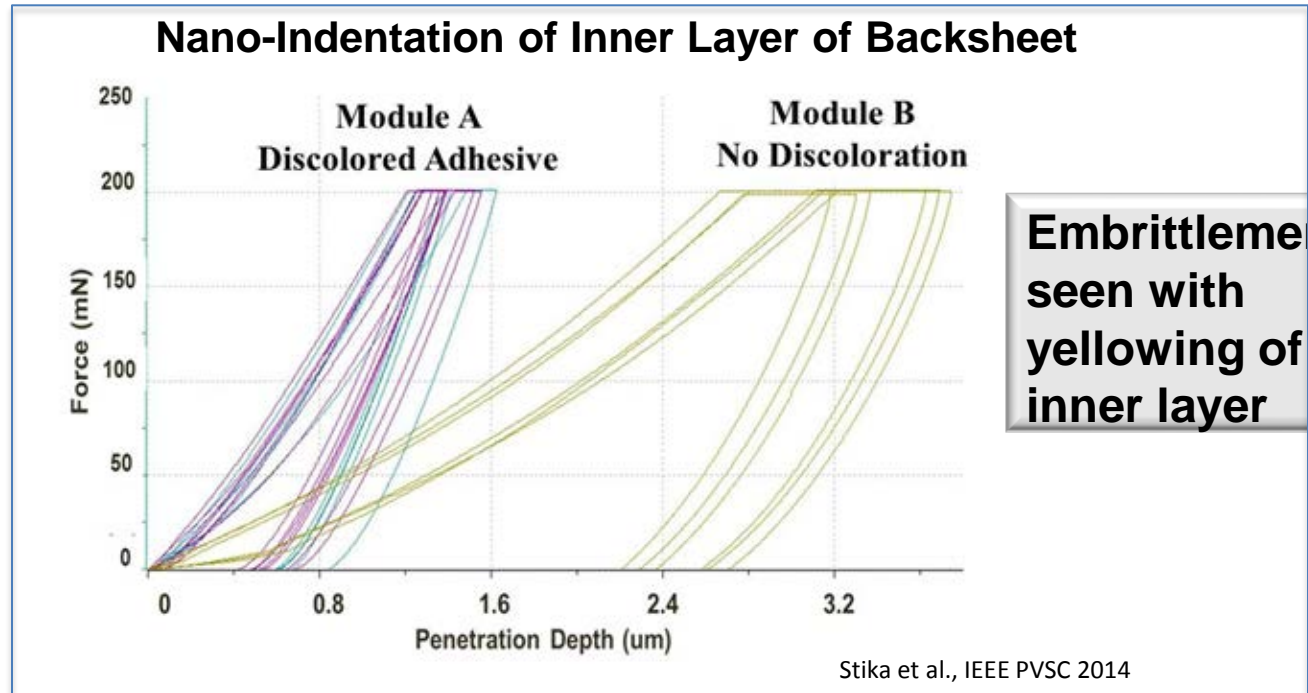
**Embrittlement  
seen with  
yellowing of  
inner layer**

- PVDF-based backsheet**
- Years in service: < 5 years
  - Location: 5 countries (Belgium, Spain, USA, Israel, Germany)
  - Five different manufacturers

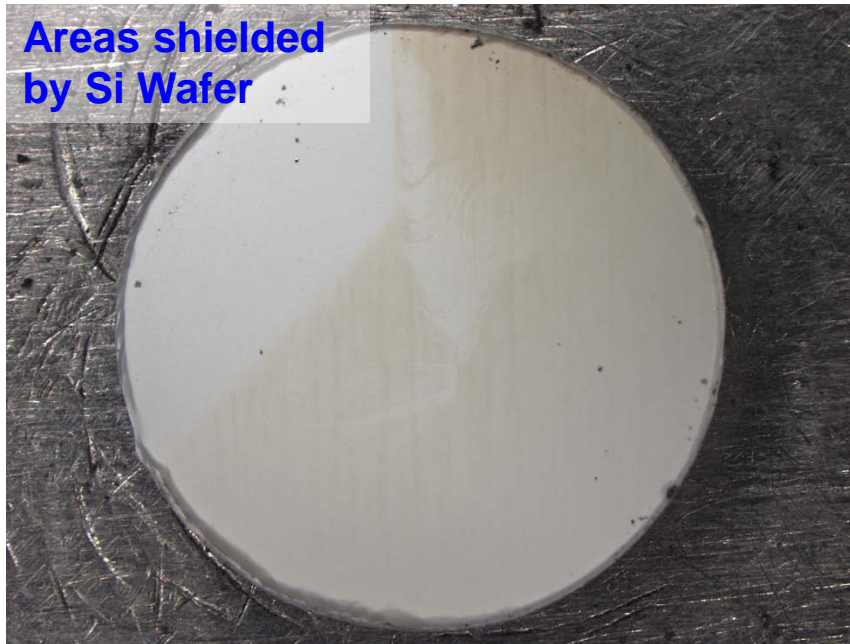
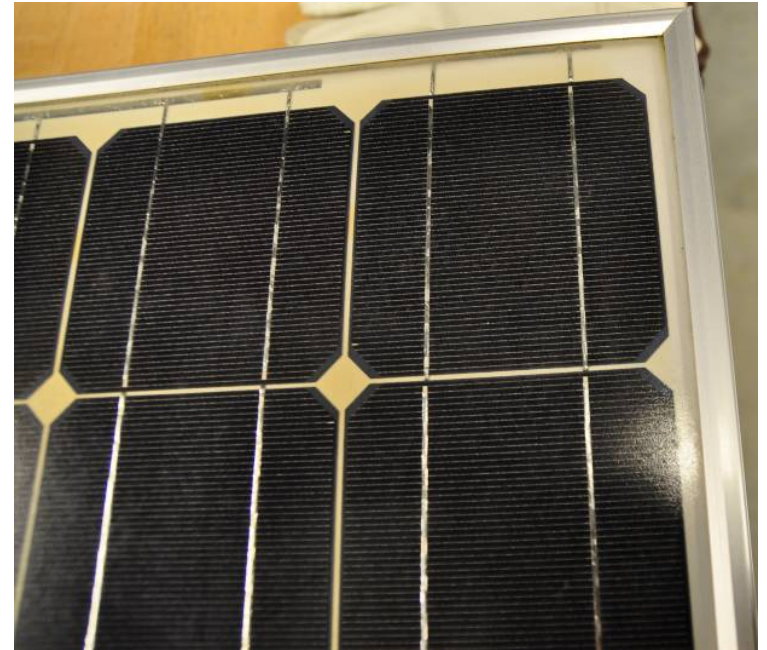
## PET-based backsheet

- Years in service: < 4 years
- Location: USA
- 100% field affected
- Rooftop and ground mount

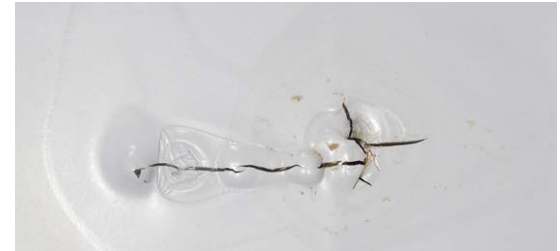
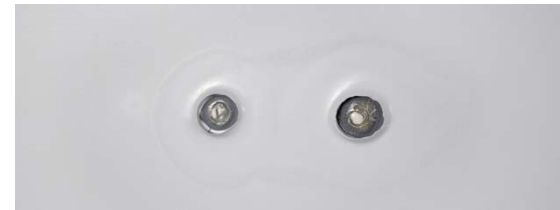
## High Intensity Hot Spot

Low softening and melting temperatures can lead to backsheets melting or cracking in the field due to partial shading and hot spots

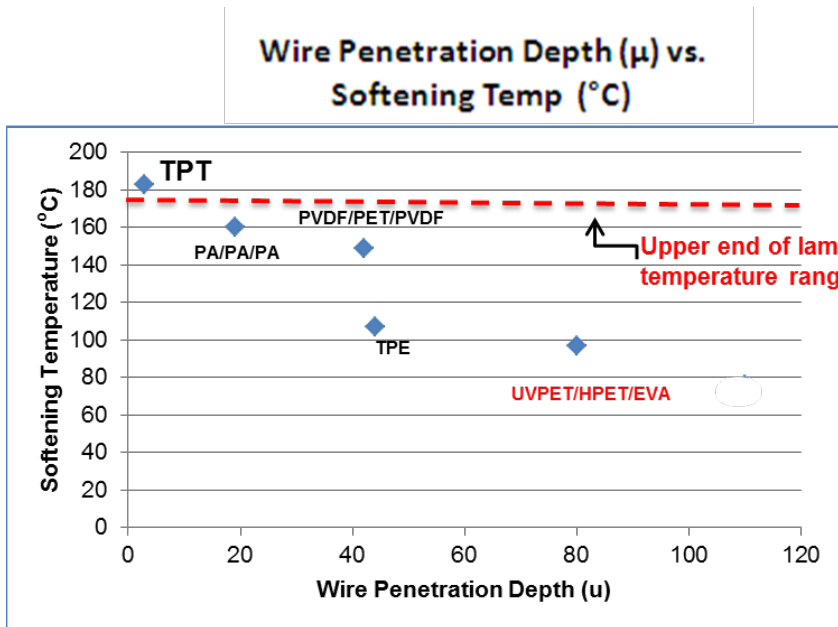
Penetration of tabbing ribbon into the inner layer of commercial backsheets under standard EVA lamination conditions

Penetration of tabbing wires evaluated by optical micrograph of a cross-sectioned backsheet with a soft inner layer

(TPT: Tedlar(R) PVF/PET/Tedlar(R) PVF)

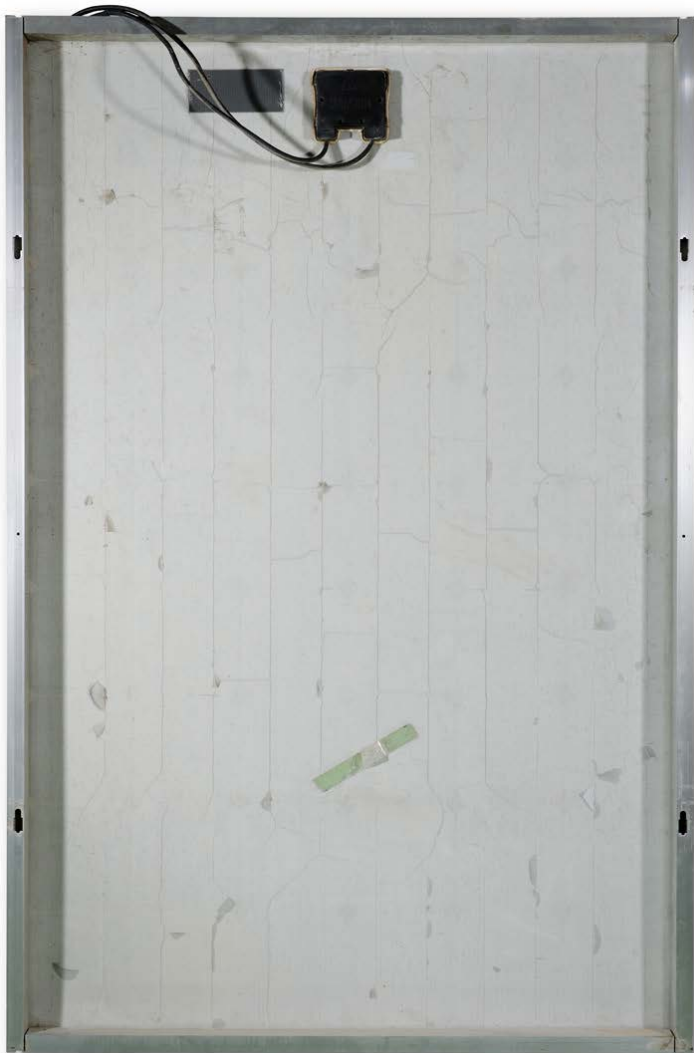
## Polyester-based backsheet

- Years in service: 4 years
- Location: Spain
- 5,000 modules affected

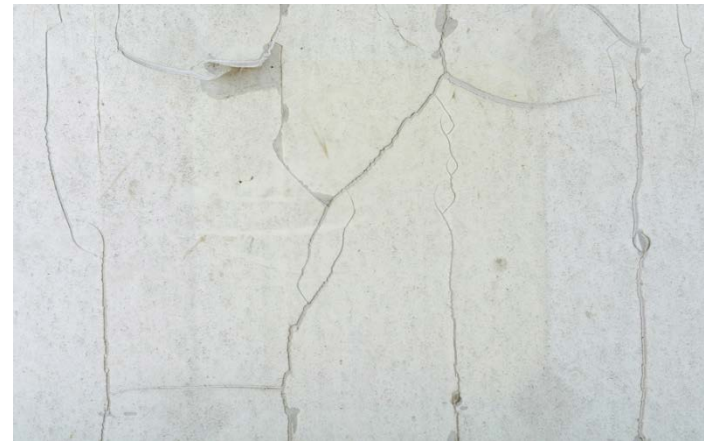
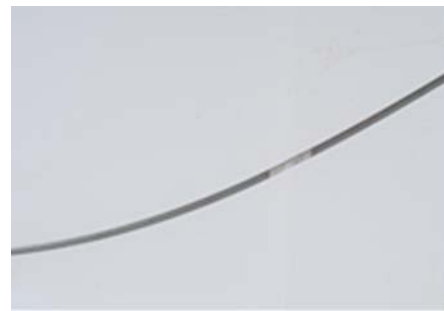
- Crack in polyester-based backsheet
- Exposes tabbing ribbon and potential electrical leakage path

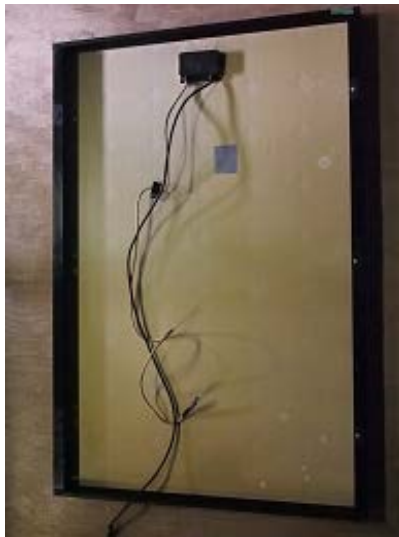
Yellowness ( $b^*$ ) measurements of 12 modules

- Yellowness measurements ( $b^*$ ) taken on 12 of 14 modules in the array
- Each module tested for yellowness in 53 locations
- Overall yellowing of backsheets due to UV or combination of stresses (thermal, UV, etc.)
  - High level of yellowing even on the interior of array ( $b^*$  of 13-20)
  - Highest yellowing is along edges with highest UV exposure ( $b^*$  up to 27)

**PET-based backsheet**

- Years in service: 15 years
- Location: Japan

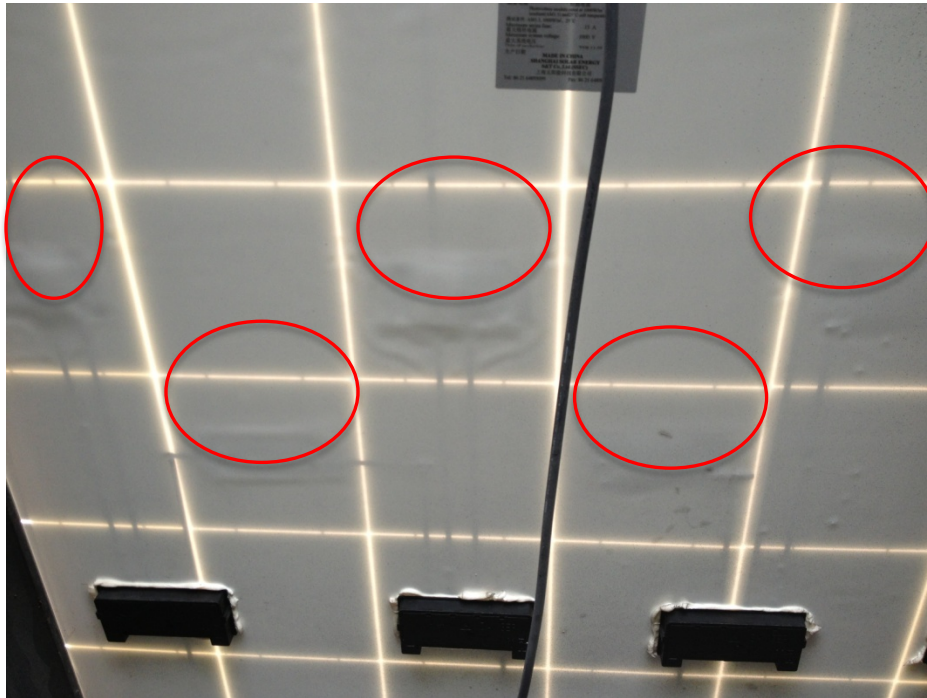
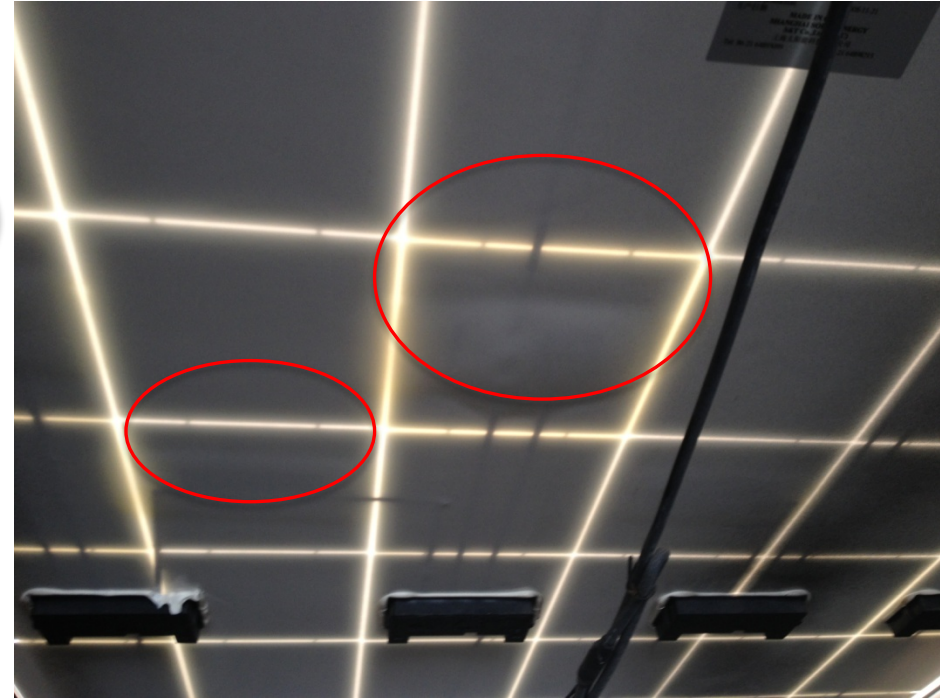
Large Amount of Delamination

Bubbling and Yellowing

## FEVE-based backsheet

- Years in service: 5 years
- Location: Shanghai, China
- Installation: Rooftop
- 30% of array affected

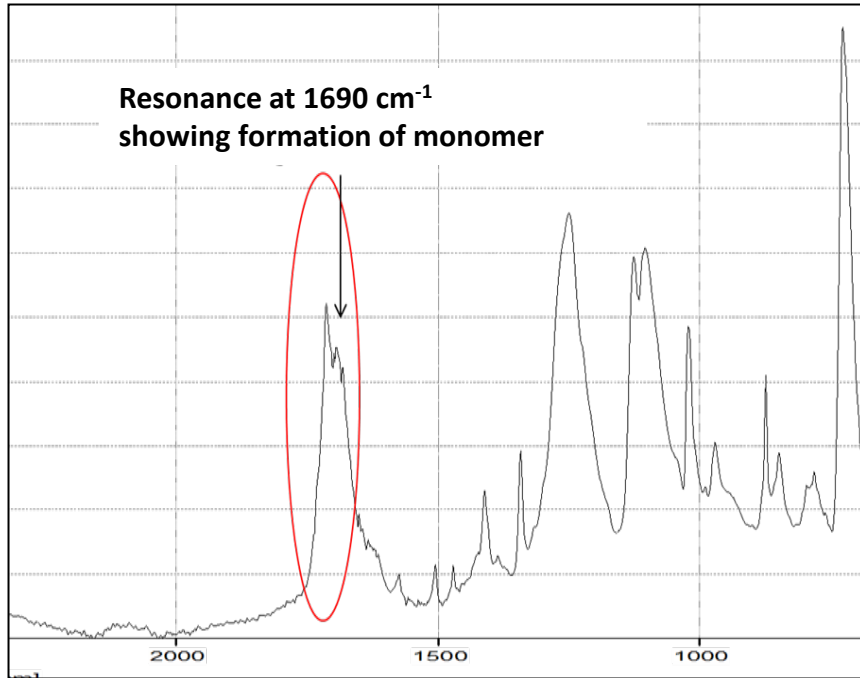
FTIR of 6 year-old fielded module in Arizona

**Same degradation observed in fielded module and accelerated UV weathering test. Polymer degradation can lead to cracking, module failure, and a safety hazard.**

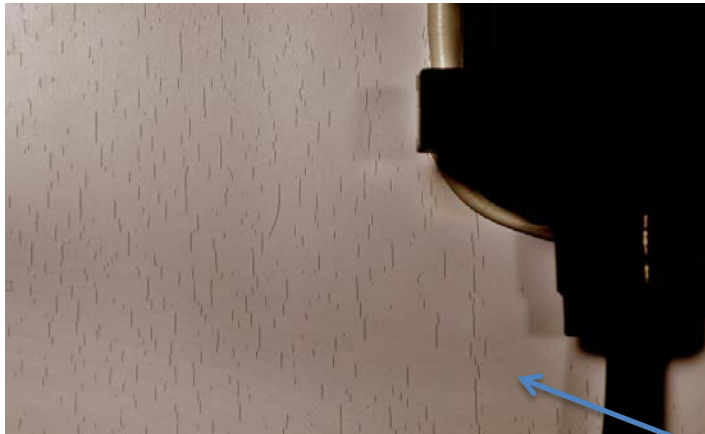
*DH1000/UVA1000/TC200*

**Fine cracking of PVDF layer in PVDF/PET/FEVE backsheet**

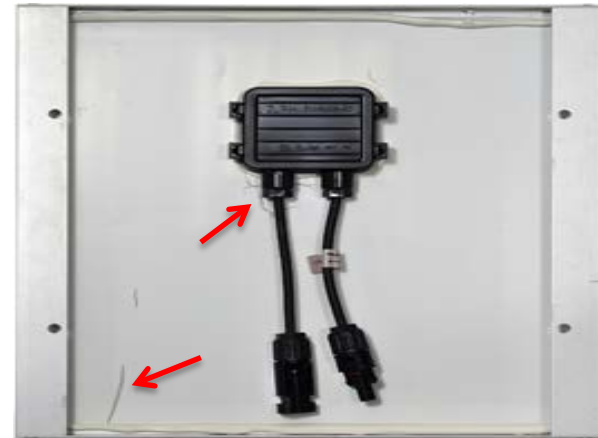
*2x(DH1000/TC200)*

**Large cracks in PVDF/PET/FEVE backsheet**

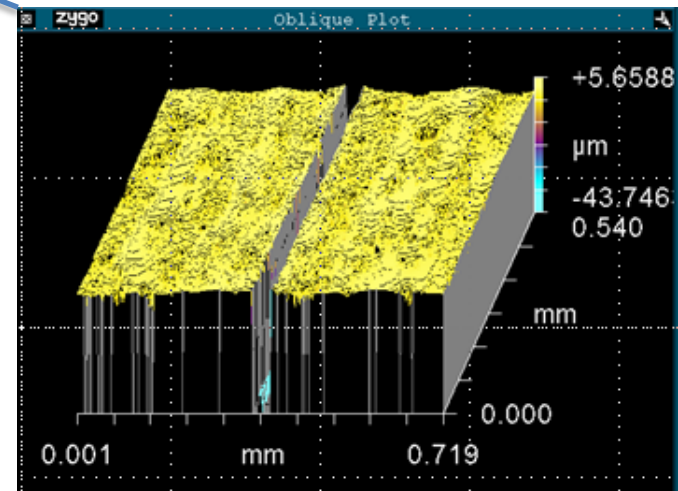
Cracks of PVDF film found along ribbon wire in full-sized module

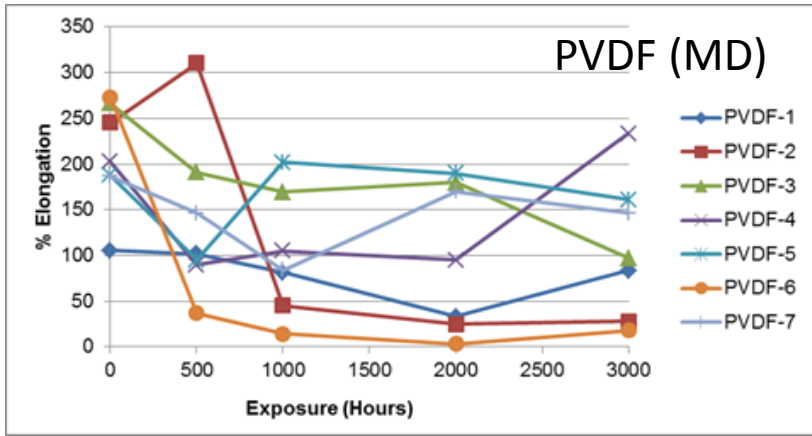
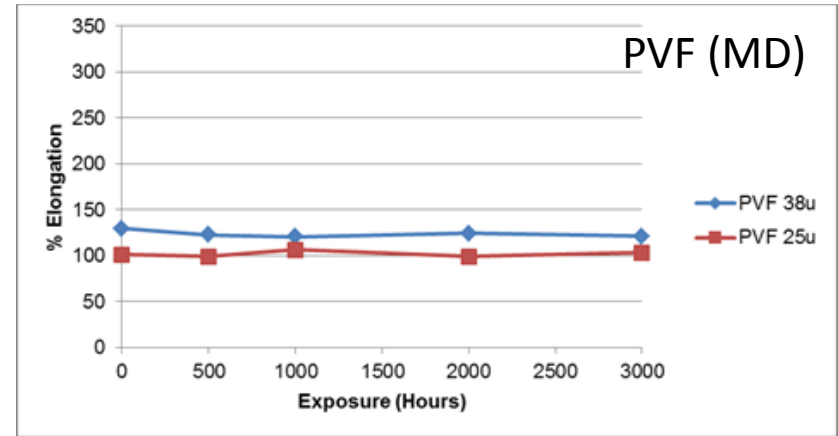
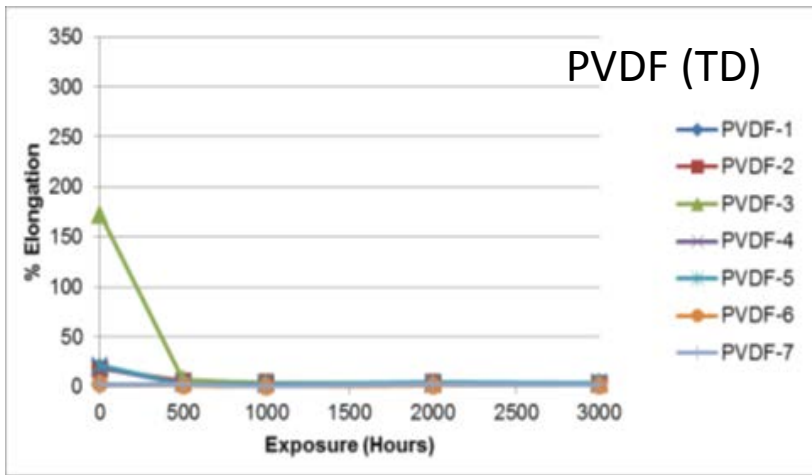
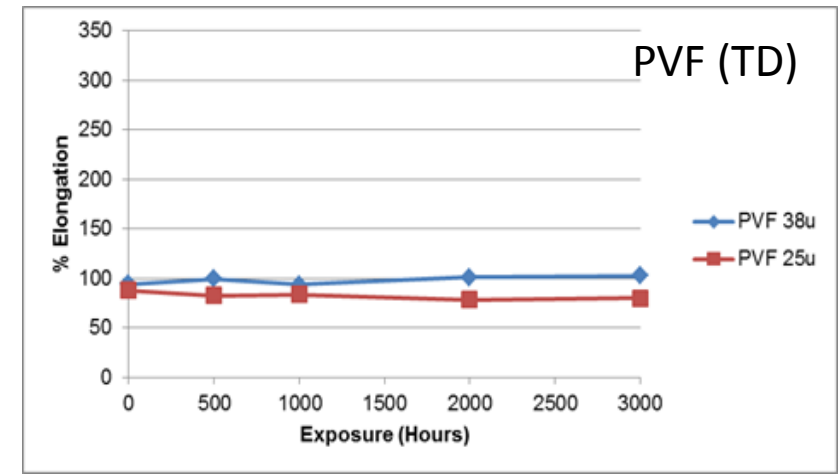
Lower elongation in the TD direction may make PVDF film more vulnerable to cracking and may be responsible for cracking in sequential testing

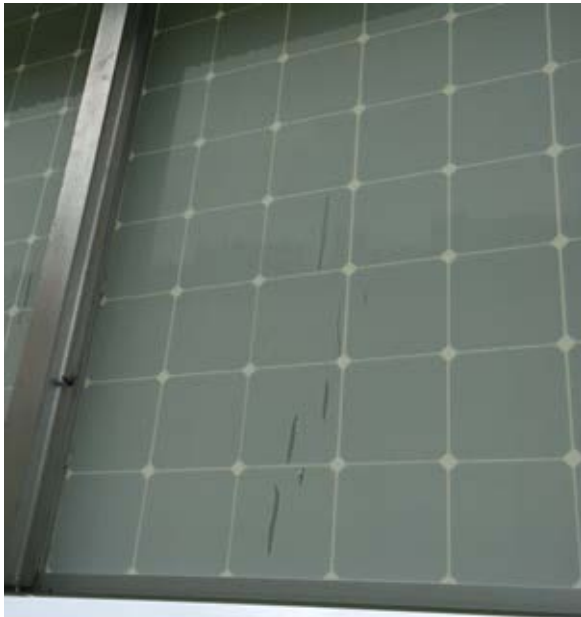
**Initial Crack**

- Initial crack formation followed by tear propagation and subsequent delamination
- Occurs consistently in the vertical direction – machine direction of backsheet

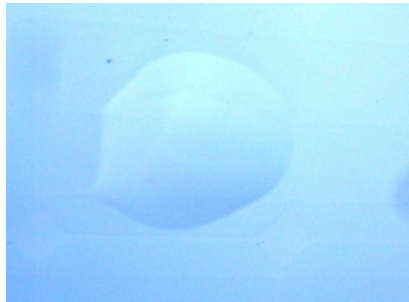
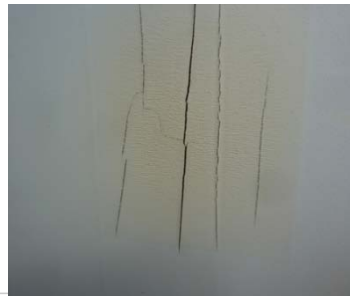
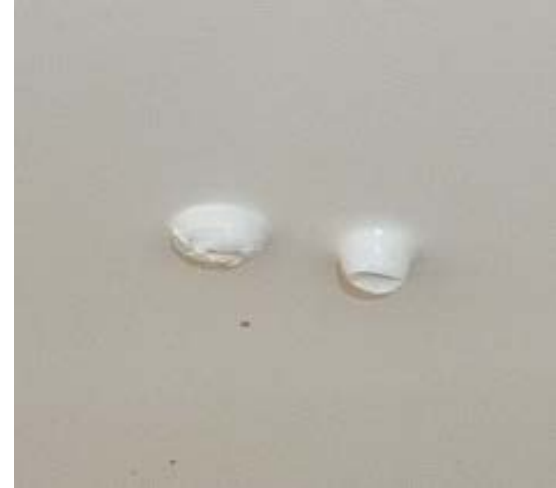
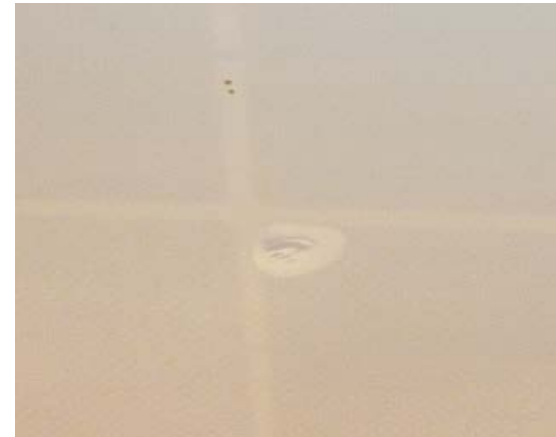
# Hot Spot Cracking, Yellowing and Softening

## PVDF-based backsheet

- Years in service: 5 years
- Location: Spain

- Years in service: 7 years
- Location: Israel
