Test Report

PERFORMANCE MEASUREMENTS OF A 3D IMAGER AND COLOR CAMERA VIEWING FORKLIFT TINES

Roger Bostelman, Will Shackleford

Mobility and Manipulators Project
(previously Industrial Autonomous Vehicles Project)
Intelligent Systems Division
Manufacturing Engineering Laboratory
National Institute of Standards and Technology
Gaithersburg, MD 20899

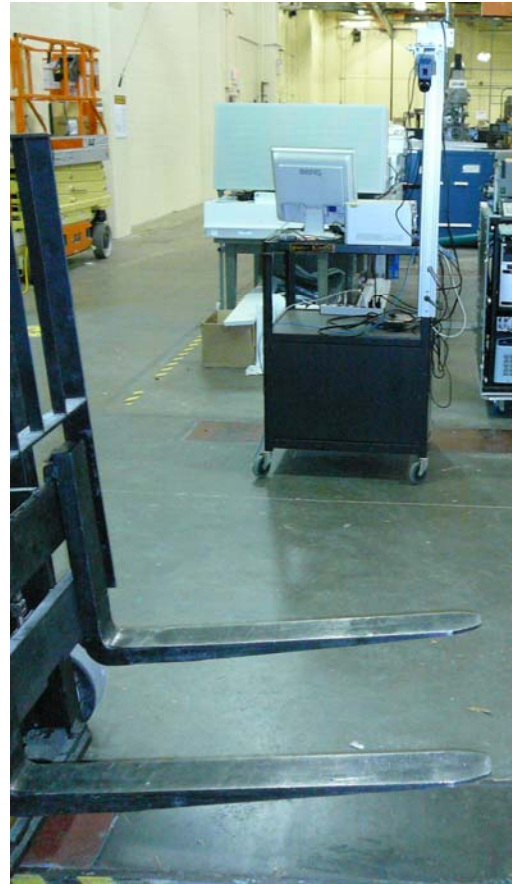
Figure 5b: Side 1
Experimental set-up
(tine-to-camera view)
with the SR3000 &
Camera viewing the
forklift tines. The red
lines show an
approximate sensor
field of view.

Figures 5 and 6 show photos of the test setup for both the Side 1 and Front angles, respectively. Figure 7 shows the view from the sensors to the forklift tines for Side 2 experiments.

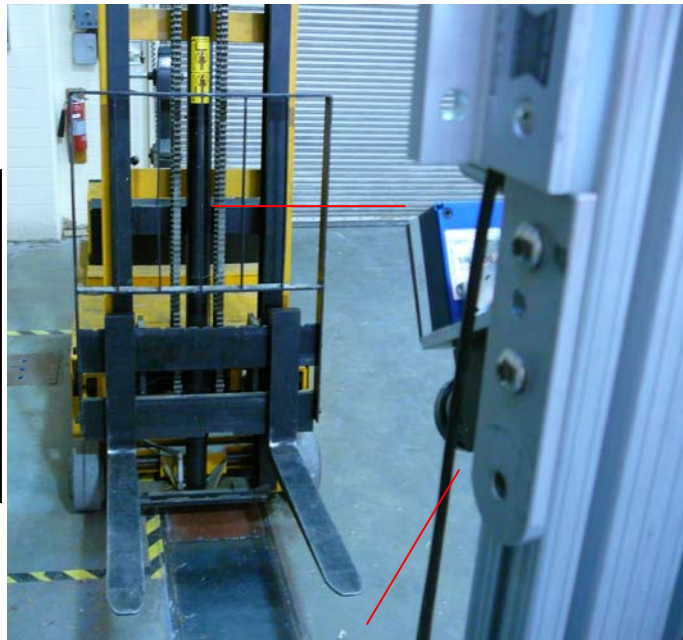
Figure 6a: Camera view
of Front Experimental
set-up with the SR3000
& Camera viewing the
forklift tines. The red
lines show an
approximate sensor
field of view.

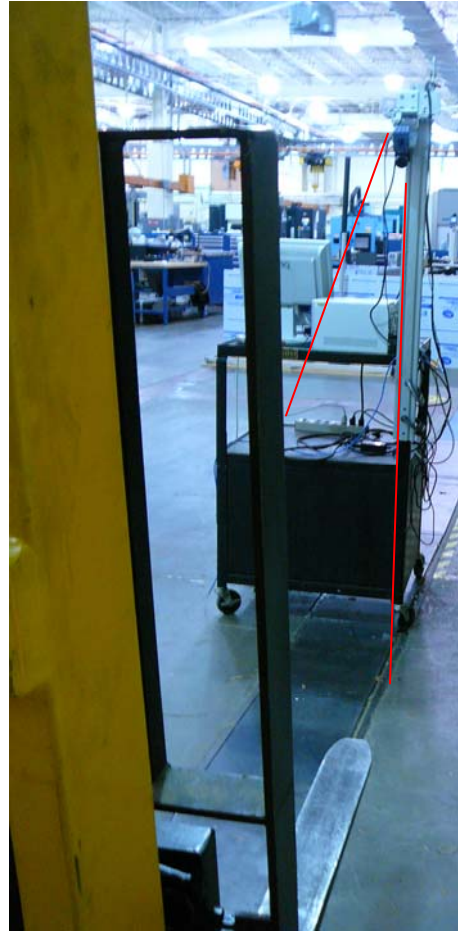
Figure 6b: Front
Experimental set-up
(tine-to-camera view)
with the SR3000 &
Camera viewing the
forklift tines. The red
lines show an
approximate sensor
field of view.

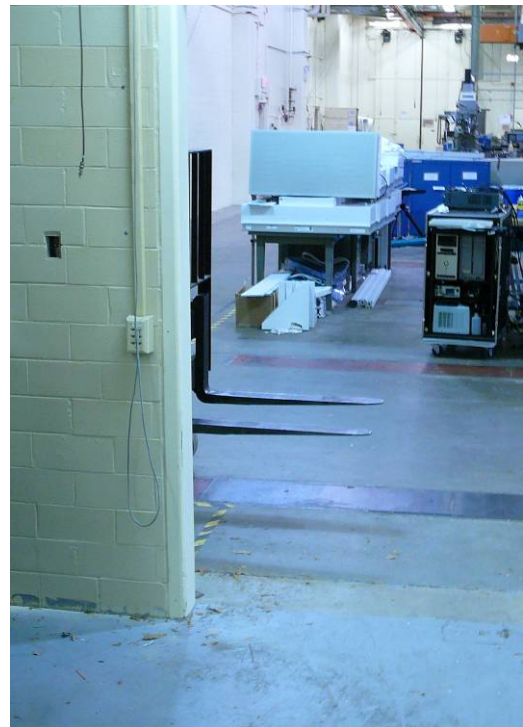
Figure 7: Side 2 view
from sensors to forks.

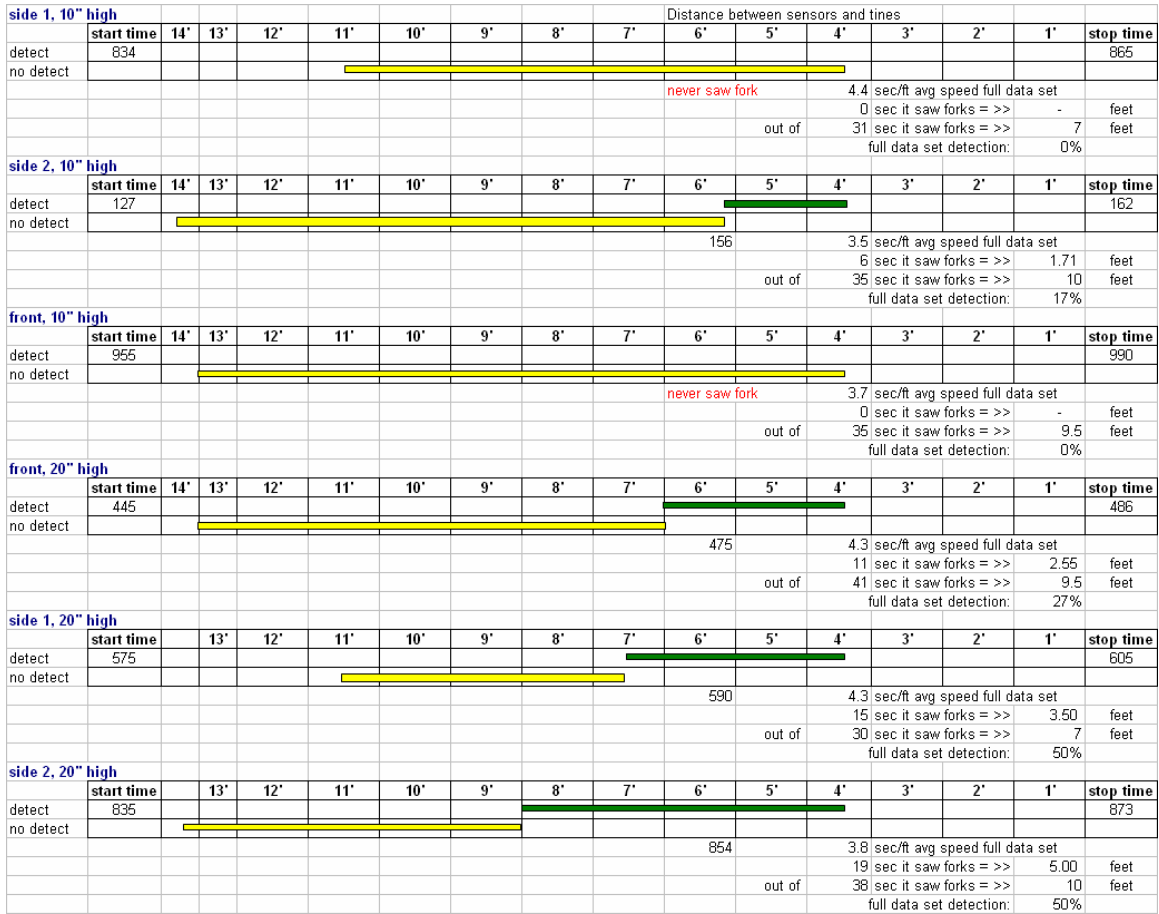
Figure 13: Tine Detect Chart for each of the six data sets graphically showing the detect distances (green bar) of forklift tines and the non-detect distances (yellow bar).

Bad data collected was based substantially on subjective reasoning of when we thought the forklift tines were detected. Each data set (video) was reviewed and determined that a significant amount of SR3000 pixels must be clustered on the forklift tines to be considered 'detected.' The time that the sensors took to reach the forks is correlated with the range to the tines is graphically shown in Figure 13 and summarized in Table 1.

Experiment	Detect%		
	full distance	last 3'	last 1.7'
Side 1, 10"	0%	0%	0%
Side 2, 10"	17%	57%	100%
Front, 10"	0%	0%	0%
Side 1, 20"	50%	100%	100%
Side 2, 20"	50%	100%	100%
Front, 20"	27%	85%	100%

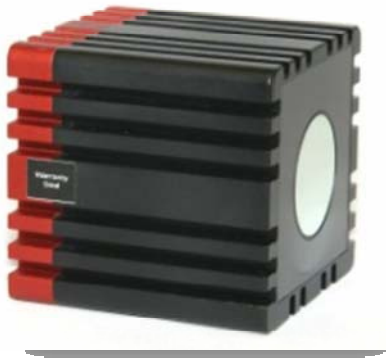
Figure 25 – SR4000 sensor

4. Perhaps a fourth possibility is to test the newest SR4000 sensor. The newest MESA SR4000 sensor, as shown in the appendices, may perhaps provide better results than the SR3000. Specifications appear similar to the SR3000 with max. range limited to 5 m. Figure 25 shows a photo, copied from the data sheet, of the new sensor.

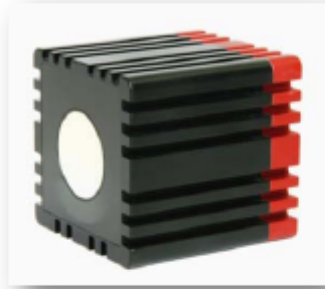
The SR4000 is an optical imaging system which provides real time distance data at video frame rates.

Based on the time-of-flight (TOF) principle, the camera employs an integrated light source. The emitted light is reflected by objects in the scene and travels back to the camera, where the precise time of arrival is measured independently by each pixel of the image sensor, producing a per-pixel distance measurement.

The accuracy of TOF cameras varies with individual camera settings, object reflectivity, and ambient lighting conditions.
