# 1 PRESERVATION BRIEFS

## Assessing Cleaning and Water-Repellent Treatments for Historic Masonry Buildings

Robert C. Mack, AIA  
Anne Grimmer

U.S. Department of the Interior  
National Park Service  
Cultural Resources  
Heritage Preservation Services

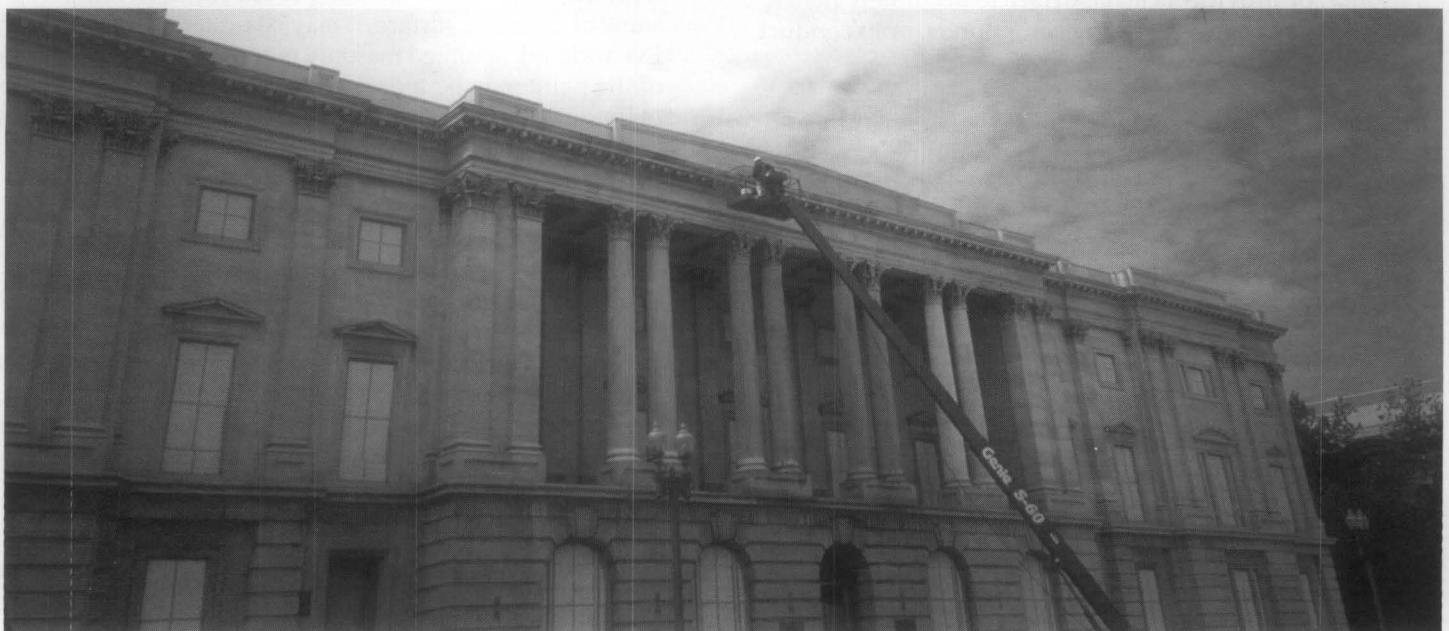
Figure 1. Low-to medium-pressure steam (hot-pressurized water washing), is being used to clean the exterior of the U.S. Tariff Commission Building, the first marble building constructed in Washington, D.C., in 1839. This method was selected by an architectural conservator as the "gentlest means possible" to clean the marble. Steam can soften heavy soiling deposits such as those on the cornice and column capitals, and facilitate easy removal. Note how these deposits have been removed from the right side of the cornice which has already been cleaned.

The Brief is intended to help develop sensitivity to the qualities of historic masonry that makes it so special, and to assist historic building owners and property managers in working cooperatively with architects, architectural conservators and contractors (Fig. 1). Although specifically intended for historic buildings, the information is applicable to all masonry buildings. This publication updates and expands *Preservation Brief 1: The Cleaning and Waterproof Coating of Masonry Buildings*. The Brief is not meant to be a cleaning manual or a guide for preparing specifications. Rather, it provides general information to raise awareness of the many factors involved in selecting cleaning and water-repellent treatments for historic masonry buildings.

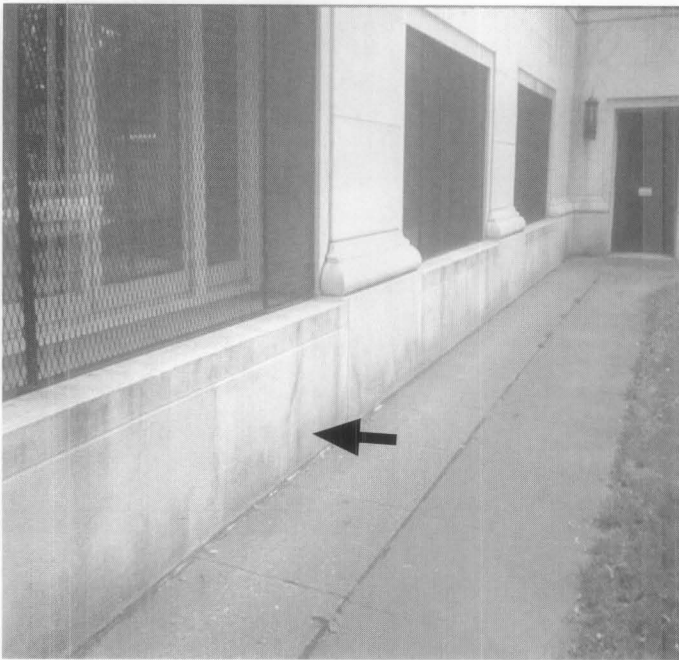
Figure 2. Biological growth as shown on this marble foundation can usually be removed using a low-pressure water wash, possibly with a non-ionic detergent added to it, and scrubbing with a natural or synthetic bristle brush.

**Identify what is to be removed.** The general nature and source of dirt or soiling material on a building must be identified to remove it in the *gentlest means possible* — that is, in the most effective, yet least harmful, manner. Soot and smoke, for example, require a different cleaning agent to remove than oil stains or metallic stains. Other common cleaning problems include biological growth such as mold or mildew, and organic matter such as the tendrils left on masonry after removal of ivy (Fig. 2).

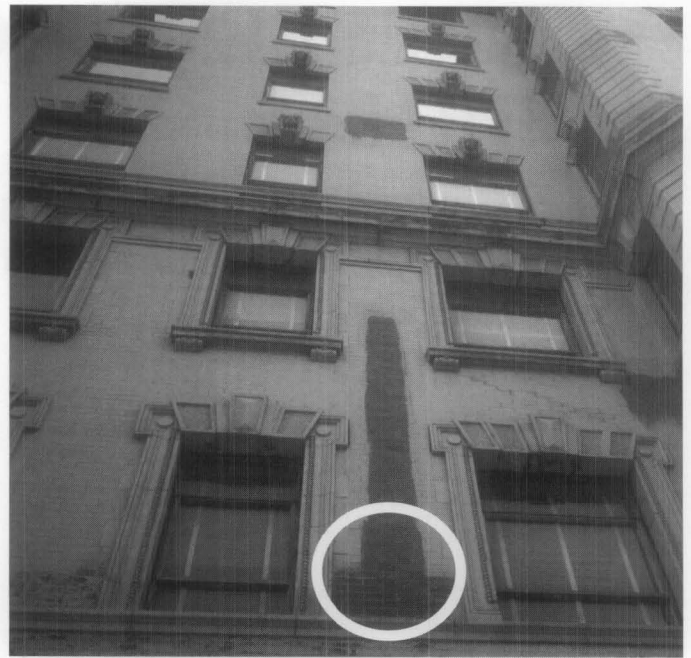
Figure 3. This small test area has revealed a red brick patch that does not match the original beige brick. This may explain why the building was painted, and may suggest to the owner that it may be preferable to keep it painted.

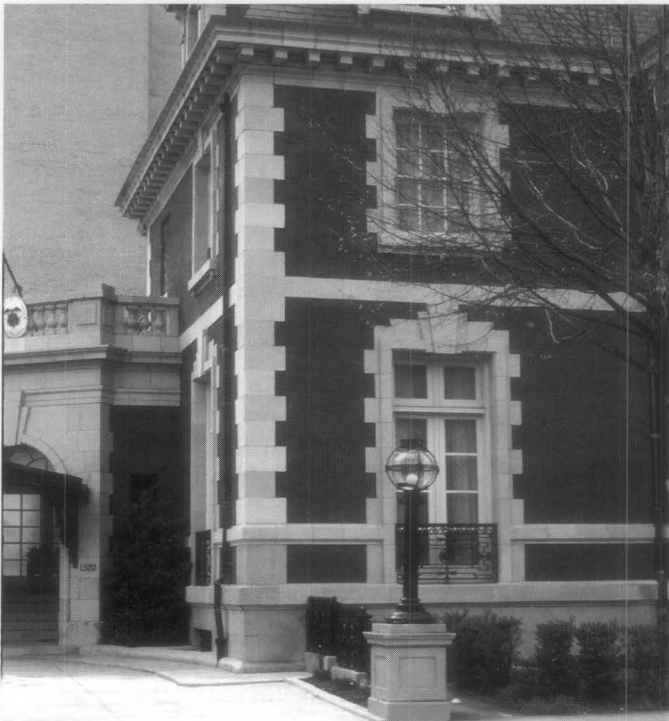
Figure 4. The foundation of this brick building is limestone, but the decorative trim above is architectural terra cotta intended to simulate stone.

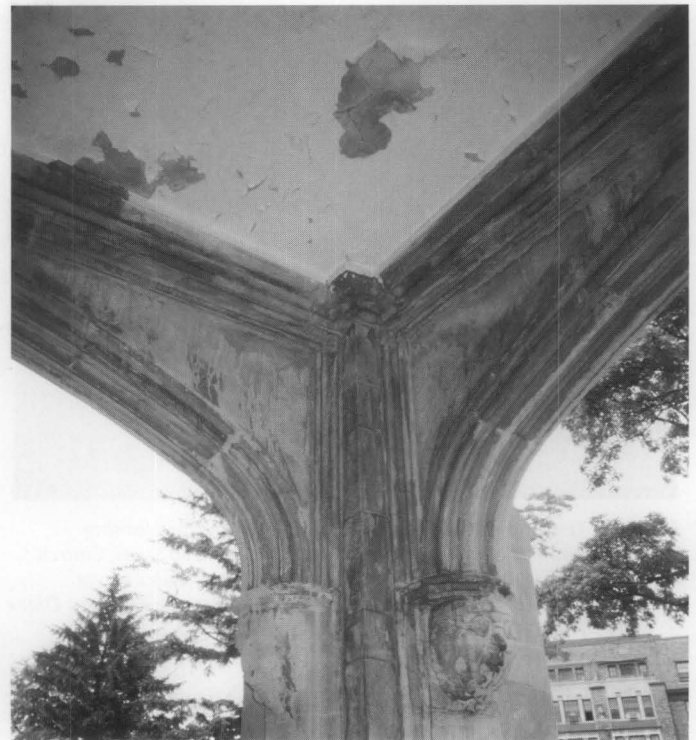
Figure 5. Repeated water washing did not remove the staining inside this limestone porte cochere. Upon closer examination, it was determined to be a water-repellent coating that had been applied many years earlier. An alkaline cleaner may be effective in removing it.

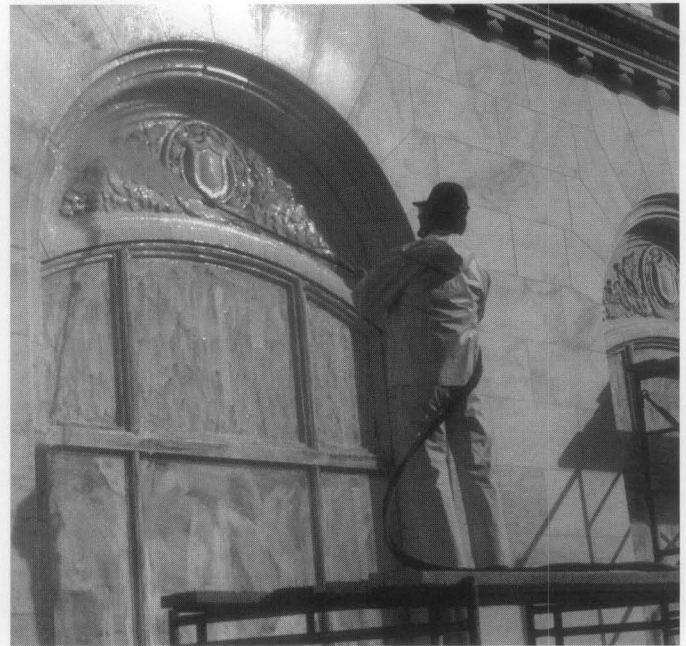
Figure 7. Glazed architectural terra cotta often may be cleaned successfully with a low-pressure water wash and hand scrubbing supplemented, if necessary, with a non-ionic detergent. Photo: National Park Service Files.

**Water Washing.** Washing with low-pressure or medium-pressure water is probably one of the most commonly used methods for removing dirt or other pollutant soiling from historic masonry buildings (Fig. 7). Starting with a very low pressure (100 psi or below), even using a garden hose, and progressing as needed to slightly higher pressure —generally no higher than 300-400 psi—is always the recommended way to begin. Scrubbing with natural bristle or synthetic bristle brushes—never metal which can abrade the surface and leave metal particles that can stain the masonry—can help in cleaning areas of the masonry that are especially dirty.

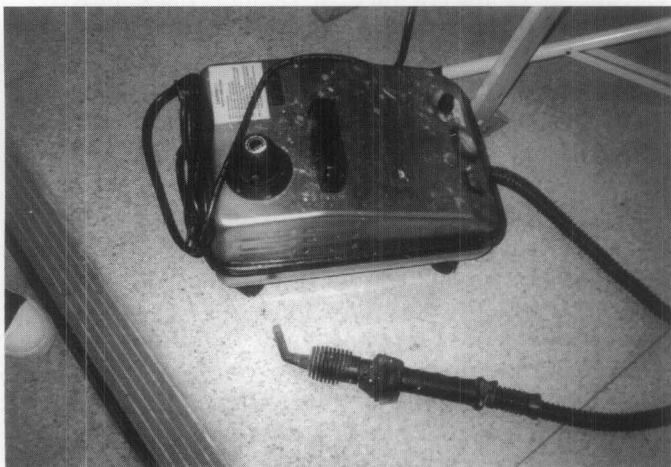
Figure 9. (Left) This small steam cleaner—the size of a vacuum cleaner—offers a very controlled and gentle means of cleaning limited, or hard-to-reach areas or carved stone details. (Right) It is particularly useful for interiors where it is important to keep moisture to a minimum, such as inside the Washington Monument, Washington, D.C., where it was used to clean the commemorative stones. Photos: Audrey T. Tepper.

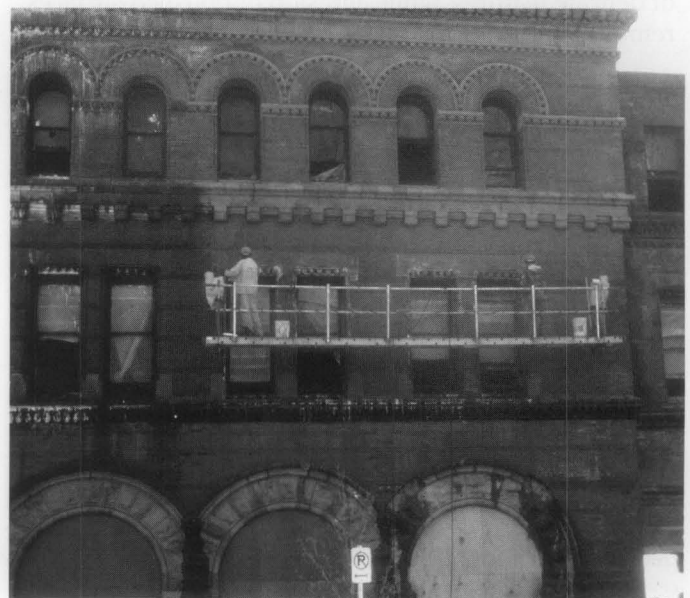
Figure 12. A mild acidic cleaning agent is being used to clean this heavily soiled brick and granite building. Additional applications of the cleaner and hand-scrubbing, and even poulticing, may be necessary to remove the dark stains on the granite arches below. Photo: Sharon C. Park, FAIA.

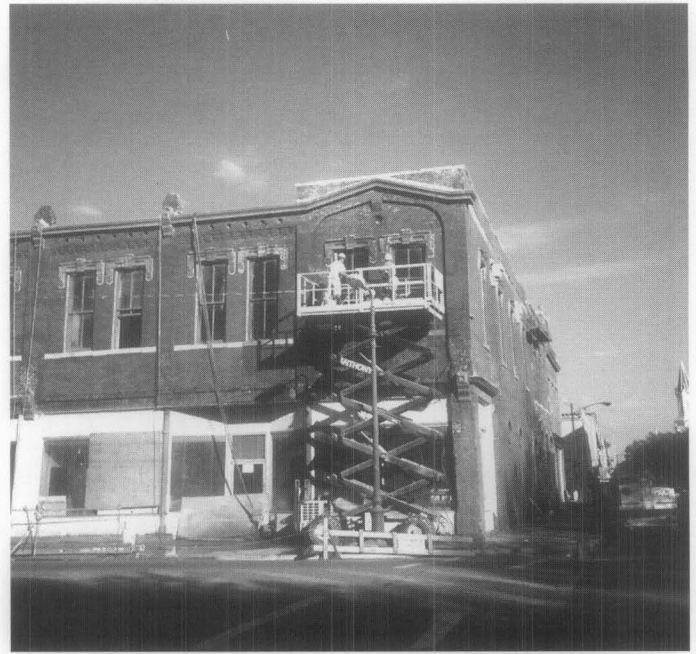
Figure 14. Chemical removal of paint from this brick building has revealed that the cornice and window hoods are metal rather than masonry.

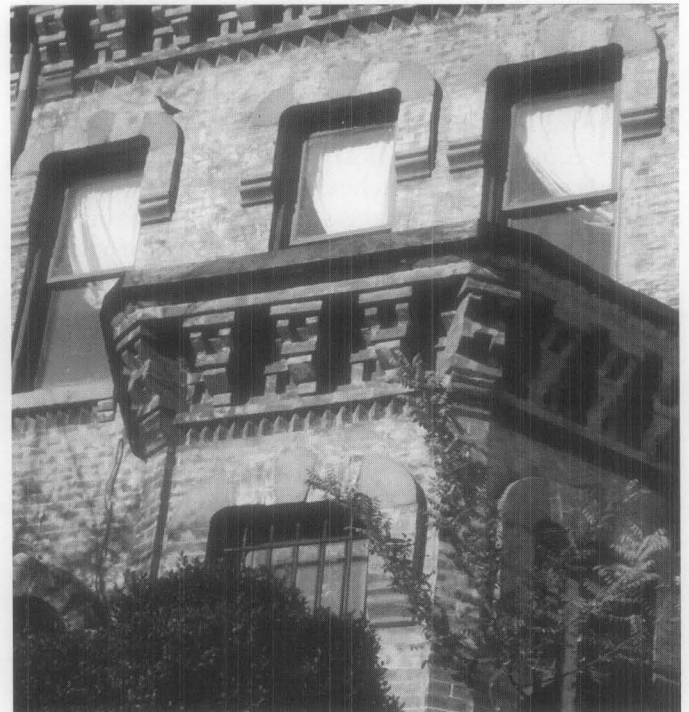
Figure 15. The whitish deposits left on the brick by a chemical paint remover may have resulted from inadequate rinsing or from the chemical being left on the surface too long and may be impossible to remove.

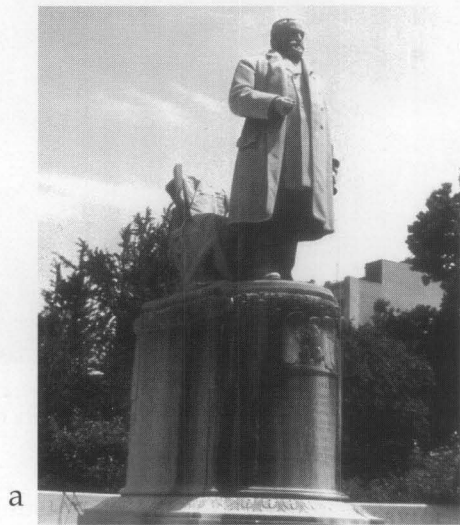
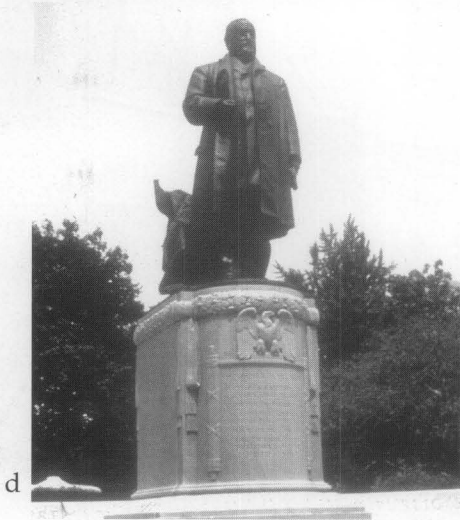
Figure 16. (a) The limestone base was heavily stained by runoff from the bronze statue above. (b) A poultice consisting of copper stain remover and ammonia mixed with fuller's earth was applied to the stone base and covered with plastic sheeting to keep it from drying out too quickly. (c) As the poultice dried, it pulled the stain out of the stone. (d) The poultice residue was removed carefully from the stone surface with wooden scrapers and the stone was rinsed with water. Photos: John Dugger.

Graffiti and stains, which have penetrated into the masonry, often are best removed by using a poultice. A poultice consists of an absorbent material or clay powder (such as kaolin or fuller's earth, or even shredded paper or paper towels), mixed with a liquid (solvent or other remover) to form a paste which is applied to the stain (Figs. 16-17). As it dries, the paste absorbs the staining material so that it is not redeposited on the masonry surface. Some commercial cleaning products and paint removers are specially formulated as a paste or gel that will cling to a vertical surface and remain moist for a longer period of time in order to prolong the action of the chemical on the stain. Pre-mixed poultices are also available as a paste or in powder form needing only the addition of the appropriate liquid. The masonry must be pre-wet before applying an alkaline cleaning agent, but not when using a solvent. Once the stain has been removed, the masonry must be rinsed thoroughly.

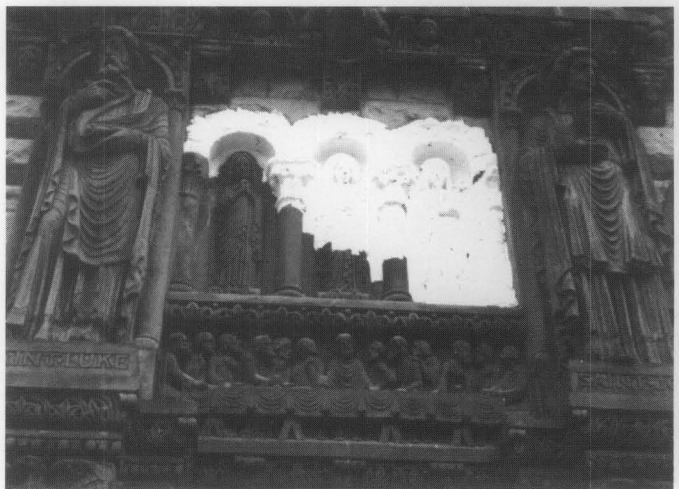
Figure 17. A poultice is being used to remove salts from the brownstone statuary on the facade of this late-19th century stone church. Photo: National Park Service Files.

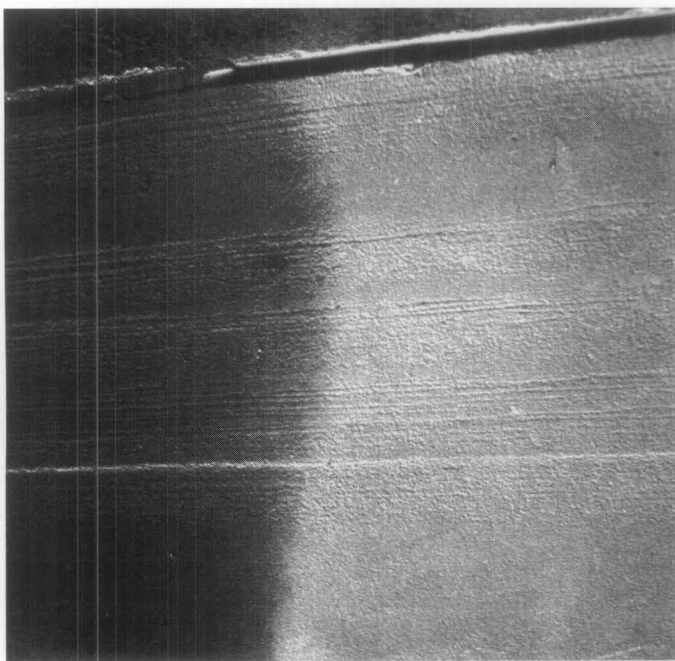
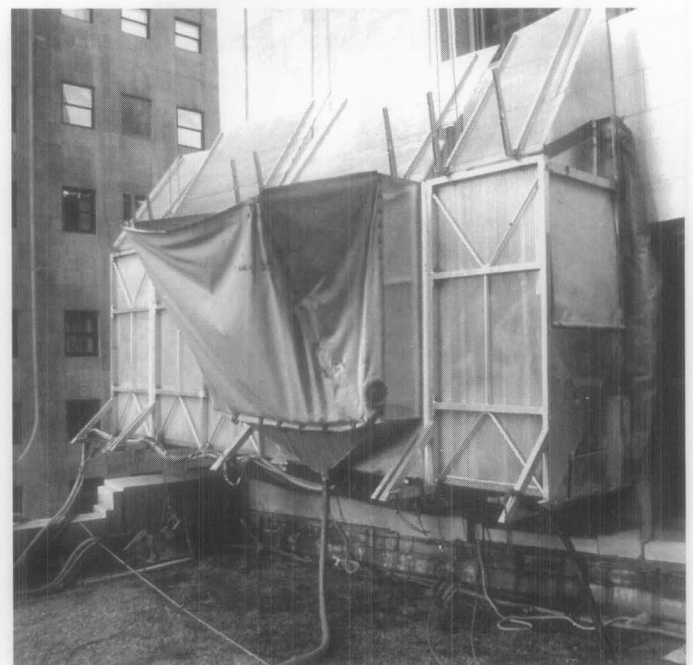
Figure 20. (Left) A comparison of the limestone surface of a 1920s office building before and after “cleaning” with a proprietary abrasive process using fine glass powder clearly shows the effectiveness of this method. But this is an abrasive technique and it has “cleaned” by removing part of the masonry surface with the dirt. Because it is abrasive, it is generally not recommended for large-scale cleaning of historic masonry, although it may be suitable to use in certain, very limited cases under controlled circumstances. (Right) A vacuum chamber where the used glass powder is collected for environmentally safe disposal is a unique feature of this particular process. The specially-trained operators in the chamber wear protective clothing, masks and breathing equipment. Photos: Tom Keohan.

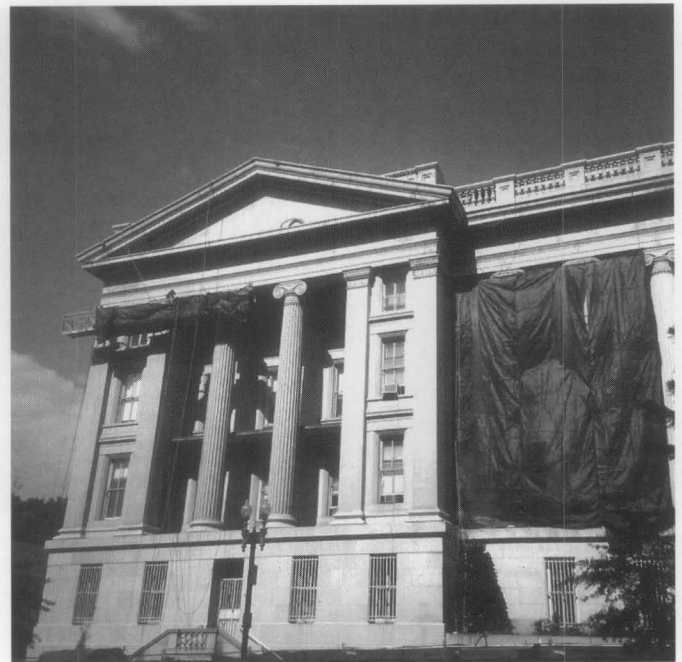
Figure 23. A tarpaulin protects and shields pedestrians from potentially harmful spray while chemical cleaning is underway on the granite exterior of the U.S. Treasury Building, Washington, D.C.

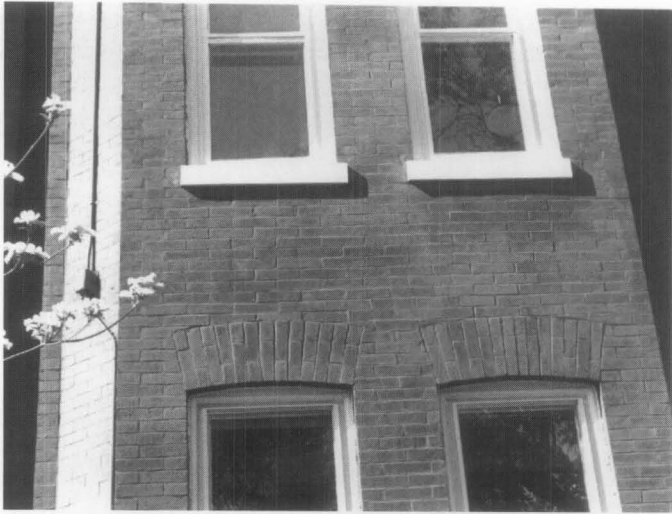
Figure 24. Although the application of a water-repellent coating was probably not needed on either of these buildings, the coating on the brick building (above), is not visible and has not changed the character of the brick. But the coating on the brick column (below), has a high gloss that is incompatible with the historic character of the masonry.

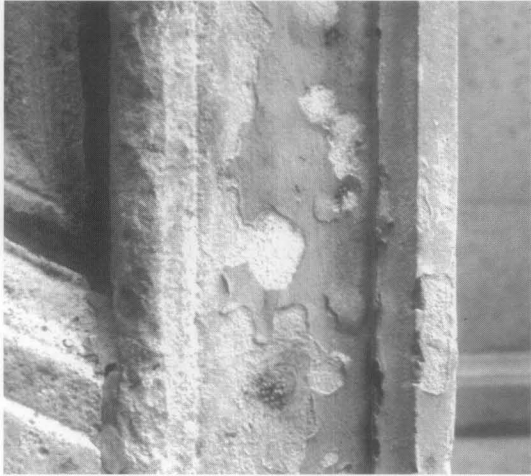
Figure 25. The clear coating applied to this limestone molding has failed and is taking off some of the stone surface as it peels. Photo: Frances Gale.

Some modern water-repellent coatings which contain a binder intended to replace the natural binders in stone that have been lost through weathering and natural erosion are described in product literature as both a water repellent and a consolidant. The fact that newer water-repellent coatings penetrate beneath the masonry surface instead of just forming a layer on top of the surface may indeed convey at least some consolidating properties to certain stones. However, a water-repellent coating cannot be considered a consolidant. In some instances, a water-repellent or "preservative" coating, if applied to already damaged or spalling stone, may form a surface crust which, if it fails, may exacerbate the deterioration by pulling off even more of the stone (Fig. 25).

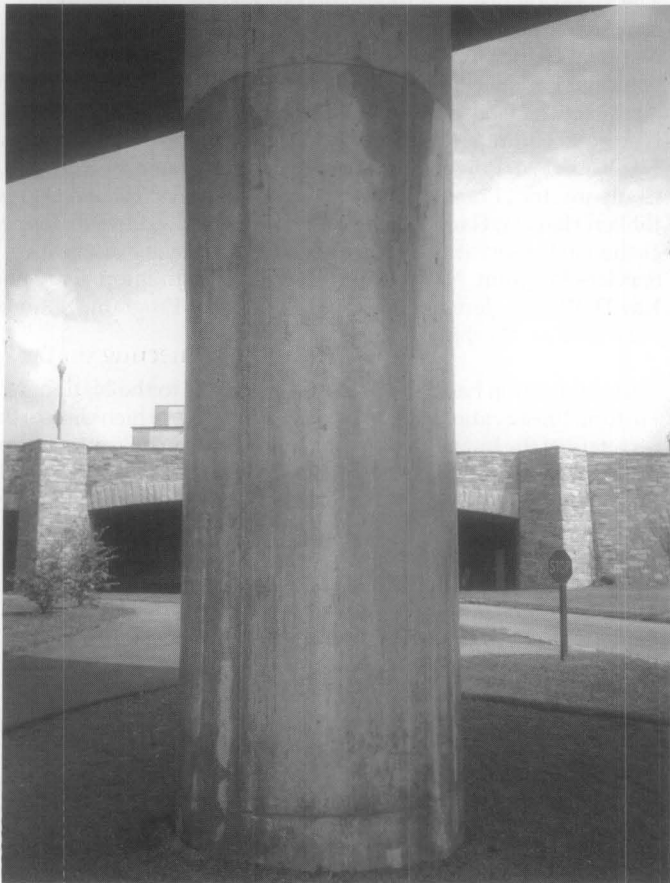
Figure 26. The anti-graffiti or barrier coating on this column is very shiny and would not be appropriate to use on a historic masonry building. The coating has discolored as it has aged and whitish streaks reveal areas of bare concrete where the coating was incompletely applied.

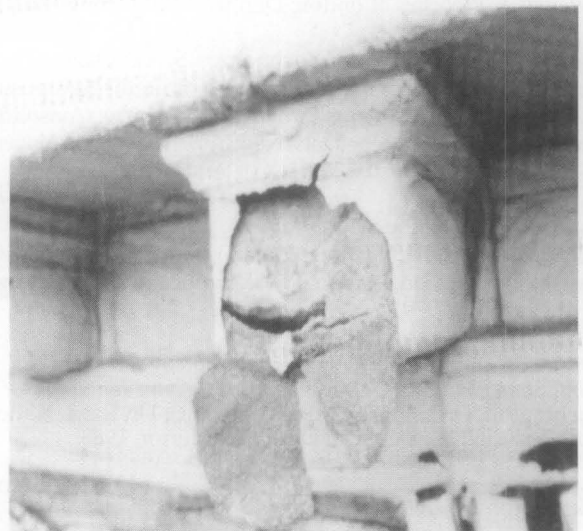
Figure 27. Instead of correcting the roof drainage problems, an elastomeric coating was applied to the already saturated limestone cornice. An elastomeric coating holds moisture in the masonry because it does not "breathe" and does not allow liquid moisture to escape. If the water pressure builds up sufficiently it can cause the coating to break and pop off as shown in this example, often pulling pieces of the masonry with it. Photo: National Park Service Files.

In addition, the water eventually will get out by the path of least resistance. If this path is toward the interior, damage to interior finishes can result; if it is toward the exterior, it can lead to damage to the masonry caused by built-up water pressure (Fig. 27).

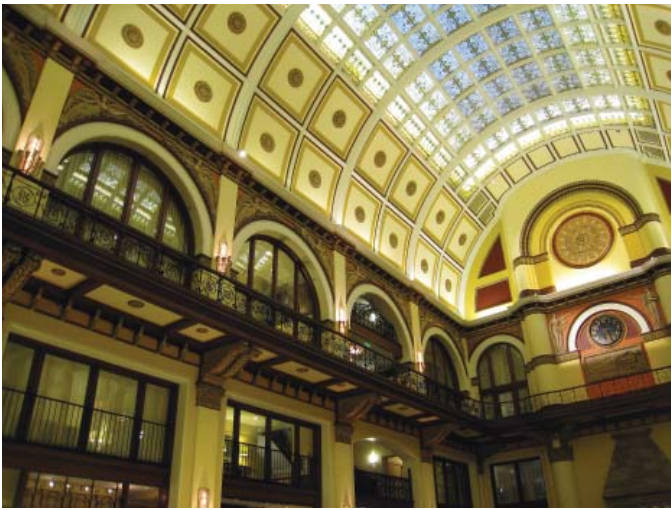
Fig. 1. A decorative, stained glass skylight allows natural daylight into the interior.

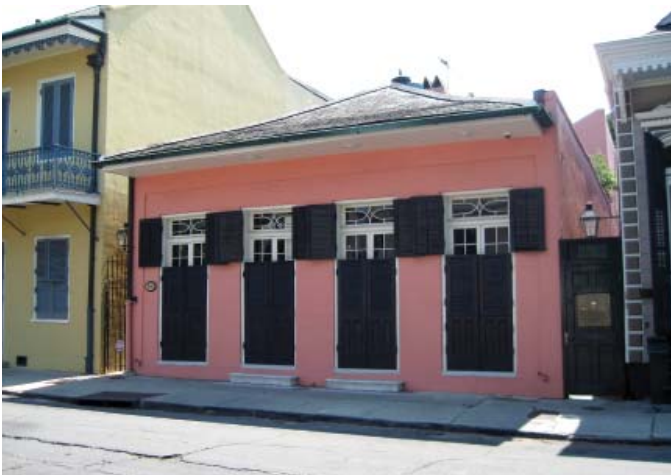
Fig. 2. Upper and lower shutters control daylight and provide privacy.

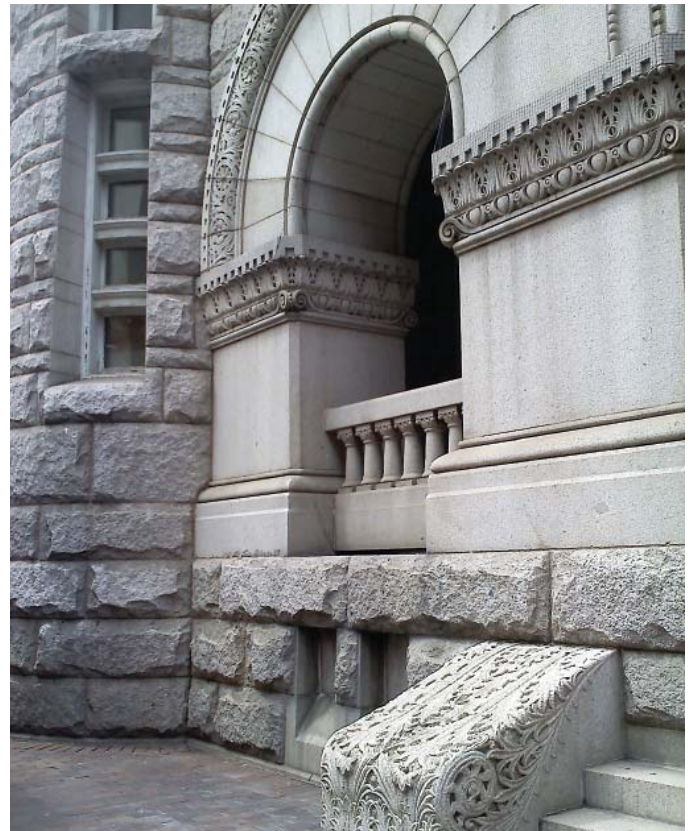
Fig. 3. Stone walls with substantial mass have high thermal inertia.

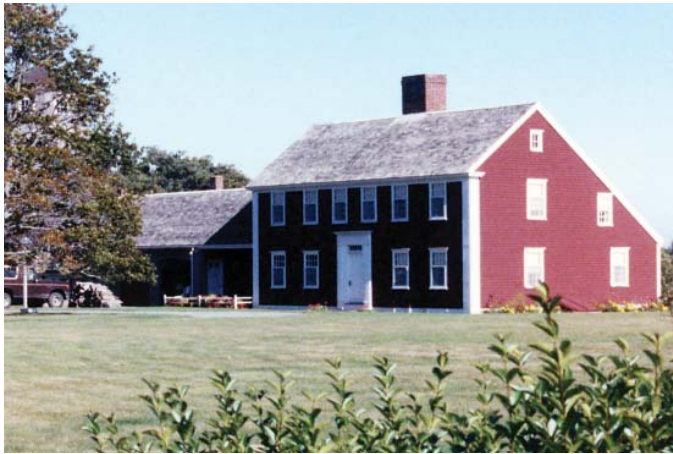
*Fig. 4. A typical New England saltbox features a steeply sloping roof to shed snow and a floor plan organized around a central chimney to conserve heat.*

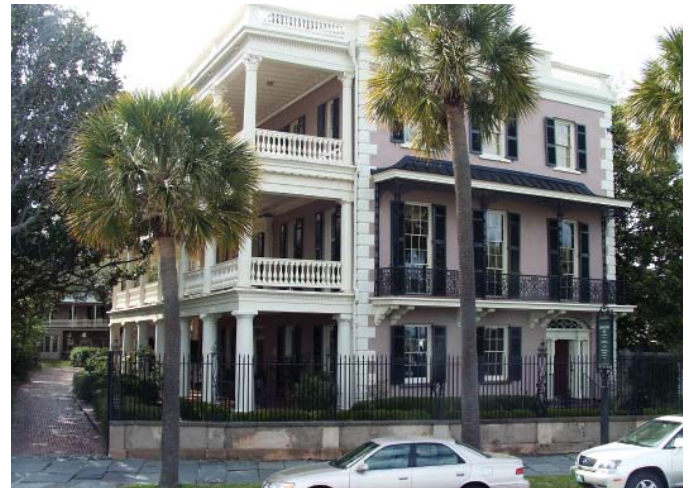
*Fig. 5. The side porches of this house in Charleston, SC, shade the large windows and provide outdoor living spaces that take advantage of sea breezes.*

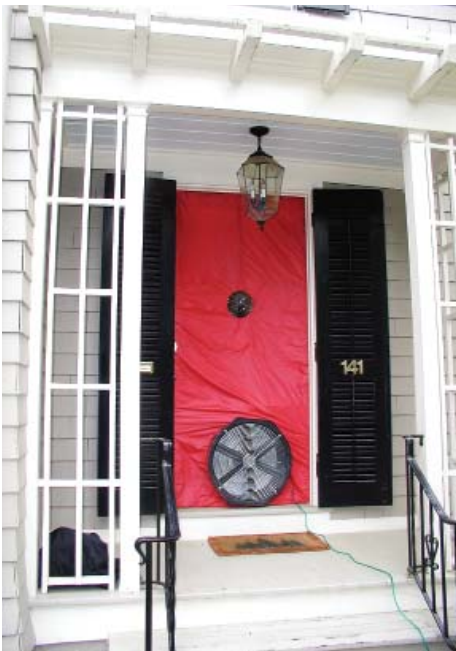
Fig. 6. (left) A blower door is used to depressurize a building by exhausting air at a rate that allows pressure gages and tracer smoke to measure the amount and location of air leakage. Photo: Robert Cagnetta, Heritage Restoration, Inc.

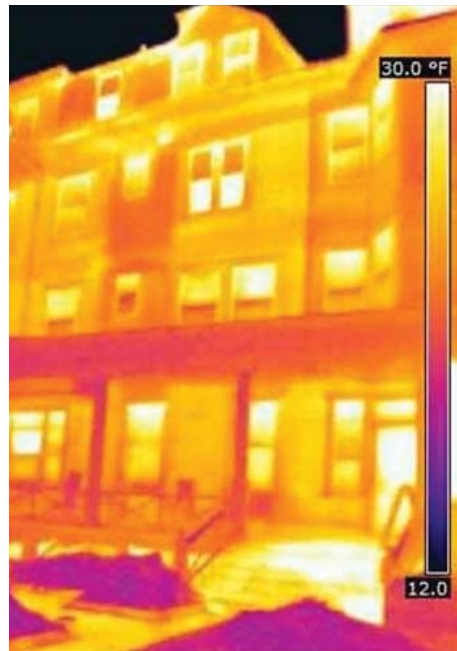
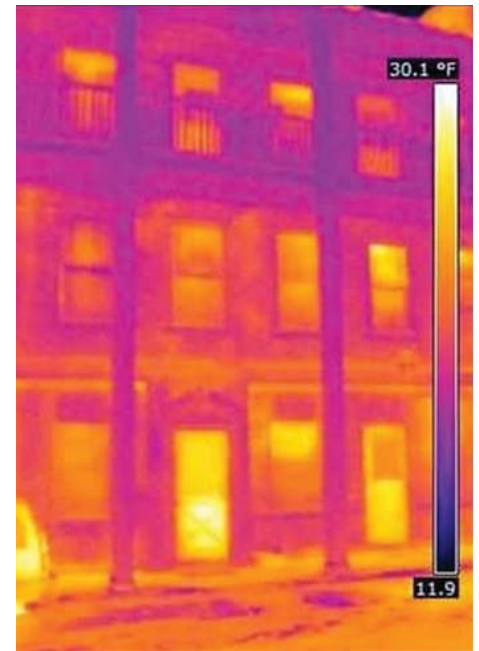
Fig. 7. (center and right) The left thermal image shows the walls of this building before insulating. After insulation was added, the cooler and, thus darker exterior walls evidence how much the heat loss has been reduced. Photos: EYP Architecture & Engineering.

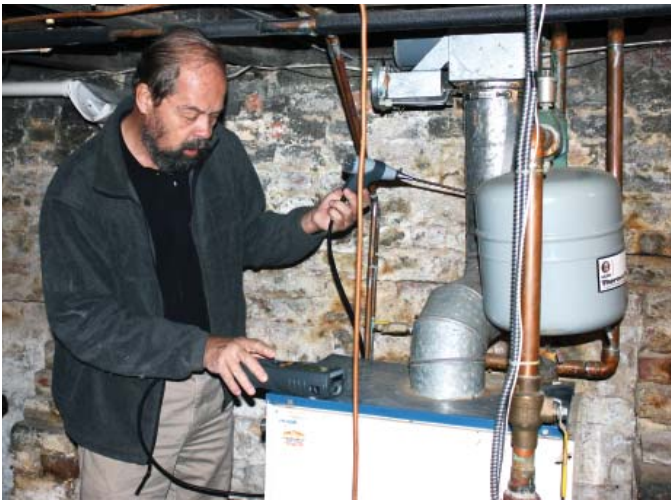
Fig. 9. An energy auditor tests the efficiency of a boiler.

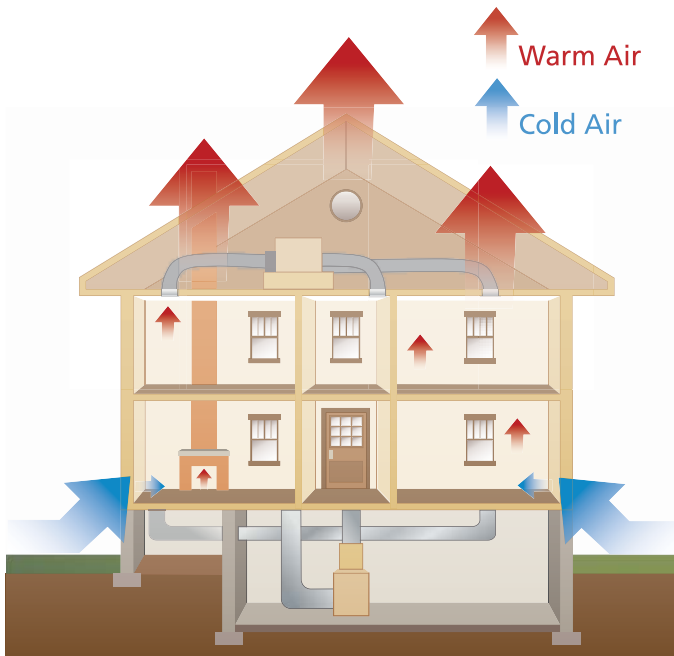
Fig. 10. The pattern of air movement referred to as the "stack effect".  
Illustration: Blank Space LLC.

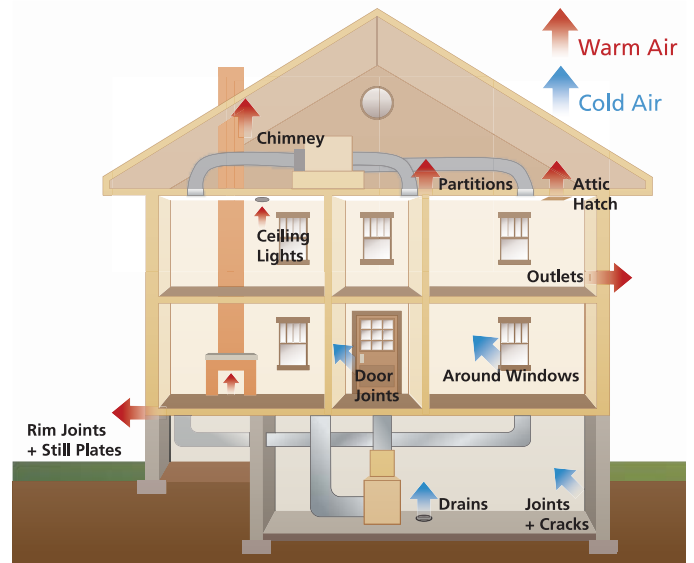
Fig. 11. Air infiltration and exfiltration.  
Illustration: Blank Space LLC.

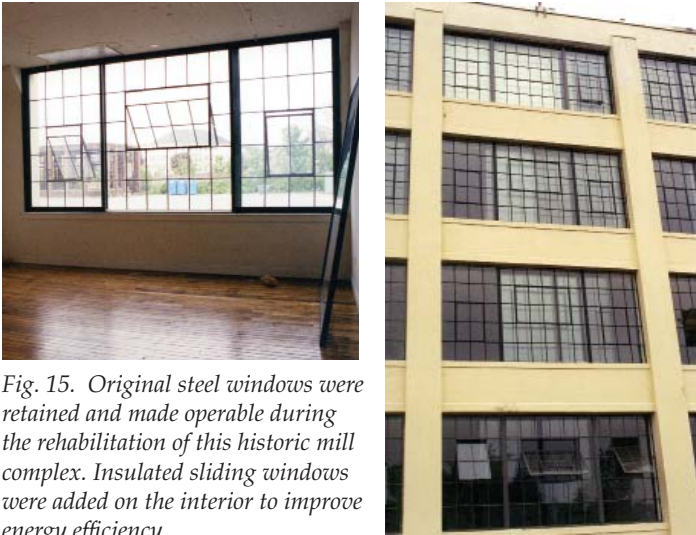
*Fig. 15. Original steel windows were retained and made operable during the rehabilitation of this historic mill complex. Insulated sliding windows were added on the interior to improve energy efficiency.*

For large, steel industrial windows, the addition of interior, insulated sliding glass windows that align with the primary vertical mullions has proven to be a successful treatment that allows the primary window to remain operable.

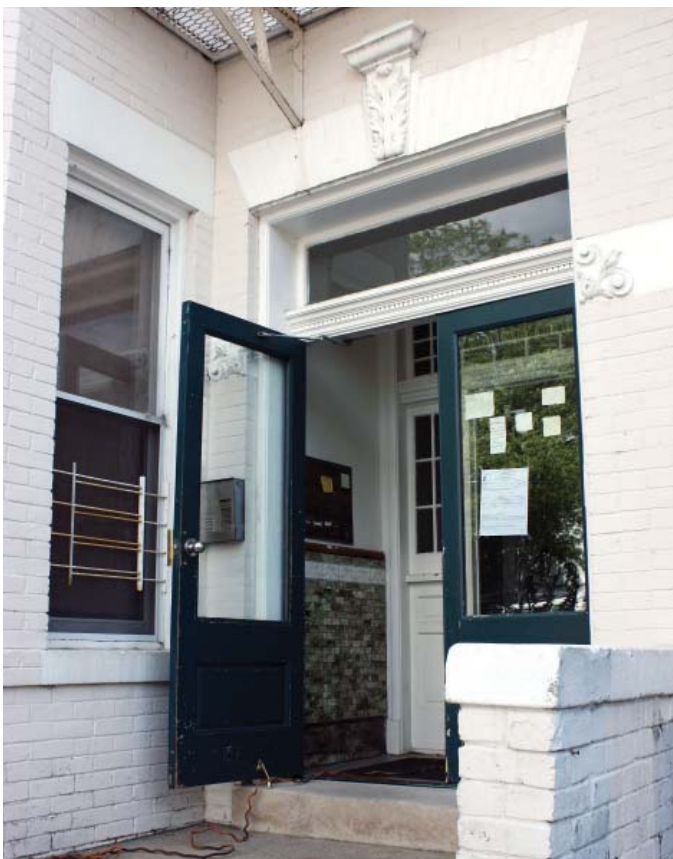
Fig. 16. Historic vestibules retain conditioned air in the living spaces.

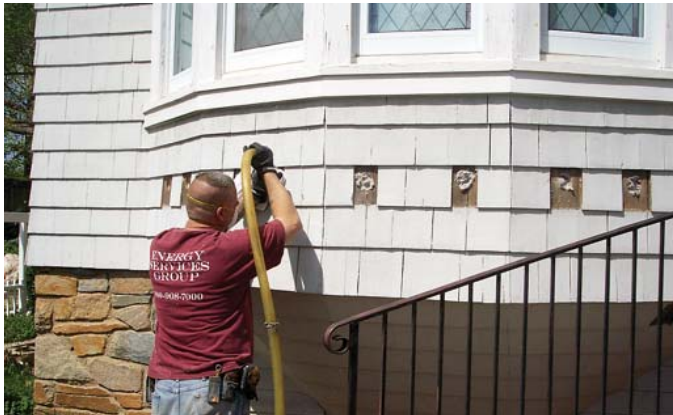
Fig. 18. Dense-packed cellulose insulation is being blown in through holes drilled in the sheathing. Once the operation has been completed, the shingles will be reinstalled. Photo: Edward Minch.

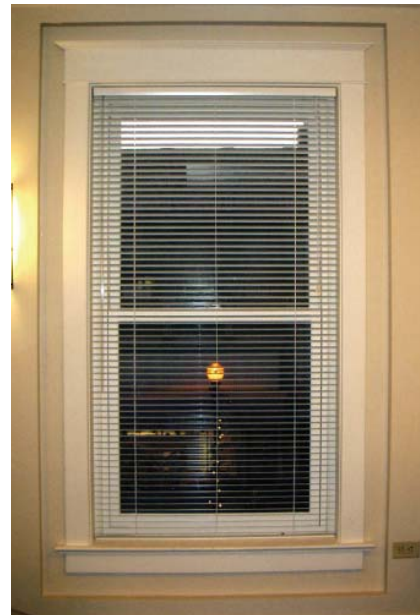
Fig. 20. The walls have been furred out inappropriately around the historic window trim creating an appearance the interior never had historically.

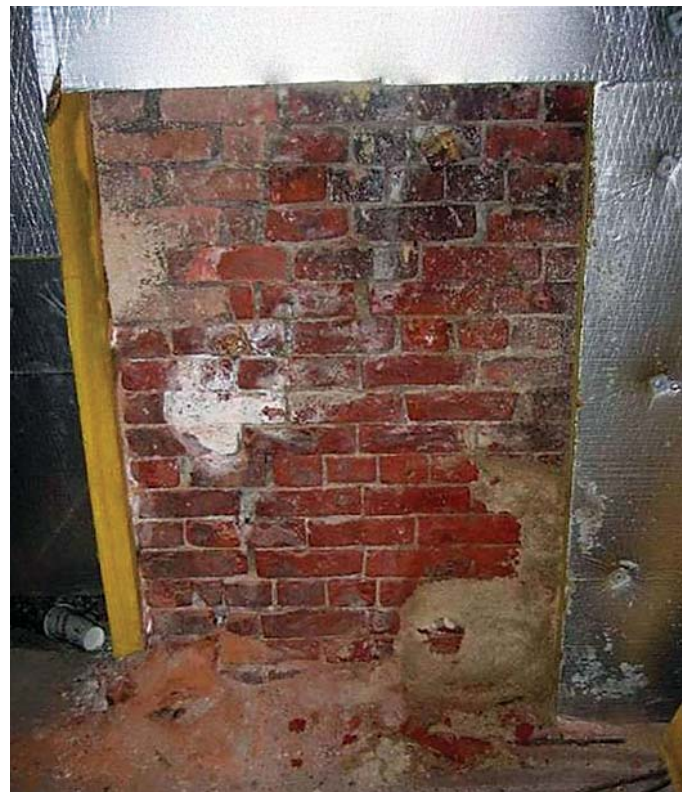
Fig. 21. The interior face of a brick masonry wall shows damage that resulted from the installation of a vapor retardant (foil facing) and thermal insulation. Photo: Simpson Gumpertz & Heger.

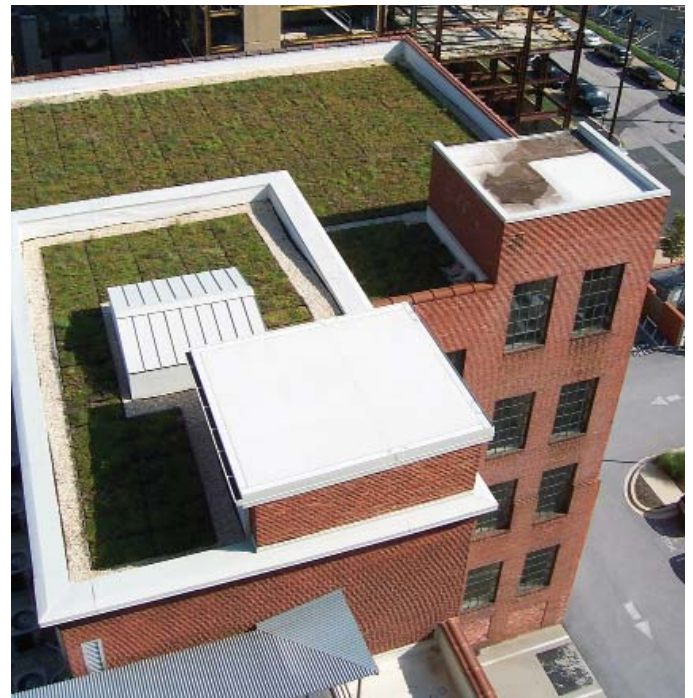
*Fig. 22. Installation of both cool and green roofs in an urban environment.*

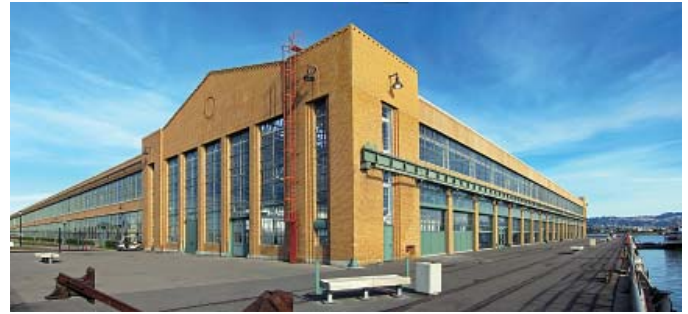
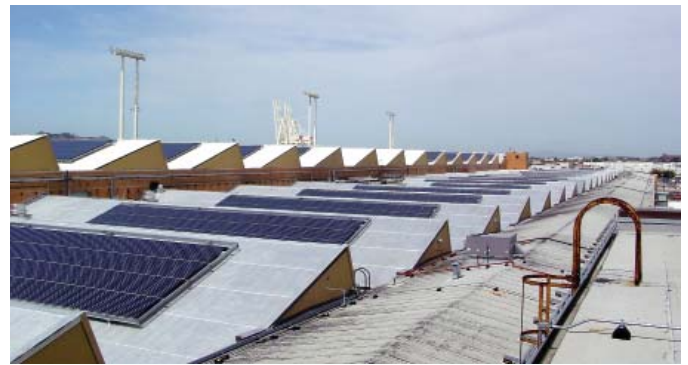
Fig. 23. Solar collectors installed in a compatible manner on low sloping sawtooth monitors. Top Photo: Neil Mishalov, Berkeley, CA.

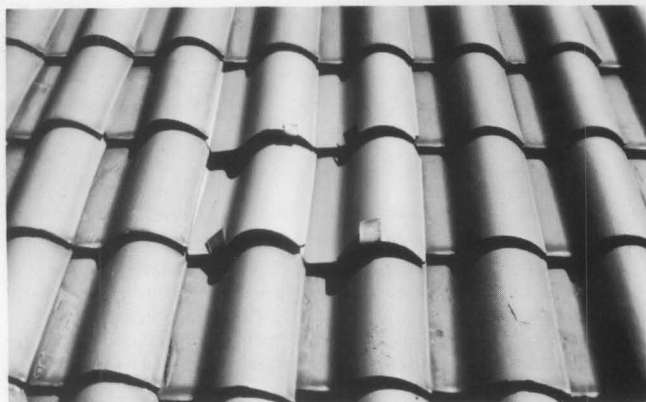
*Repairs on this pantile roof were made with new tiles held in place with metal hangers. (Main Building, Ellis Island, New York)*

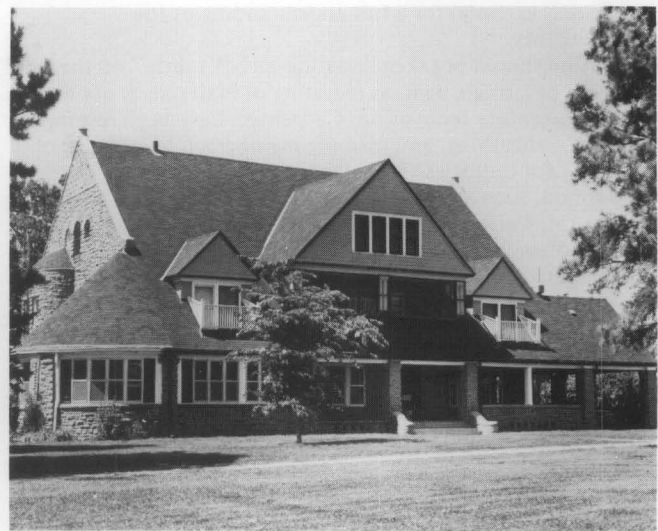
*These two views of the same house demonstrate how the use of a substitute material can drastically affect the overall character of a structure. The textural interest of the original tile roof was lost with the use of asphalt shingles. Recent preservation efforts are replacing the tile roof. (Frank House, Kearney, Nebraska, photo courtesy of the Nebraska State Historical Society, Lincoln, Nebraska)*

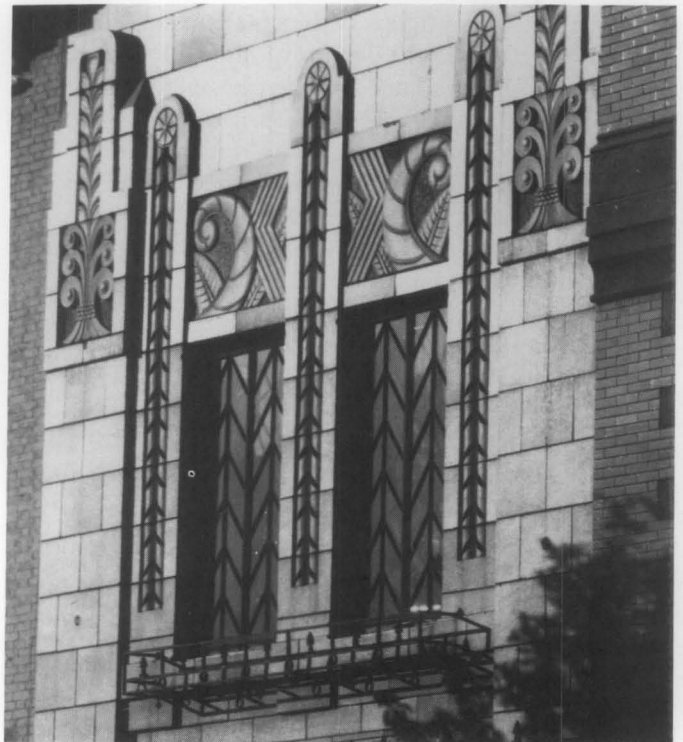
*Fig. 1 Often highly distinctive in design and craftsmanship, rolled steel windows play an important role in defining the architectural character of many later nineteenth and early twentieth century buildings. Art Deco, Art Moderne, the International Style, and Post World War II Modernism depended on the slim profiles and streamlined appearance of metal windows for much of their impact. Photo: William G. Johnson.*

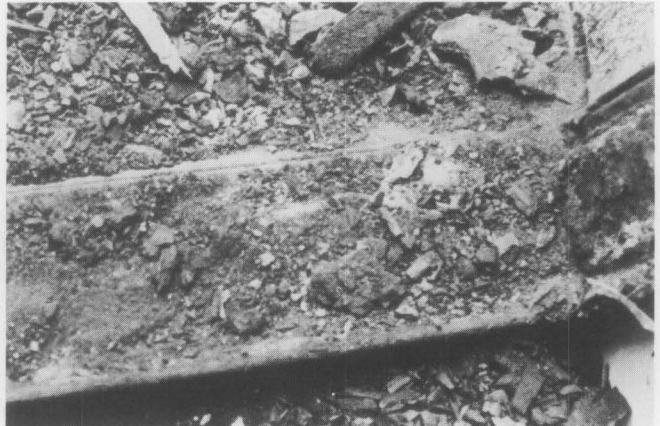
Fig. 6 d. View looking down towards the sill. The subframes appeared very rusted, but were in good condition once debris was vacuumed and surface rust was removed, in place, with chemical compounds. Where necessary, epoxy and steel filler was used to patch depressions in order to make the subframe serviceable again.

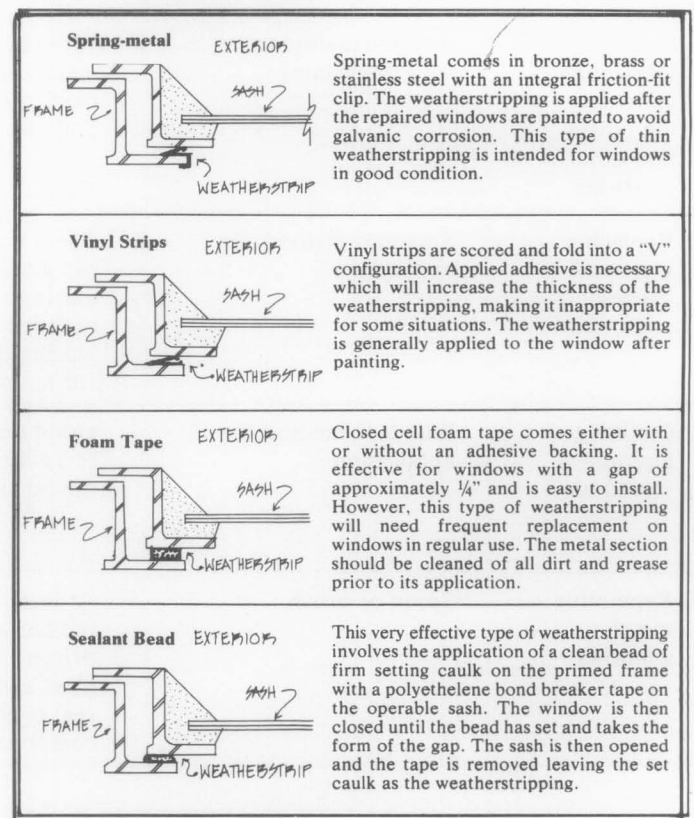
Fig. 8 APPROPRIATE TYPES OF WEATHERSTRIPPING FOR METAL WINDOWS. Weatherstripping is an important part of upgrading the thermal efficiency of historic steel windows. The chart above shows the jamb section of the window with the weatherstripping in place. Drawings: Sharon C. Park, AIA.

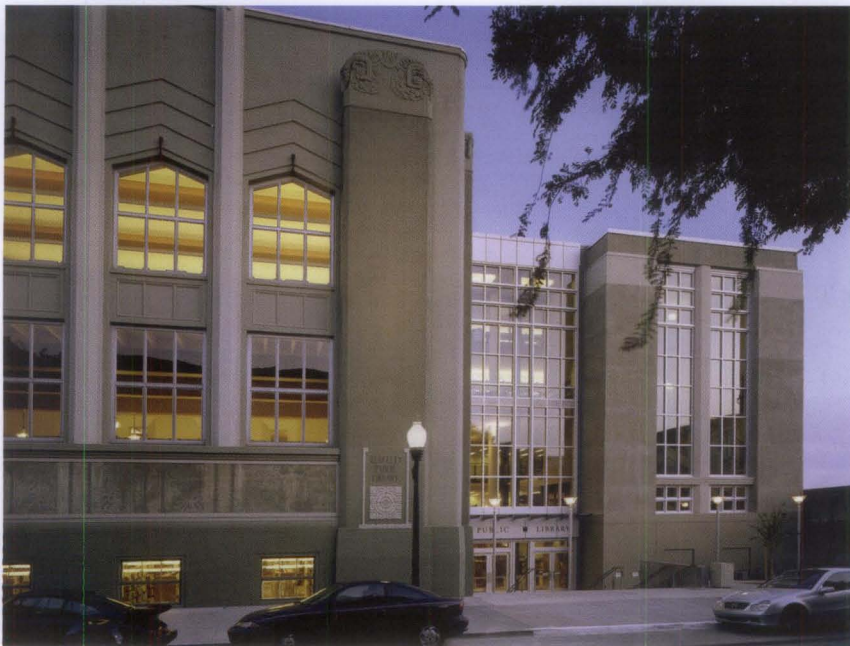
Figure 1. The addition to the right with its connecting hyphen is compatible with the Collegiate Gothic-style library. The addition is set back from the front of the library and uses the same materials and a simplified design that references, but does not copy, the historic building. Photo: David Wakely Photography.

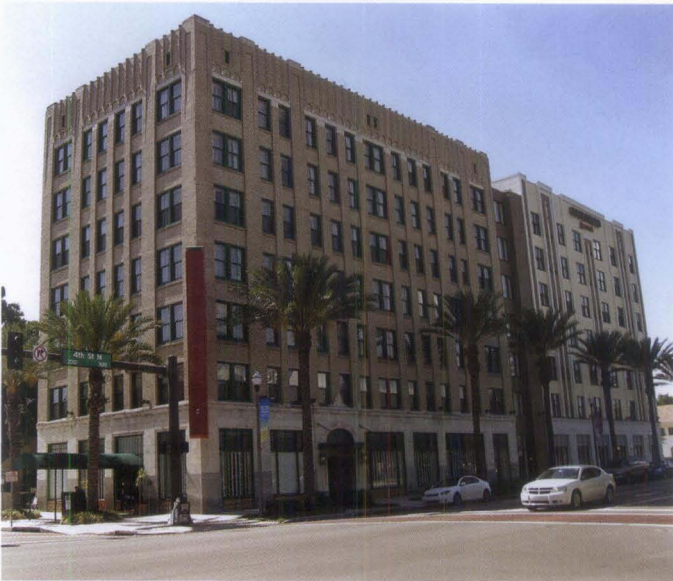
Figure 2. The new section on the right is appropriately scaled and reflects the design of the historic Art Deco-style hotel. The apparent separation created by the recessed connector also enables the addition to be viewed as an individual building.

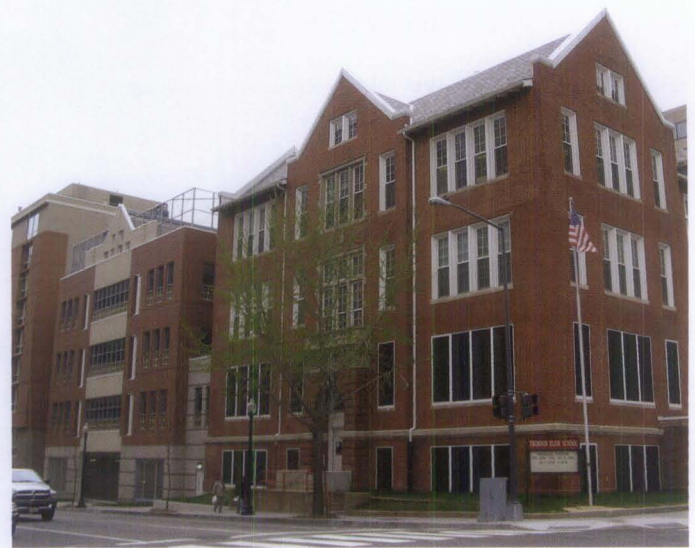
Figure 3. The red and buff-colored parking addition with a rooftop playground is compatible with the early-20th century school as well as with the neighborhood in which it also serves as infill in the urban setting.
