# 1 PRESERVATION BRIEFS

## Assessing Cleaning and Water-Repellent Treatments for Historic Masonry Buildings

Robert C. Mack, AIA  
Anne Grimmer

U.S. Department of the Interior  
National Park Service  
Cultural Resources  
Heritage Preservation Services

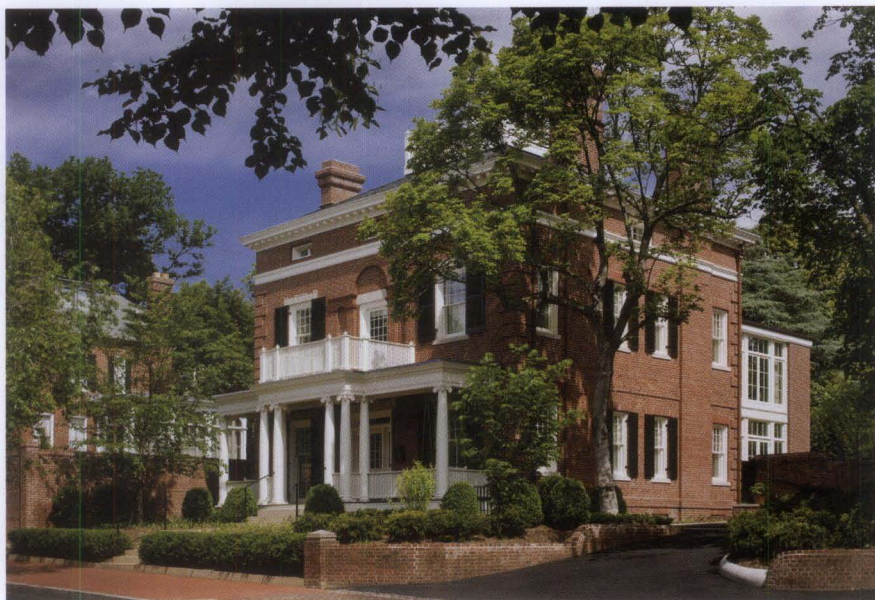
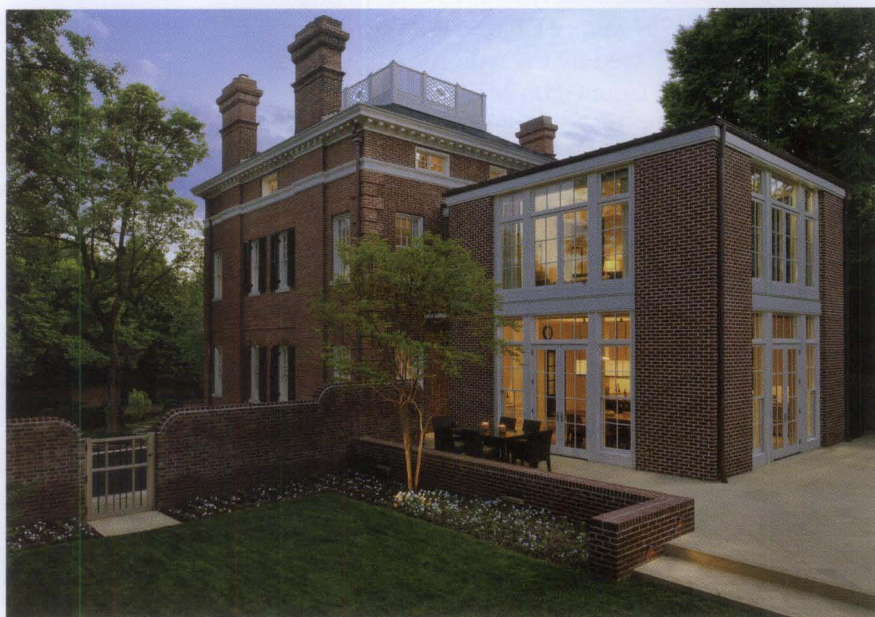
*Figure 4. This glass and brick structure is a harmonious addition set back and connected to the rear of the Colonial Revival-style brick house. Cunningham/Quill Architects. Photos: © Maxwell MacKenzie.*

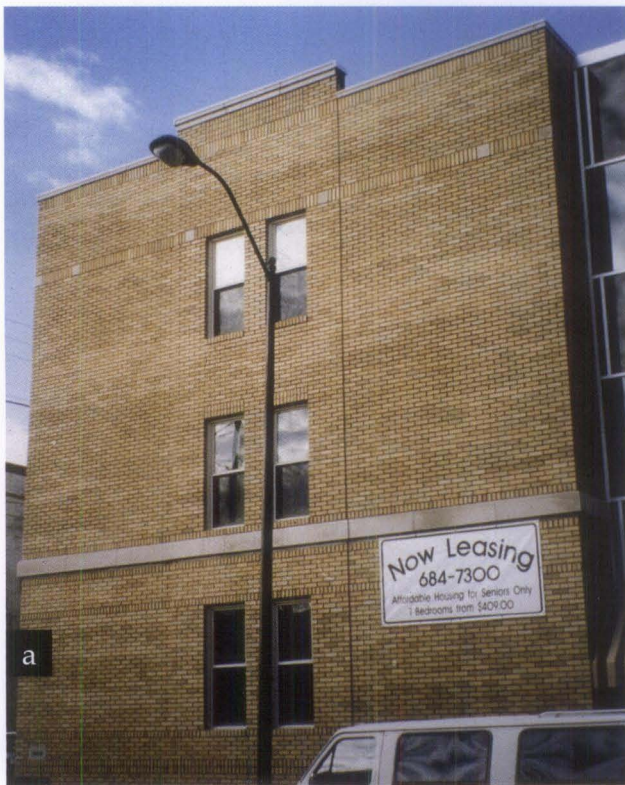
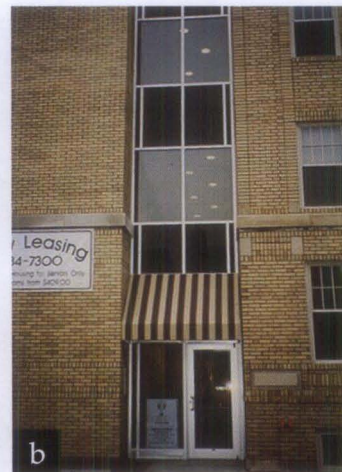
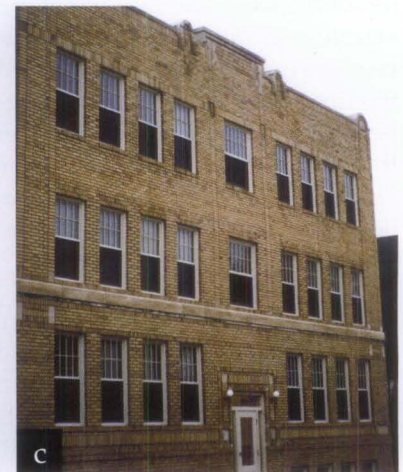
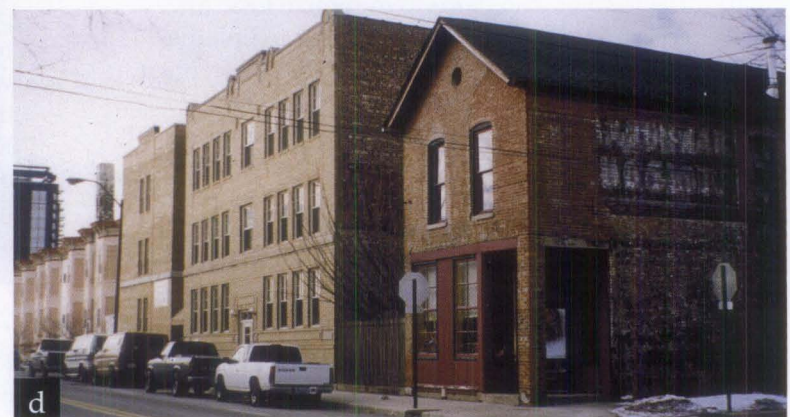
Figure 5. This addition (a) is constructed of matching brick and attached by a recessed connector (b) to the 1914 apartment building (c). The design is compatible and the addition is smaller and subordinate to the historic building (d).

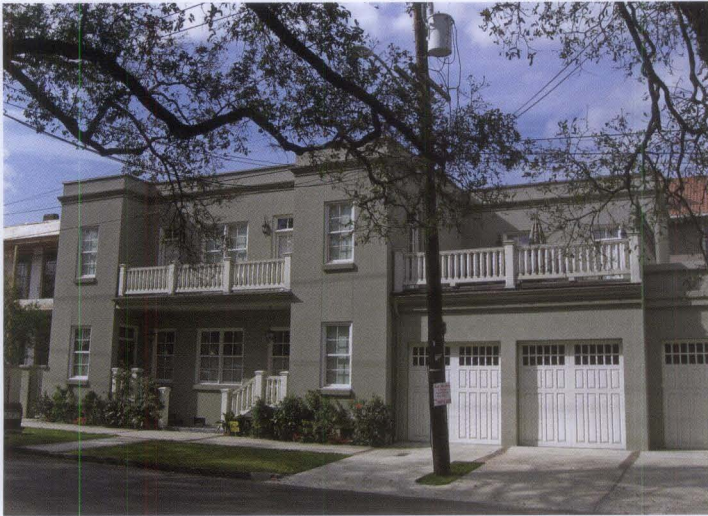
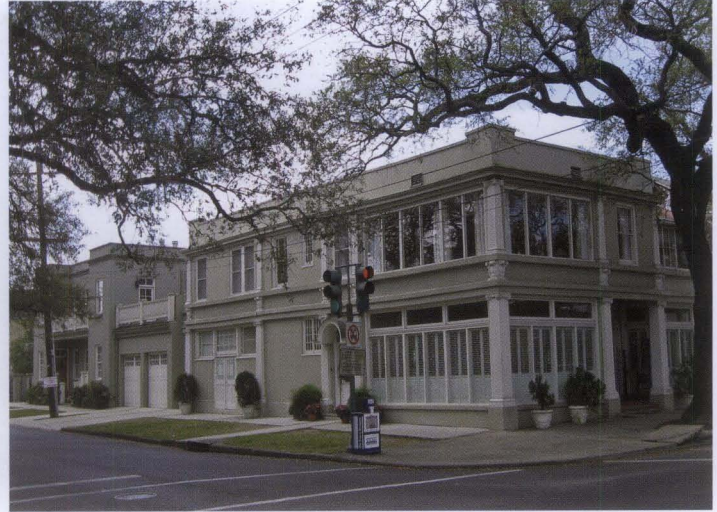
Figure 6. A new addition (left) is connected to the garage which separates it from the main block of the c. 1910 former florist shop (right). The addition is traditional in style, yet sufficiently restrained in design to distinguish it from the historic building.

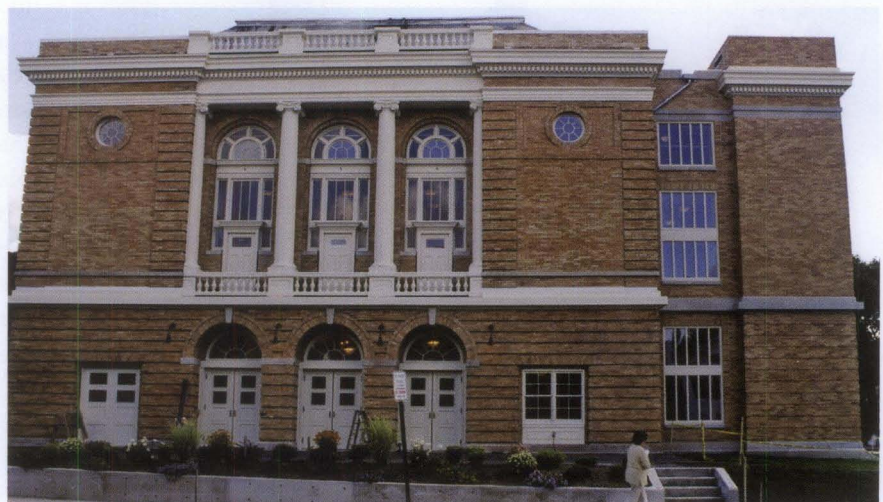
Figure 7. A vacant side lot was the only place a new stair tower could be built when this 1903 theater was rehabilitated as a performing arts center. Constructed with matching materials, the stair tower is set back with a recessed connector and, despite its prominent location, it is clearly subordinate and differentiated from the historic theater.

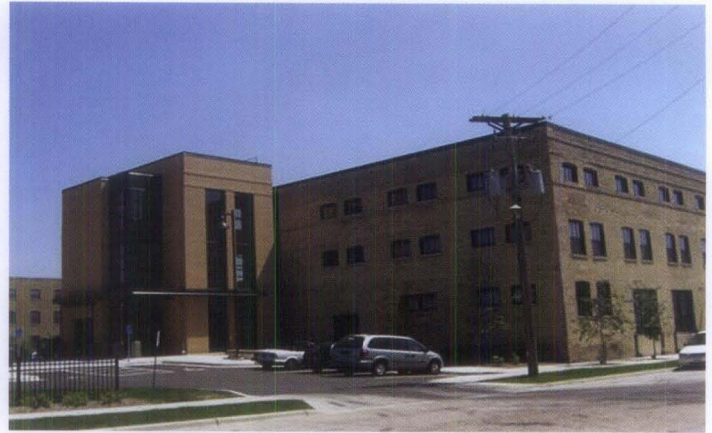
Figure 8. The rehabilitation of this large, early-20th century warehouse (left) into affordable artists' lofts included the addition of a compatible glass and brick elevator/stair tower at the back (right).

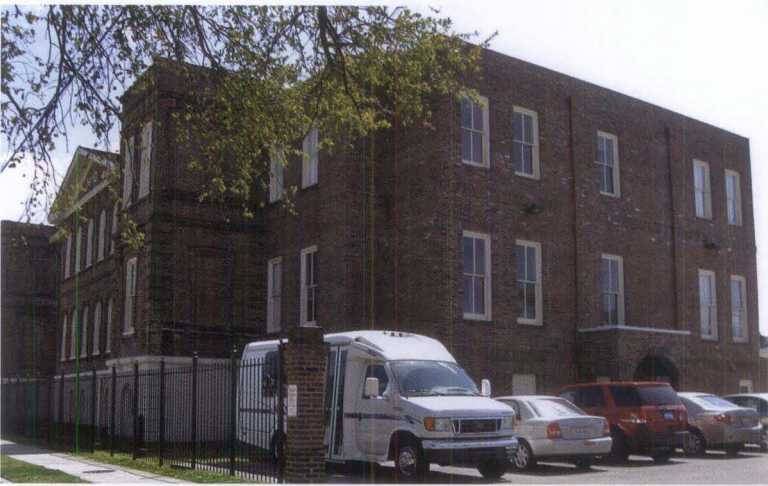
Figure 9. A simple, brick stair tower replaced two non-historic additions at the rear of this 1879 school building when it was rehabilitated as a women's and children's shelter. The addition is set back and it is not visible from the front of the school.

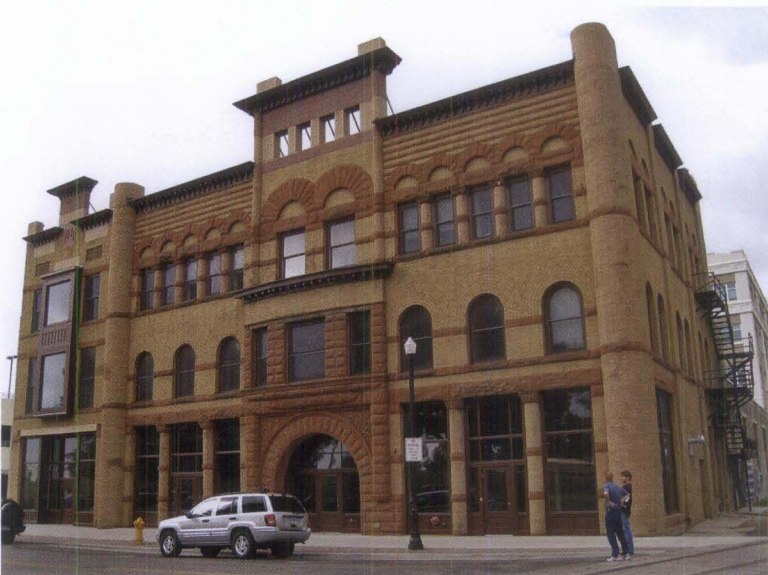
Figure 10. The small size and the use of matching materials ensures that the new addition on the left is compatible with the historic Romanesque Revival-style building.

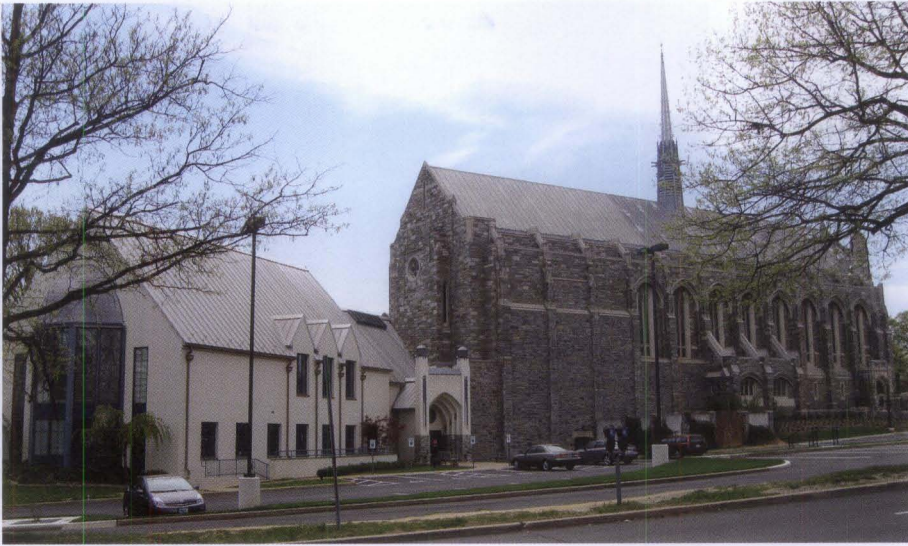
Figure 11. The addition to this early-20th century Gothic Revival-style church provides space for offices, a great hall for gatherings and an accessible entrance (left). The stucco finish, metal roof, narrow gables and the Gothic-arched entrance complement the architecture of the historic church. Placing the addition in back where the ground slopes away ensures that it is subordinate and minimizes its impact on the church (below).

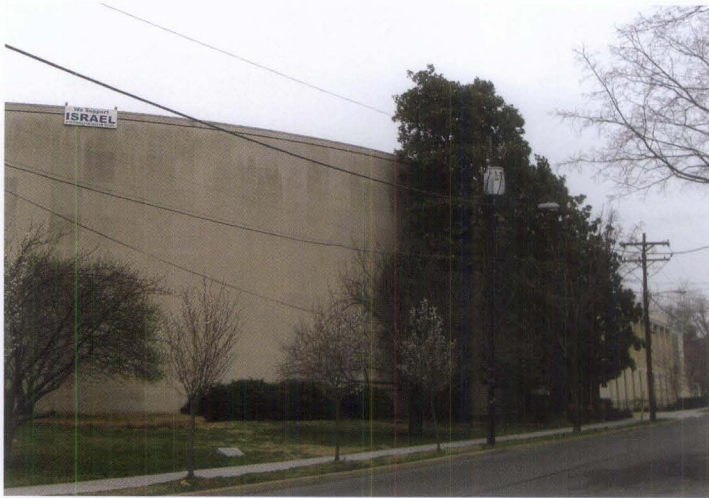
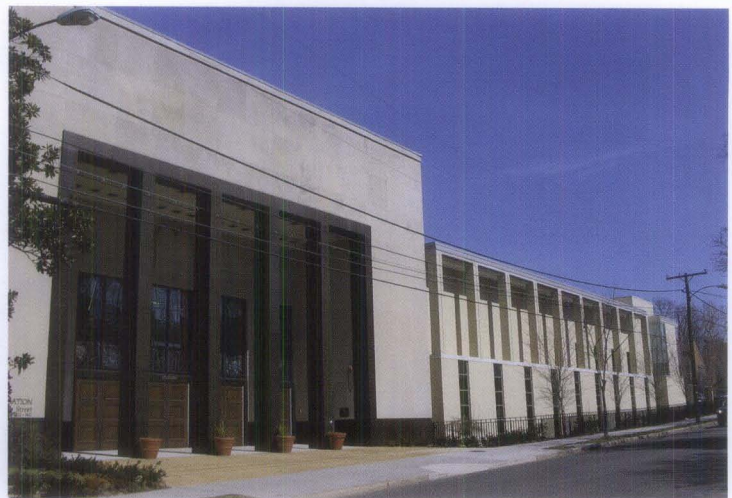
Figure 12. This 1954 synagogue (left) is accessed through a monumental entrance to the right. The new education wing (far right) added to it features the same vertical elements and color and, even though it is quite large, its smaller scale and height ensure that it is secondary to the historic resource.

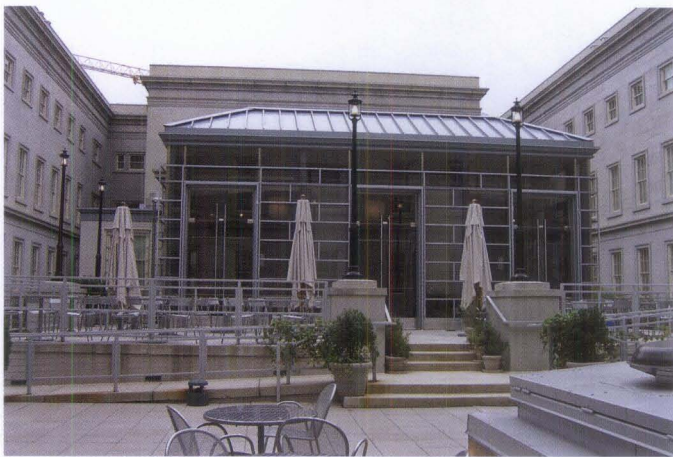
Figure 13. A glass and metal structure was constructed in the courtyard as a restaurant when this 1839 building was converted to a hotel. Although such an addition might not be appropriate in a more public location, it is compatible here in the courtyard of this historic building.

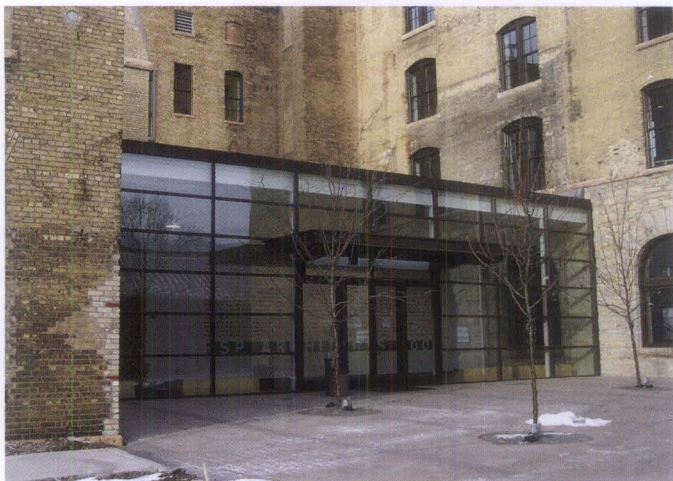
Figure 14. This glass addition was erected at the back of an 1895 former brewery during rehabilitation to provide another entrance. The addition is compatible with the plain character of this secondary elevation.

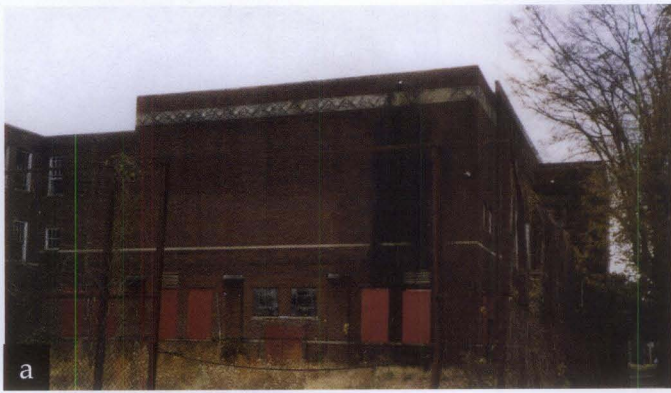
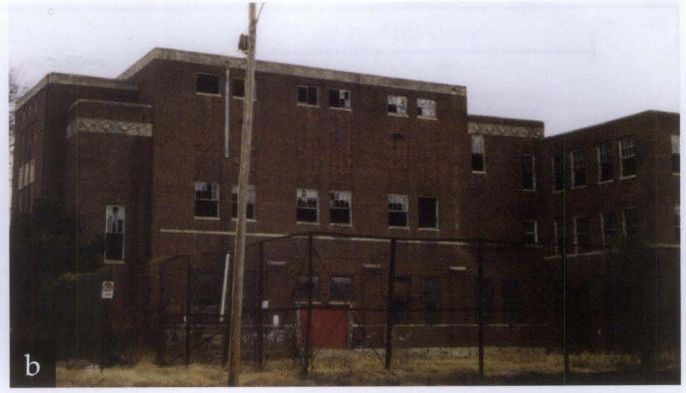
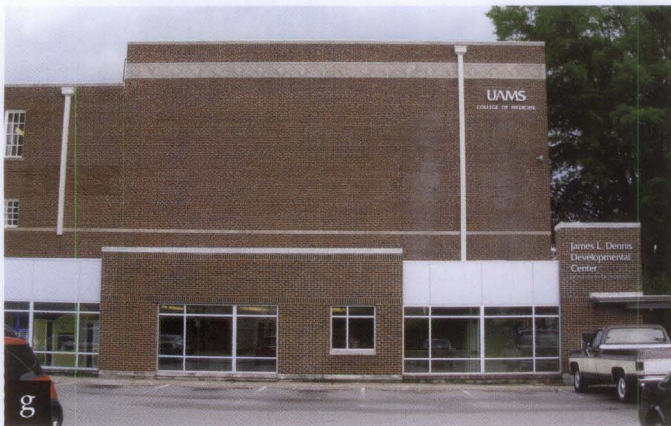
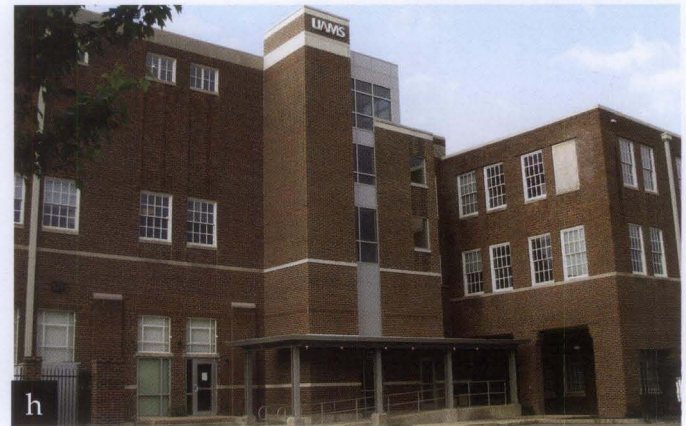
Figure 15. The rehabilitation of a c. 1930 high school auditorium for a clinic and offices proposed two additions: a one-story entrance and reception area on this elevation (a); and a four-story elevator and stair tower on another side (b). The gabled entrance (c) first proposed was not compatible with the flat-roofed auditorium and the design of the proposed stair tower (d) was also incompatible and overwhelmed the historic building. The designs were revised (e-f) resulting in new additions that meet the Standards (g-h).

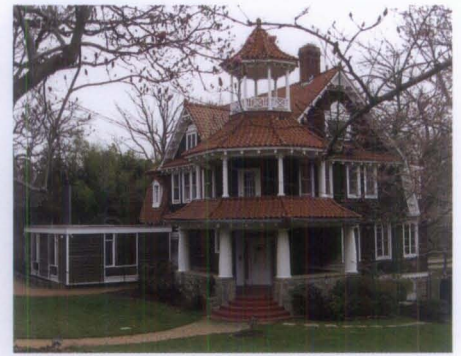
Figure 17. The small addition on the left is starkly different and it is not compatible with the eclectic, late-19th century house.

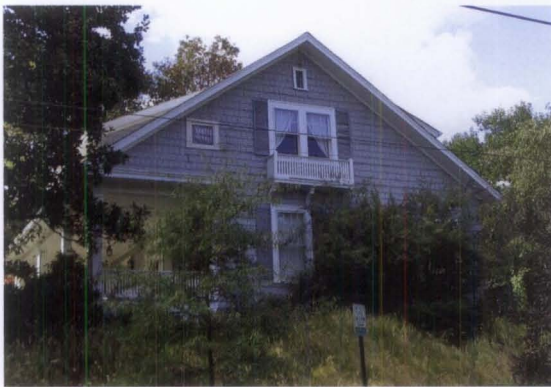
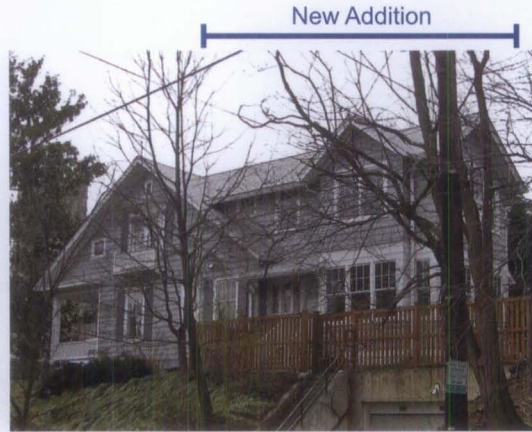
Figure 18. The expansion of a one- and one-half story historic bungalow (left) with a large two-story rear addition (right) has greatly altered and obscured its distinctive shape and form.

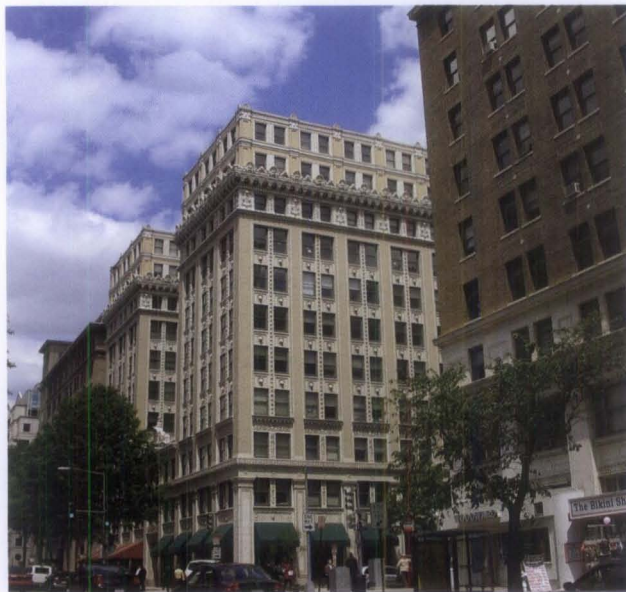
Figure 19. The upper two floors of this early-20th century office building were part of the original design, but were not built. During rehabilitation, the two stories were finally constructed. This treatment does not meet the Standards because the addition has given the building an appearance it never had historically.

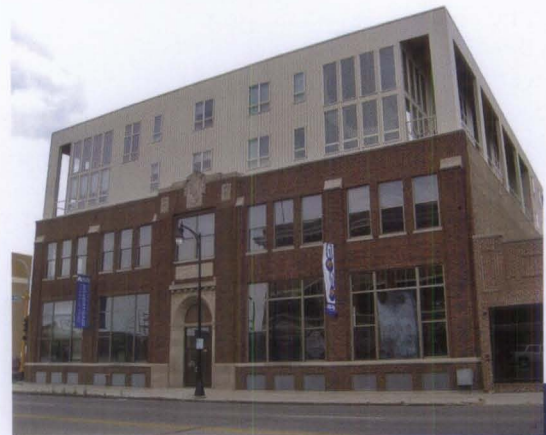
Figure 20. The height, as well as the design, of these two-story rooftop additions overwhelms the two-story and the one-story, low-rise historic buildings.

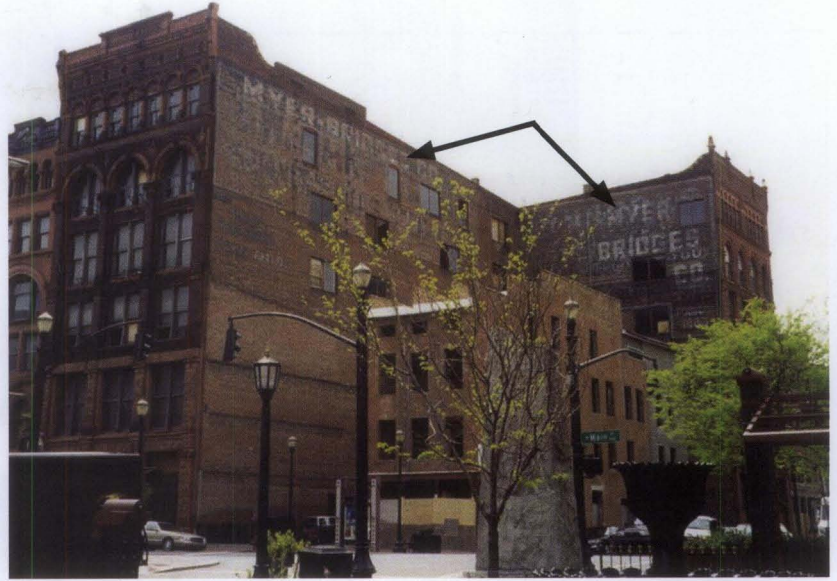
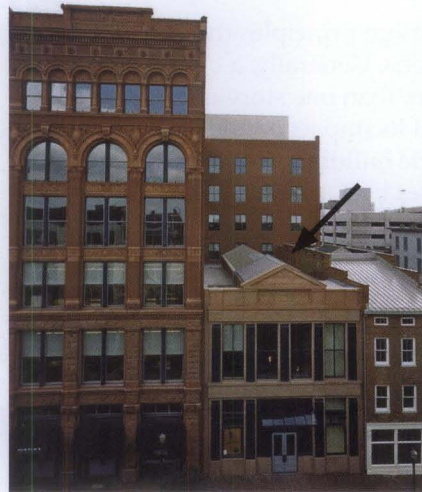
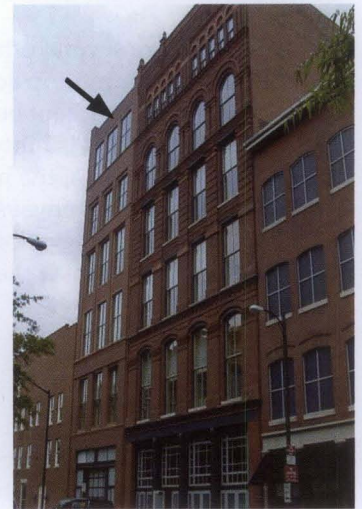
Figure 21. Both wings of this historic L-shaped building (top), which fronts on two city streets, adjoined vacant lots. A two-story addition was constructed on one lot (above, left) and a six-story addition was built on the other (above, right). Like the historic building, which has two different facades, the compatible new additions are also different and appear to be separate structures rather than part of the historic building.

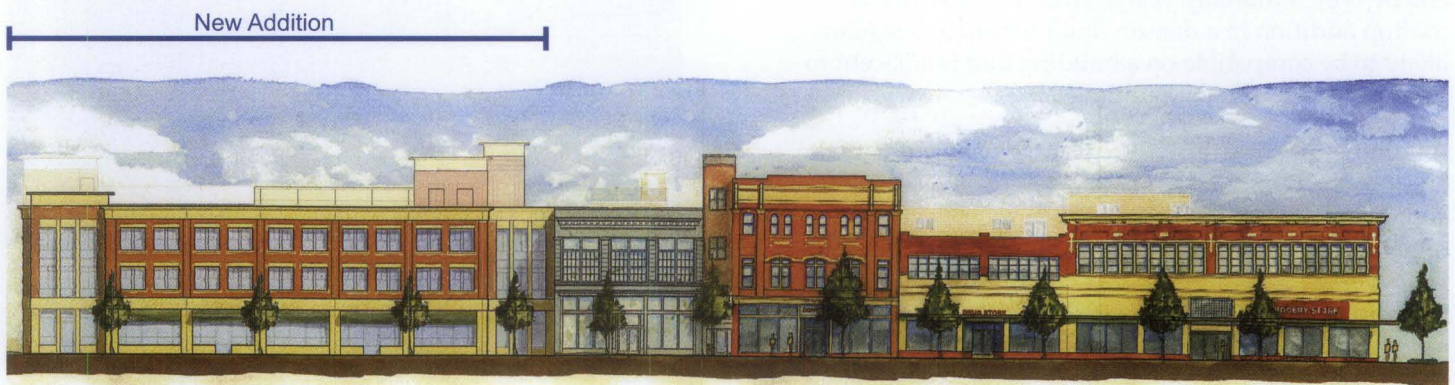
Figure 22. The proposed new addition is compatible with the historic buildings that remain on the block. Its design with multiple storefronts helps break up the mass.

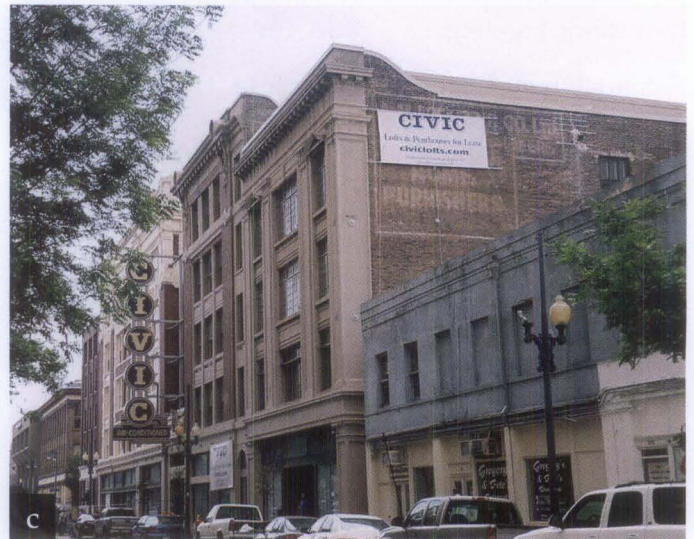
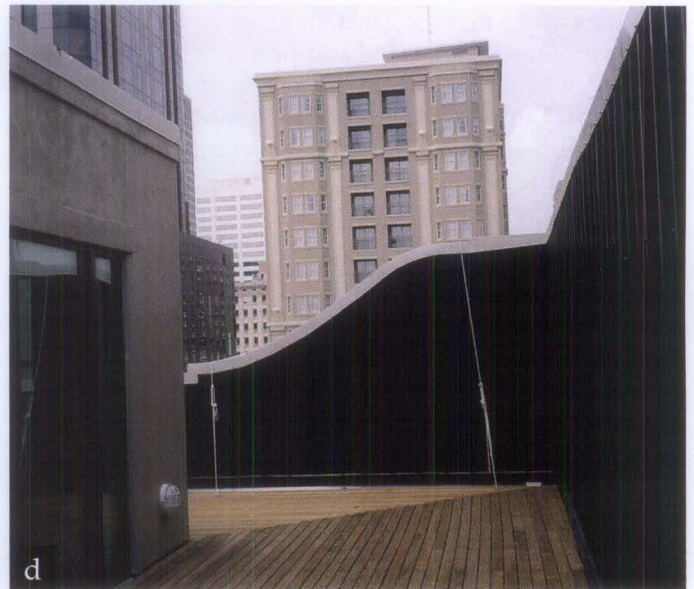
Figure 23. Colored flags marking the location of a proposed penthouse addition (a) were placed on the roof to help evaluate the impact and visibility of an addition planned for this historic furniture store (b). Based on this evaluation, the addition was constructed as proposed. It is minimally visible and compatible with the 1912 structure (c). The tall parapet wall conceals the addition from the street below (d).

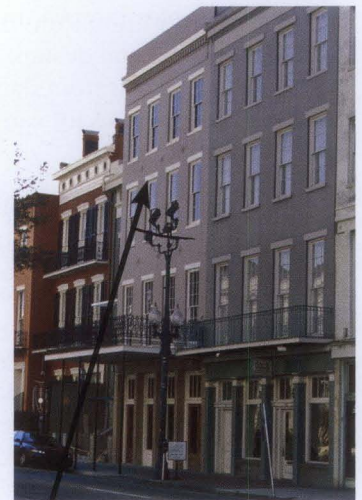
*Figure 26. A rooftop addition would have negatively impacted the character of the primary facade (right) of this mid-19th century, four-story structure and the low-rise historic district. However, a third floor was successfully added on the two-story rear portion (below) of the same building with little impact to the building or the district because it blends in with the height of the adjacent building.*

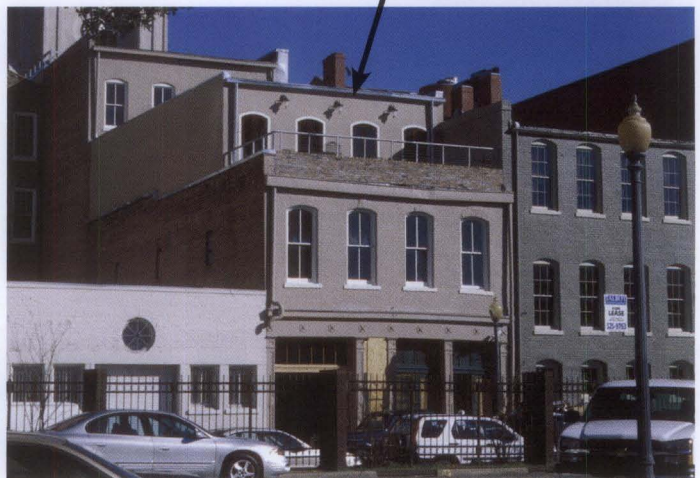
*Figure 25. It was possible to add a compatible, three-story, penthouse addition to the roof of this five-story, historic bank building because the addition is set far back, it is surrounded by taller buildings and a deep parapet conceals almost all of the addition from below.*

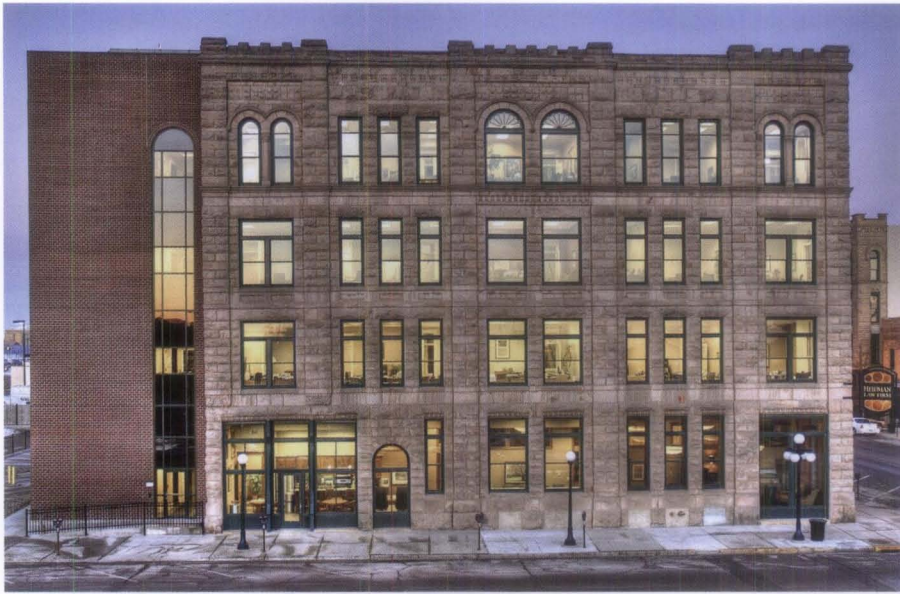
Figure 27. Although the new brick stair/elevator tower (left) is not visible from the front (right), it is on a prominent side elevation of this 1890 stone bank. The compatible addition is set back and does not compete with the historic building. Photos: Chadd Gossmann, Aurora Photography, LLC.

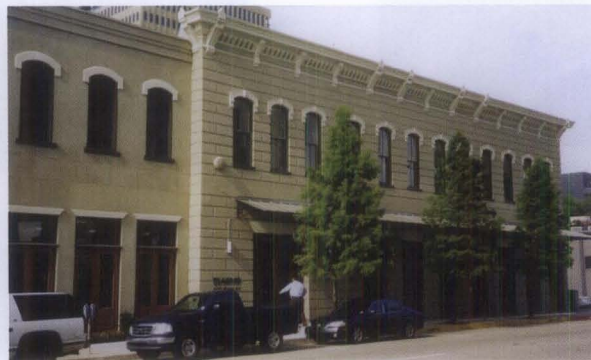
Figure 28. A small addition (left) was constructed when this 1880s train station was converted for office use. The paired doors with transoms and arched windows on the compatible addition reflect, but do not replicate, the historic building (right).

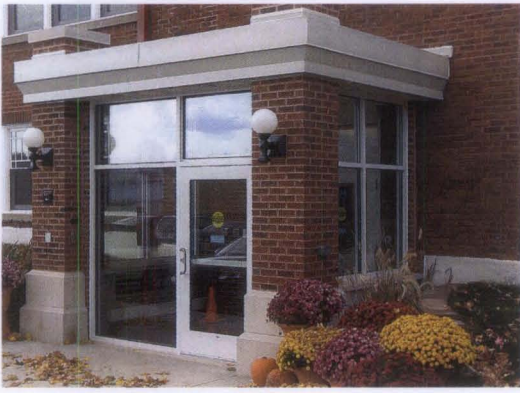
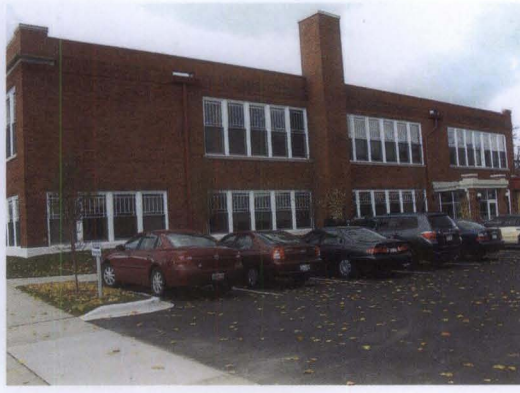
Figure 29. This simple glass and brick entrance (left) added to a secondary elevation of a 1920s school building (right) is compatible with the original structure.

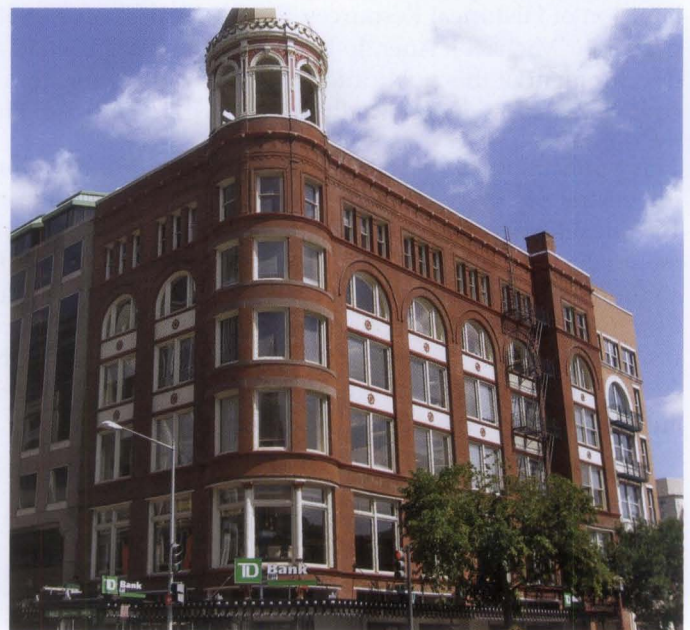
Figure 30. The small addition on the right of this late-19th century commercial structure is clearly secondary and compatible in size, materials and design with the historic building.

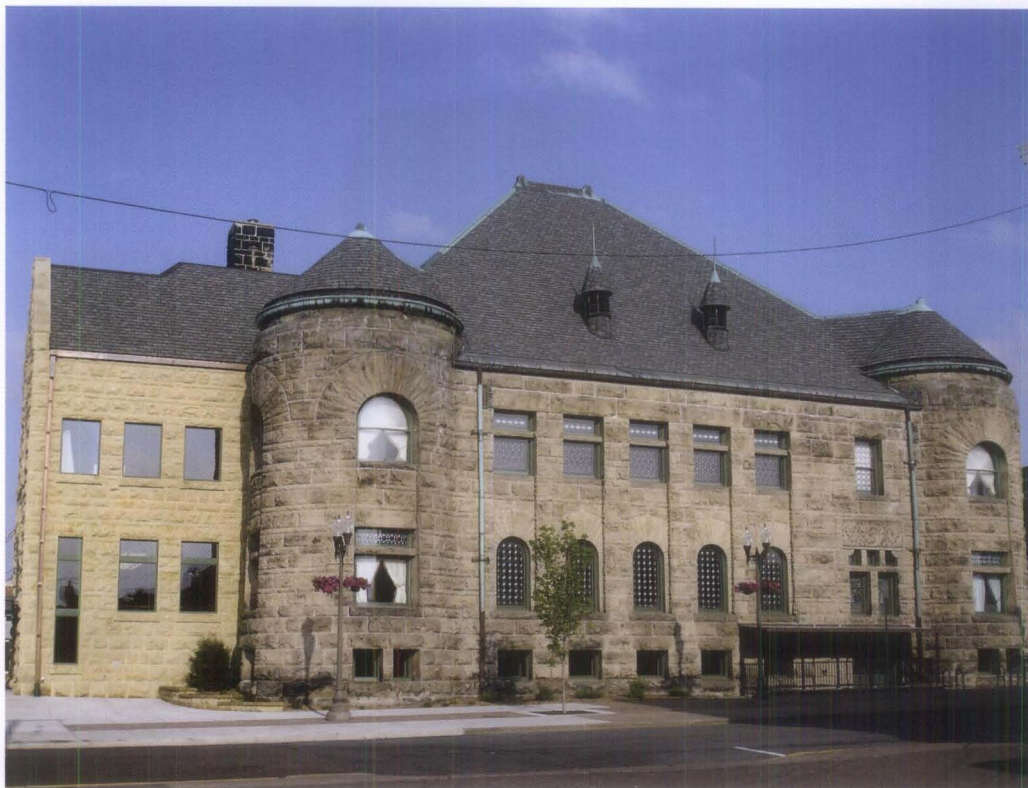
Figure 31. An elevator/stair tower was added at the back of this Richardsonian Romanesque-style theater when it was rehabilitated. Rough-cut stone and simple cut-out openings ensure that the addition is compatible and subordinate to the historic building. Photo: Chuck Liddy, AIA.

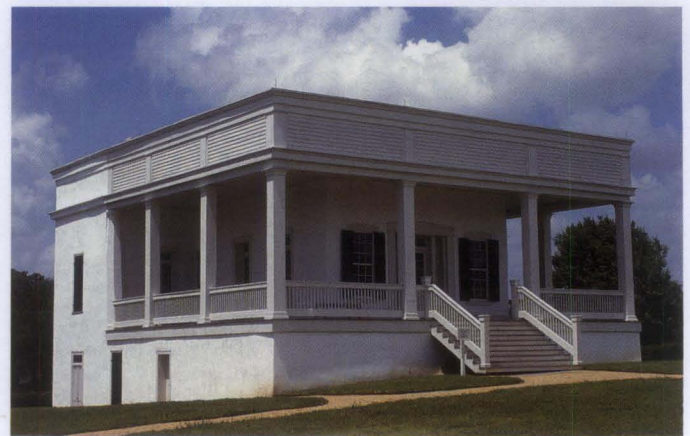
Figure 1. The Sebastopol House in Seguin, Texas, is an 1856 Greek Revival-style house constructed of lime concrete. Lime concrete or "limecrete" was a popular construction material, as it could be made inexpensively from local materials. By 1900, the town had approximately ninety limecrete structures, twenty of which remain. Photo: Texas Parks and Wildlife Department.

publicized in the second edition of Orson S. Fowler's *A Home for All* (1853) which described the advantages of "gravel wall" construction to a wide audience. The town of Seguin, Texas, thirty-five miles east of San Antonio, already had a number of concrete buildings by the 1850s and came to be called "The Mother of Concrete Cities," with approximately ninety concrete buildings made from local "lime water" and gravel (Fig. 1).

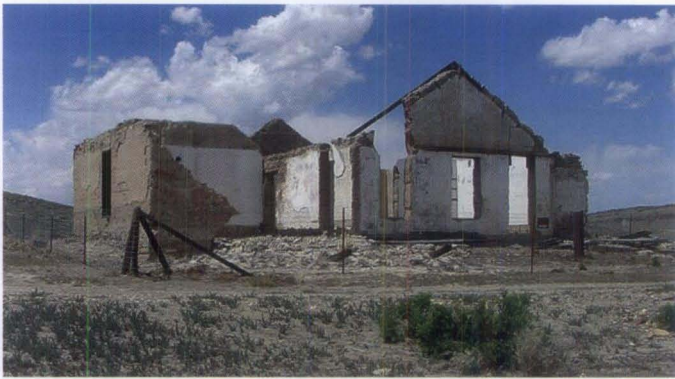
*Figure 2. Chatterton House was the home of the post trader at Fort Fred Steel in Wyoming, one of several forts established in the 1860s to protect the Union Pacific Railroad. The walls of the post trader's house were built using stone aggregate and lime, without cement. The use of this material presents special preservation challenges.*

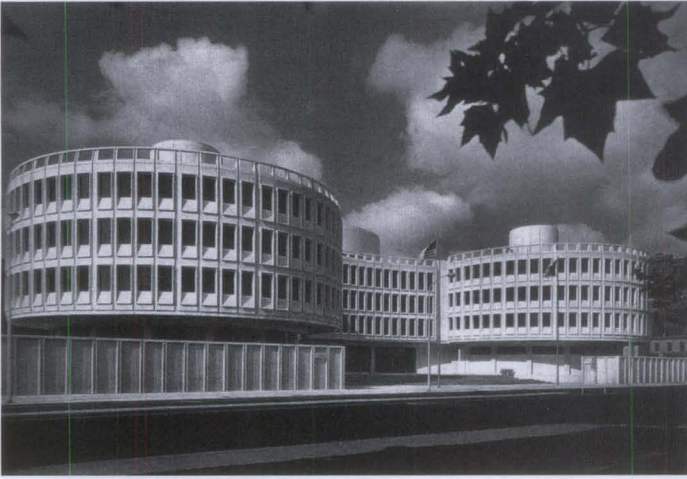
Figure 5. Following World War II, architects and engineers took advantage of improvements in concrete production, quality control, and advances in precast concrete to design structures such as the Police Headquarters building in Philadelphia, Pennsylvania, constructed in 1961. Photo: Courtesy of the Philadelphia Police Department.

During the early twentieth century, Ernest Ransome in Beverly, Massachusetts, Albert Kahn in Detroit, and Richard E. Schmidt in Chicago, promoted concrete for use in “Factory Style” utilitarian buildings with an exposed concrete frame infilled with expanses of glass. Thomas Edison’s cast-in-place reinforced concrete homes in Union Township, New Jersey (1908), proclaimed a similarly functional emphasis in residential construction. From the 1920s onward, concrete began to be used with spectacular design results: examples include John J. Earley’s Meridian Hill Park in Washington, D.C.; Louis Bourgeois’ exuberant, graceful Baha’i Temple in Wilmette, Illinois (1920–1953), for which Earley fabricated the concrete (Fig. 4); and Frank Lloyd Wright’s Fallingwater near Bear Run, Pennsylvania (1934). Continuing improvements in quality control and development of innovative fabrication processes, such as the Shockbeton method for precast concrete, provided increasing opportunities for architects and engineers. Wright’s Guggenheim Museum in New York City (1959); Geddes Brecher Qualls & Cunningham’s Police Headquarters building in Philadelphia, Pennsylvania (1961); and Eero Saarinen’s soaring terminal building at Dulles International Airport outside Washington, D.C., and the TWA terminal at Kennedy Airport in New York (1962), exemplify the masterful use of concrete achieved in the modern era (Fig. 5).

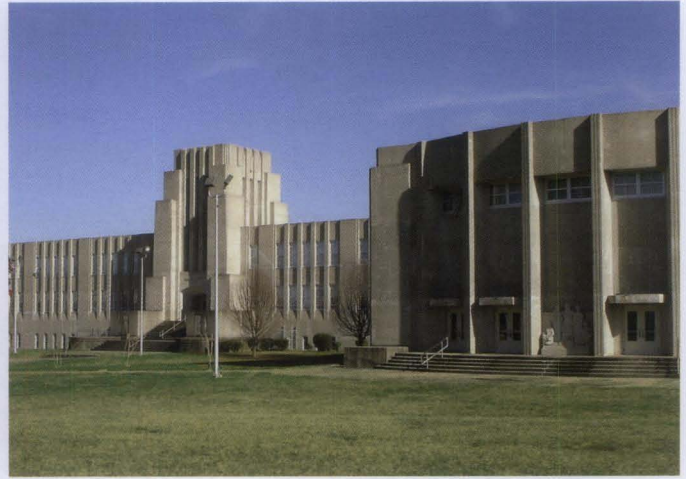
Figure 6. The Bailey Magnet School in Jackson, Mississippi, was designed as the Jackson Junior High School by the firm of N.W. Overstreet & Town in 1936. The streamlined building exemplifies the applicability of concrete to creating a modern architectural aesthetic. Photo: Bill Burris, Burris/Wagnon Architects, P.A.

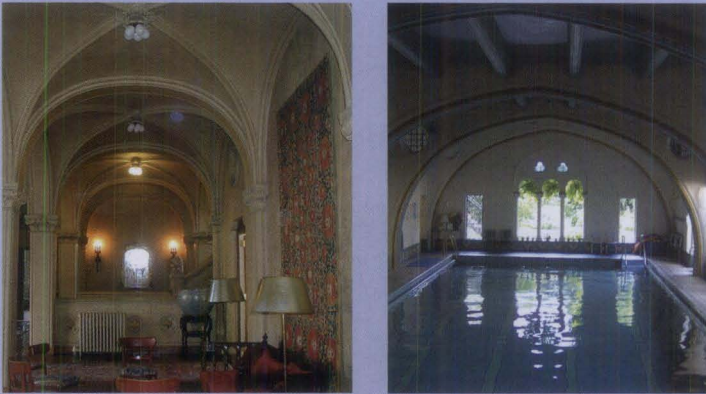
Figure 10. The Berkeley City Club has significant interior spaces and features of concrete construction, including the lobby and pool. Photos: Una Gilmartin (left) and Brian Kehoe (right), Wiss, Janney, Elstner Associates, Inc.

The expanded use of concrete provided new opportunities to create dramatic spaces and ornate architectural detail on the interiors of buildings, at a significant cost savings over traditional construction practices. The architectural design of the Berkeley City Club in Berkeley, California, expressed Moorish and Gothic elements in concrete on the interior of the building (Fig. 10). Used as a woman's social club, the building was designed by noted California architect Julia Morgan and constructed in 1929. The vaulted ceilings, columns, and ornamental capitals of the lobby and the ornamental arches and beamed ceiling of the "plunge" are all constructed of concrete.

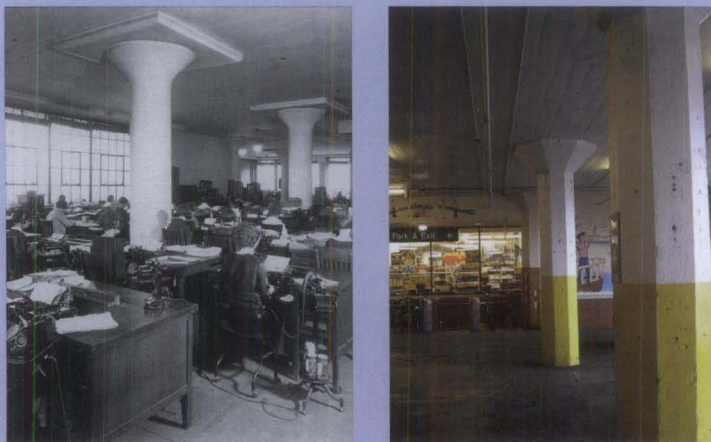
Figure 11. Whether in a circa 1925 office (left) or in a parking garage and retail facility (right), exposed concrete structures help characterize these building interiors. Photo: Minnesota Historical Society (left).

The historic character of a building's interior can also be conveyed in a more utilitarian manner in terms of concrete features and finishes (Fig. 11). The exposed concrete structure—columns, capitals, and drop panels—is an integral part of the character of this old commercial building in Minneapolis. In concrete warehouse and factory buildings of the early twentieth century, exposed concrete columns and formboard finish concrete slab ceilings are common features as seen in this warehouse, now converted for use as a parking garage and shops.

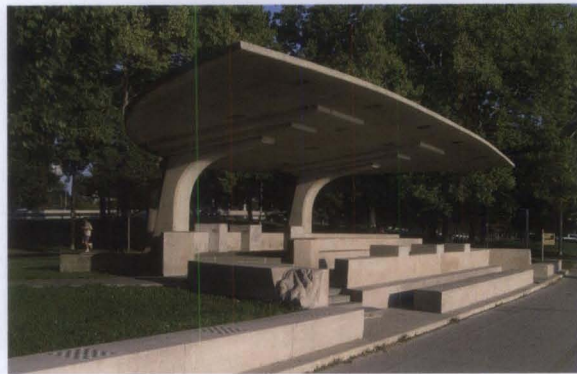
*Figure 8. The Chess Pavilion in Chicago's Lincoln Park was designed by architect Morris Webster and constructed in 1956. The pavilion is a distinctive landscape feature, with its reinforced concrete cantilevered slab that provides cover for chess players.*

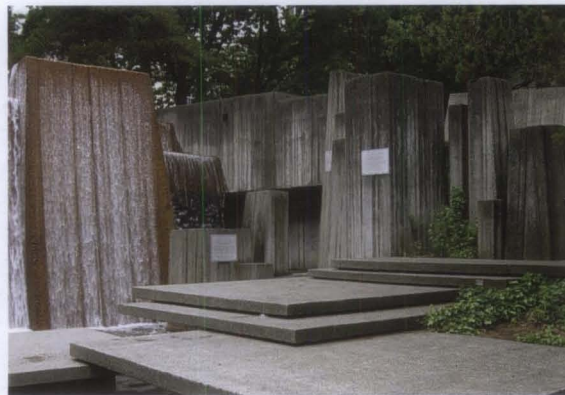
*Figure 9. The Ira C. Keller Fountain in Portland, Oregon, was designed by Lawrence Halprin and constructed in 1969. The fountain is constructed primarily of concrete pillars with formboard textures and surrounding elements, patterned with geometric lines, which facilitate the path of water. Photo: Anita Washko, Wiss, Janney, Elstner Associates, Inc.*

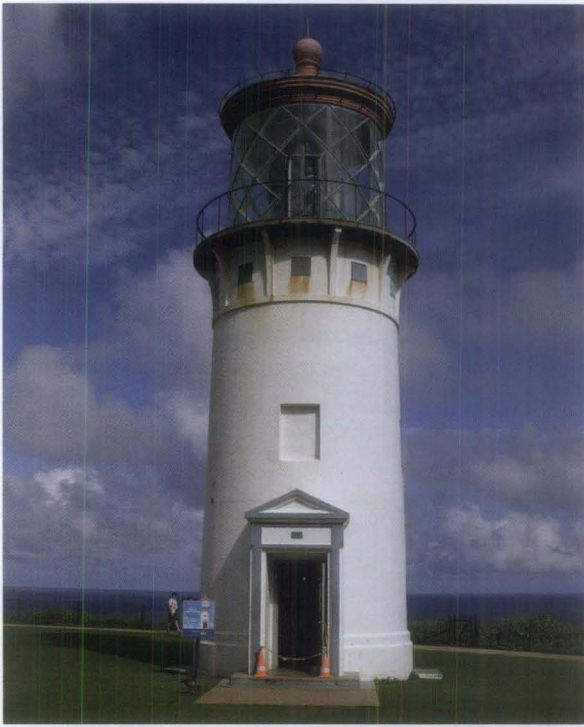
Figure 12. The concrete lighthouse at the Kilauea Point Light Station, Kilauea, Kauai, Hawaii, was constructed circa 1913. The concrete, which was a good quality, high strength mix for its day, is in good condition after almost one hundred years in service. Deterioration in the form of spalling related to corrosion of embedded reinforcing steel has occurred primarily in areas of higher ornamentation such as projecting bands and brackets (see close-up photo).

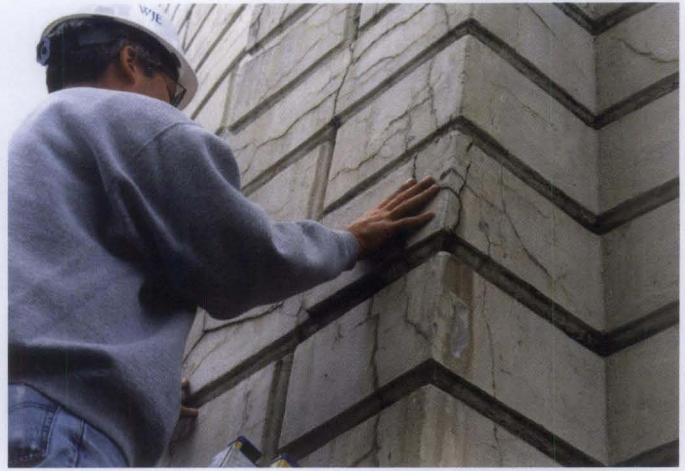
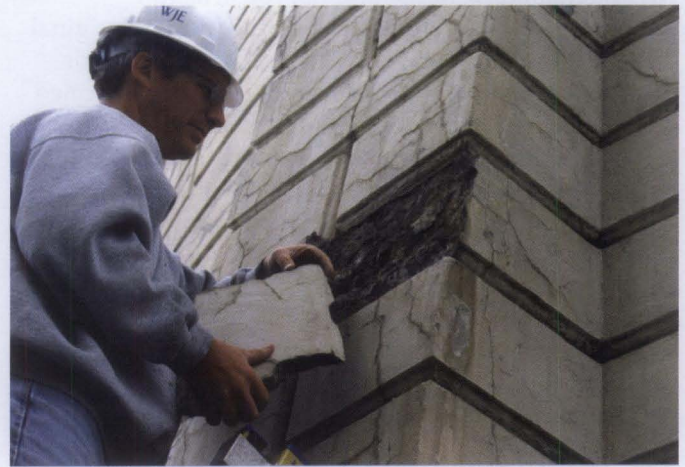
*Figures 14. Layers of architectural concrete that have debonded (spalled) from the surface were removed from a historic water tank during the investigation performed to assess existing conditions. Photos: Anita Washko, Wiss, Janney, Elstner Associates, Inc.*

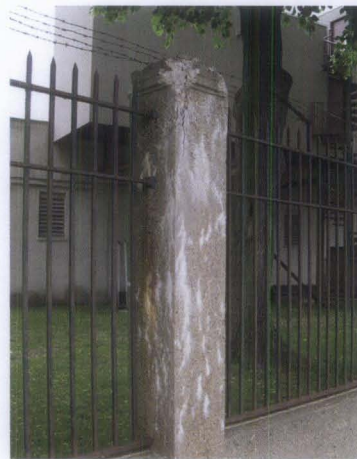
Figure 15. Evidence of moisture movement through concrete is apparent in the form of mineral deposits on the concrete surface. Cyclic freezing and thawing of entrapped moisture, and corrosion of embedded reinforcement, have also contributed to deterioration of the concrete column on this fence at Crocker Field in Fitchburg, Massachusetts, designed by the Olmsted Brothers.

Staining of the concrete surface can be related to soiling from atmospheric pollutants or other contaminants, dirt accumulation, and the presence of organic growth. However, stains can also indicate more serious underlying problems, such as corrosion of embedded reinforcing steel, improper previous surface treatments, alkali-aggregate reaction, or efflorescence, the deposition of soluble salts on the surface of the concrete as a result of water migration (Fig. 15).

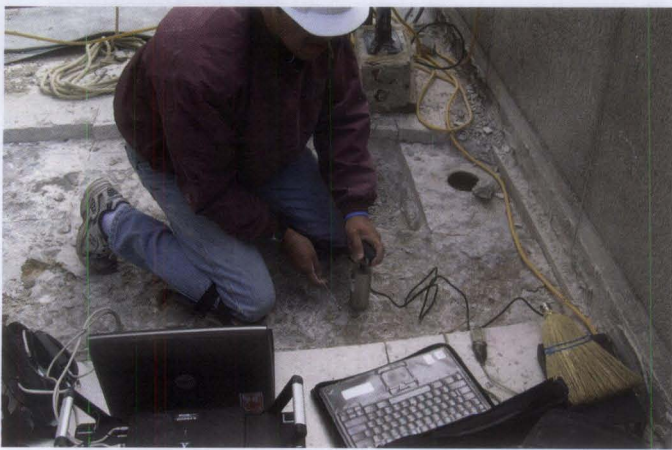
Figure 16. Impact echo testing is performed on a concrete structural slab to help determine depth of deterioration. In this method, a short pulse of energy is introduced into the structure and a transducer mounted on the impacted surface of the structure receives the reflected input waves or echoes. These waves are analyzed to help identify flaws and deterioration within the concrete.

A number of nondestructive testing methods can be used in the field to evaluate concealed conditions. Basic techniques include sounding with a hand-held hammer (or for horizontal surfaces, a chain) to help identify areas of delamination. More sophisticated techniques include impact-echo testing (Fig. 16), ground penetrating radar, pulse velocity, and other methods that characterize concrete thickness and locate voids or delaminations. Magnetic detection instruments are used to locate embedded reinforcing steel and can be calibrated to identify the size and depth of reinforcement. Corrosion measurements can be taken using copper-copper sulfate half-cell tests or linear polarization techniques to determine the probability or rate of active corrosion of the reinforcing steel.
