# 1 PRESERVATION BRIEFS

## Assessing Cleaning and Water-Repellent Treatments for Historic Masonry Buildings

Robert C. Mack, AIA  
Anne Grimmer

U.S. Department of the Interior  
National Park Service  
Cultural Resources  
Heritage Preservation Services

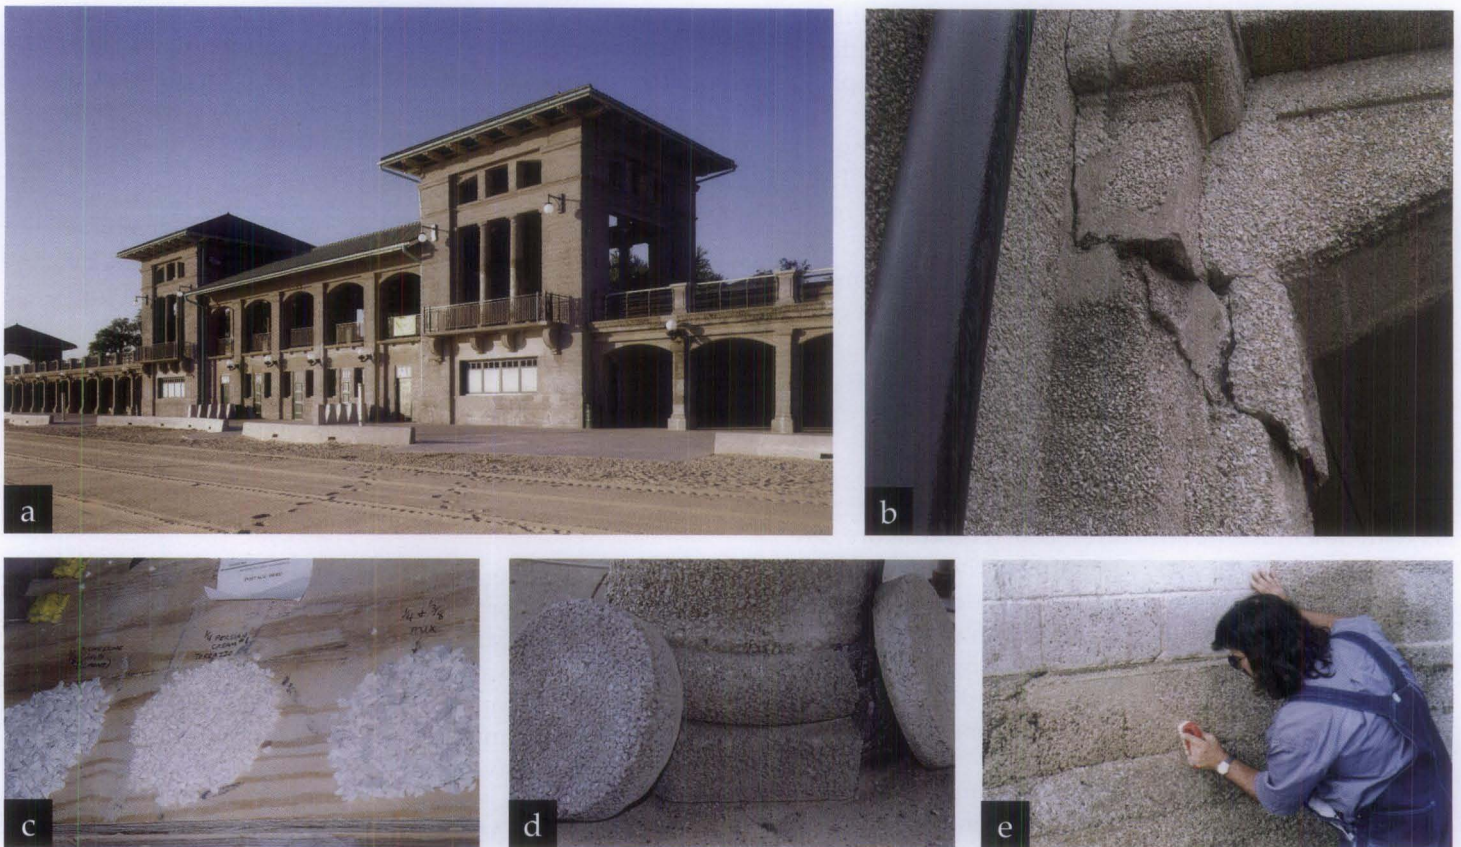
Figure 17. (a) The 63rd Street Beach House was constructed on the shoreline of Chicago in 1919. The highly exposed aggregate concrete of the exterior walls of the beach house was used for many buildings in the Chicago parks as an alternative to more expensive stone construction. Photo: Leslie Schwartz Photography. (b) Concrete deterioration included cracking, spalling, and delamination caused by corrosion of embedded reinforcing steel and concrete damage due to cyclic freezing and thawing. (c) Various sizes and types of aggregates were reviewed for matching to the original concrete materials. (d) Mock-ups of the concrete repair mix were prepared for comparison to the original concrete. Considerations included aggregate type and size, cement color, proportions, aggregate exposure, and surface finish. (e) The craftsman finished the surface to replicate the original appearance in a mock-up on the structure. Here, he used a nylon bristle brush to remove loose paste and expose the aggregate, creating a variable surface to match the adjacent original concrete.

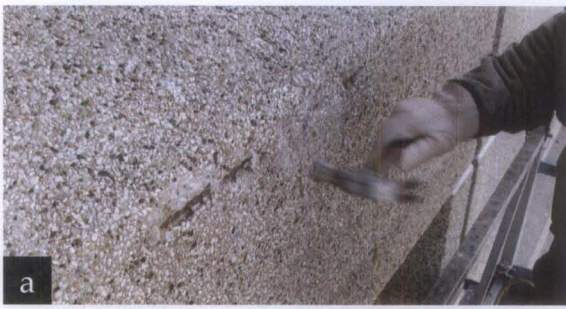
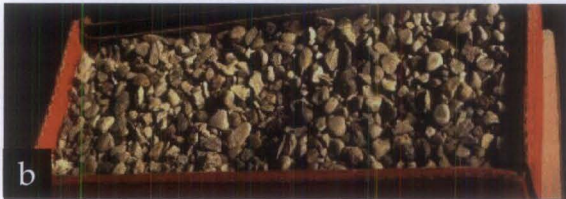
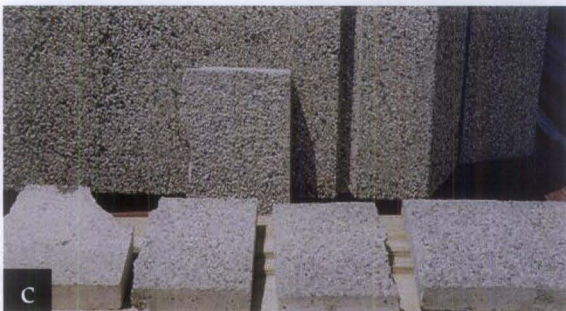
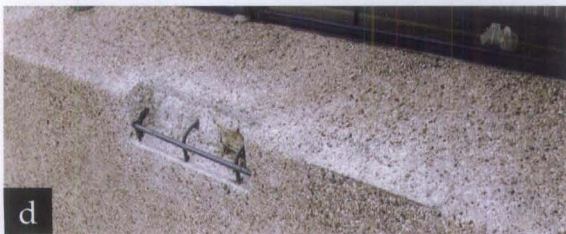
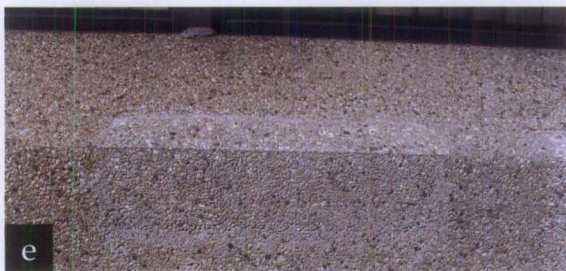
Figure 18. (a) Exposed aggregate precast concrete is sounded with a hammer to detect areas of deterioration. Corrosion of the exposed reinforcing steel bar has led to spalling of the adjacent concrete. (b) Samples of aggregate considered for use in repair concrete are compared to the original concrete materials in terms of size, color, texture, and reflectance. (c) Various sample panels are made using the selected concrete repair mix design for comparison to the original concrete on the building, and the mix design is adjusted based on review of the samples. (d) After removal of the spall, the concrete surface is prepared for installation of a formed patch. (e) Prior to placement of the concrete, a retarding agent is brush-applied to the inside face of the formwork to slow curing at the surface. After the concrete is partially cured, the forms are removed and the surface of the concrete is rubbed to remove some of the paste and expose the aggregate to match the original concrete.

Repair measures should be selected that retain as much of the original material as possible, while providing for removal of an adequate amount of deteriorated concrete to provide a sound substrate for a durable repair. The installed repair must visually match the existing concrete as closely as possible and should be similar in other aspects such as compressive strength, permeability, and other characteristics important in the mix design of the concrete (Fig. 18).

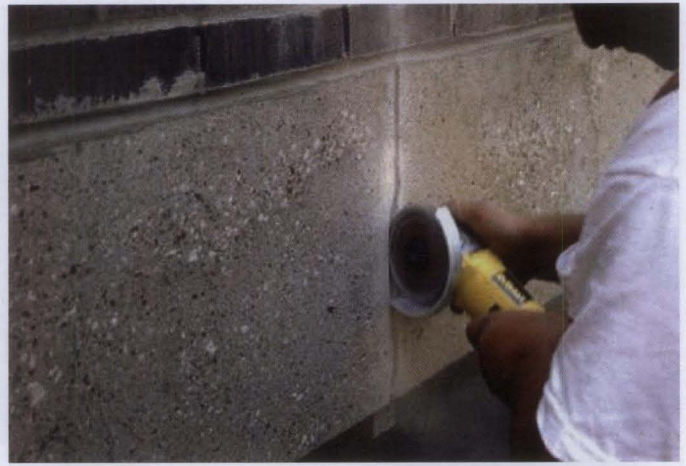
Figure 19. A high-speed grinder is used to widen a crack in preparation for installation of a sealant. This process is called "routing." After the crack is prepared, the sealant is installed to prevent moisture infiltration through the crack. Although sealant repairs can provide a durable, watertight repair for moving cracks, they tend to be very visible.

Active structural cracks (which move as loads are added or removed) and thermal cracks (which move as temperatures fluctuate) must be repaired in a manner that will accommodate the anticipated movement. In some more extreme cases, expansion joints may have to be introduced before crack repairs are undertaken. Active cracks may be filled with sealants that will adhere to the sides of the cracks and will compress or expand during crack movement. The design, detailing, and execution of sealant repairs require considerable attention, or they will detract from the appearance of the historic building. The routing and cleaning of a crack, and installation of an elastomeric sealant to prevent water penetration, is used to address cracks where movement is anticipated. However, unless located in a concealed area of the concrete, this technique is often not acceptable for historic structures because the repair will be visually intrusive (Fig. 19). Other approaches, such as installation of a cementitious crack repair, may need to be considered even though this type of repair may be less effective or have a shorter service life than a sealant repair.

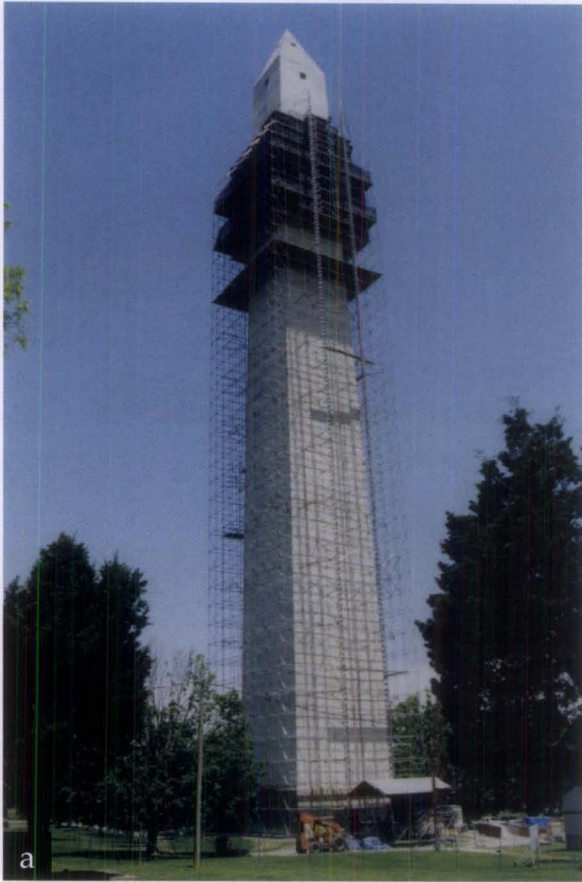
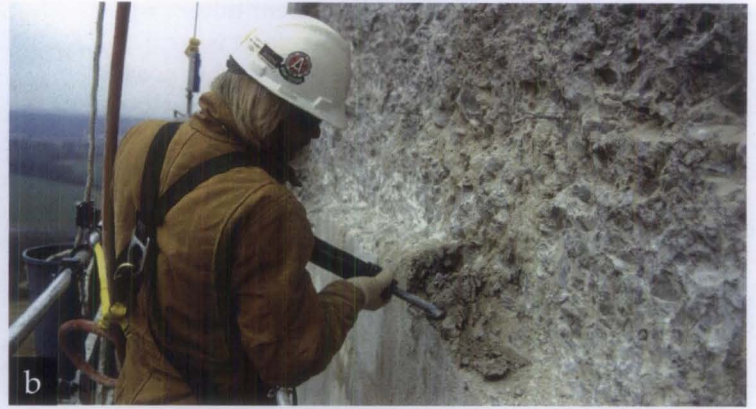
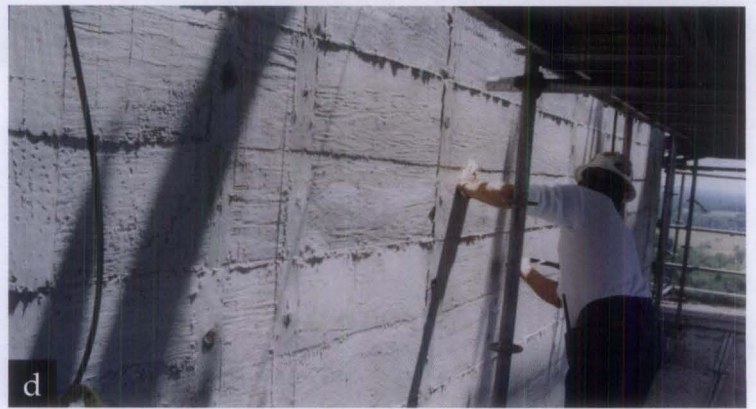
Figure 20. (a) The Jefferson Davis Memorial in Fairview, Kentucky, constructed from 1917–1924, is 351 feet tall and constructed of unreinforced concrete. The walls of the memorial are 8 feet thick at the base and 2 feet thick at the top of the wall. Access to the monument for investigation was provided by rappelling techniques, while ground supported and suspended scaffolding was used to access the exterior during repairs. (b) The concrete was severely deteriorated at isolated locations, with spalling and damage from cyclic freezing and thawing of entrapped water. In addition, previous repairs were at the end of their service life and removal of deteriorated concrete and failed previous repairs was required. Light duty chipping hammers were used to avoid damage to adjacent material when removing deteriorated concrete to the level of sound concrete. (c) Field samples were performed to match the color, finish, and texture of the original concrete. A challenge in matching of historic concrete is achieving variability of appearance. (d) The completed surface after repairs exhibits intentional variability of the concrete surface to match the appearance of the original concrete. Some formwork imperfections that would normally be removed by finishing were intentionally left in place, to replicate the highly variable finish of the original concrete. (e) The Jefferson Davis Memorial after completion of repairs in 2004. Photo e: Joseph Lenzi, Senler, Campbell & Associates, Inc.

due to original construction techniques, architectural design, or differential exposure to weather. Trial repairs and mock-ups are used to evaluate the proposed replacement concrete work and to refine construction techniques (Fig 20).

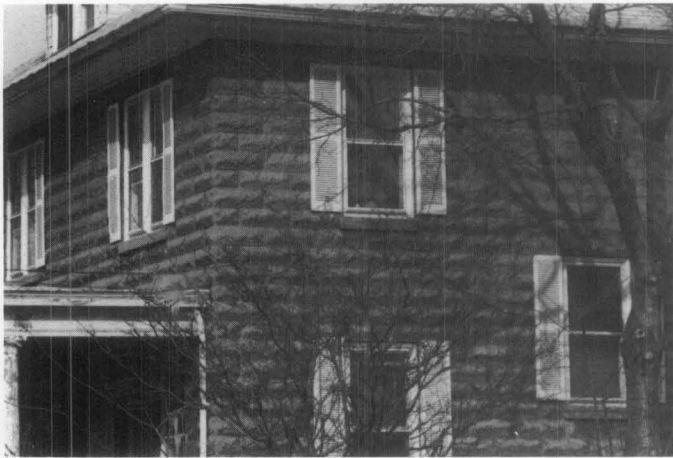
*Illus. 3. Casting concrete to represent quarried stone was a popular late 19th-century technique seen in this circa 1910 mail-order house. While most components were delivered by rail, the foundations and exterior masonry were completed by local craftsmen. Photo: Sharon C. Park, AIA.*

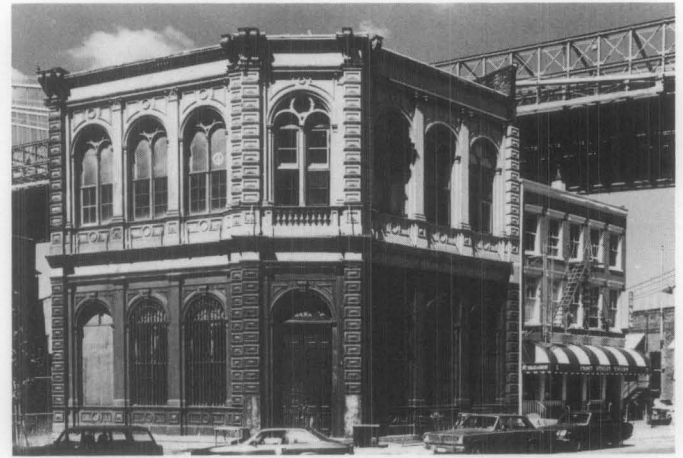
*Illus. 4. The 19th-century also produced a variety of metal products used in imitation of other materials. In this case, the entire exterior of the Long Island Safety Deposit Company is cast-iron representing stone. Photo: Becket Logan, Friends of Cast Iron Architecture.*

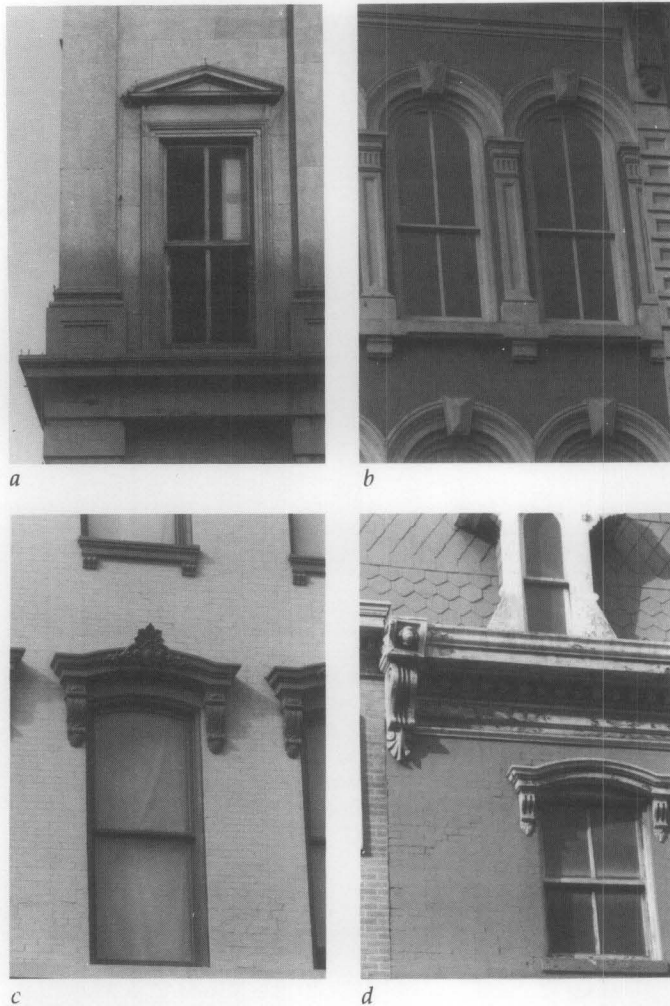
*Illus. 5. The four historic examples of various window hoods shown are: (a) stone; (b) cast stone; (c) cast-iron; and (d) sheet metal. The criteria for selecting substitute materials today (availability, quality, delivery dates, cost) are not much different from the past. Photo: Sharon C. Park, AIA.*

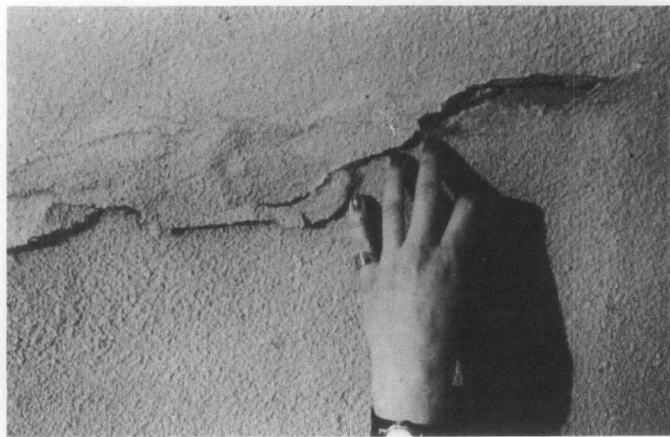
*Illus. 6. Substitute materials should never be considered as a cosmetic cover-up for they can cause great physical damage and can alter the appearance of historic buildings. For example, a fiberglass coating was used at Ranchos de Taos, NM, in place of the historic adobe coating which had deteriorated. The waterproof coating sealed moisture in the walls and caused the spalling shown. It was subsequently removed and the walls were properly repaired with adobe. Photo: Lee H. Nelson, FAIA.*

Because the overzealous use of substitute materials can greatly impair the historic character of a historic structure, all preservation options should be explored thoroughly before substitute materials are used. It is important to remember that the purpose of repairing damaged features and of replacing lost and irreparably damaged ones is both to match visually what was there and to cause no further deterioration. For these reasons it is not appropriate to cover up historic materials with synthetic materials that will alter the appearance, proportions and details of a historic building and that will conceal future deterioration (see illus. 6).

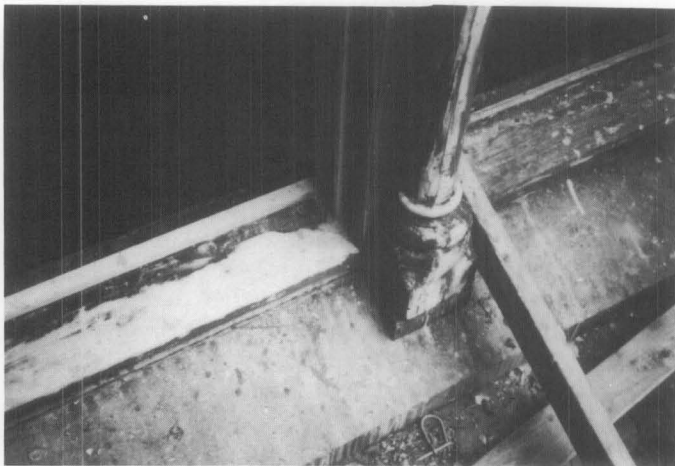
*Illus. 7. Whenever possible, historic materials should be repaired rather than replaced. Epoxy, a synthetic resin, has been used to repair the wood window frame and sill at the Auditors Building (1878) Washington, DC. The cured resin is white in this photo and will be primed and painted. Photo: Lee H. Nelson, FAIA.*

Some materials have been used successfully for the repair of damaged features such as epoxies for wood infilling, cementitious patching for sandstone repairs, or plastic stone for masonry repairs. Repairs are preferable to replacement whether or not the repairs are in kind or with a synthetic substitute material (see illus. 7).

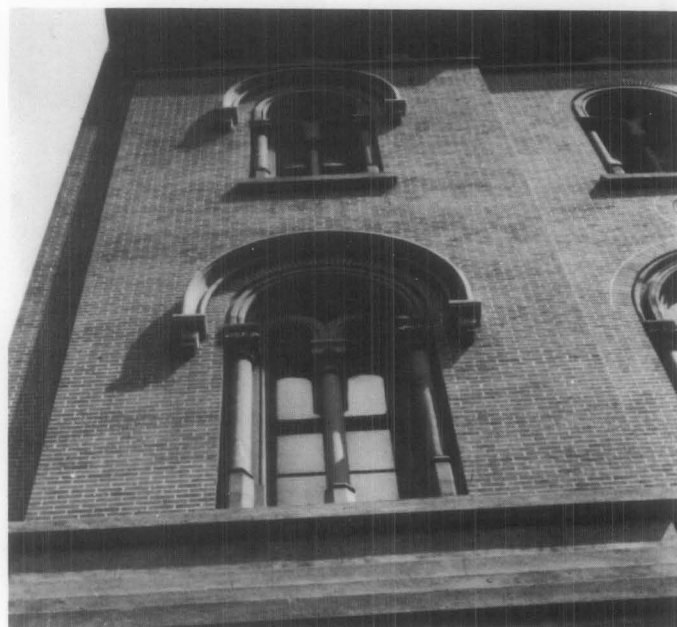
*Illus. 8. Even when materials are not locally available, it may be possible and cost effective to find sources elsewhere. For example, the local sandstone was no longer available for the restoration of the New York Shakespeare Festival Public Theater. The deteriorated sandstone window hoods, were replaced with stone from Germany that closely matched the color and texture of the historic sandstone. Photo: John G. Waite.*

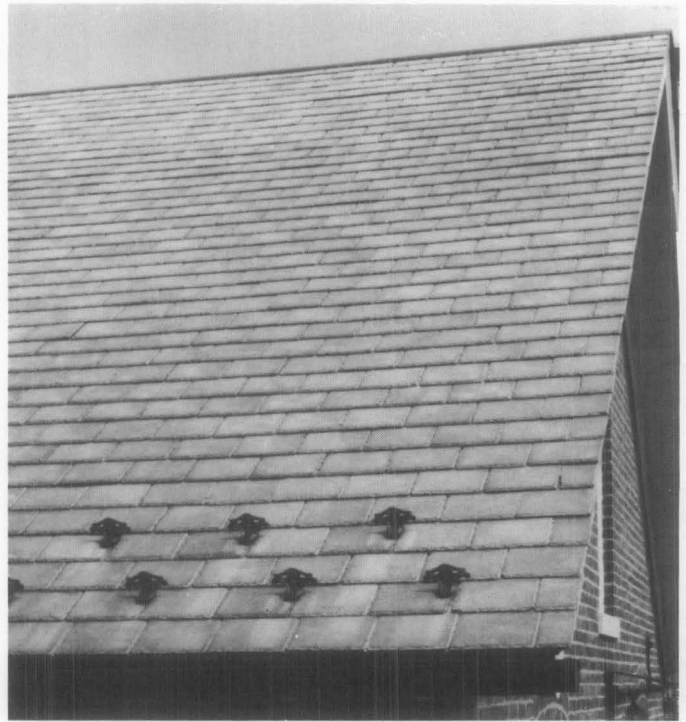
*Illus. 14. The visual qualities of the historic feature must be matched when using substitute materials. In this illustration, the lighter weight mineral fiber cement shingles used to replace the deteriorated historic slate roof were detailed to match the color, size, shape and pattern of the original roofing and the historic snow birds were reattached. Photo: Sharon C. Park, AIA.*

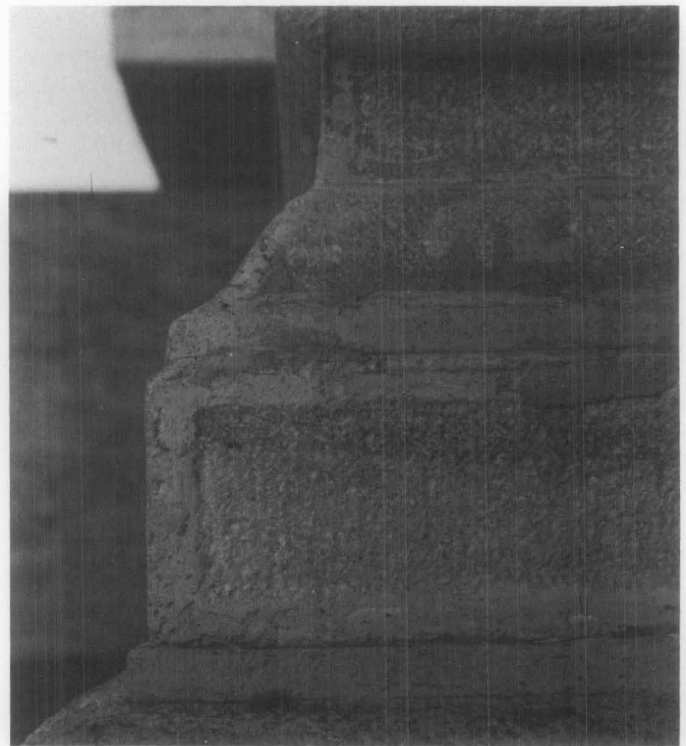
*Illus. 15. Poor quality workmanship can be avoided. In this example, the crudely cast concrete entrance pier (shown) did not match the visual qualities of the remaining historic sandstone (not shown). The aggregate is too large and exposed; the casting is not crisp; the banded tooling edges are not articulated; and the color is too pale. Photo: Sharon C. Park, AIA.*

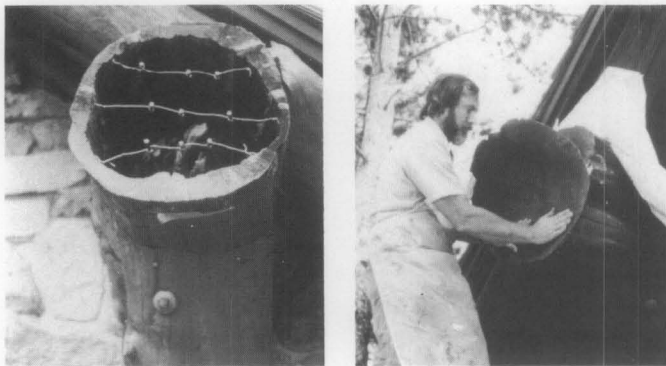
*Illus. 17. Care must be taken to ensure that the replacement materials will work within a predesigned system. At the Norris Museum, Yellowstone National Park, the 12-inch diameter log rafters, part of an intricate truss system, had rotted at the inner core from the exposed ends back to a depth of 48 inches. The exterior wooden shells remained intact. Fiberglass rods (left photo) and specially formulated structural epoxy were used to fill the cleaned out cores and a cast epoxy wafer end with all the detail of the original wood graining was laminated onto the log end (right photo). This treatment preserved the original feature with a combination of repair and replacement using substitute materials as part of a well thought out system. Photos: Courtesy of Harrison Goodall.*

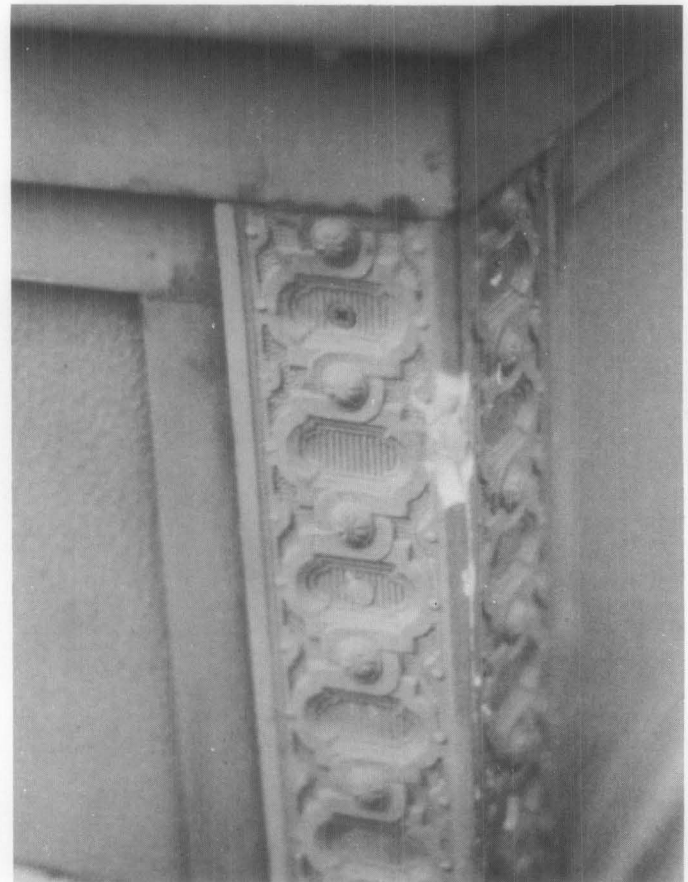
*Illus. 20. Long-term performance can be affected by where the substitute material is located. In this case, fiberglass was used as part of a storefront at street level. Due to the brittle nature of the material and the frequency of impact likely to occur at this location, an unsightly chip has resulted. Photo: Sharon C. Park, AIA.*

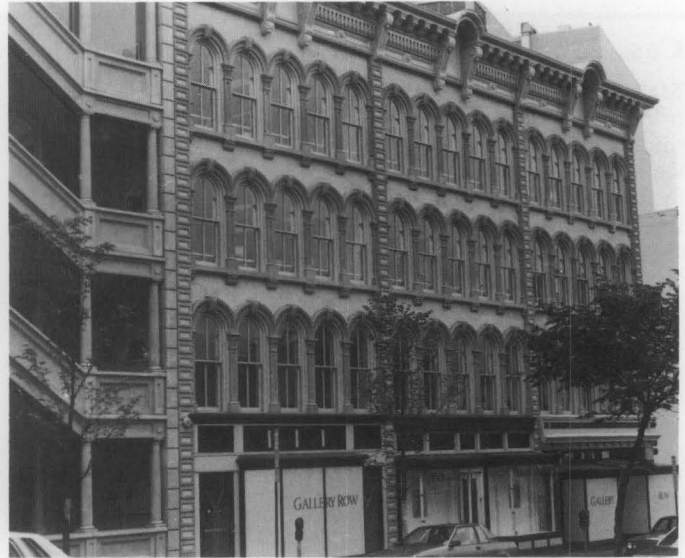
*Illus. 22. A fiber reinforced polymer (fiberglass) cornice and precast concrete elements replaced deteriorated features on the 19th-century exterior. Photo: Sharon C. Park, AIA.*

Once all reasonable options for repair or replacement in kind have been exhausted, the choice among a wide variety of substitute materials currently on the market must be made (see illus. 22). The charts at the end of this Brief describe a number of such materials, many of them in the family of modified concretes which are gaining greater use. The charts do not include wood, stamped metal, mineral fiber cement shingles and some other traditional imitative materials, since their properties and performance are better known. Nor do the charts include vinyls or molded urethanes which are sometimes used as cosmetic claddings or as substitutes for wooden millwork. Because millwork is still readily available, it should be replaced in kind.

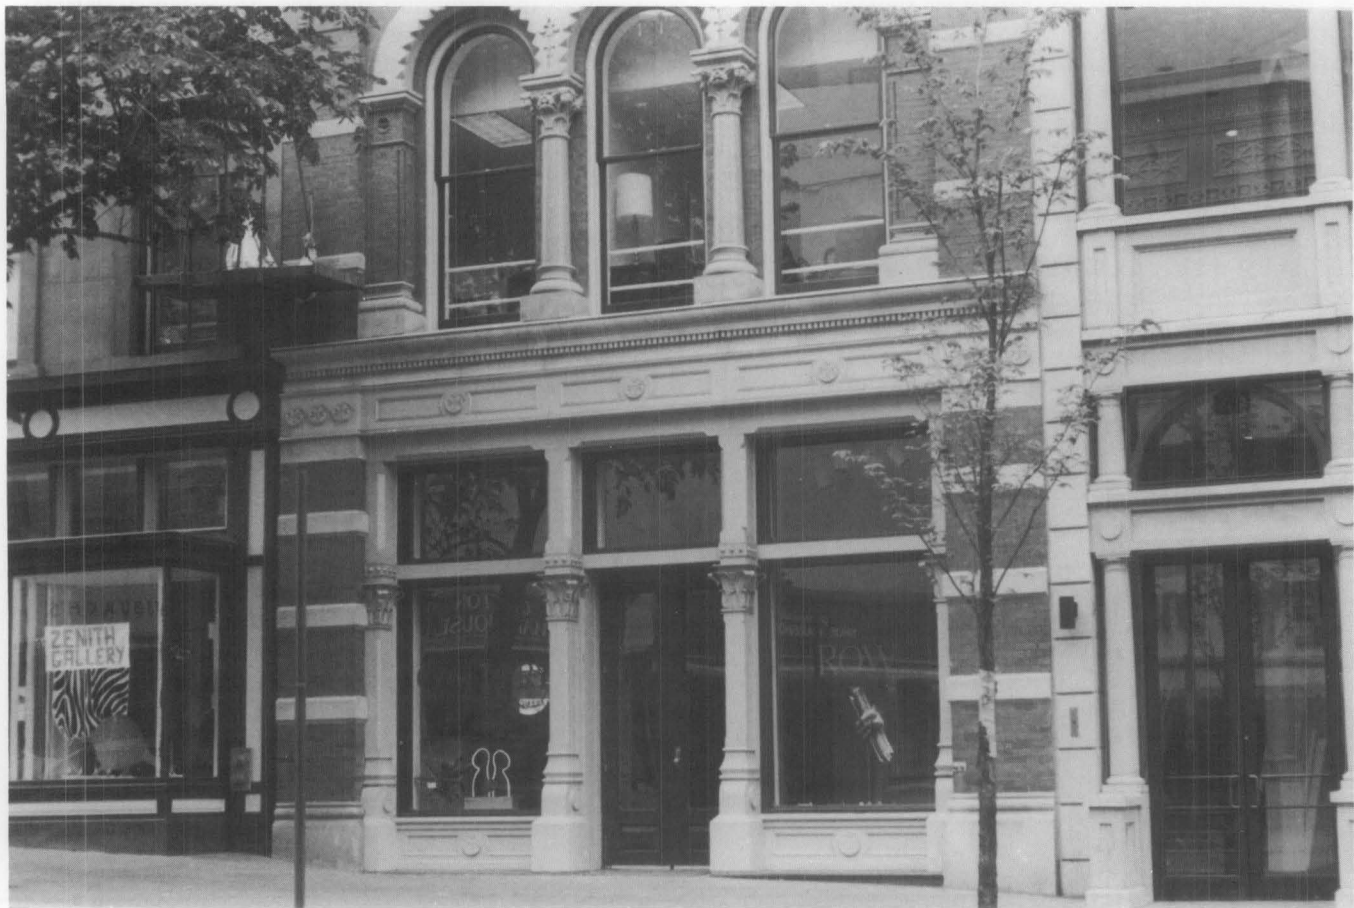
The new cast aluminum storefront replaced the lost 19th-century cast-iron original. Photo: Sharon C. Park, AIA.

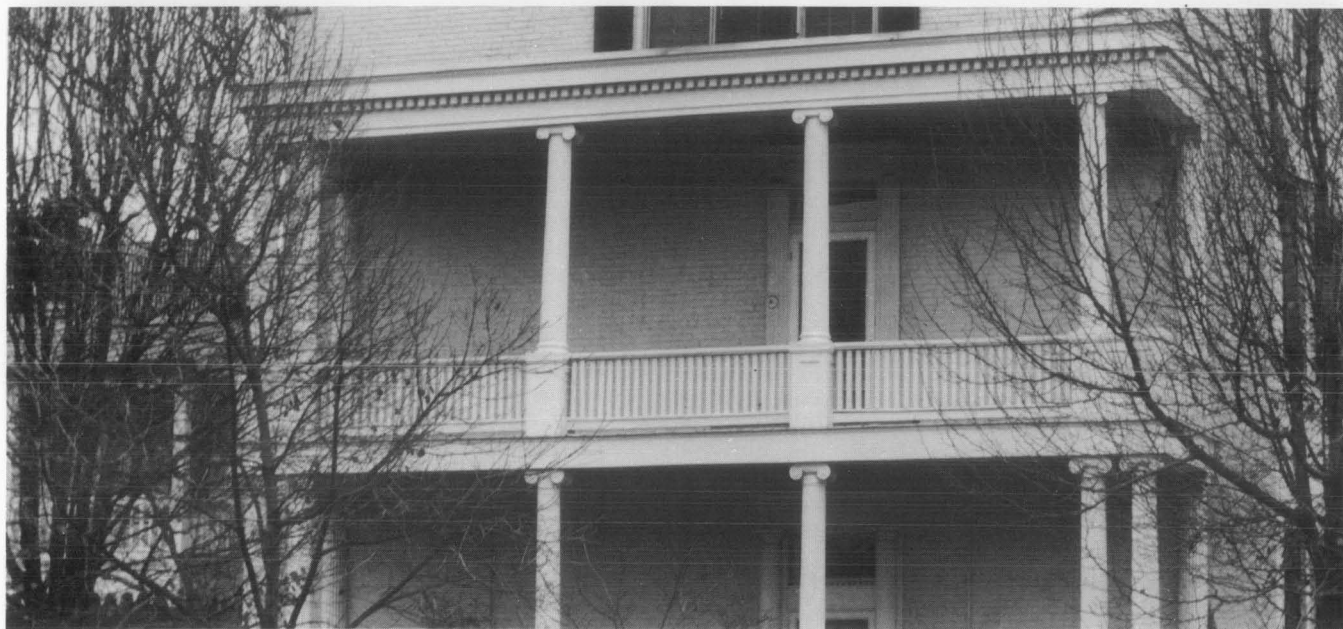
*Columns were repaired and a capital was replaced in epoxy on this 19th-century 2-story porch. Photo: Dell Corporation*

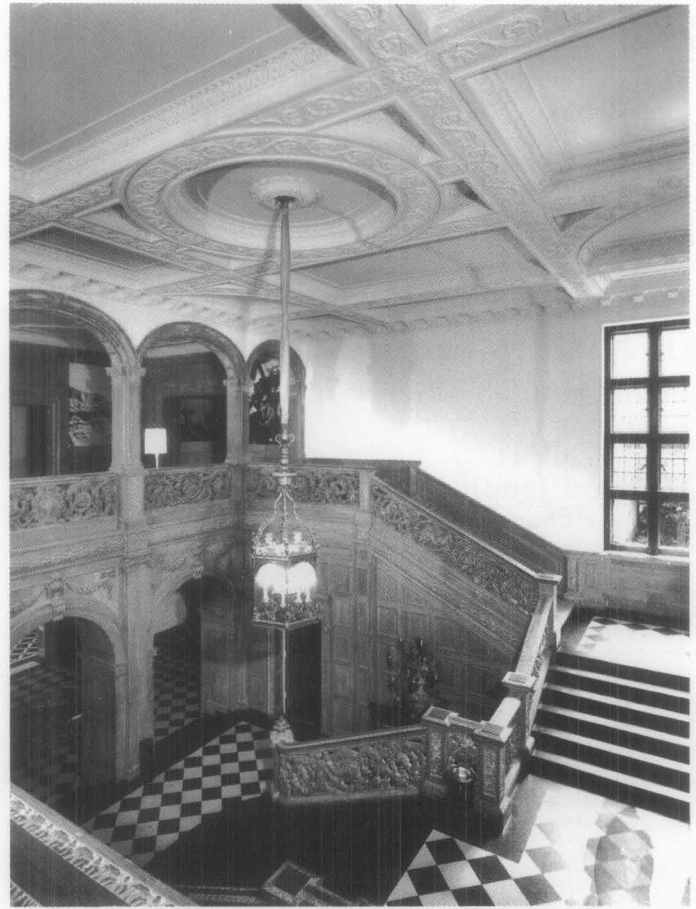
Figure 1. This architect-designed interior reflects early 20th century American taste: the checkerboard tile floor, wood wainscot, coffered ceiling, and open staircase are richly detailed and crafted by hand. Not only are the individual architectural features worthy of preservation, but the planned sequence of spaces—entry hall, stairs, stair landings, and loggia—imparts a grandeur that is characteristic of high style residences of this period. This interior is of Greystone, Los Angeles, California. Photography for HABS by Jack E. Boucher

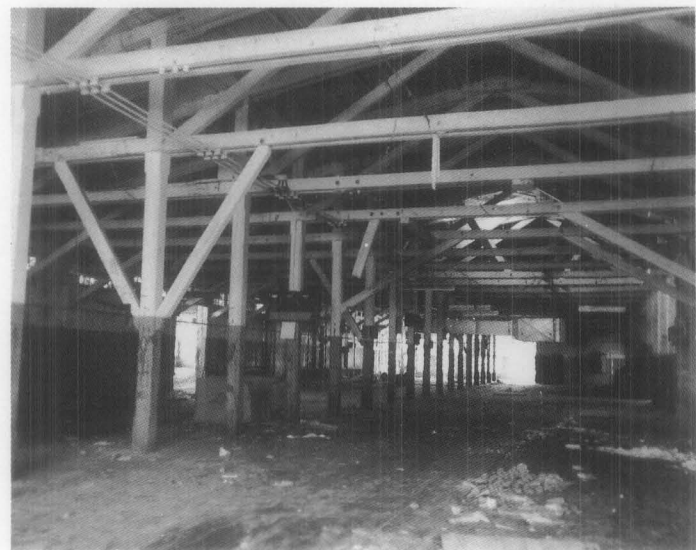
Figure 2. The interiors of mills and industrial buildings frequently are open, unadorned spaces with exposed structural elements. While the new uses to which this space could be put are many—retail, residential, or office—the generous floor-to-ceiling height and exposed truss system are important character-defining features and should be retained in the process of rehabilitation.

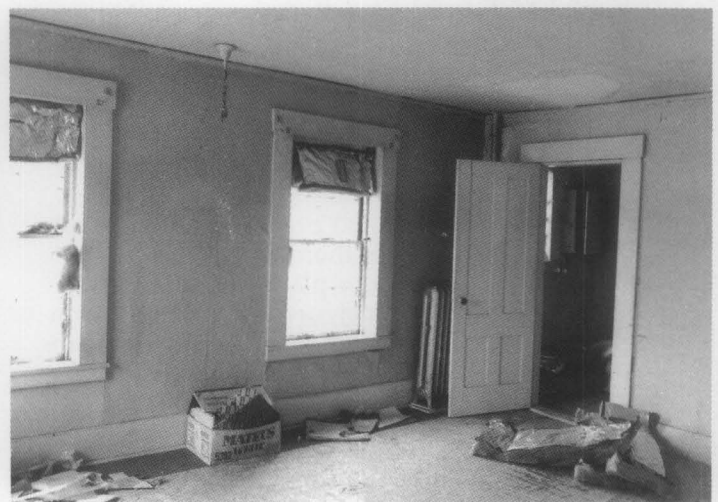
Figure 5. The interior of a simply detailed worker's house of the 19th century may be as important historically as the richly ornamented interior seen in figure 1. Although the interior of this house has not been properly maintained, the wide baseboards, flat window trim, and four-panel door are characteristic of workers' housing during this period and deserve retention during rehabilitation.

Features and finishes, even if machine-made and not exhibiting particularly fine craftsmanship, may be character-defining; these would include pressed metal ceilings and millwork around windows and doors. The interior of a plain, simple detailed worker's house of the 19th century may be as important historically as a richly ornamented, high-style townhouse of the same period. Both resources, if equally intact, convey important information about the early inhabitants and deserve the same careful attention to detail in the preservation process.

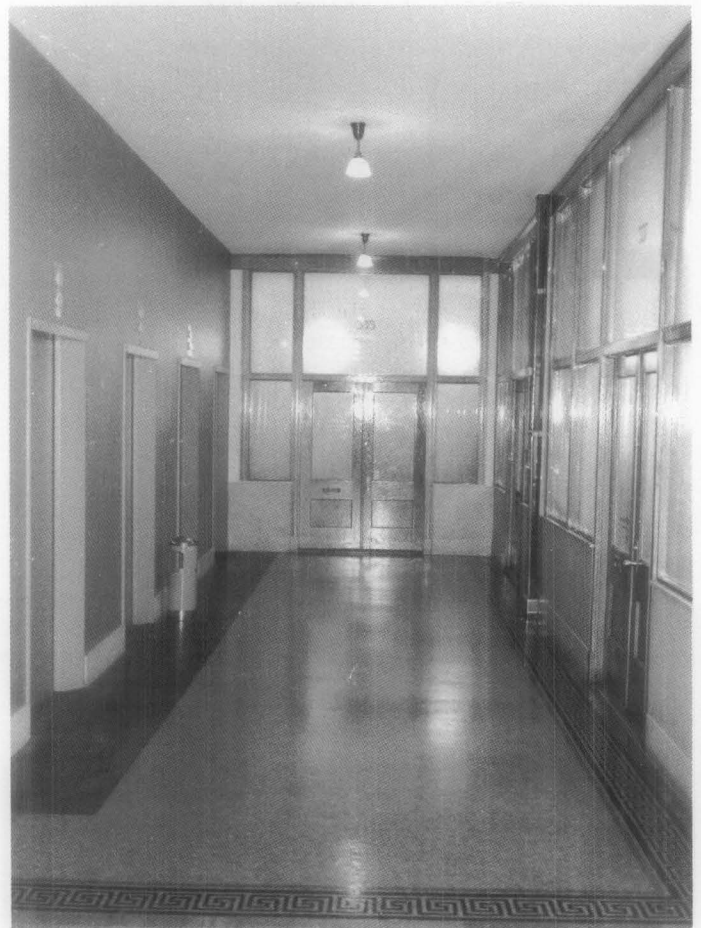
Figure 6. This corridor, located in the historic Monadnock Building in Chicago, has glazed walls, oak trim, and marble wainscoting, and is typical of those found in late 19th and early 20th century office buildings. Despite the simplicity of the features, a careful attention to detail can be noted in the patterned tile floor, bronze mail chute, and door hardware. The retention of corridors like this one should be a priority in rehabilitation projects involving commercial buildings.

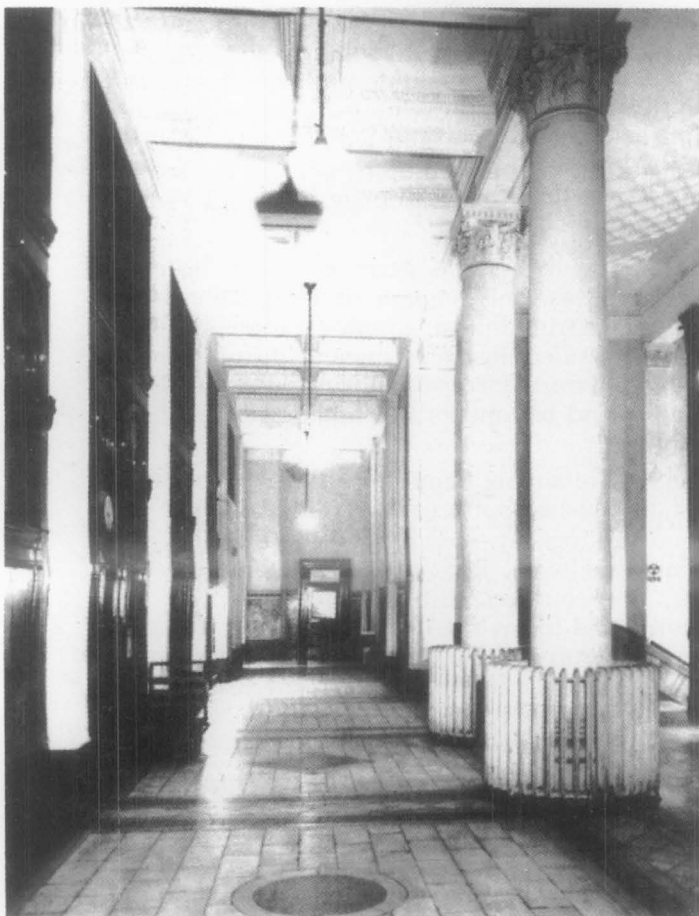
Figure 9. The tangible reminders of early mechanical systems can be worth saving. In this example, in the Old Post Office in Washington, D.C., radiators encircle Corinthian columns in a decorative manner. Note, too, the period light fixtures. These features were retained when the building was rehabilitated as retail and office space. Photo: Historic American Buildings Survey

7. Retain and preserve visible features of early mechanical systems that are important in defining the overall historic character of the building, such as radiators, vents, fans, grilles, plumbing fixtures, switchplates, and lights. If new heating, air conditioning, lighting and plumbing systems are installed, they should be done in a way that does not destroy character-defining spaces, features and finishes. Ducts, pipes, and wiring should be installed as inconspicuously as possible: in secondary spaces, in the attic or basement if possible, or in closets.

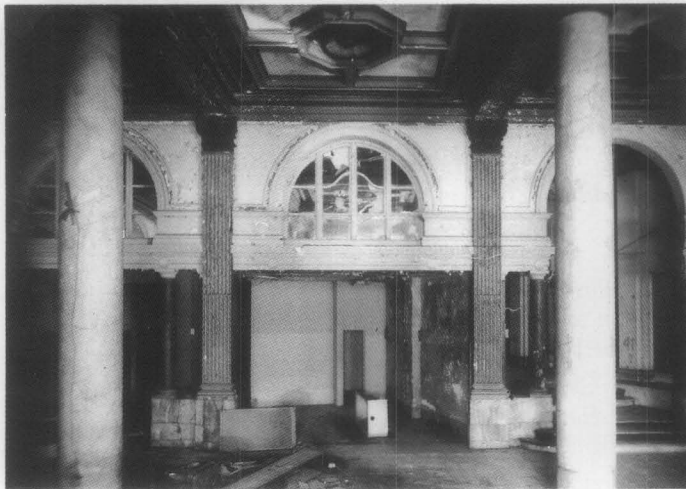
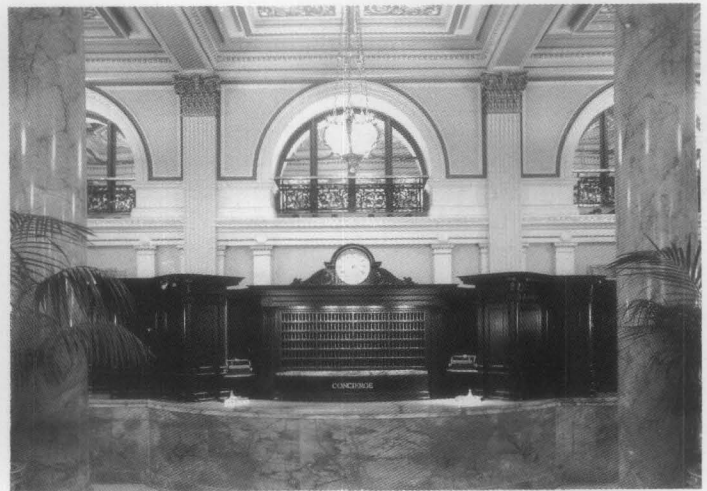
Figure 11. These dramatic "before" and "after" photographs show a severely deteriorated space restored to its original elegance: plaster has been repaired and painted, the scagliola columns have been restored to match marble using traditional craft techniques, and missing decorative metalwork has been re-installed in front of the windows. Although some reorganization of the space took place, notably the relocation of the front desk, the overall historic character of the space has been preserved. These views are of the lobby in the Willard Hotel, Washington, D.C. Credit: Commercial Photographers (left); Carol M. Highsmith (right)

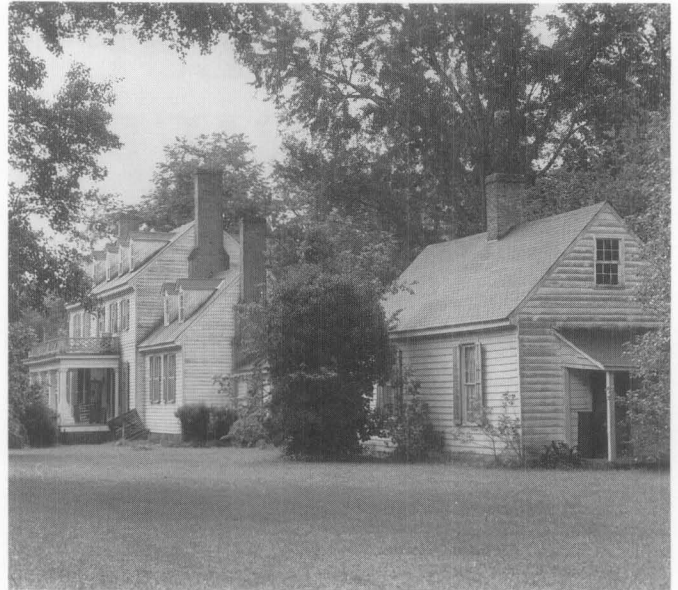
1. Eighteenth century and later vernacular architecture depended on the siting of the building, deciduous trees, cross ventilation, and the placement of windows and chimneys to maximize winter heating and natural summer cooling. Regional details, as seen in this Virginia house, include external chimneys and a separate summer kitchen to reduce fire risk and isolate heat in the summer. Photo: NPS Files.

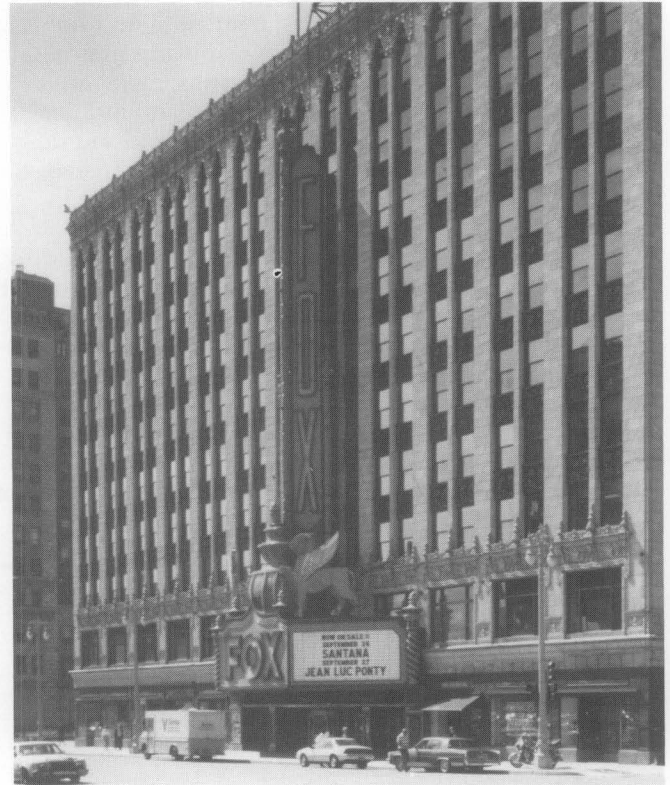
3. The circa 1928 Fox Theater in Detroit, designed by C. Howard Crane, was one of the earliest twentieth century buildings to provide air conditioning to its patrons. The early water-cooled system was recently restored. Commercial and highrise buildings of the twentieth century were able, mostly through electrical power, to provide sophisticated systems that integrated many building services. Photo: William Kessler and Associates, Architects.

**Twentieth Century.** The twentieth century saw intensive development of new technologies and the notion of fully *integrating mechanical systems* (see figure 3). Oil and gas furnaces developed in the nineteenth century were improved and made more efficient, with electricity becoming the critical source of power for building systems in the latter half of the century. Forced air heating systems with ducts and registers became popular for all types of buildings and allowed architects to experiment with architectural forms free from mechanical encumbrances. In the 1920s large-scale theaters and auditoriums introduced central air conditioning, and by mid-century forced air systems which combined heating and air conditioning in the same ductwork set a new standard for comfort and convenience. The combination and coordination of a variety of systems came together in the post-World War II highrise buildings; complex heating and air conditioning plants, electric elevators, mechanical towers, ventilation fans, and full service electric lighting were integrated into the building's design.

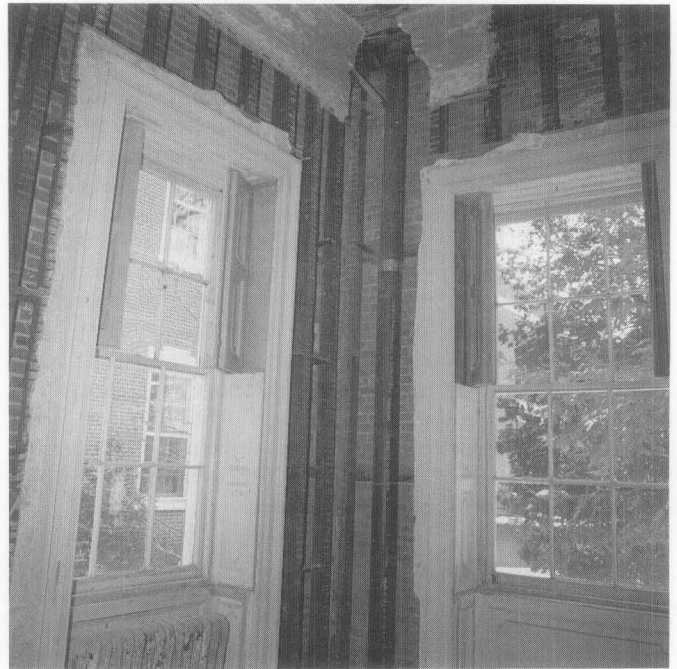
5. The installation of vapor retarders in walls of historic buildings in an effort to contain interior moisture can cause serious damage to historic finishes as shown here. In this example, all the wall plaster and lath have been stripped in preparation for a vapor barrier prior to replastering. Controlling interior temperature and relative humidity can be more effective than adding insulation and vapor barriers to historic perimeter walls. Photo: Ernest A. Conrad, P.E.

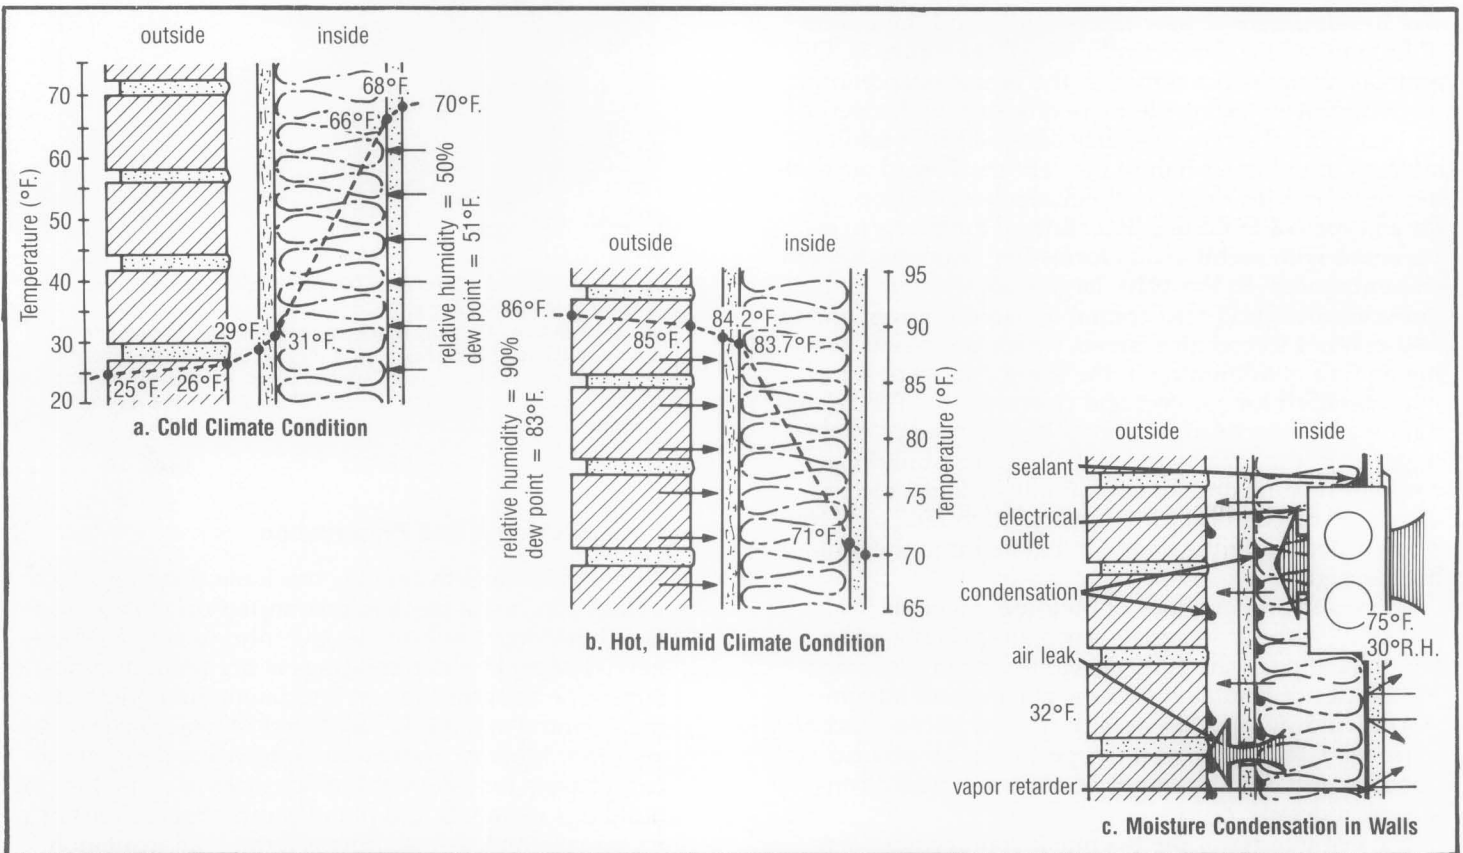
4. Mechanical heating and cooling systems change the interior climate of a building. Moisture in the air will dissipate from the warmer area of a building to the colder area and can cause serious deterioration of historic materials. Condensation can form if the dew point occurs within the building wall, particularly one that has been insulated (see a and b). Even when vapor retarders are installed (c), any non-continuous areas will provide spaces for moisture to pass. Wall Section Drawings: NPS files

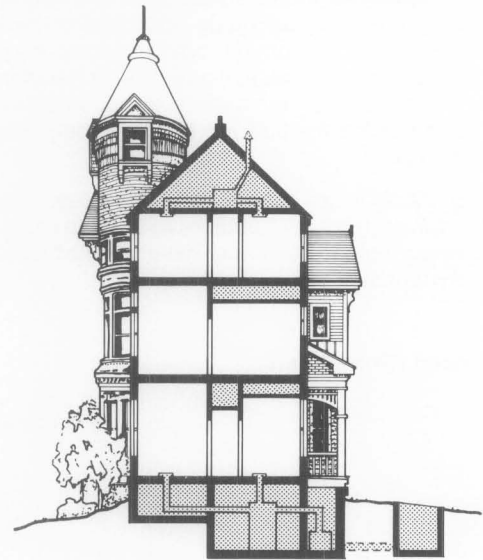
8. In considering options for new systems, existing spaces should be evaluated for their ability to house new equipment. This sketch shows several areas where new mechanical equipment could be located to avoid damaging significant spaces. Sketch: NPS files

4. **Prioritize architecturally significant spaces, finishes, and features to be preserved.** Significant architectural spaces, finishes and features should be identified and evaluated at the outset to ensure their preservation. This includes significant existing mechanical systems or elements such as hot water radiators, decorative grilles, elaborate switchplates, and non-mechanical architectural features such as cupolas, transoms, or porches. Identify non-significant spaces where mechanical equipment can be placed and secondary spaces where equipment and distribution runs on both a horizontal and vertical basis can be located. Appropriate secondary spaces for housing equipment might include attics, basements, penthouses, mezzanines, false ceiling or floor cavities, vertical chases, stair towers, closets, or exterior below-grade vaults (see figure 8).

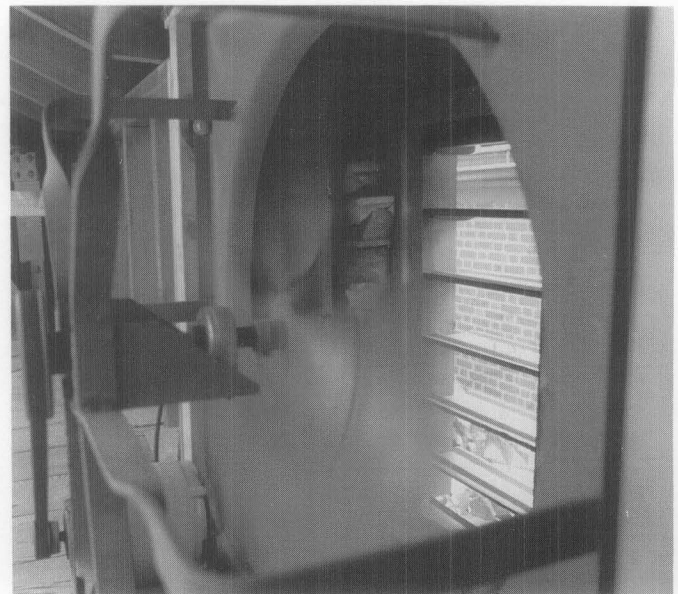
9. Improving ventilation through traditional means should not be overlooked in planning new or upgraded HVAC systems. In mild climates, good exhaust fans can often eliminate the need for air conditioning or can reduce equipment size by reducing cooling loads. Photo: Ernest A. Conrad, P.E.

costs of these components and systems? Are parts of an existing system being reused and upgraded? The benefits of added ventilation should not be overlooked (see figure 9). What are the trade-offs between one large central system and multiple smaller systems? Should there be a forced air ducted system, a 2-pipe fan coil system, or a combined water and air system? What space is available for the equipment and distribution system? Assess the fire-risk levels of various fuels. Understand the advantages and disadvantages of the various types of mechanical systems available. *Then evaluate each of these systems in light of the preservation objectives established during the design phase of planning.*
