# 1 PRESERVATION BRIEFS

## Assessing Cleaning and Water-Repellent Treatments for Historic Masonry Buildings

Robert C. Mack, AIA  
Anne Grimmer

U.S. Department of the Interior  
National Park Service  
Cultural Resources  
Heritage Preservation Services

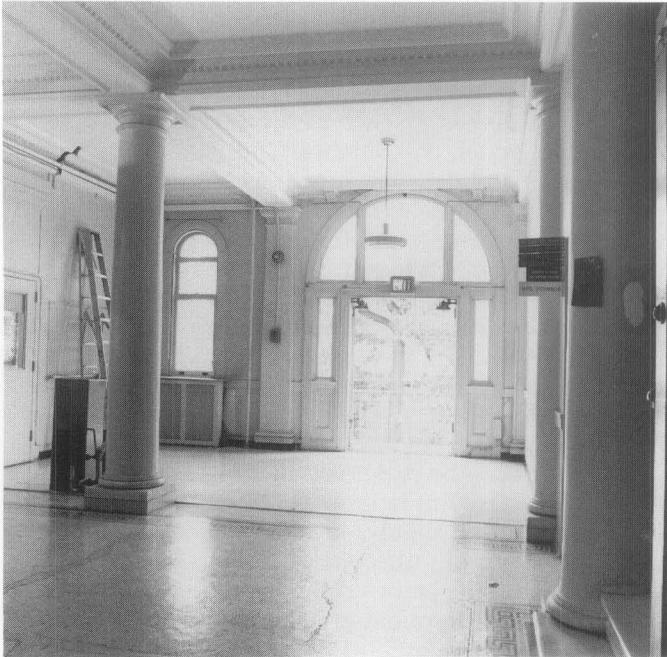
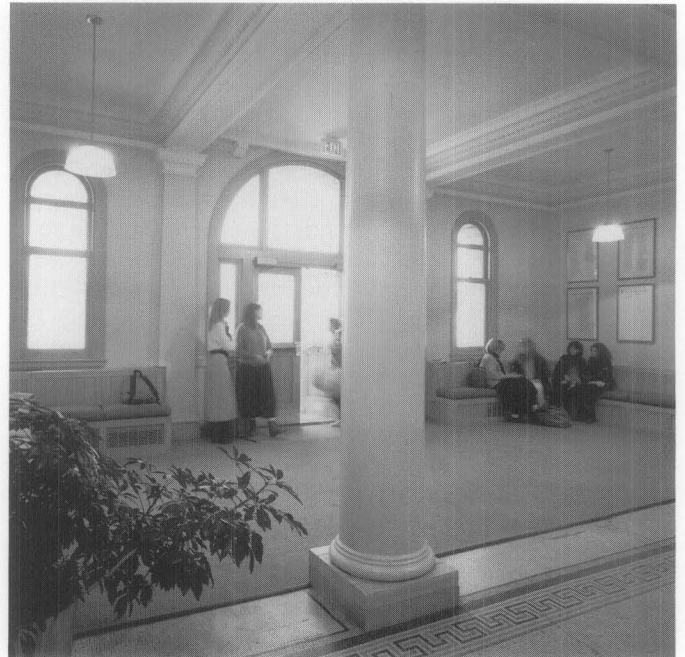
a. Before and after of a circa 1900 school entrance. The radiators have been replaced with a two-pipe fan coil system built into bench seats. The ceiling was preserved and no exposed elements were required to add air conditioning. Piping runs are under the benches and there was no damage to the masonry walls. Photos: Notter Finegold + Alexander Inc. and Lautman Photography, Washington.

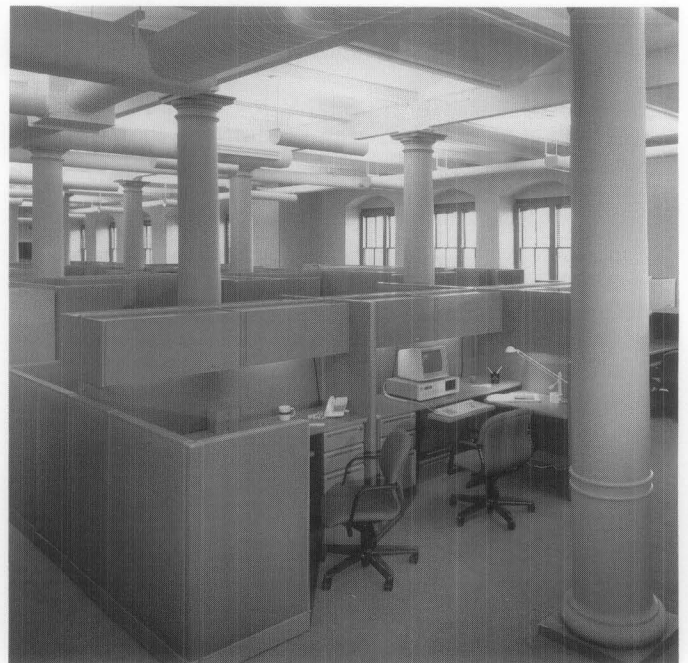
after

d. Auditors Buildings, Washington, D.C. This upper floor workspace had been modified over the years with dropped ceilings and partitions. In the recent restoration, the open plan workspace was restored, the false ceiling was removed, and the fireproof construction was exposed. A variable air volume (VAV) system using round double shell exposed ductwork is in keeping with the industrial character of the architectural space. Photo: Kenneth Wyner Photography, courtesy of Notter Finegold + Alexander Inc. Before view provided by Notter Finegold + Alexander/Mariani.

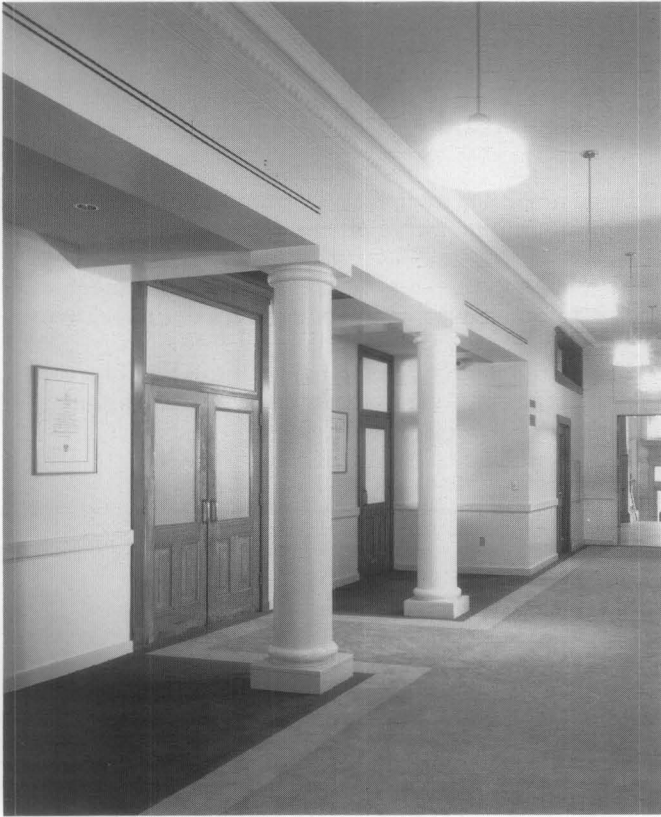
b. Central air conditioning was installed in the corridors of this circa 1900 school building by adding an air handler over the entrance from a vestibule. The custom-designed slot registers provide linear diffusers without detracting from the architecture of the space. Photo: Lautman Photography courtesy of Notter Finegold + Alexander Inc.

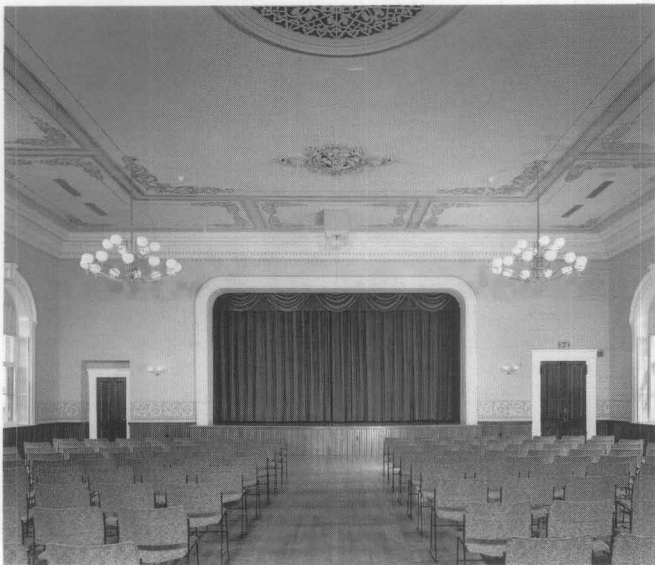
e. Town Hall, Andover, MA. The upstairs auditorium was restored and new mechanical systems were installed. Perimeter baseboard radiation provides heat and air handlers, located in the attic space provide air conditioning. The cast iron ceiling grille was adapted for return air and the supply registers were installed in a symmetrical and regular manner to minimize impact on the historic ceiling. Photo: David Hewitt/Anne Garrison for Ann Beha Associates.

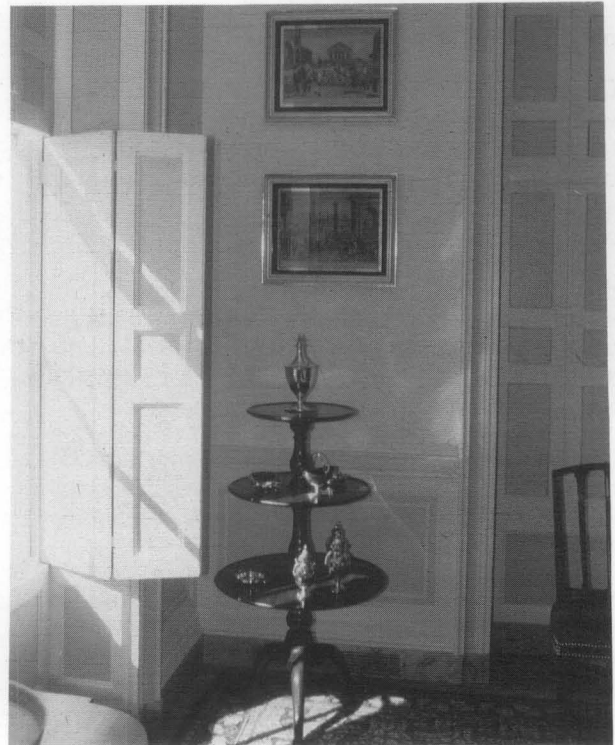
f. Homewood, Baltimore, MD. This elegant circa 1806 residence is now a house museum. The registers for the forced air ducted system seen behind the table legs, are grained to blend with the historic baseboards. The HVAC system uses a water/air system where chilled water and steam heat are converted to conditioned air. Photo: Courtesy Homewood Museum, Johns Hopkins University.

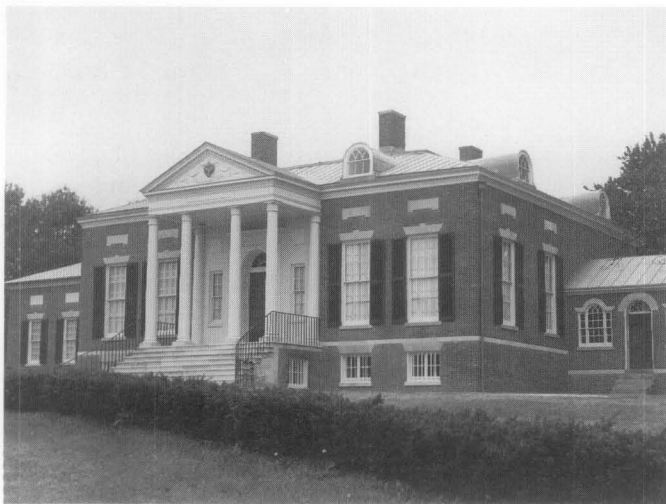
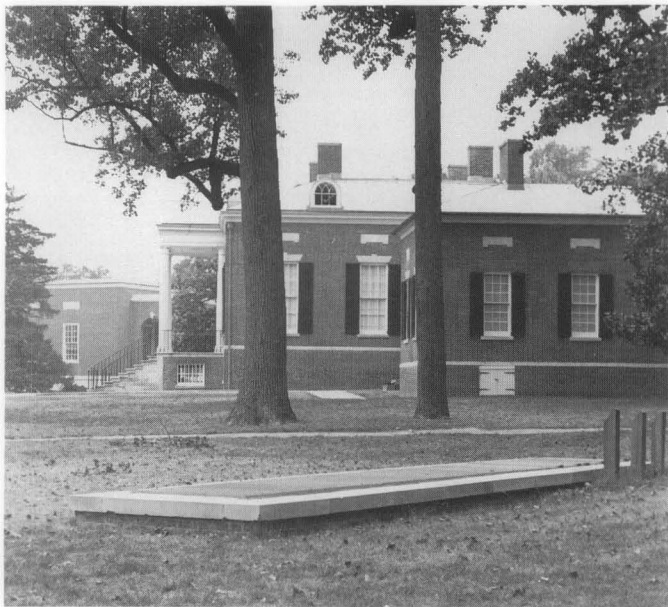
11. During the restoration of this 1806 National Historic Landmark (photo a), a new climate control system was installed. The architects removed all the earlier mechanical equipment from the house and installed new equipment in a 30' × 40' concrete vault located underground 150 feet from the house itself (photo b). Only conditioned air is blown into the house reusing much of the circa 1930s ductwork. Photos: Thomas C. Jester.

**4. Balance quantitative requirements and preservation objectives.** The ideal system may not be achievable for each historic resource due to cost, space limitations, code requirements, or other factors beyond the owner's control. However, significant historic spaces, finishes, and features can be preserved in almost every case, even given these limitations. For example, if some ceiling areas must be slightly lowered to accommodate ductwork or piping, these should be in secondary areas away from decorative ceilings or tall windows. If modern fan coil terminal units are to be visible in historic spaces, consideration should be given to custom designing the cabinets or to using smaller units in more locations to diminish their impact. If grilles and registers are to be located in significant spaces, they should be designed to work within the geometry or placement of decorative elements. All new elements, such as ducts, registers, pipe-runs, and mechanical equipment should be installed in a reversible manner to be removed in the future without further damage to the building (see fig 11).

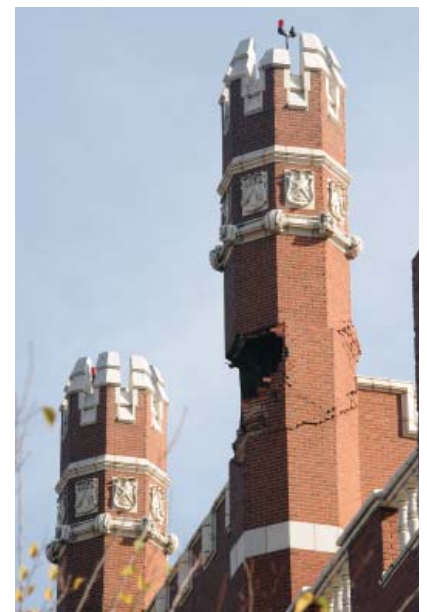
Figure 1. In 2011, a 5.6 magnitude earthquake substantially damaged all four turrets atop St. Gregory's University Benedictine Hall in Shawnee, Oklahoma. Photo: St. Gregory University.

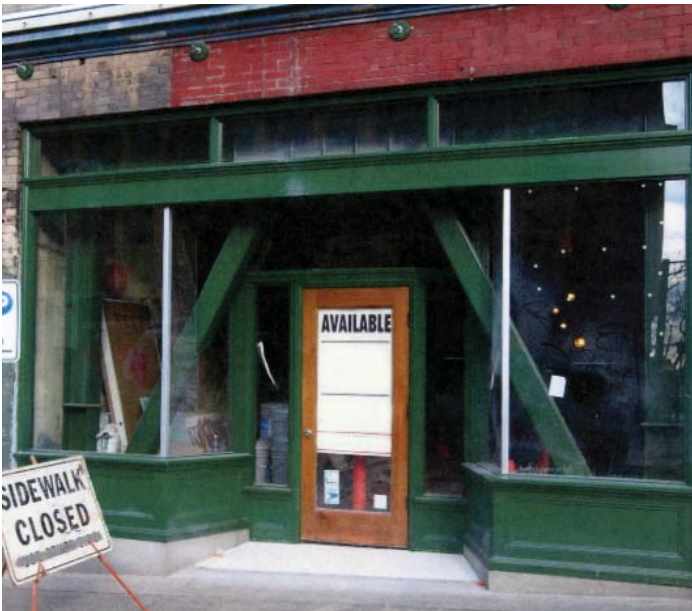
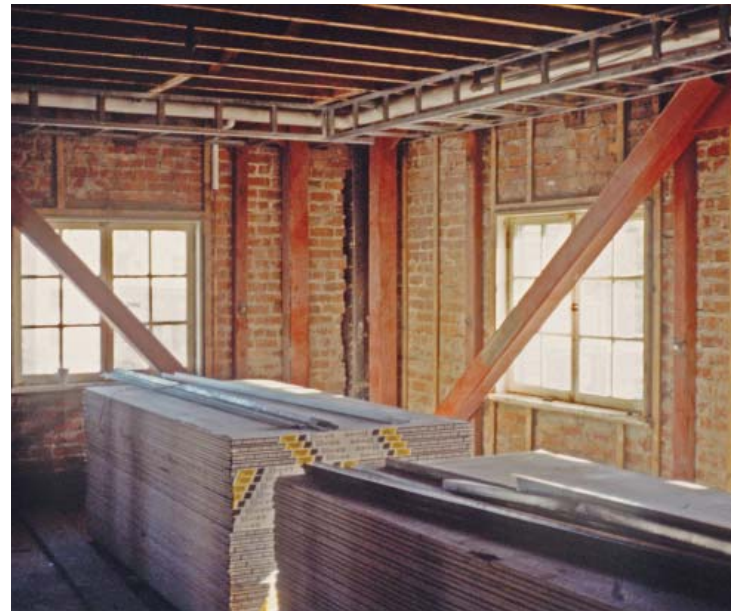
Figures 2-3. Standard approaches to seismic rehabilitation, such as adding diagonal bracing to reinforce window and storefront openings as seen in these photos, can be visually intrusive. Figure 2 (left). Figure 3 (right). Photo: Steade Craig.

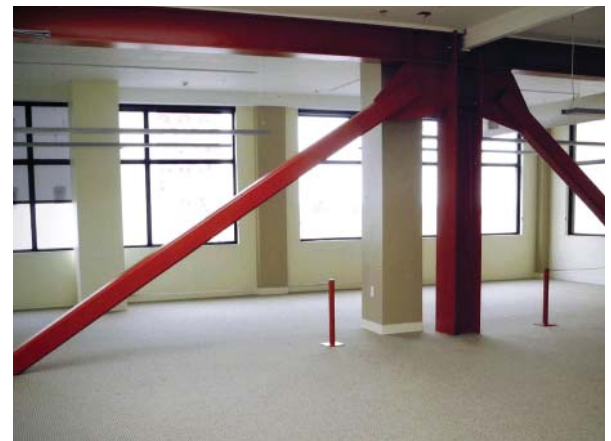
Figures 4-5. Using moment frames (horizontal and vertical steel members identified by the arrows) set back behind storefront openings as seen in Figure 4 (left), or placing brace frames (in red) away from the windows as illustrated in Figure 5 (right) are solutions that meet historic preservation goals. Figure 4. Photo: Elizabeth Hilton.

Many prescriptive code complying standards can result in the destruction of much of a historic building's appearance and integrity. This is because the most expedient way to reinforce a building is to introduce a completely new complying structural system, to add new structural members, and to fill in irregularities or large openings without regard to how the new structural elements or modifications affect its architectural design. The results of these approaches can be quite intrusive (Figures 2-3). However, structural reinforcement can be introduced sensitively while still meeting code requirements. In such cases, its design, placement, patterning, and detailing will respect the historic character of the building, even when the reinforcement itself is visible (Figures 4-5).

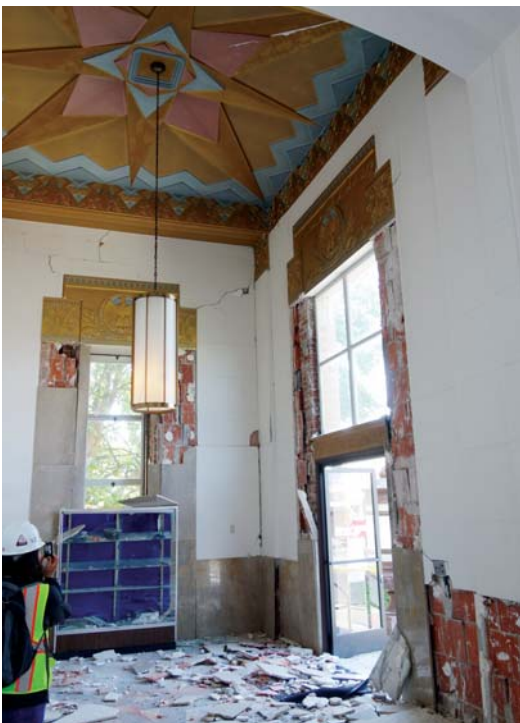
Figure 6. Failing nonstructural elements such as the stone-veneer window and door surrounds shown in this image can become a life-safety hazard when they block or impede an exit path. Photo: Wiss, Janney, Elstner and Associates, Inc.

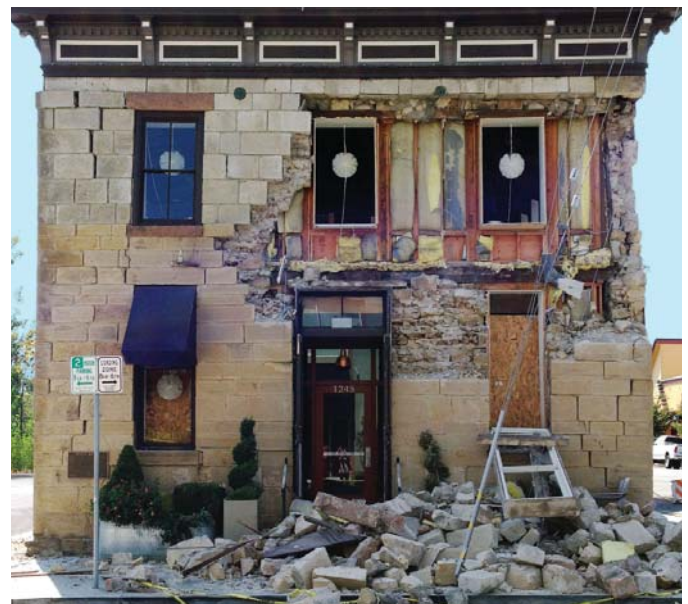
Figure 8. Unreinforced masonry buildings, such as this 1875 stone building damaged during the 2014 South Napa, California earthquake, can be particularly vulnerable to earthquake damage. Photo: Architectural Resources Group.

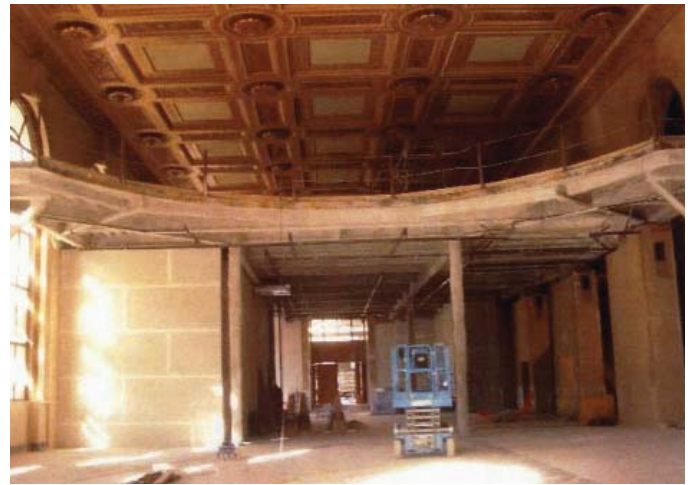
Figure 12. A mezzanine was added to the original banking hall of this 1921 former bank building as a seismic strengthening measure. Subdividing such an important character-defining space can result in a severe loss to a building's historic integrity.

The placement of additional structural reinforcement should be carefully considered to avoid or appreciably minimize any impact on the building's significant or primary exterior and interior spaces (Figure 12). New structural elements should be located within interstitial or utilitarian spaces whenever possible. Alterations within secondary spaces are preferable to alterations of primary spaces, but care should be taken to preserve historic materials and character to the greatest extent feasible in these areas as well. When new structural elements must be added within significant interior spaces, the placement and location should avoid major alterations to the overall volume, distinctive architectural features, or finishes within the space, as well as to its character (Figures 13-15). (See *Preservation Brief 17: Architectural Character—Identifying the Visual Aspects of Historic Buildings as an Aid to Preserving their Character*, and *Preservation Brief 18: Rehabilitating Interiors in Historic Buildings: Identifying and Preserving Character-Defining Elements*.)

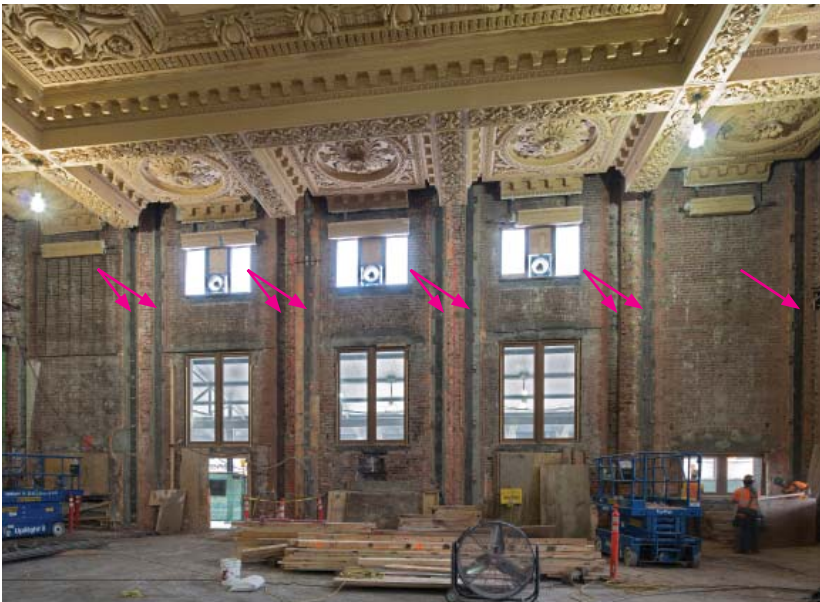
Figures 13-14. Vertical steel reinforcement members were inserted and grouted into the walls of the main waiting room in Seattle's historic 1906 King Street Railroad Station to strengthen them (top left). To replace the original plaster ornamentation, molds were made to cast new replacement plaster elements as shown on this work-in-progress photo (top right). Photos: John Stamets.

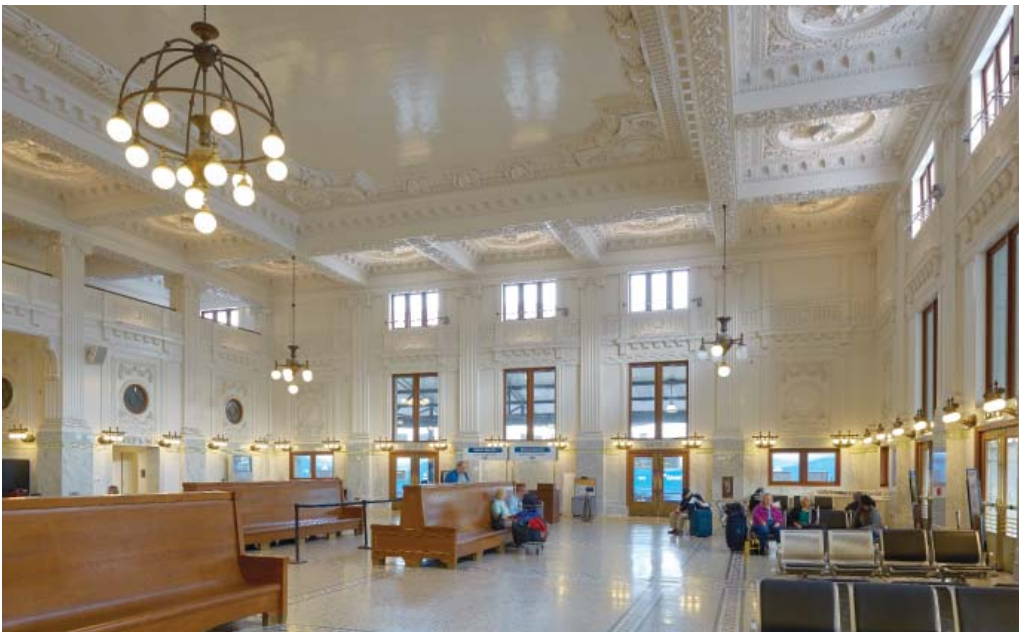
Figure 15. After completion of the seismic reinforcement, the replicated plaster ornamentation was installed and the decorative painted finishes restored, returning the waiting room of King Street Station to its historic appearance. Photo: Doug Scott.

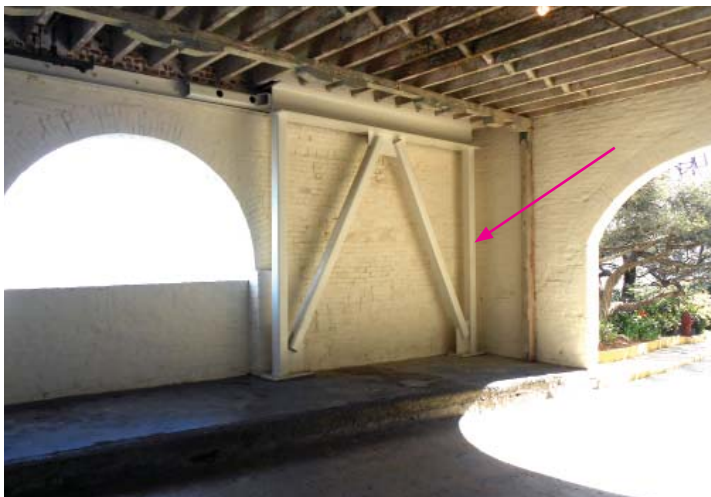
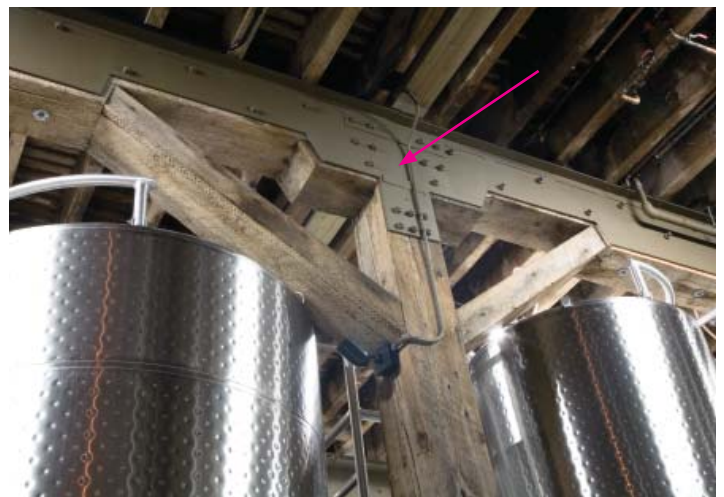
Figures 17 and 18. Careful placement of the new structural reinforcement, painted to match the surrounding building elements, if left exposed, minimizes its visual impact. New added structural elements may be left exposed when their visibility does not impair the historic character of the building. Figure 17 (left). Photo: Jason Hagin. Figure 18 (right). Photo: Architectural Resources Group.

From a design perspective, the vast majority of historic buildings can tolerate a well-planned and placed system of seismic reinforcement. Utilitarian structures, such as warehouses, may be able to receive fairly visible reinforcement systems without undue damage to their historic character (Figures 17-18). Other, more architecturally detailed buildings or those with more finished or decorative interior surfaces will benefit from more hidden systems. However, installation of such systems may require the temporary removal and reinstallation of significant features as part of the seismic rehabilitation work. Most buildings can incorporate

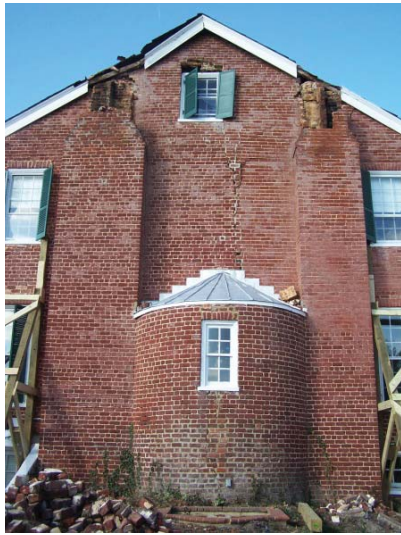
Figure 19. Chimneys are common nonstructural features susceptible to earthquake damage, even in zones of low-to medium-seismic activity as shown on this building in Virginia damaged in a 2011 earthquake. Photo: Suzanne Tripp.

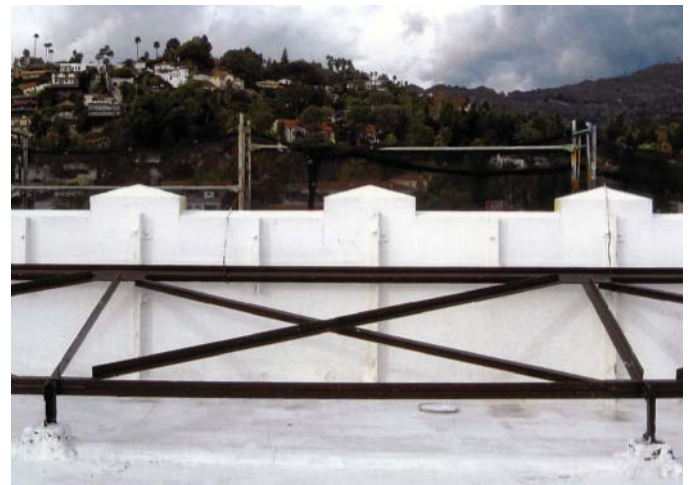
Figure 20. Bracing parapet walls, as illustrated in the typical detail drawing on the left, and as installed in the image on the right, helps avoid hazards from falling debris.

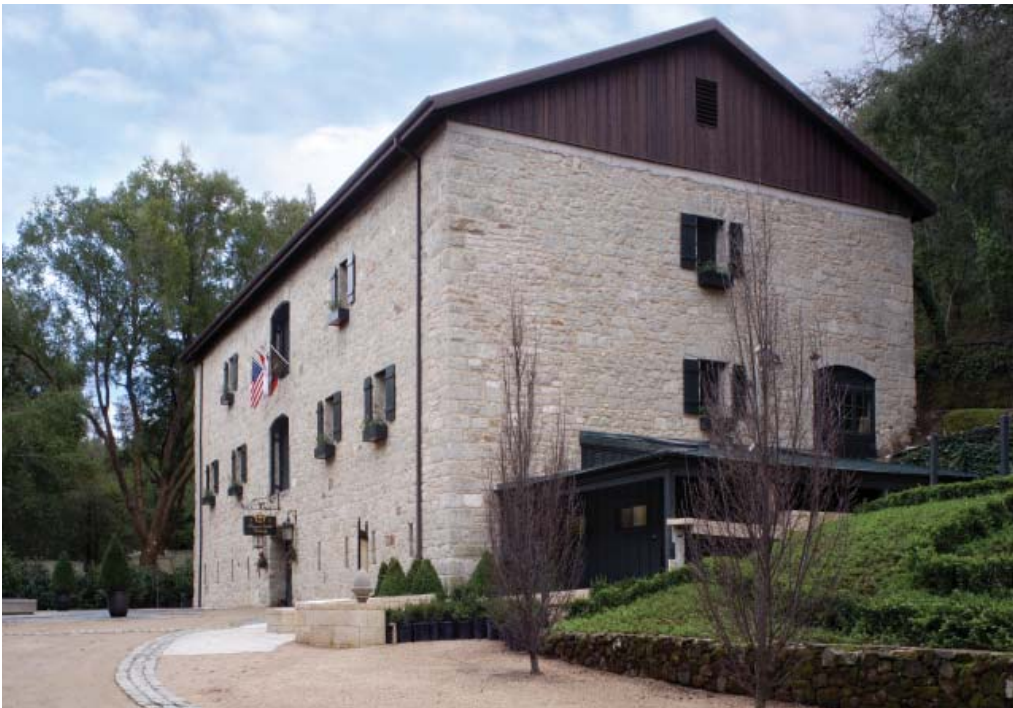
Figure 21 Historic wine cellar building in Napa, California.

Figure 22. Drawing of the wine cellar's front wall showing the locations of the center cores for continuous steel reinforcement rods to be inserted and grouted in place.

The seismic rehabilitation of this historic wine cellar building shown in Figure 21 included center coring of the exterior stone walls to add steel reinforcement, as illustrated in Figures 22 and 23. The floors were tied to the steel reinforcement in the walls using eye bolts, as seen in Figures 24 and 25, eliminating the need for exterior washers or plates. Figure 21. Photo: Architectural Resources Group. Figures 22-25. Photos: MKM & Associates.

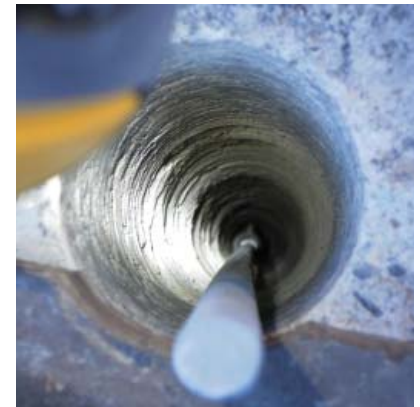
Figure 23. View of one of the center cores drilled down through the wall.

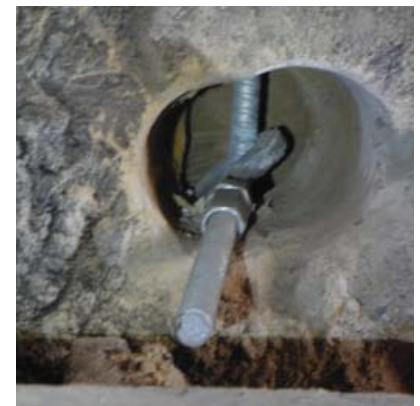
Figure 24. Eye bolts used to anchor the floor to the wall.

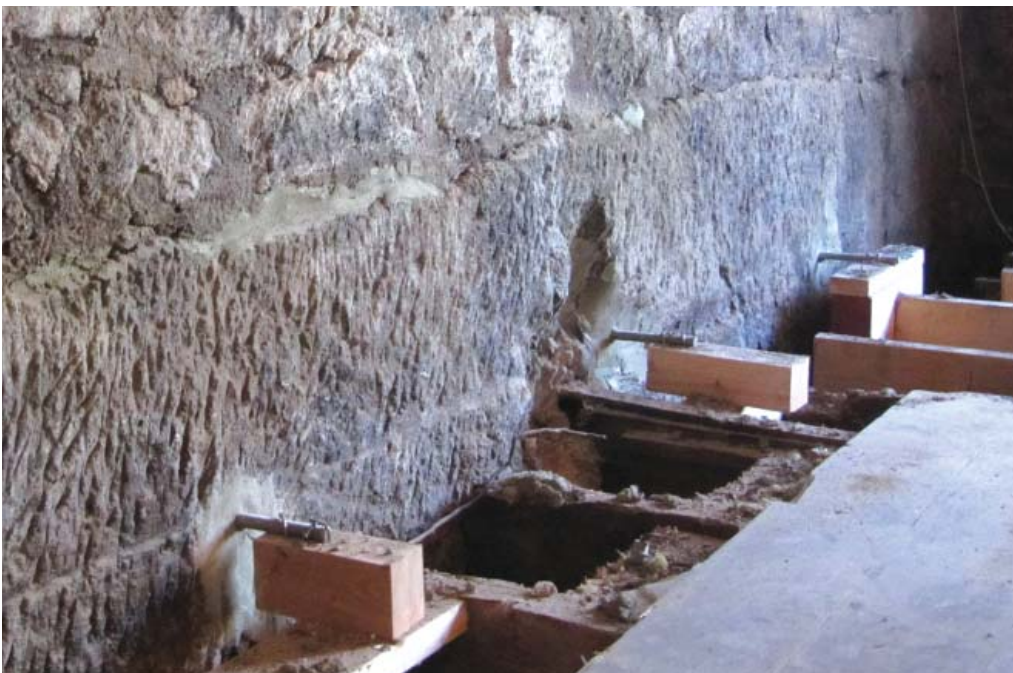
Figure 25. Location of the eye bolts after grouting

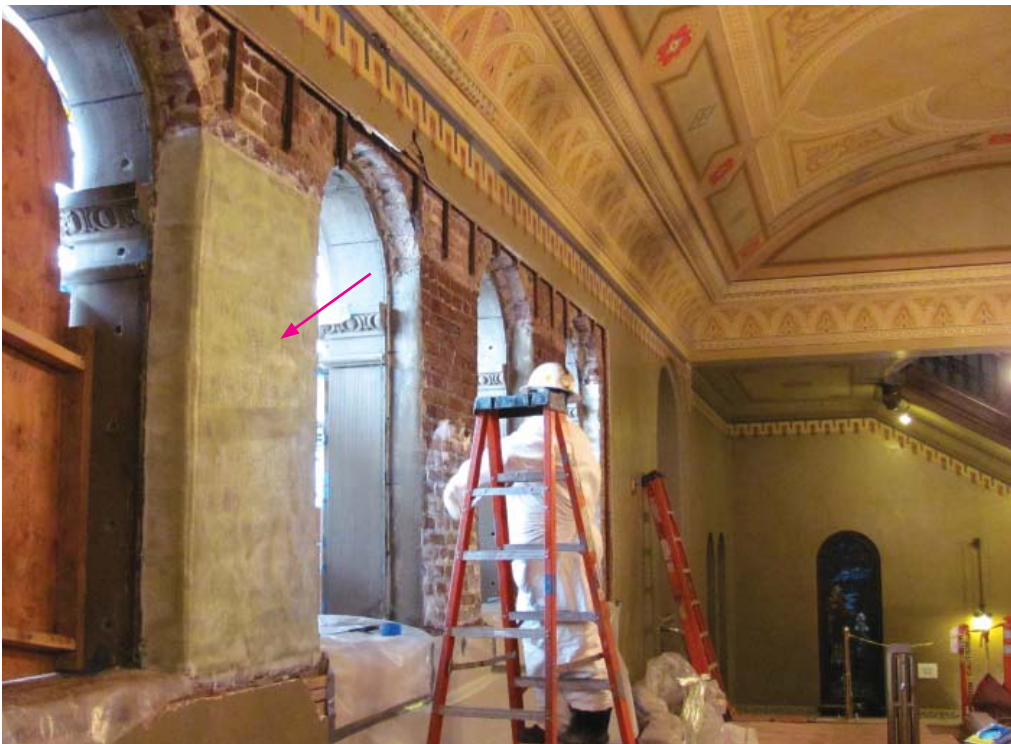
Figure 26. Epoxy-embedded fiberglass mesh is being bonded to the back of the brick pilasters of this 1906 unreinforced masonry building. New finishes matching the appearance and detailing of the original finishes will be applied over the mesh. Photo: Wiss, Janney, Elstner and Associates, Inc.

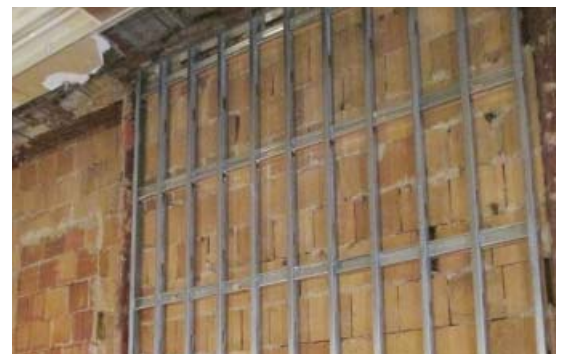
Figure 27. A new steel stud wall is being added to one side of this interior hollow-clay tile wall. The side with the least amount of historic finishes was chosen as the least disruptive location for the added reinforcement. The wall will be returned to its original appearance by installing new finishes matching the historic finishes. Photo: Wiss, Janney, Elstner and Associates, Inc.

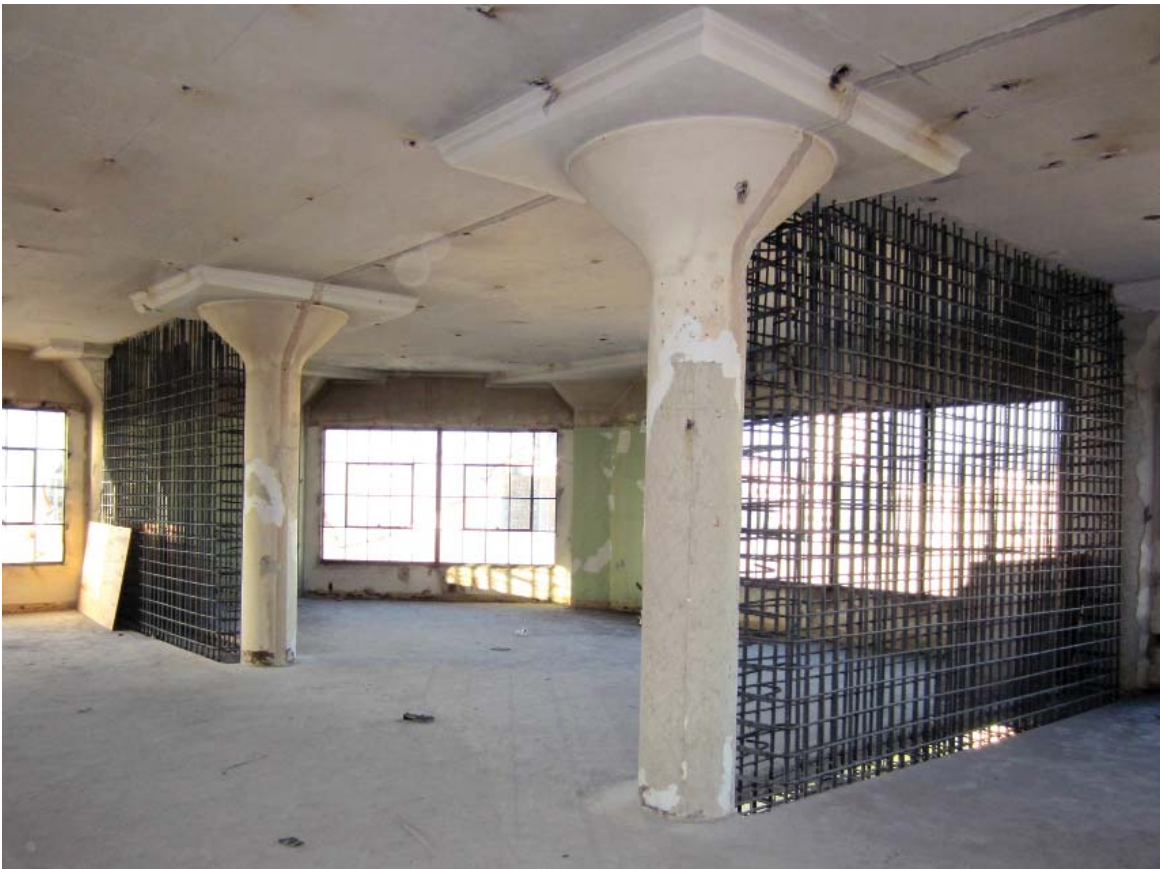
Figure 28. Steel reinforcement for the new shear walls, perpendicular to the windows, is being installed in this concrete-frame building.  
Photo: Robert Chattel.

systems of various types (flat slabs, two-way slabs, and beam-and-slab). Exterior and interior walls are often unreinforced masonry, commonly called infill, and are typically nonstructural, presenting the deficiencies described previously. The most important structural vulnerability of this construction type is the lack of ductility. Prior to 1960, building codes may not have required concrete-frame buildings to be designed and detailed for ductile performance (i.e., not fail when loaded beyond capacity) to resist lateral forces, depending on the region. Concrete-frame buildings were required to be “ductile” in the 1976 Uniform Building Code. In many historic concrete-frame buildings, because the connection between the columns and beams is not strong enough to resist the lateral loads during an earthquake, the buildings are in danger of collapsing. Particularly vulnerable buildings of this type are those with relatively few concrete walls and columns that are weaker than the beams or slabs. Mitigating this condition is typically accomplished by adding a new system, such as shear walls (Figure 28).

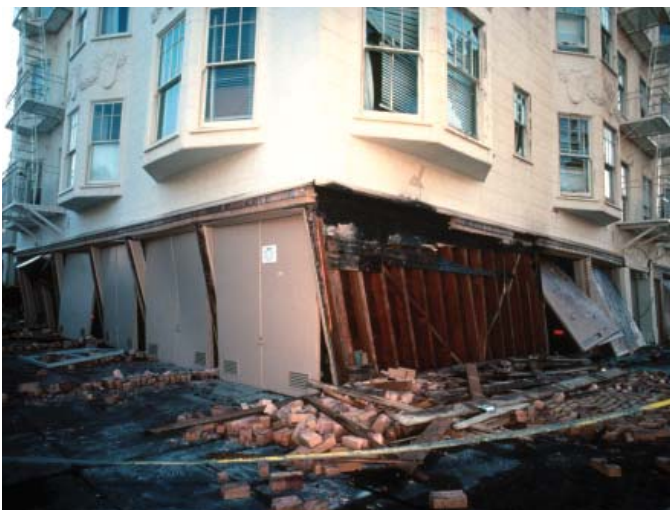
Figure 30. Large perimeter openings and a limited number of interior partitions on the ground floor can create a “weak story” condition that makes buildings particularly vulnerable to earthquake damage. Photo: USGS.

type that is also very susceptible to damage during earthquakes. The upper floors of these buildings typically have a repetitive interior layout which gives them uniform strength and stiffness. The lower floors however, because they typically have larger exterior openings and may have more varied interior configurations and large open spaces, often create a “weak story” condition (Figure 30).
