NCST Technical Investigation of Hurricane Maria (Puerto Rico)

Performance of Critical Buildings Project

Recent Progress: Wind Tunnel Testing (1/8)

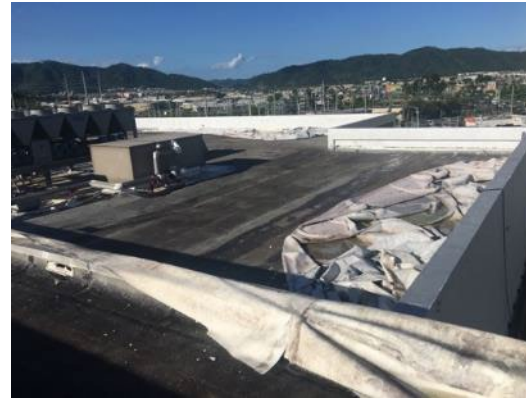
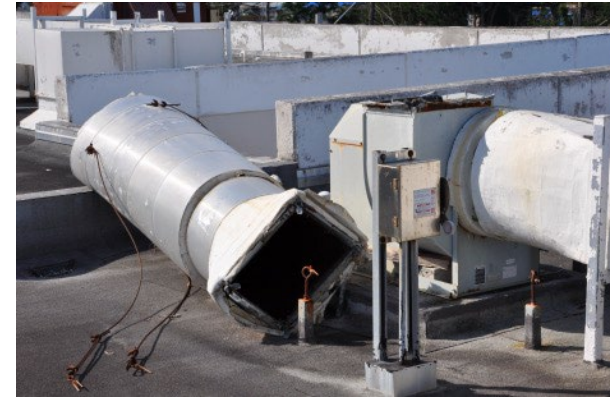
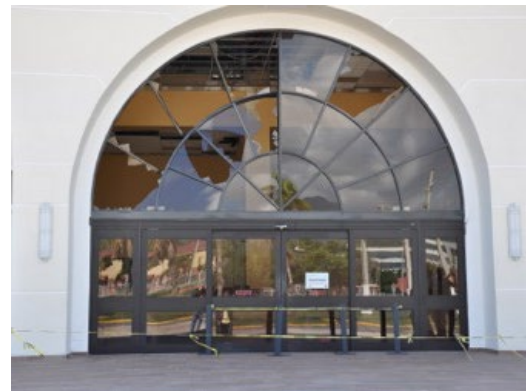
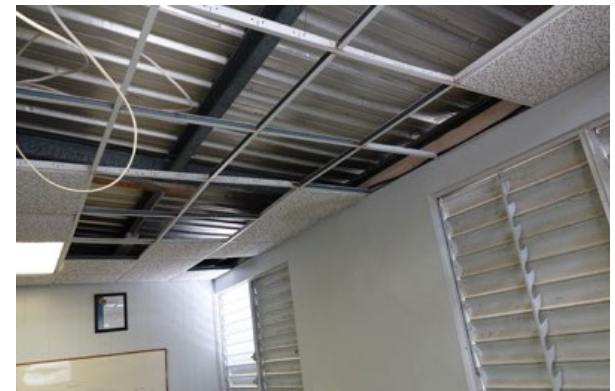
Engineered buildings with good structural performance suffered significant ***damage to building envelopes***, and penetration of rainwater resulted in extensive ***nonstructural damage*** and ***loss of function***:

- roof covering and rooftop equipment damage from wind and windborne debris;
- window and door damage caused by wind and windborne debris;
- rainfall ponding on the roof due to excessive rainfall rates and debris blocking drains; and
- wind-driven rain penetration through undamaged cladding, such as windows and doors.

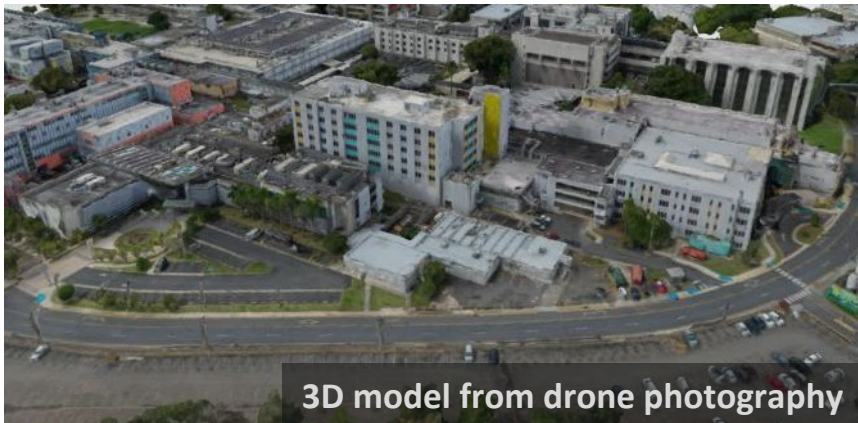
3D model from drone photography

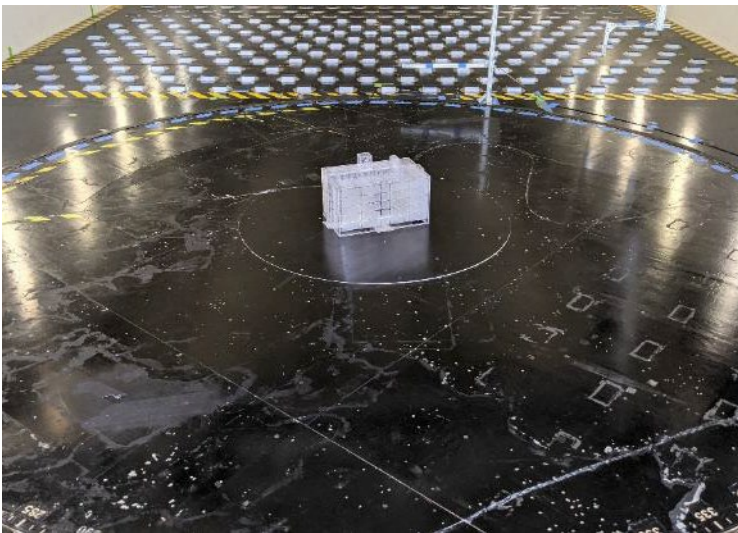
Case 1: Isolated Building

- Performed testing over 180° range of wind angles in 10° increments, for cases with and without the area model and proximity buildings
- Tests conducted under different approach flow conditions:
 - Standard Exposure C (“open terrain”) approach flow: considered for isolated building to facilitate comparisons with standard provisions
 - Simulation of topographic effects for each direction using Flow Field Modulator

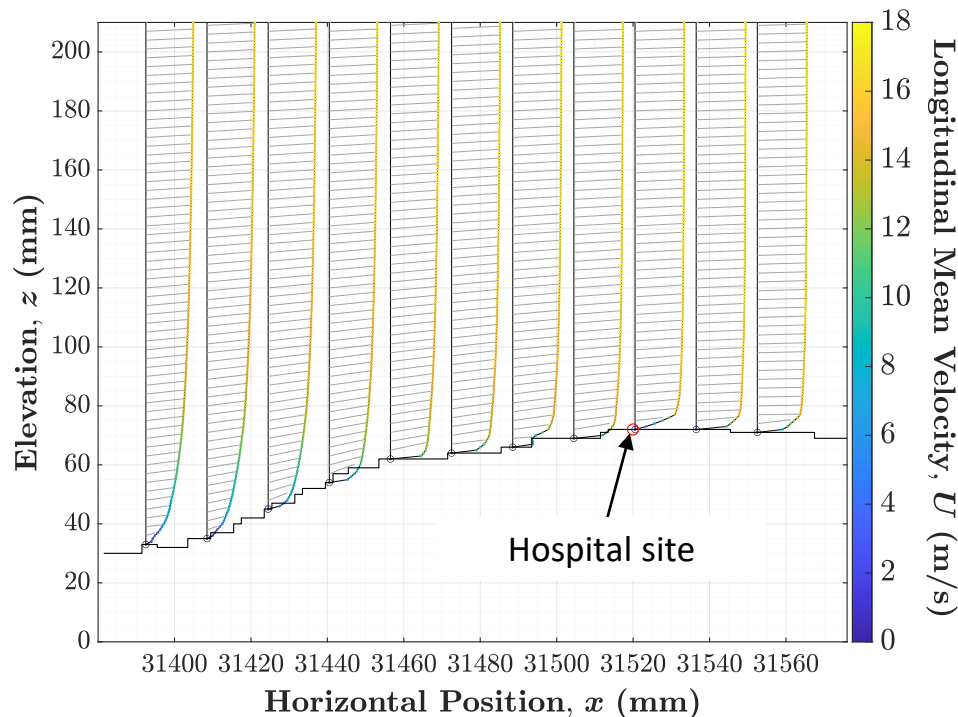
PIV Approach Flow Measurements

- Measurements of approach flow velocity profiles at hospital site obtained from Mayagüez topographic model (1:3100 scale) using Particle Image Velocimetry (PIV)
- Approach flow profiles at 1:100 scale simulated using Flow Field Modulator for wind tunnel testing of building and area model

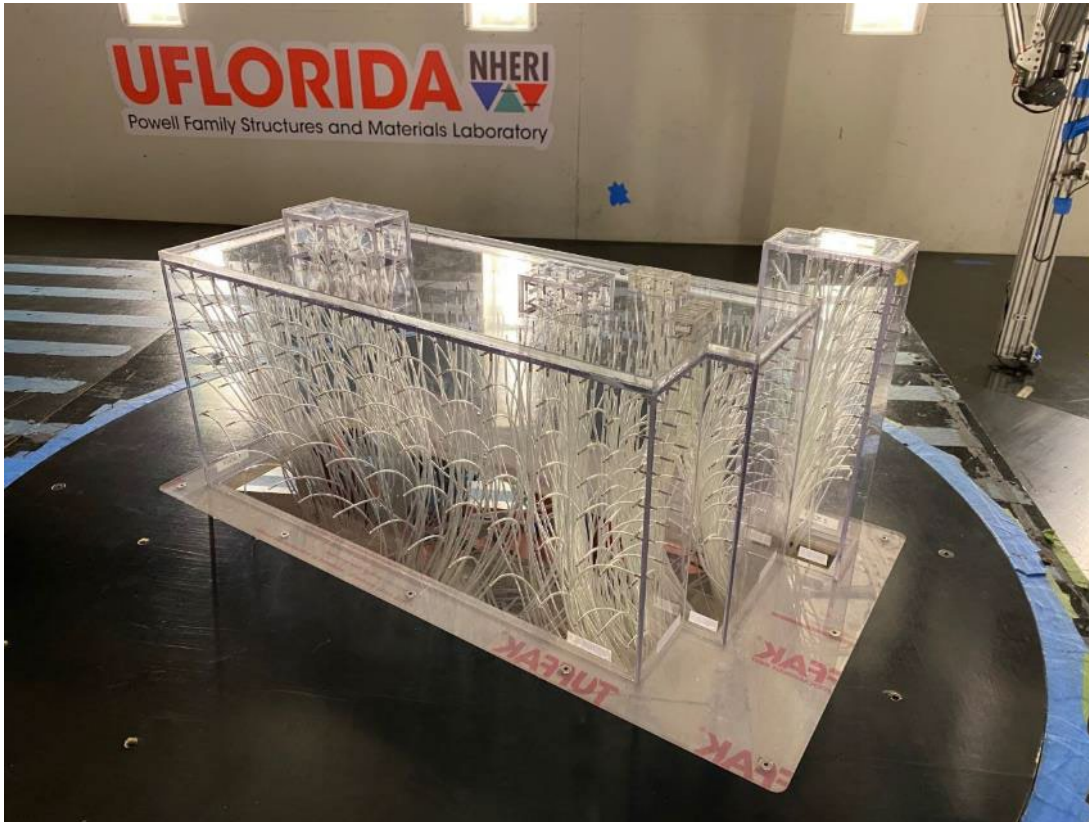
Pressure Tap Model

- **Pressure tap model:** used for measurement of surface pressures on components, cladding, and rooftop equipment
- **Load cell model:** used for measurement of resultant forces on rooftop equipment

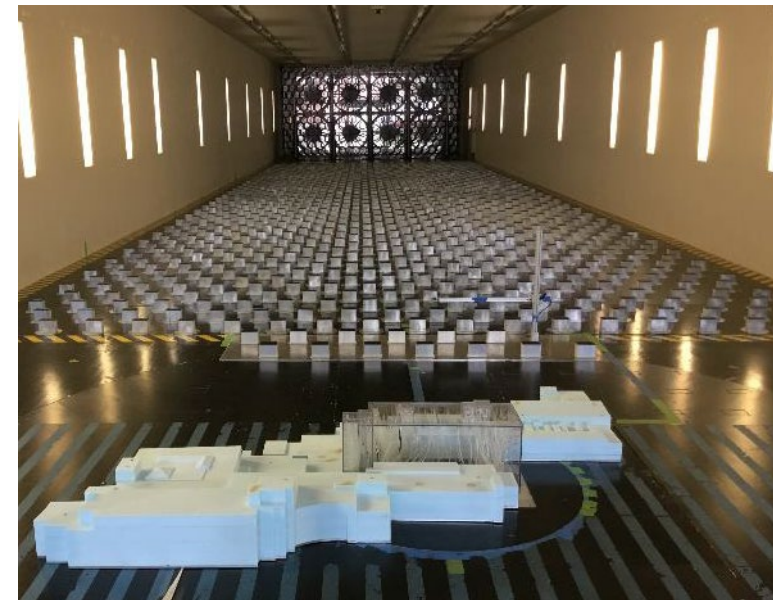
Building + Proximity Buildings, Exposure B

- Two approaches used for simulation of wind angle:
 - Stationary testing with 10° increments of wind angle
 - Nonstationary testing with continuously varying wind angle
- Tests conducted under different approach flow conditions:
 - Standard Exposure C (“open terrain”): facilitates comparisons with standards
 - Exposure B+ (“suburban”): corresponds to estimated roughness at hospital site

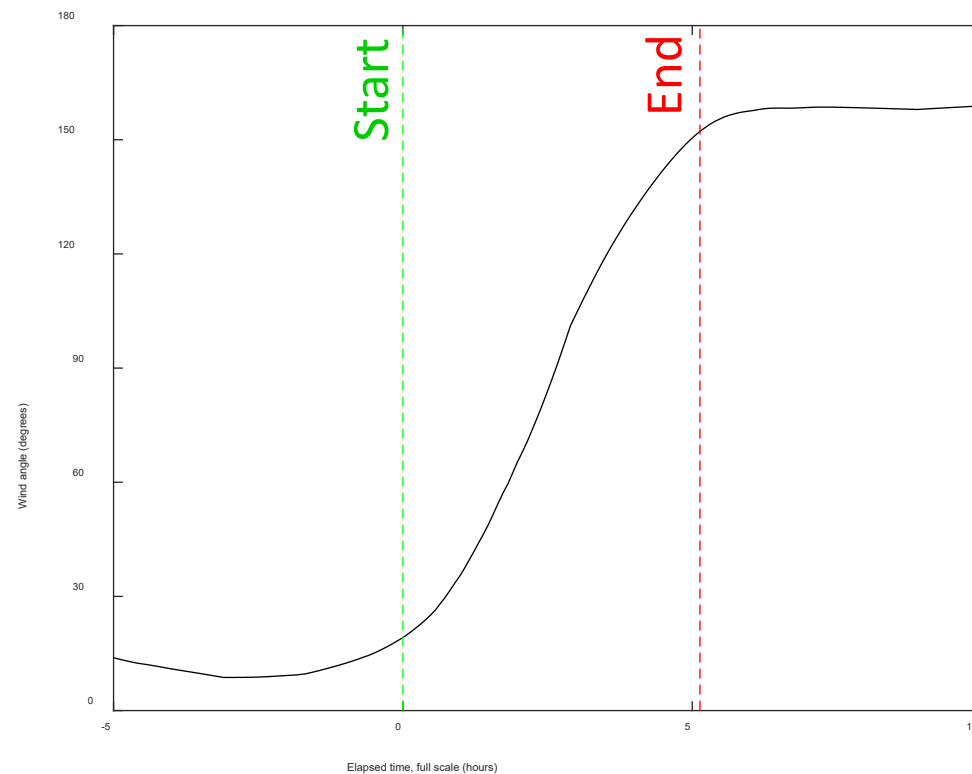
Nonstationary simulation of Hurricane Maria wind direction history

- Time histories of wind speed and wind direction obtained from wind-field model
- Portion of record with peak gust wind speeds exceeding 100 mph selected for testing
- Similitude relationships used to scale the wind direction history to model scale (1:100)
- Wind angle history simulated in wind tunnel by controlling rotation of turntable
