**Federal Building and Fire Safety Investigation
of the World Trade Center Disaster**

**National Construction Safety Team
Advisory Committee Meeting**

**Project 6 – Structural Fire Response and
Collapse Analysis**

October 19, 2004

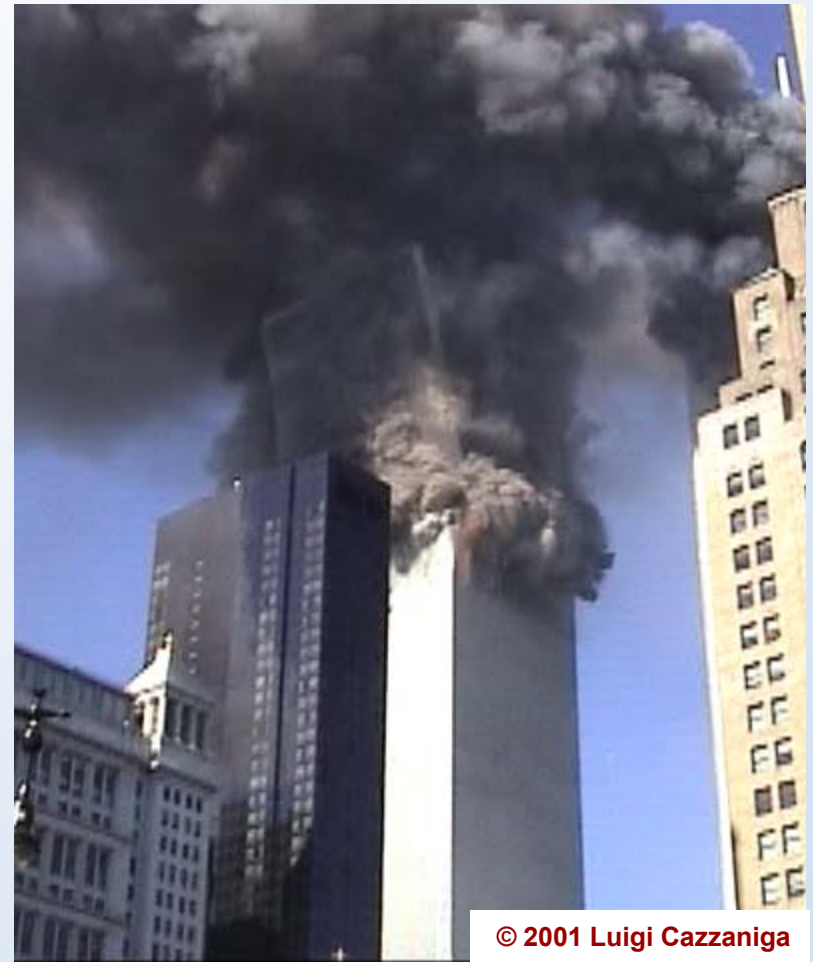
WTC 2 Collapse

WTC 2 tilted to the east and south and twisted in a counterclockwise motion in this view from the northeast.

- ❑ Due to the additional loads on the perimeter columns on the East face and the inward pulling of those columns, the East perimeter wall bowed inwards and highly stressed sections buckled.
- ❑ The section of the building above the impact zone began tilting to the East and South as both the East perimeter columns and the impact-damaged South perimeter columns buckled. The instability rapidly progressed horizontally across both faces and across the North face.
- ❑ The change in potential energy due to the downward movement of the building mass above the buckled columns exceeded the strain energy that could be absorbed by the structure. Global collapse then ensued.

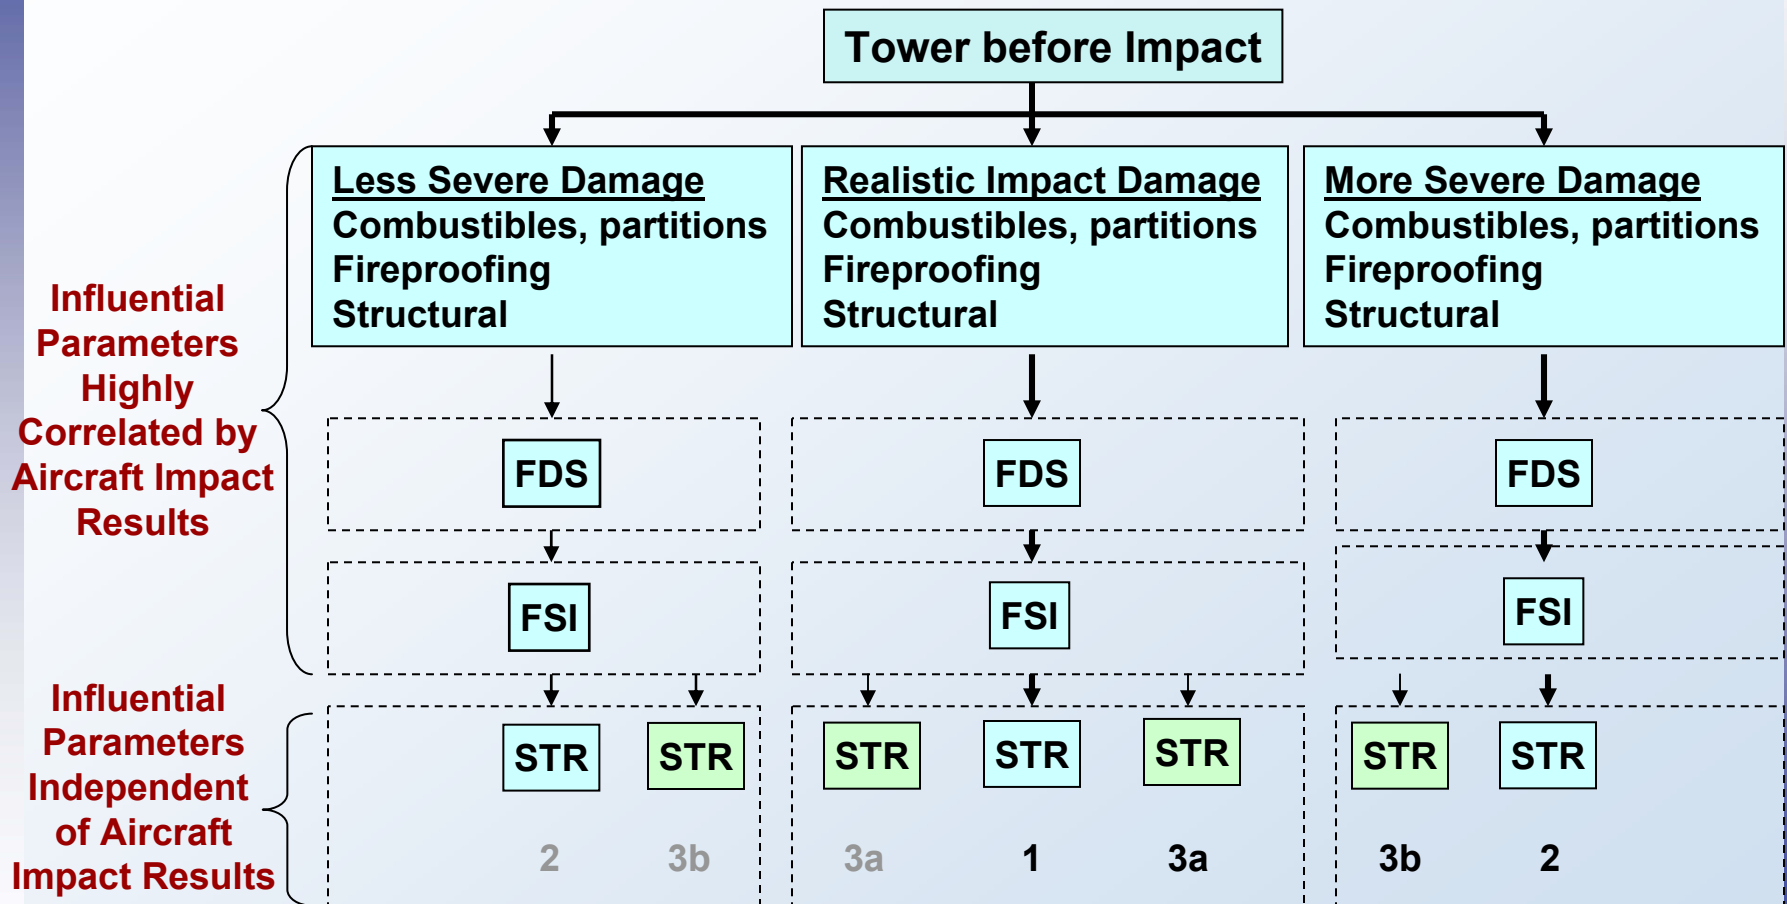
Pruned Analysis Tree for Influential Parameter Effects

Bounding computational analyses of subsystems and global systems, for specific response behaviors that were required to be captured in the final analyses, provided valuable insight into the collapse sequence.

These insights along with the sensitivity studies enabled significant reduction of the number of scenarios to be analyzed from the full analysis tree.

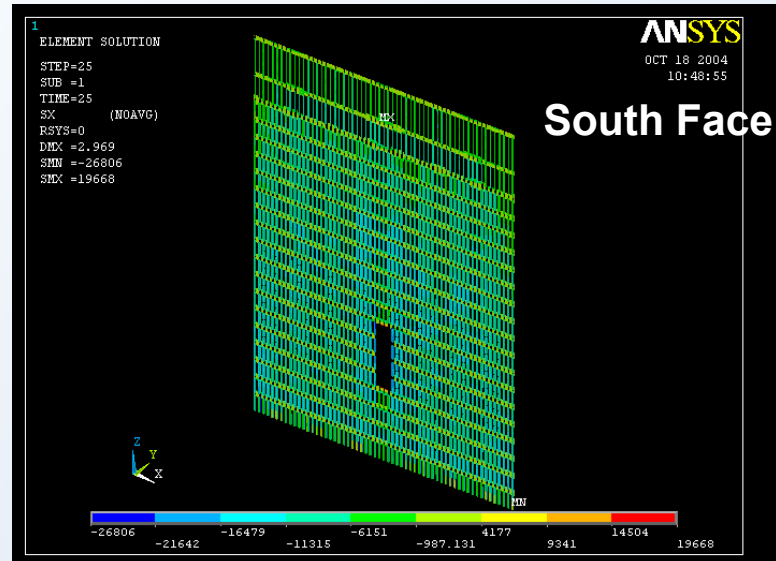
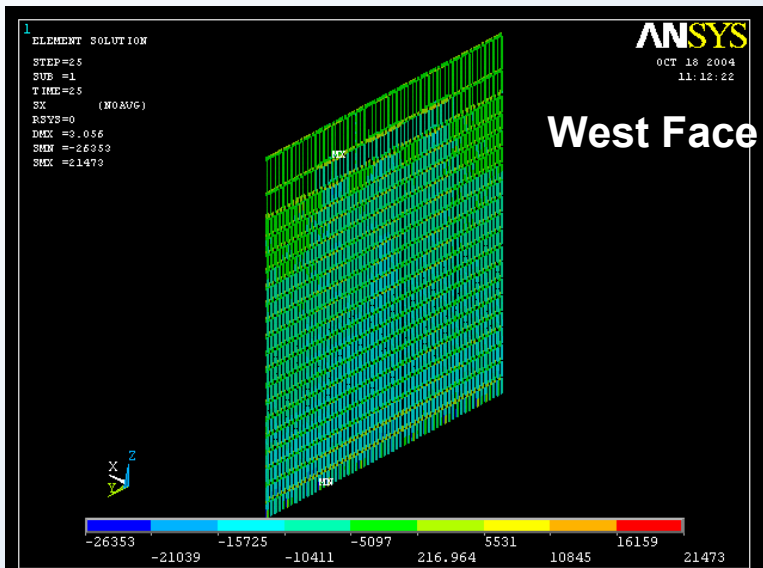
Stresses in Other Faces After Aircraft Impact in WTC1 (10x)

Combined axial and bending stresses are:

- below 28 ksi ($DCR \leq 0.3$) in the South face
- below 26 ksi ($DCR \leq 0.2$) in the East and West faces

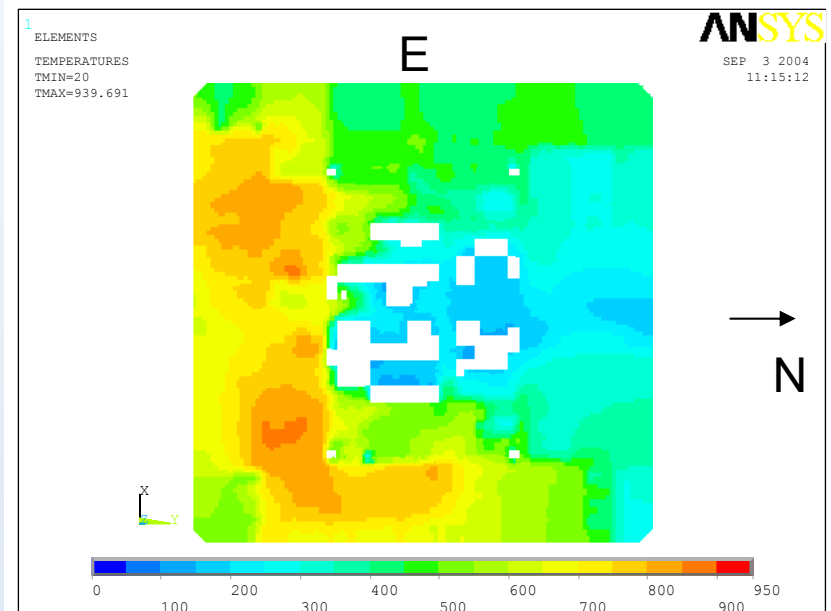
Temperature Distributions for Bottom of Slab of WTC 1 Floor 96 for Realistic Fires

600 s

6000 s

Truss temperatures exceeded 500 °C to 600 °C **only** where fireproofing damage **and** fire exposure occurred. Trusses were observed to cool as fires moved to other areas, whereas concrete slab temperatures continued to rise.
