**Federal Building and Fire Safety Investigation
of the World Trade Center Disaster**

**Project 6: Structural Fire Response and
Collapse Analysis**

**Building and Fire Research Laboratory
National Institute of Standards and Technology
U.S. Department of Commerce**

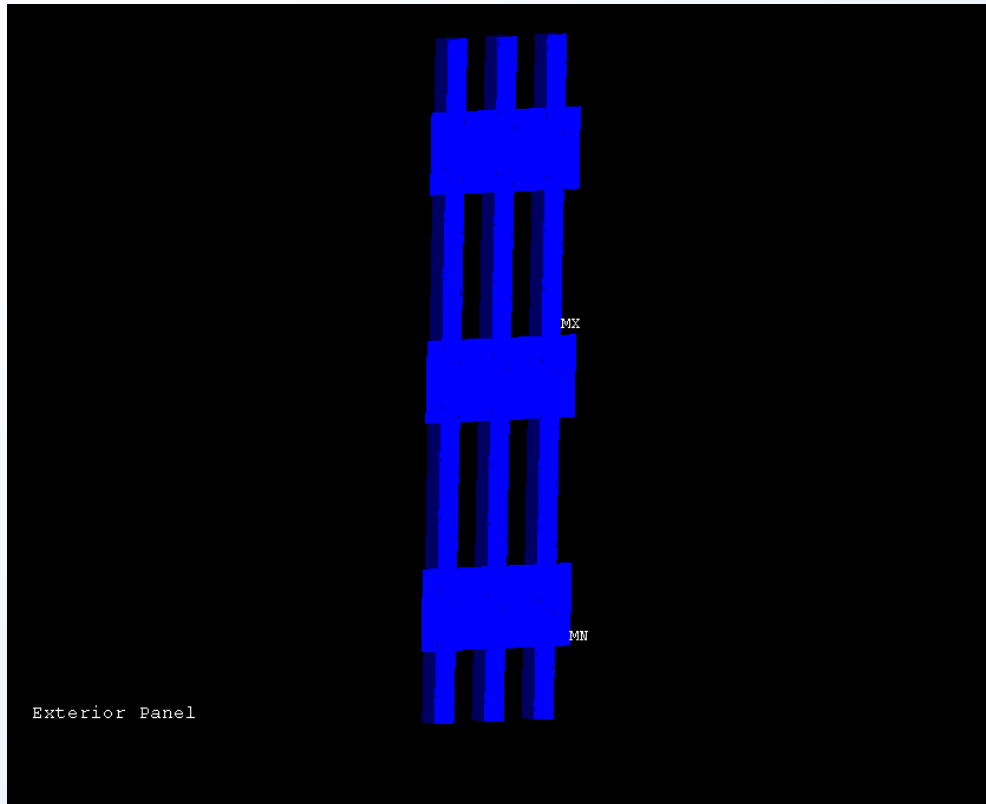
Task 1 Progress: Exterior Column Panel Buckling Behavior

Computer Model (ANSYS)

- Geometric nonlinearity
- Material nonlinearity

- Buckling of initially perfectly straight column

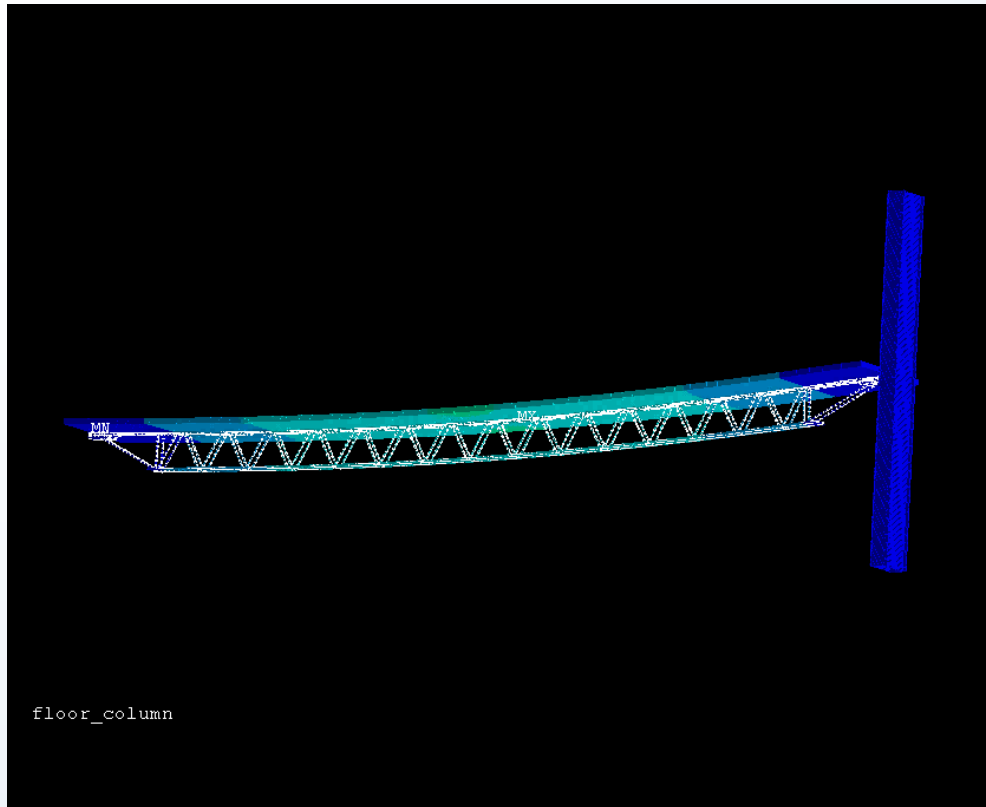
Task 1 Progress: Floor Section Behavior

Computer Model (ANSYS)

- Geometric nonlinearity
- Material nonlinearity
- Uniform load (dead load + service load)

- Buckling under lateral restraint
- Effect of fire conditions
 - Uniform heating
 - Representative fires (FDS)
- Effect of thermal restraint
 - Unrestrained
 - Fully restrained
 - Partially restrained (column stiffness)

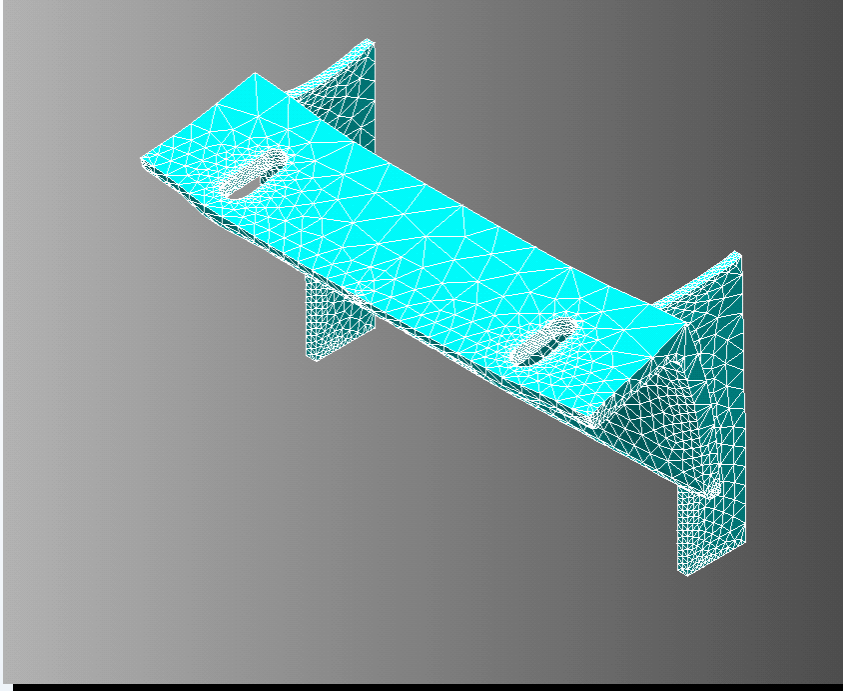
Task 1 Progress: Seated Truss Connection

Computer Model (ANSYS)

- Geometric nonlinearity
- Material nonlinearity

- Vertical load (gravity) plus bolt pull-out

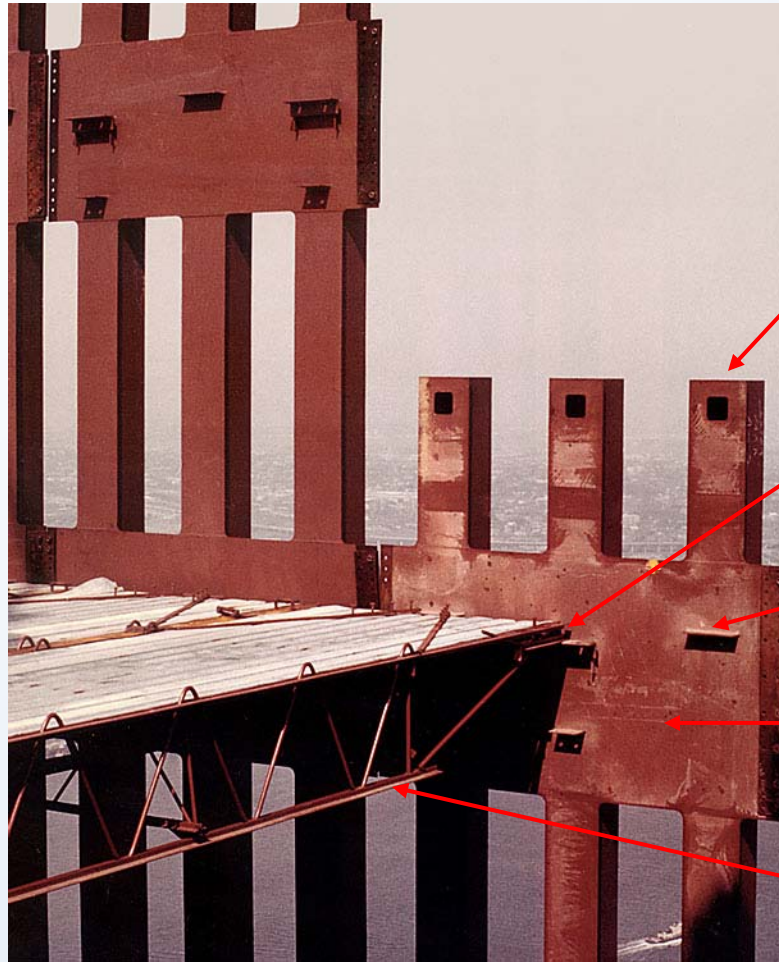
Floor Truss System and Exterior Column Panels

Bolted column connection

Floor truss seat connection

Strap attachment plate

Exterior column panel

Floor truss

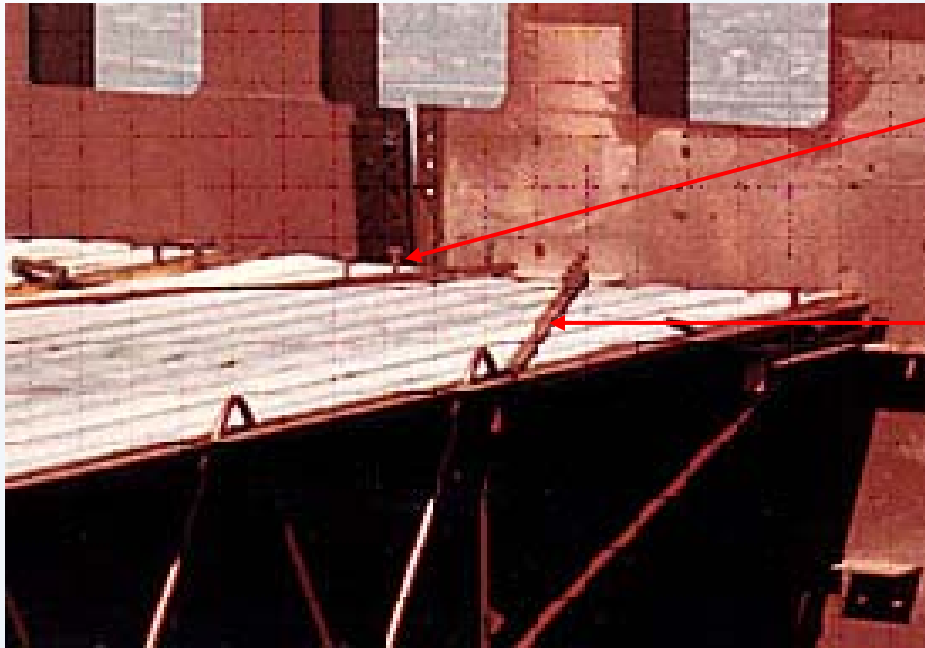
Floor Truss System and Exterior Column Panels

Shear studs

Diagonal straps

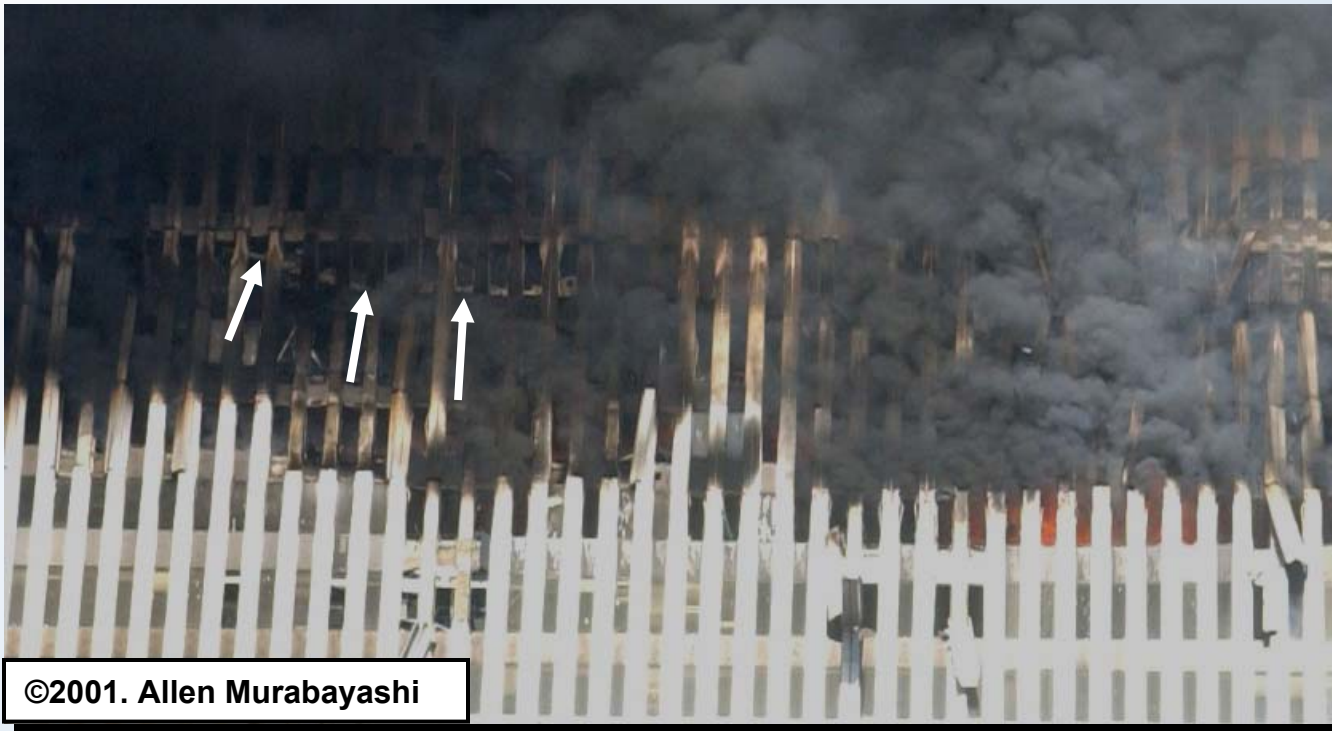
Lateral Bracing of Exterior Columns

Visual evidence that floor-to-exterior column connection failed

- ❑ Possibilities: lateral capacity, vertical capacity, or both exceeded

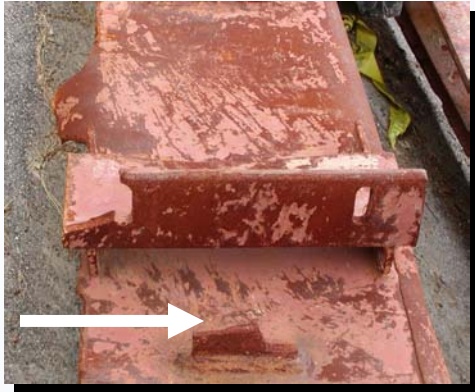
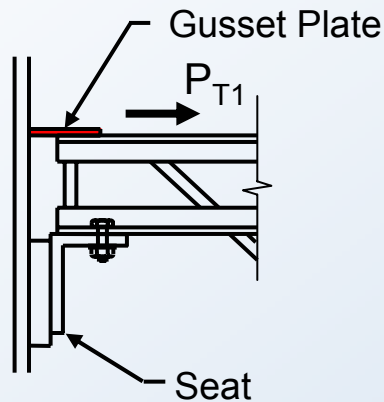
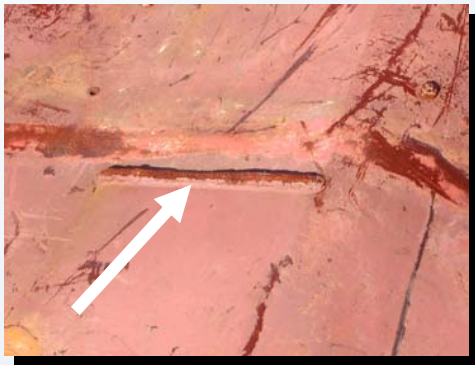
Task 4a Progress: Lateral Bracing of Exterior Columns (P_T)

$$P_T = P_{T1} + P_{T2} + P_{T3}$$

Ultimate Strength of
Gusset Plate per
AISC Specification
(1999)

Concrete breakout
strength per ACI-
318 (2002)

Failure by
Concrete breakout

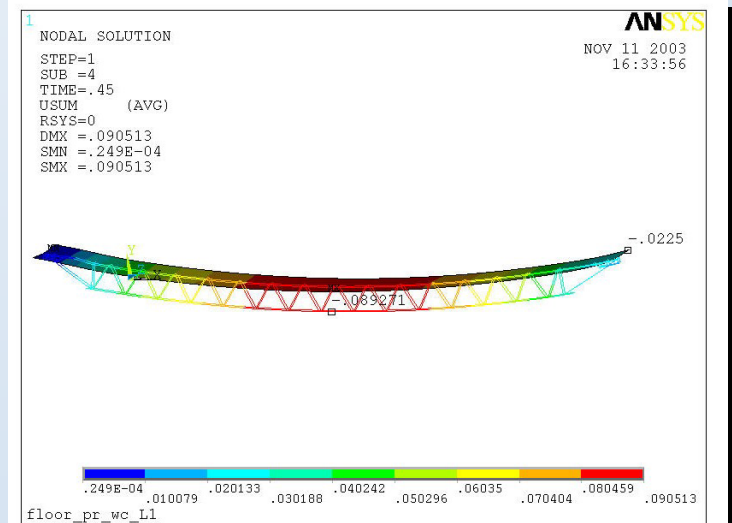
Task 4a Progress: Buckling of Floor System (P_B)

Analytical (Euler) Solution

- ❑ Sensitive to end condition assumptions

ANSYS Computer Solution

- ❑ 80 in wide panel (by symmetry)
- ❑ Geometric nonlinearities included
- ❑ Ambient temperature
- ❑ Preliminary results within bounds of simplified analytical solutions

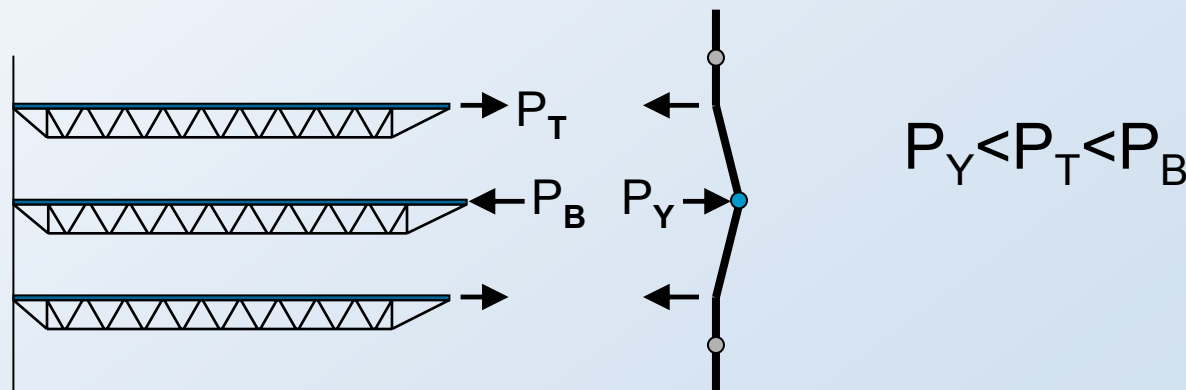
Task 4a Progress: In-Plane Failure Modes - Interim Findings of Simplified Analysis

Relative capacities (weakest to strongest) at room temperatures under lateral loads

- ❑ Exterior column yielding (P_Y)
- ❑ Floor-to-column connection failure (P_T)
- ❑ Floor system buckling (P_B)

Capacities change with elevated temperature; relative order does not change.

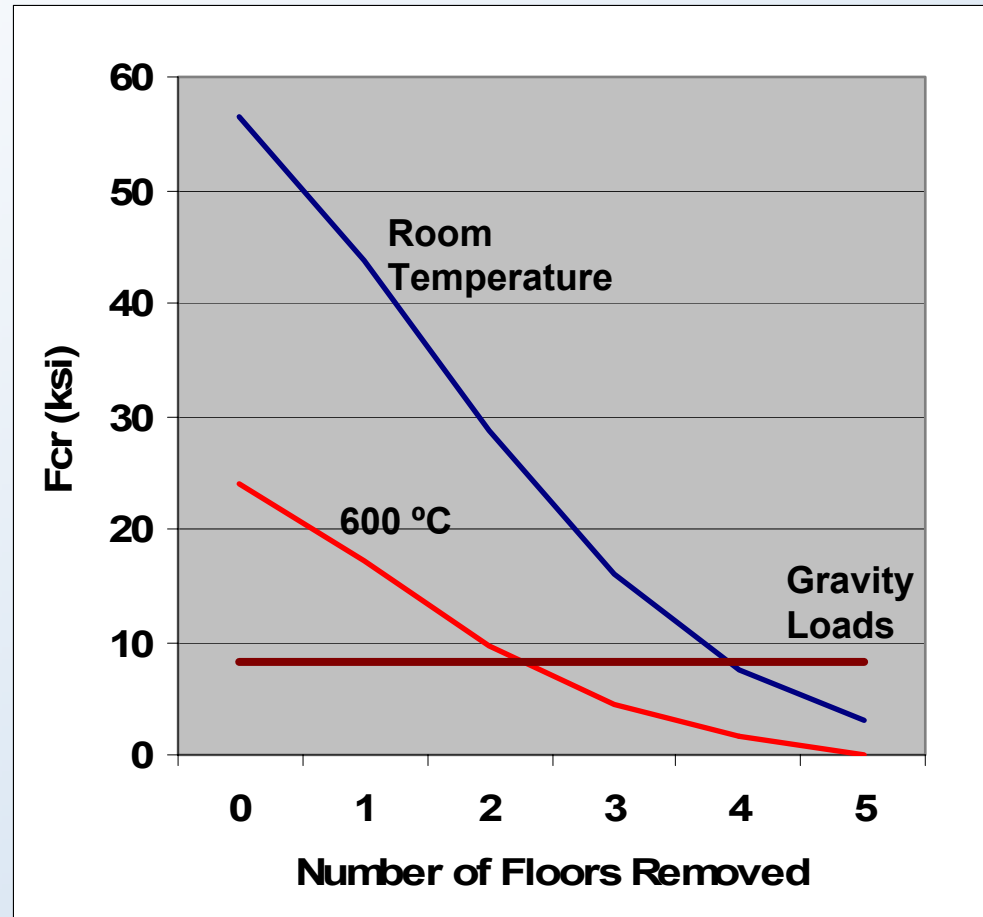
Task 4b Progress: Effect of Floor Removal on Column Failure – A Typical Example

Average for Exterior Columns

WTC 1 North Face
Floor 95 under
Service Loads

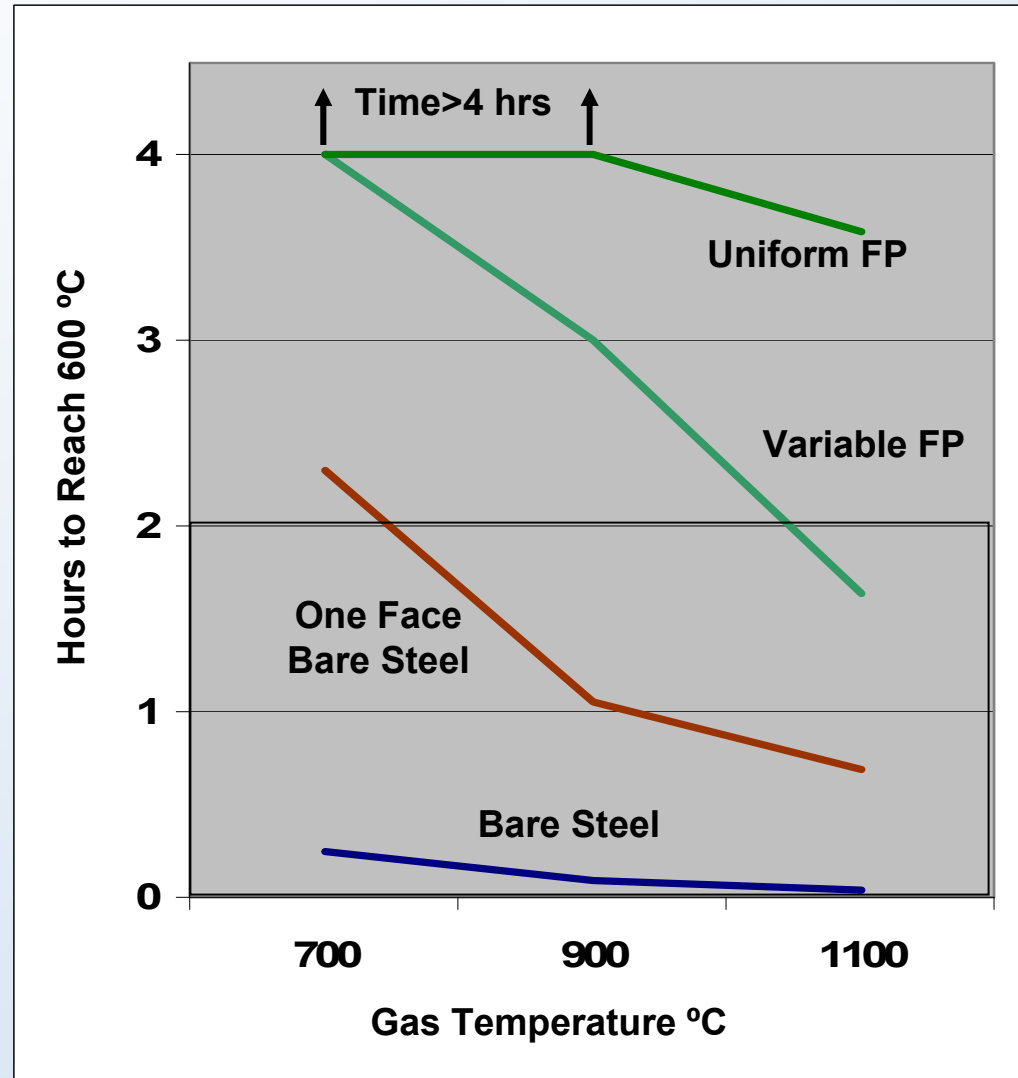
Task 4c Progress: Estimated Times for Core Columns to Reach 600 °C

Typical Core Column

12WF133

Floor 92-95

(2-3/16-in fireproofing)

Bare Steel

Uniform Thickness

One Face Bare Steel

20% Variable Thickness

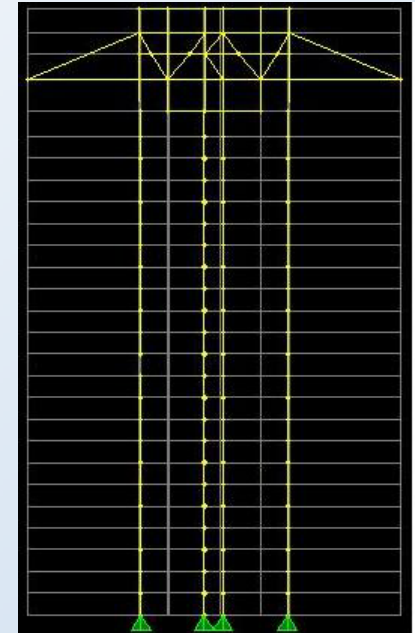
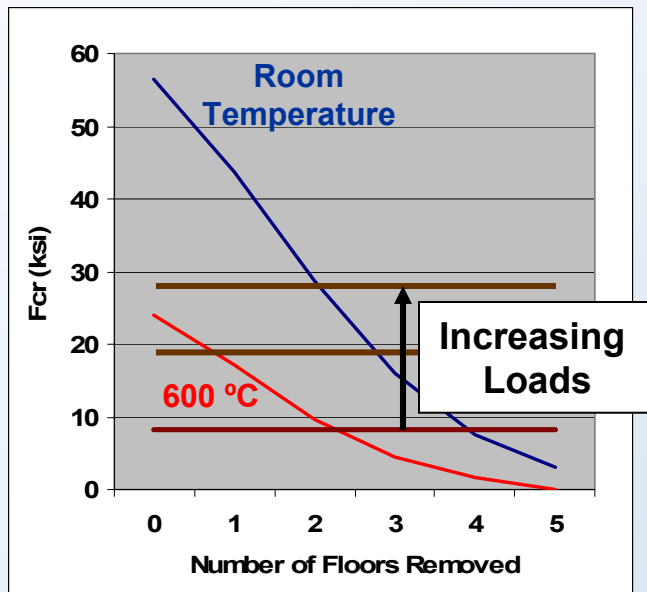
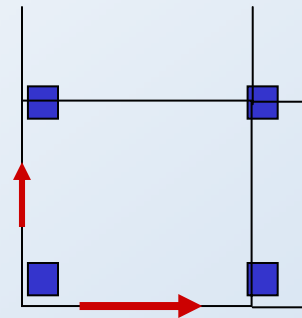
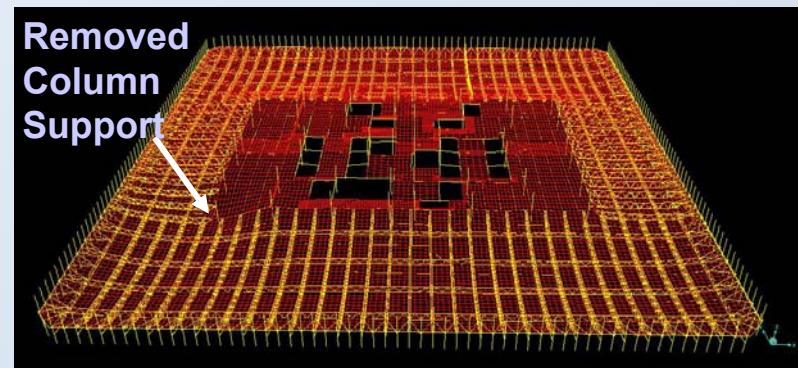
Task 4d Progress: Simplified Analysis of Load Redistribution Effects on Column Failure

Loads from severed or damaged columns are redistributed to the remaining columns. Columns will continue to redistribute loads as they fail during fires

As column loads increase, less damage (fire and loss of floors) is needed to fail columns

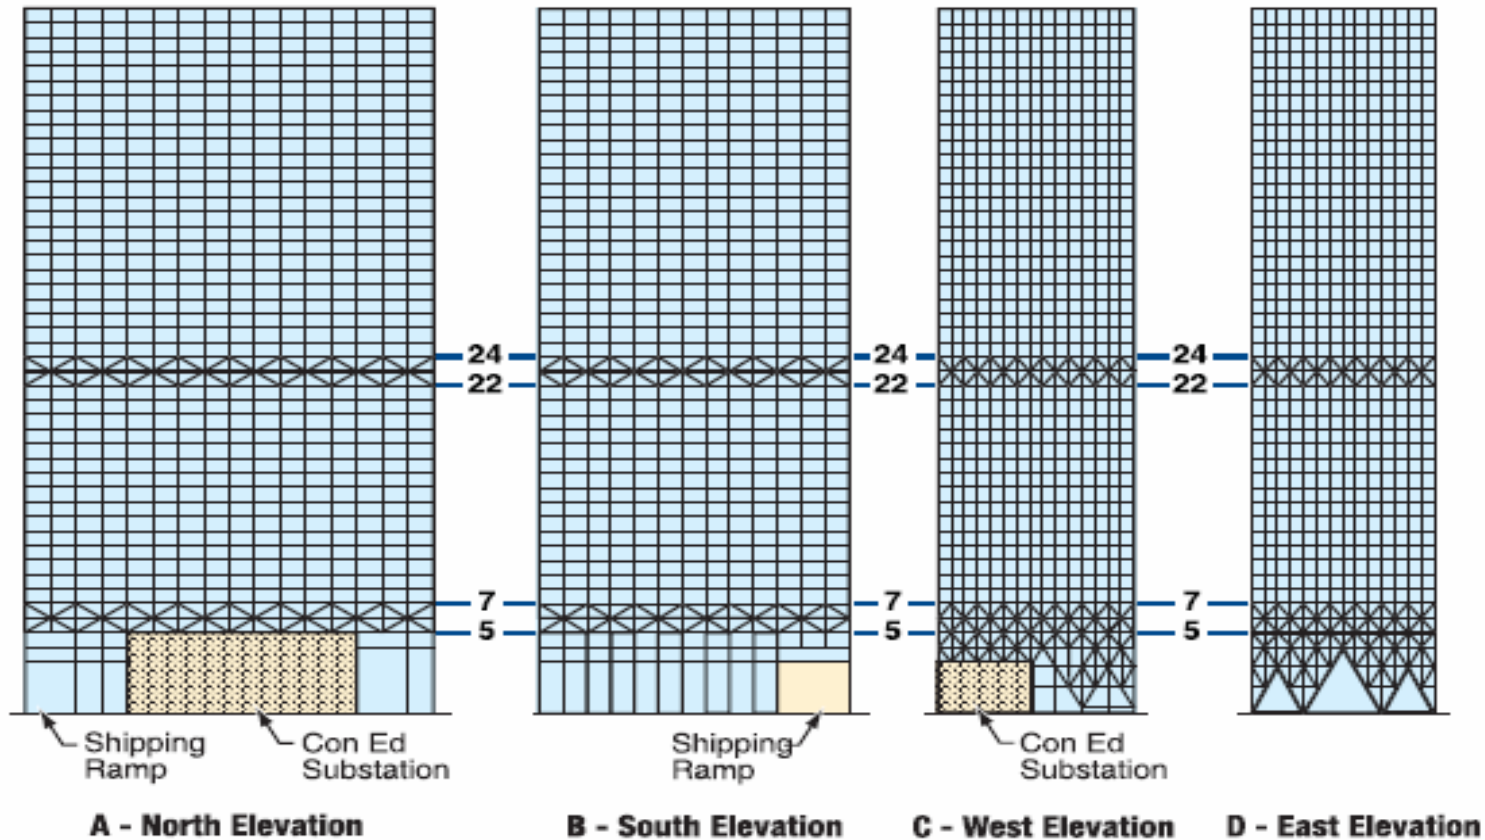
WTC 7 Structural Features

NOTE: Belt trusses located at floors 5-7 and 22-24.

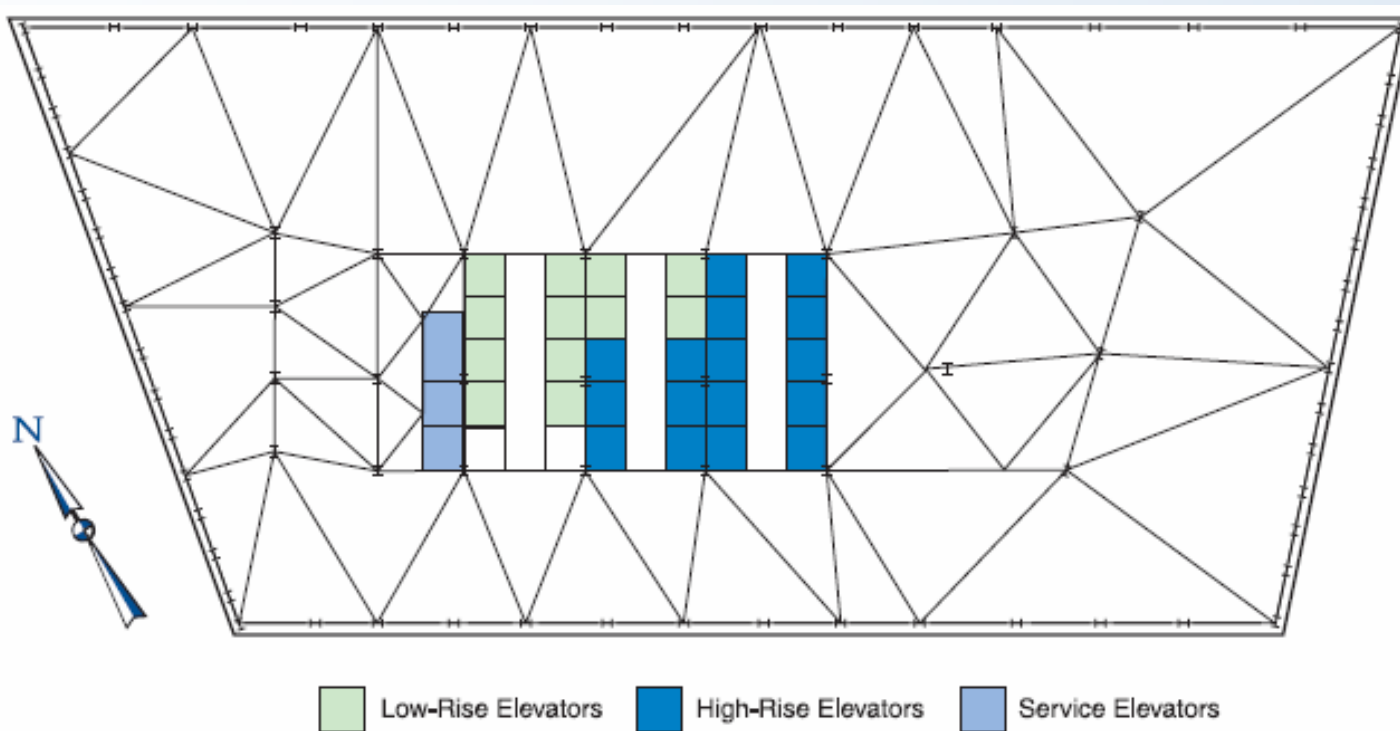
Figure 5-4 Fifth floor diaphragm plan showing T-sections embedded in 14-inch slab.

Floor 5 is a 14-in slab reinforced with T-beams

Floor 7 is an 8-in reinforced slab

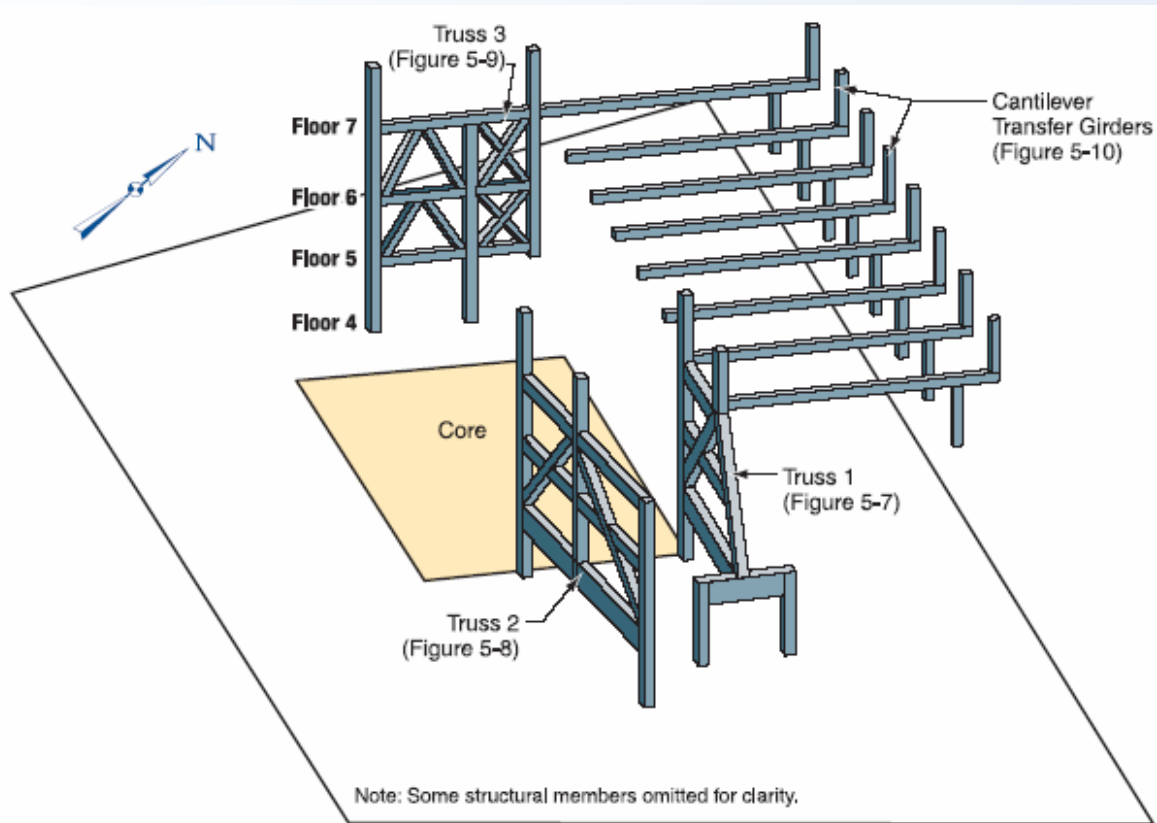
Figure 5-5 3-D diagram showing relation of trusses and transfer girders.

Transfer trusses between floors 5 to 7 were large structural members (600-1000 plf)
