# NCST Investigation of the Champlain Towers Collapse

Glenn R. Bell  
Associate Lead Investigator

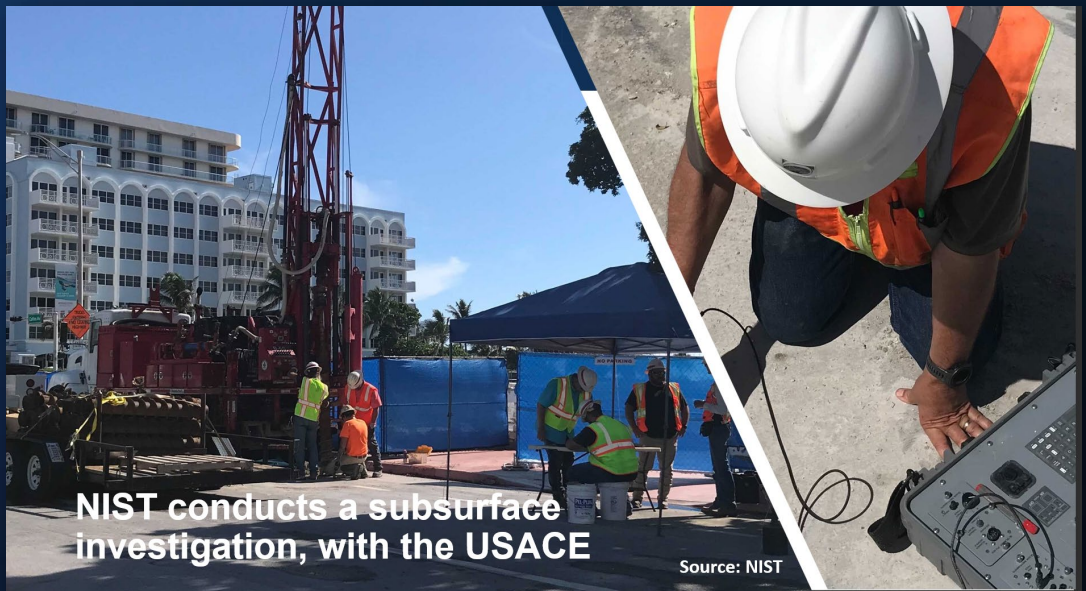
**NIST conducts a subsurface investigation, with the USACE**
