## NIST/UL Workshop on Photovoltaic Materials Durability

# Corrosion-induced AC Impedance Elevation in Crystalline Silicon Photovoltaic Cells/Modules

Tadanori Tanahashi (RCPV, AIST)

December 13, 2019

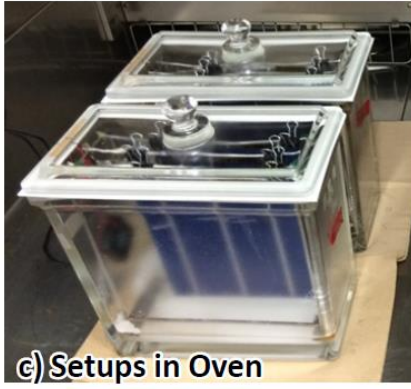
## HAc-Vapor Exposure of Bare PV Cells

**at 85°C / 80% rh**

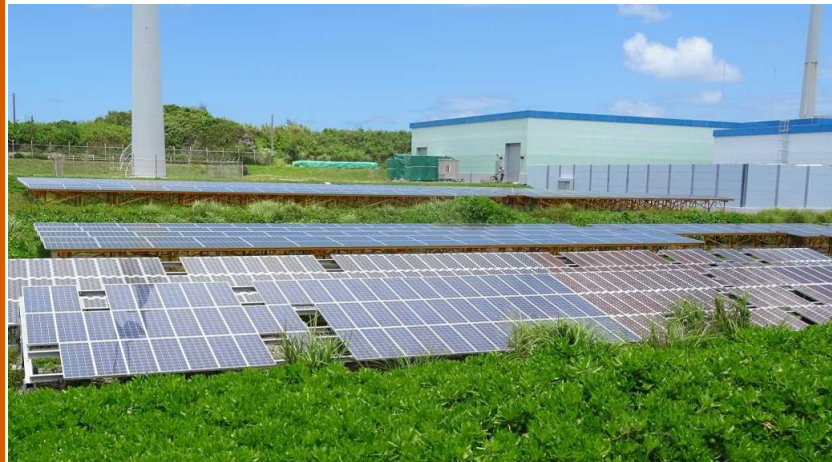
## Outdoor Exposure

**Ex. Outdoor Exposed PV Module from 1994 in Cfa Climate**

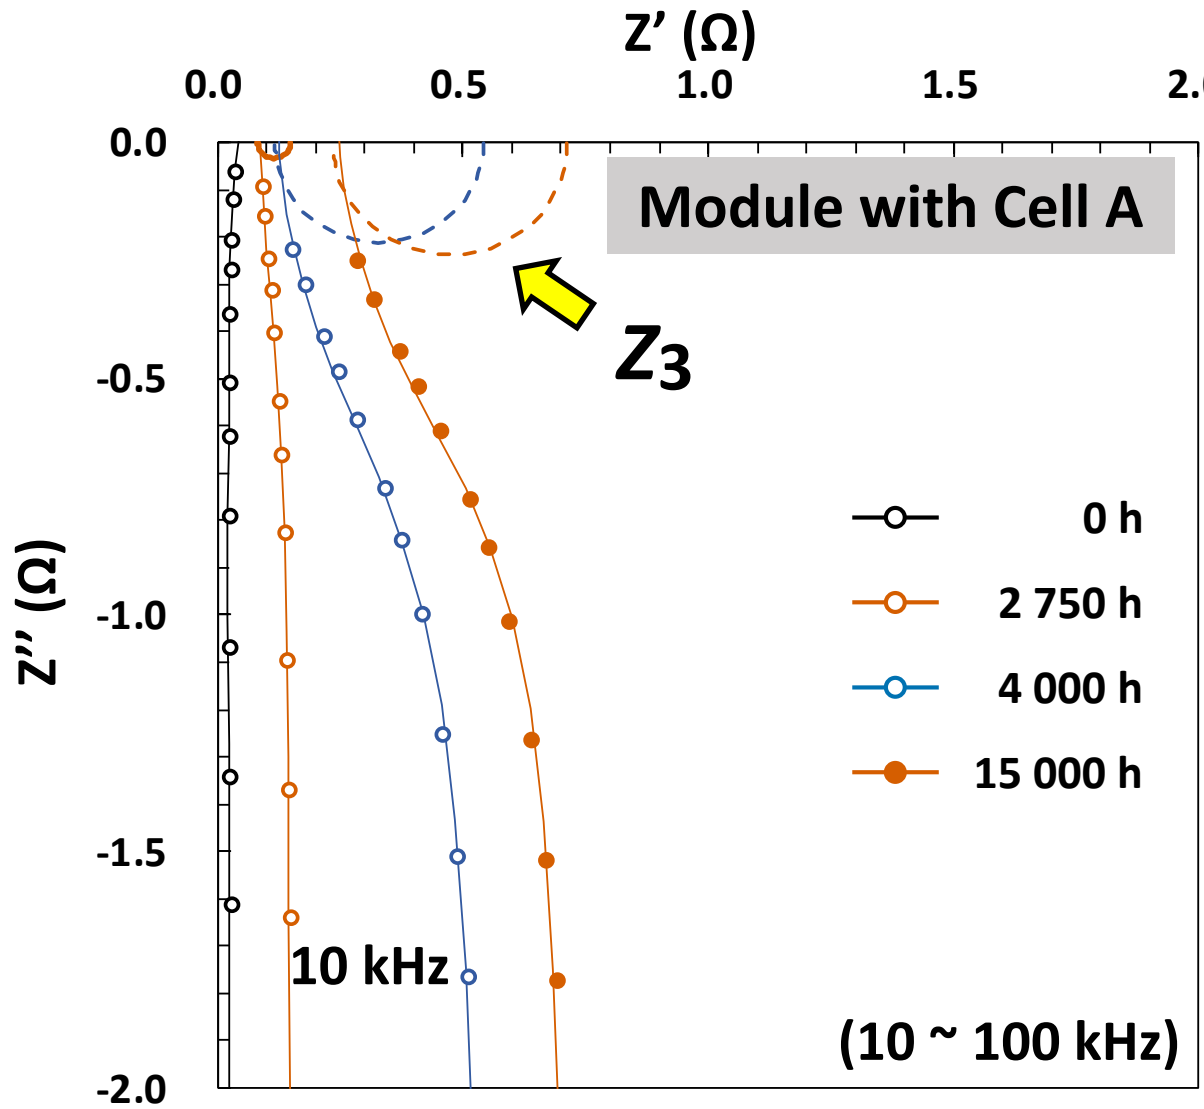
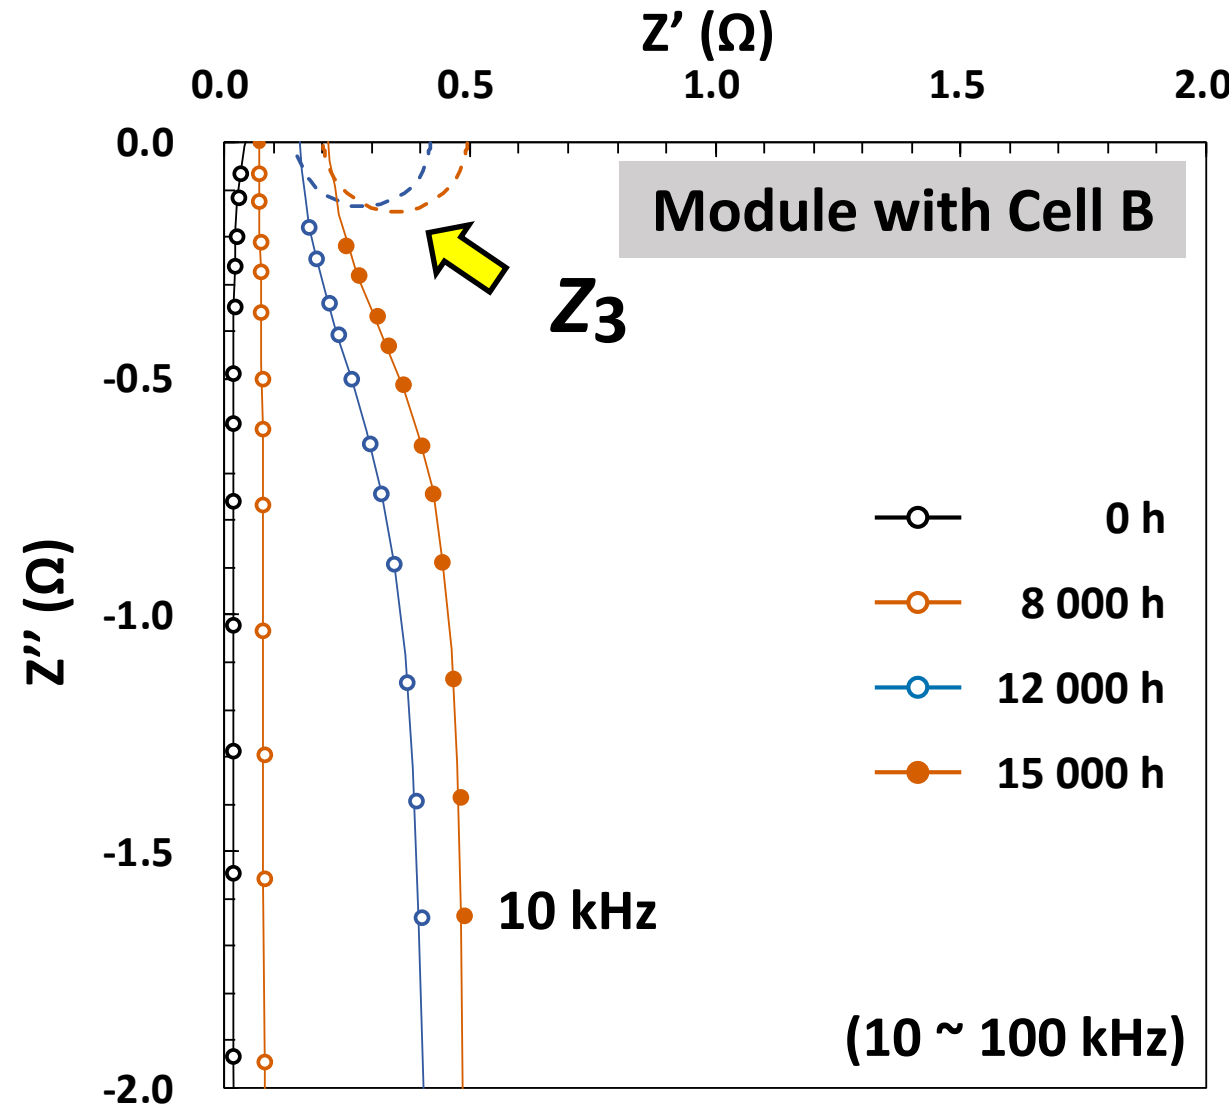
Emergent Incidence & Evolution of  $Z_3$

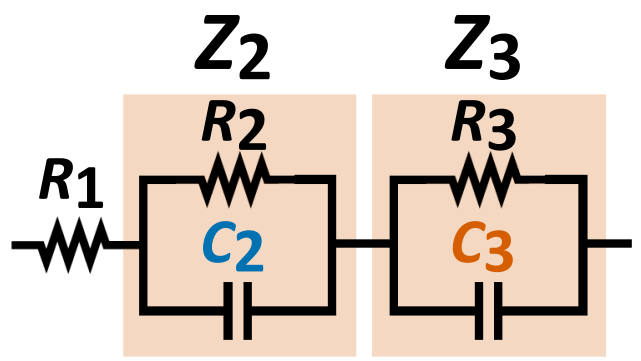
Module with Cell A

### Synchronized Changes

- FF /  $P_m$ : Reduction
- $R_1$  /  $R_3$ : Elevation
- $C_3$ : Emergent Expression / Decay

Constant

- $C_2$

AC Equivalent Circuit

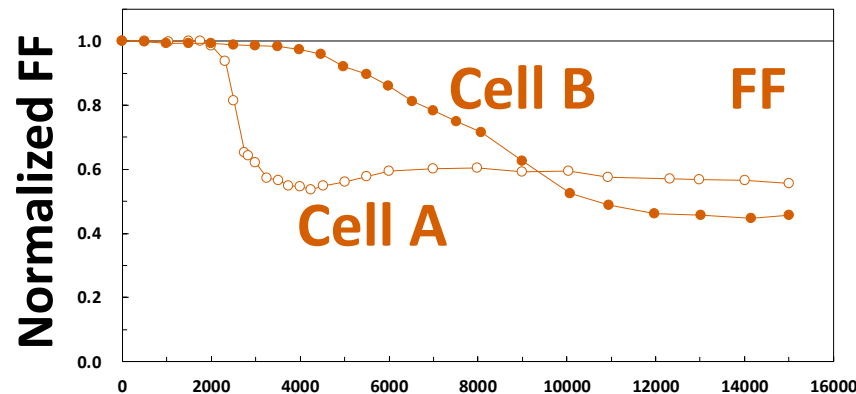
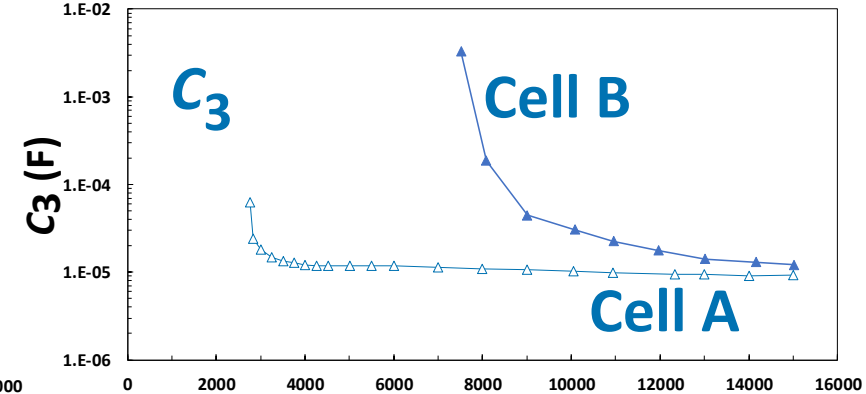
## Complete Differences in Degradation Kinetics

AC Equivalent Circuit

Duration of DH Stress Test (h)

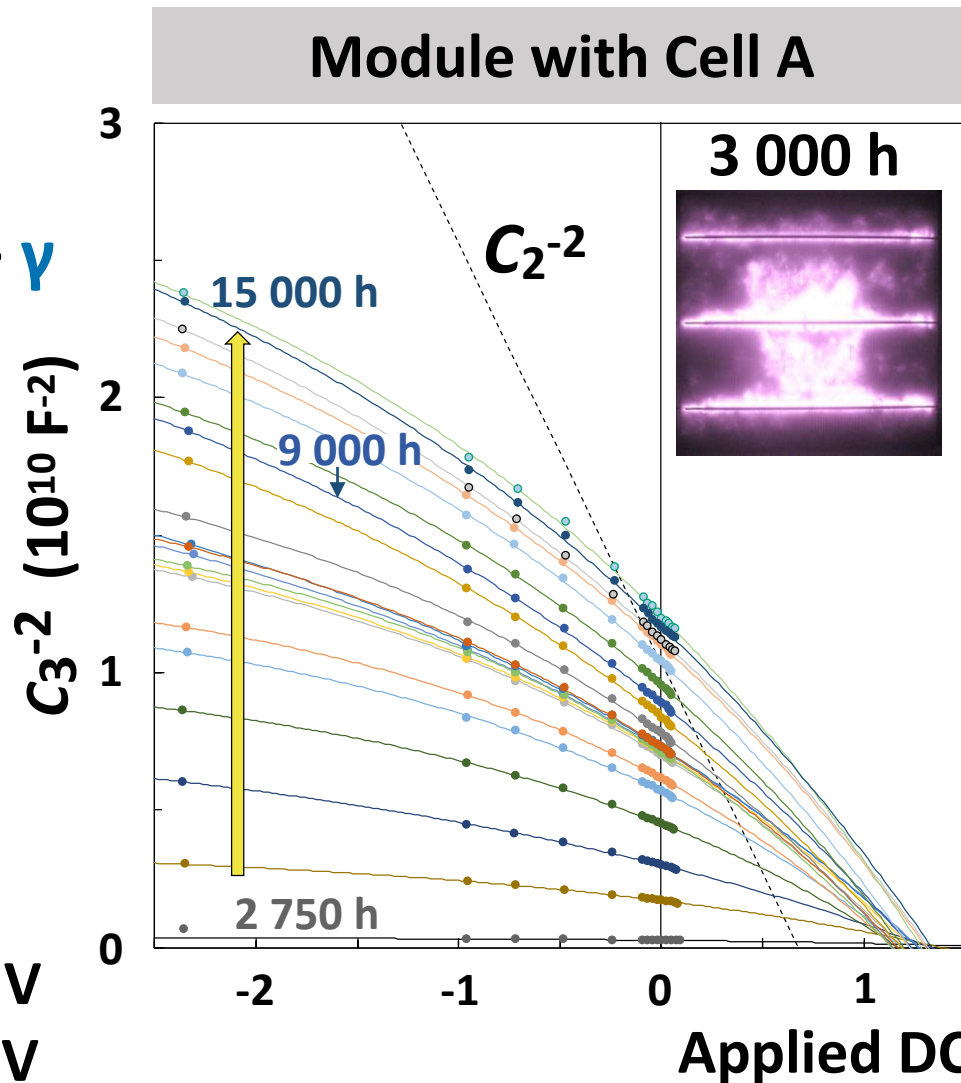
# Mott-Schottky Plots [ $C_3$ ]

$C_3$ : non-Linear

$$C_3^{-2} = \alpha \exp(-\beta V) + \gamma$$

$\alpha$ : Reduction

$\beta$ : nearly Const.

$\gamma$ : Elevation

Cell A =  $1.233 \pm 0.072$  V

Cell B =  $1.010 \pm 0.077$  V

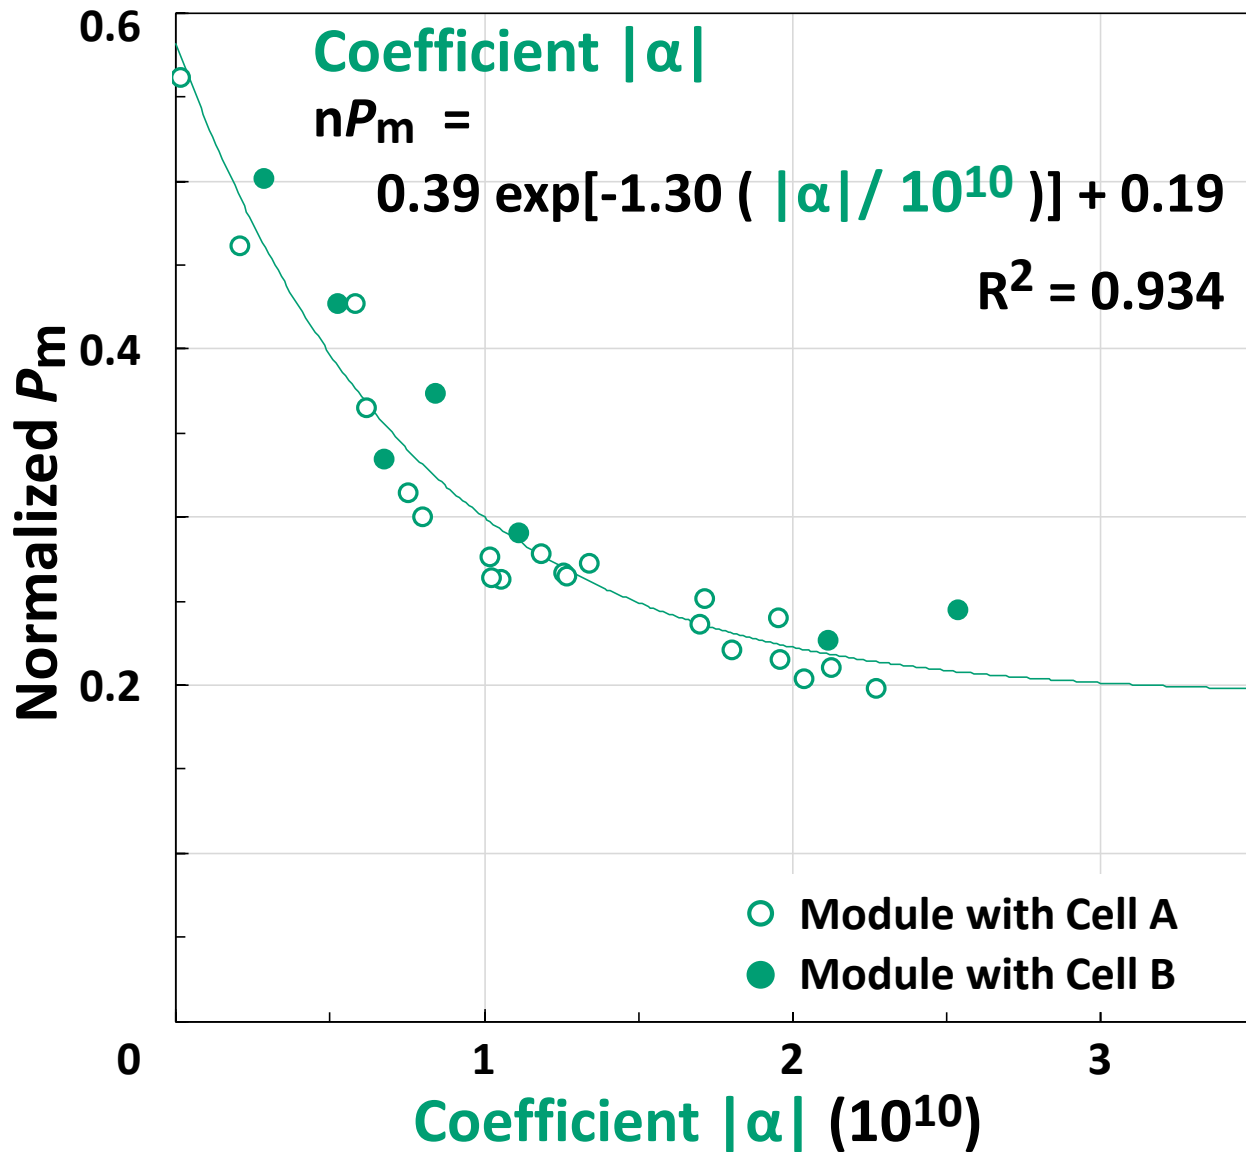
## Correlation of Coeff. $|\alpha| \cdot \gamma$ with $P_m$ -Loss
