**Federal Building and Fire Safety Investigation
of the World Trade Center Disaster**

Visual Data Collection and Analysis

**William M. Pitts, Research Chemist
Building and Fire Research Laboratory
National Institute of Standards and Technology
U.S. Department of Commerce
wpitts@nist.gov**

Visual Collection and Time Line Development for WTC 1, 2, and 7

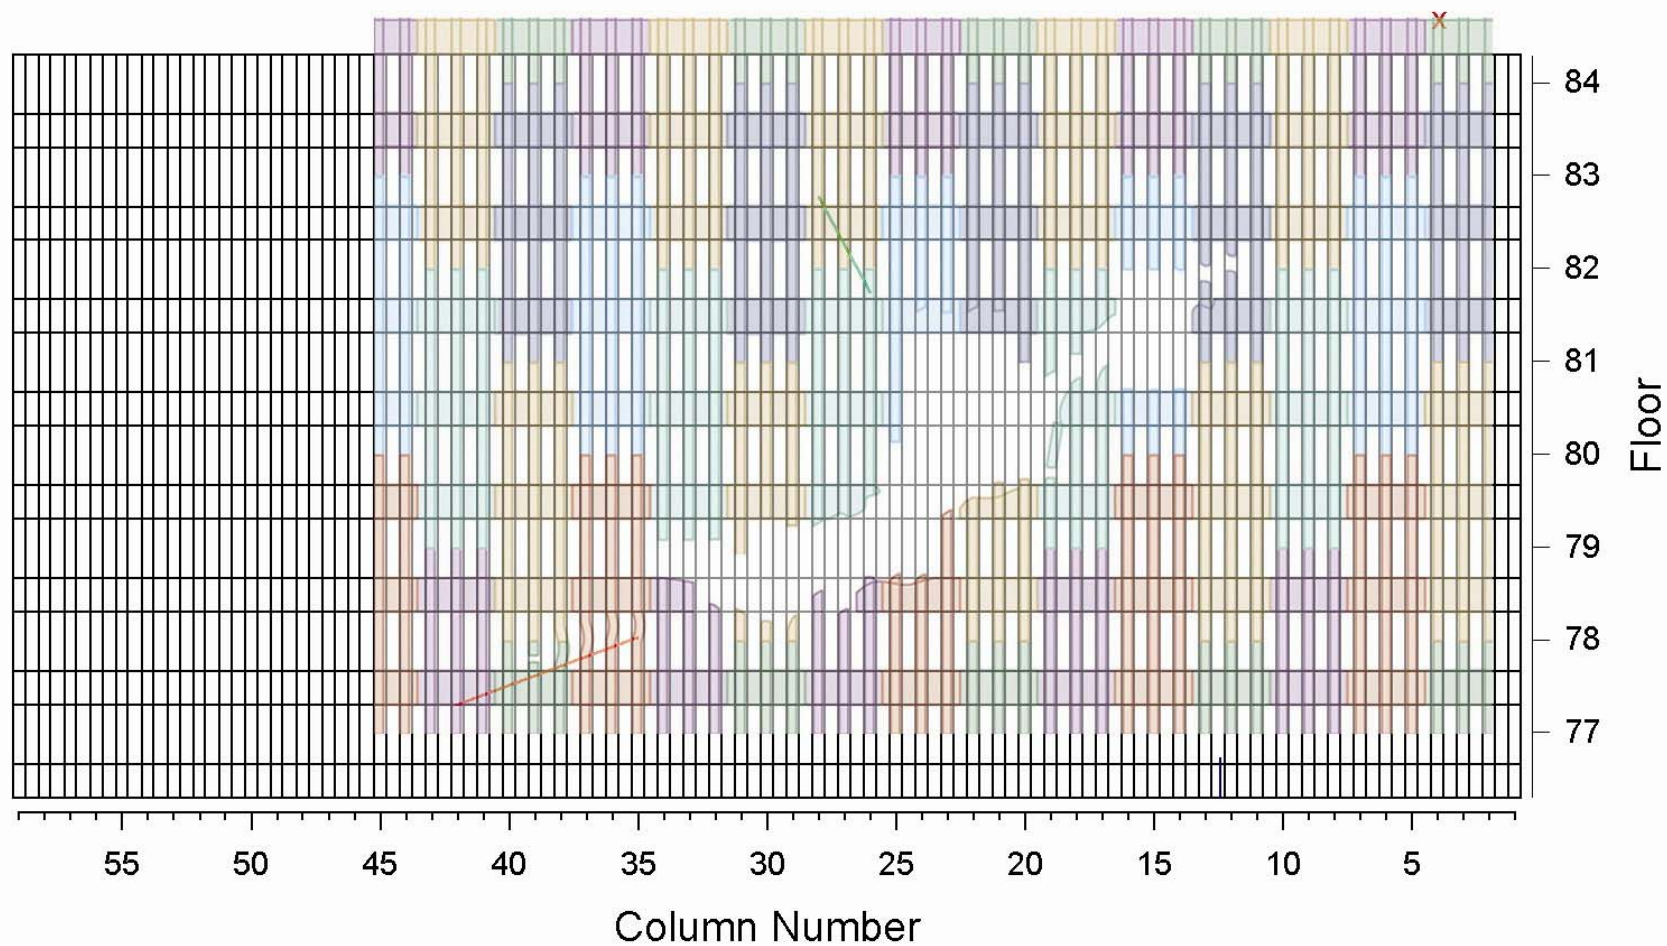
Plane Wing and Tail Marks on the South Face of Tower 2
Left Wing: 77th, Tail: 83rd, Right Wing: 85th

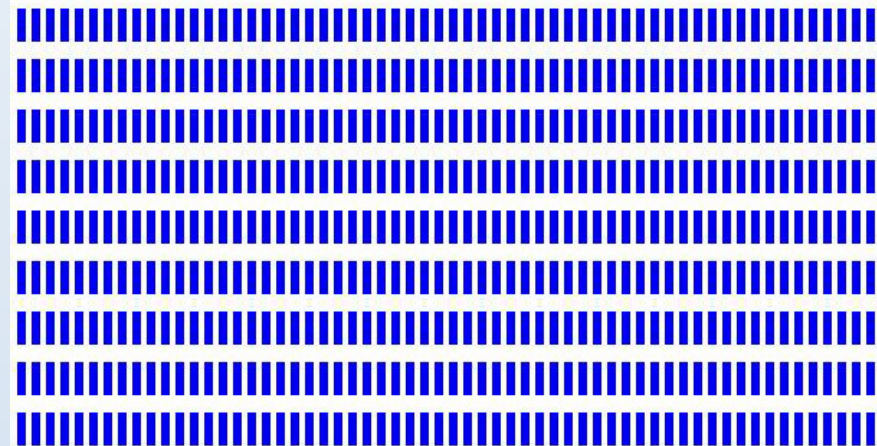
WTC 2 Initial Windows Missing

- Windows intact
- Windows missing
- Hidden
