Trends in Field Failure Modes

John Wohlgemuth

PowerMark Corporation

**Atlas/NIST Workshop on
Photovoltaic Materials Durability**

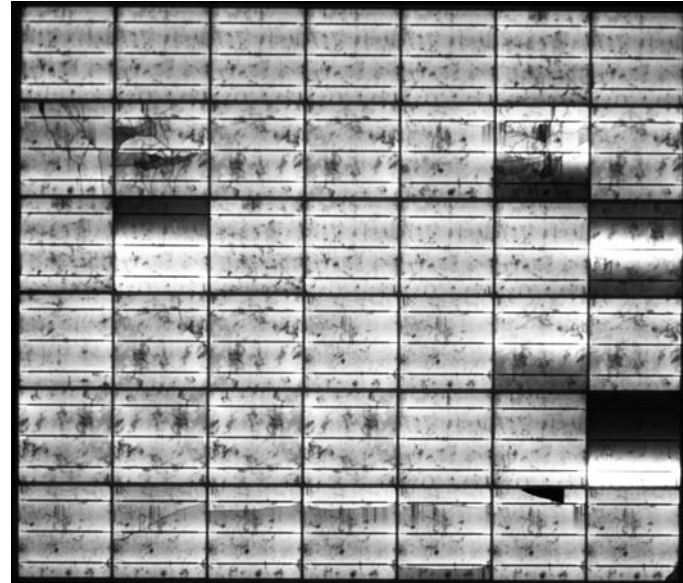
Broken Interconnects

- Interconnects break due to stress caused by thermal expansion and contraction or due to repeated mechanical stress.
- Early modules suffered open circuits due to broken interconnects so redundancy helps.
- Observed in EL as dark areas where that interconnect should be collecting.
- What makes it worse
 - Substrates with high thermal expansion coefficients
 - Larger cells
 - Thicker ribbon
 - Stiffer ribbon
 - Kinks in ribbon
 - Not enough free ribbon between solder bonds on adjacent cells.
- Problem mostly eliminated with
 - Extremely soft flexible ribbon
 - Tab across designs
 - Multiple ribbons per cell
 - Use of glass superstrates

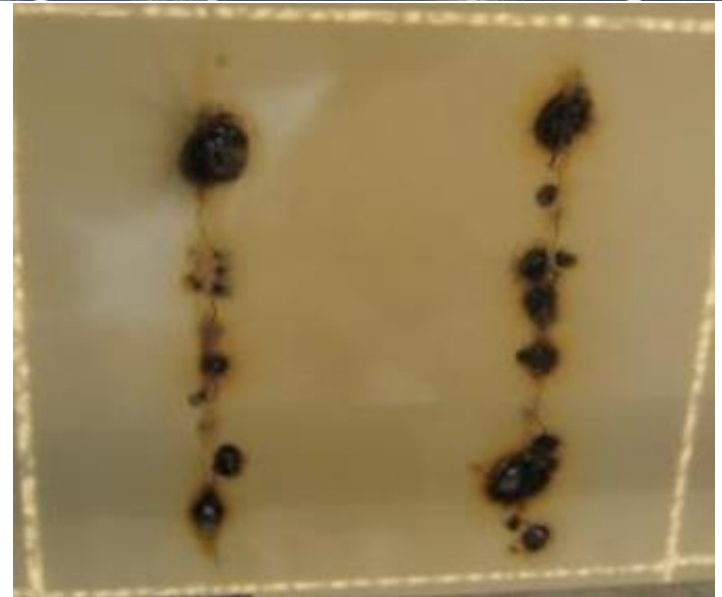
Solder Bond Failures

- Solder bonds fail due to fatigue caused by cyclic loading, e.g. repetitive thermal, mechanical or electrical stresses.
- Early modules typically only had 1 solder bond at each end of the interconnect ribbon and only one ribbon per cell so failure of one solder bond resulted in an open circuit failure of the whole module.
- Even today non-cell solder bonds often have little or no redundancy so failure of one of these bonds can lead to drop out of a cell string, a whole module or even a whole string of modules.
- Single point failures like the top picture are usually workmanship related.
- Multiple failures like the bottom picture are usually design related (solder bonds too small) or a process issue (production equipment not in control).

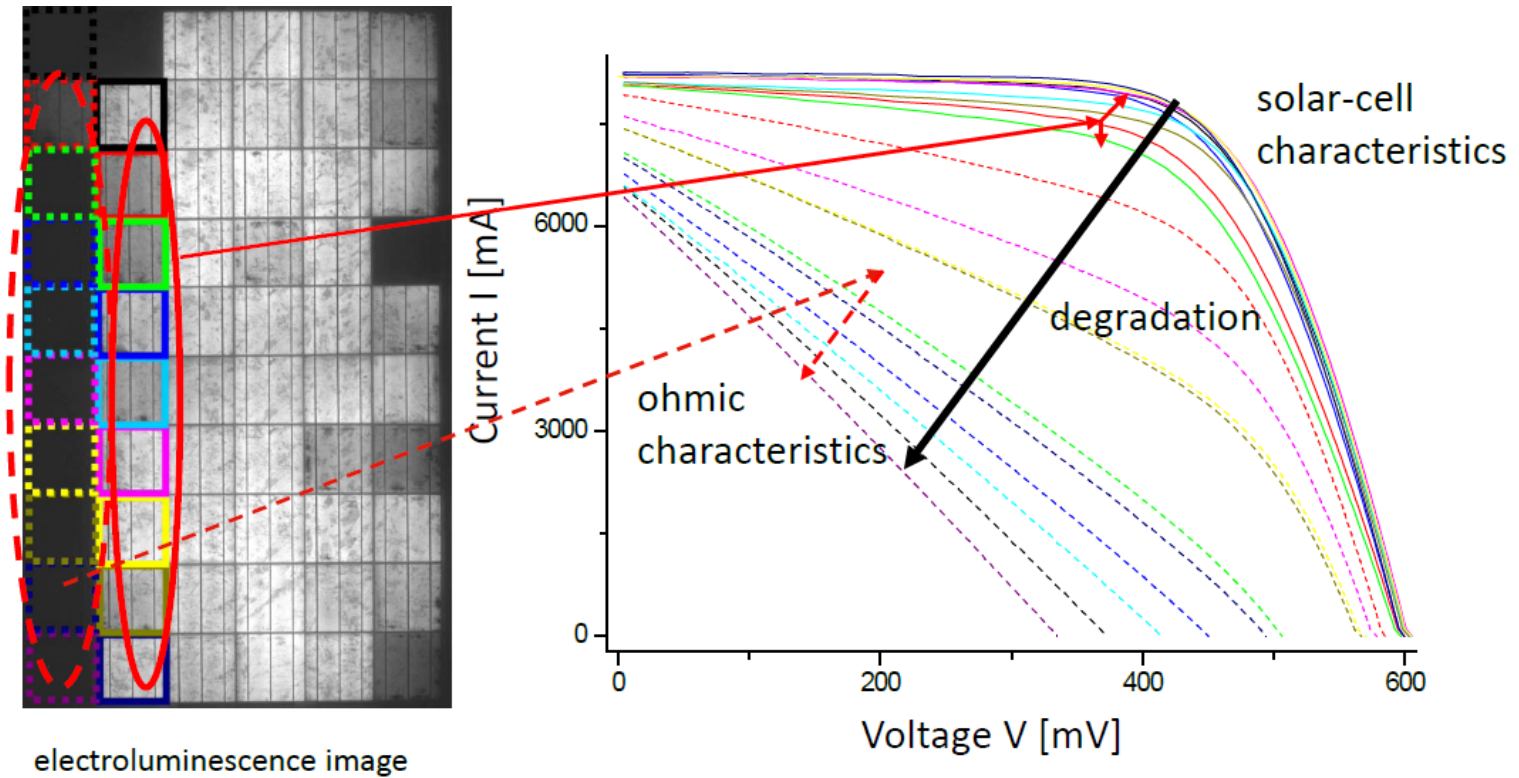
PID-s → Potential induced degradation by shunting of solar cell

- This is a more recent defect with reports of PV systems suffering power loss due to System Voltage Stress or PID.
- It only occurs when modules are operated at high negative bias and seems to require high humid or frequent rain, that is the module front glass gets wet.
- Appears to be related to Na ion migration from the glass through the encapsulant to the cells. Effected cells are shunted. See EL picture
- **Only cells with SiN AR coating appear to be susceptible. Tuning the index of the SiN can change the degree of degradation significantly. This may mean it is susceptible to process variability, so some so called PID resistant cells end up having PID field problems.**
- Process is at least partially reversible by switching the direction of the bias voltage or removing bias.
- **More permanent solution appears to be use of lower conductivity encapsulants.**
