Champlain Towers South Collapse NCST Investigation Update

NCST Advisory Committee Meeting

October 19, 2022

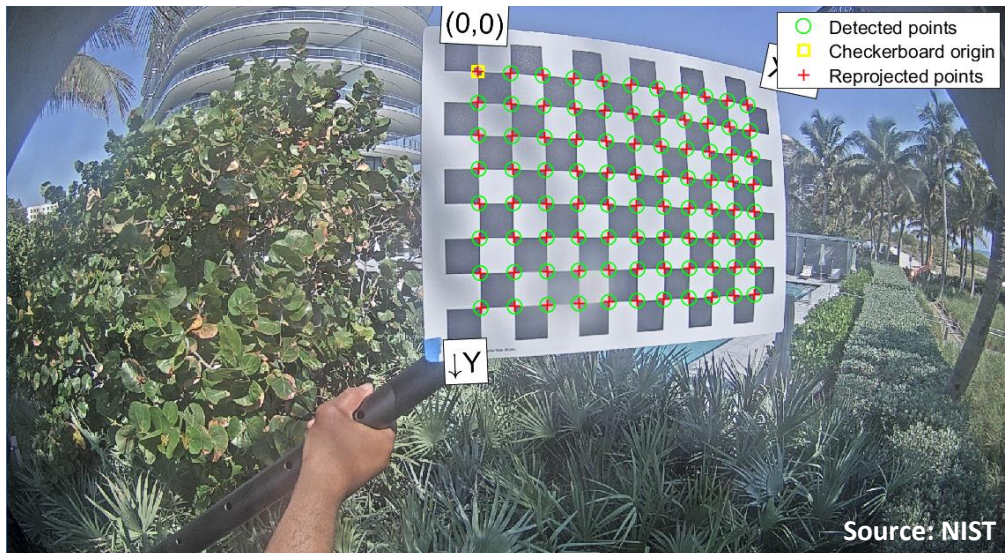
Original image with corners detected

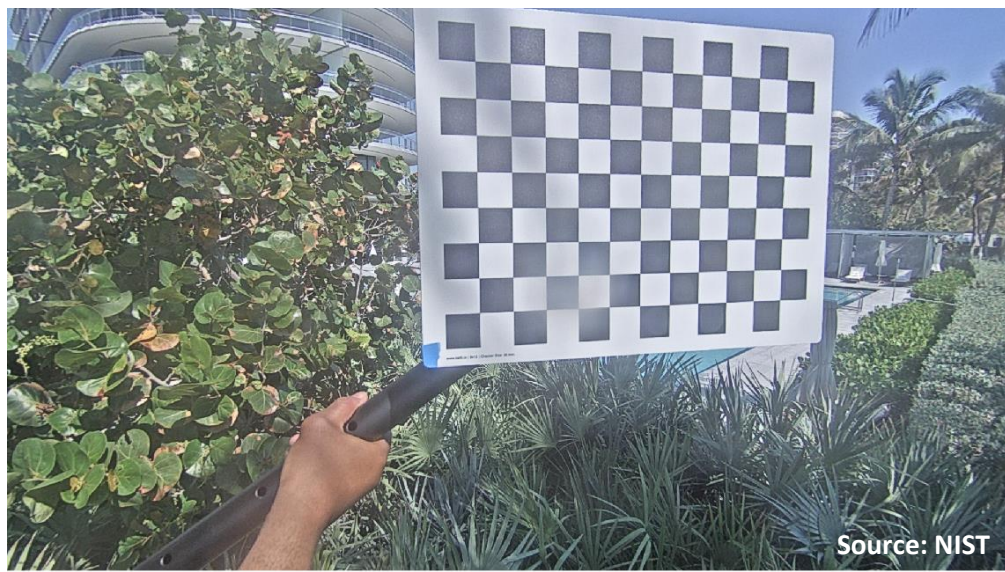
Rectified image

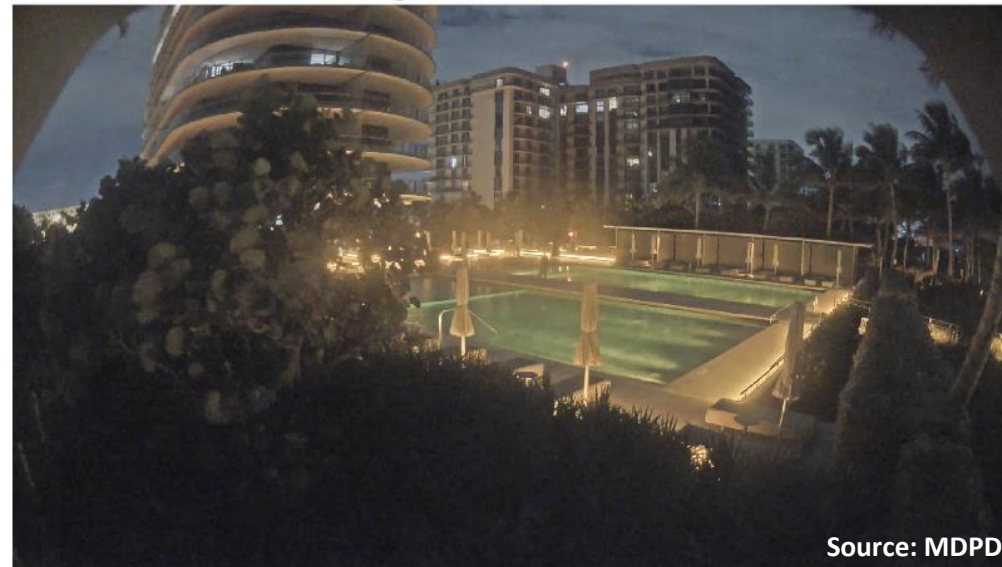
Original video frame 135

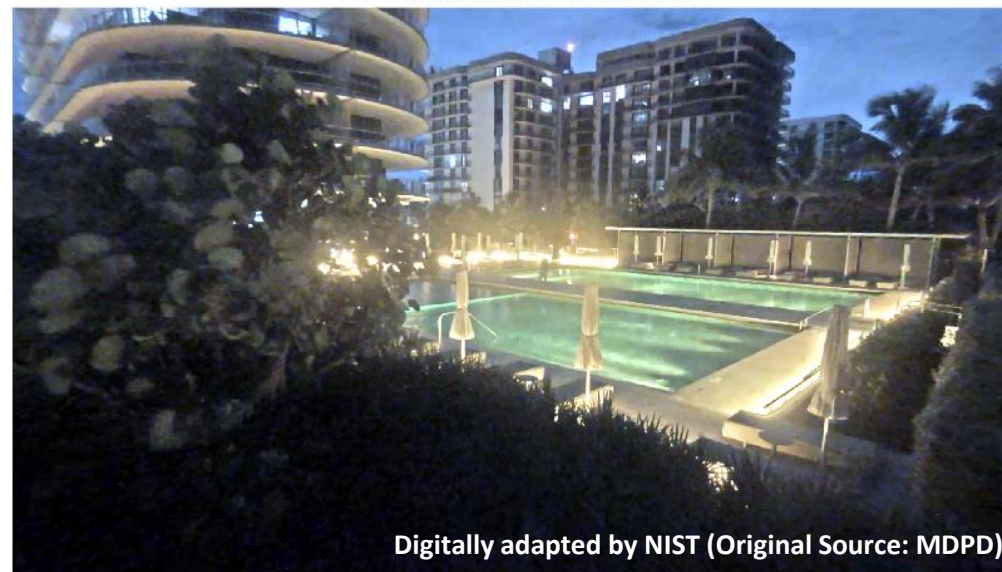
Rectified video frame 135

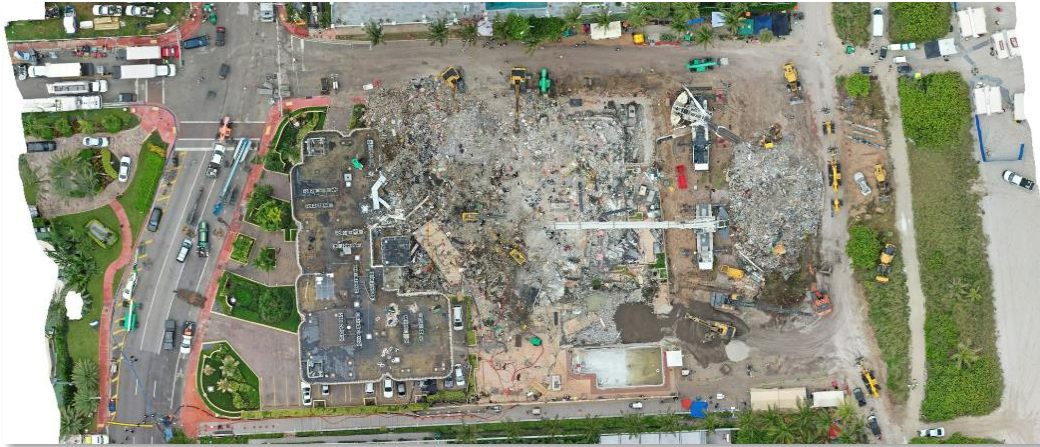
Develop Targeted Image Tagging

Example: Corrosion of top-of-slab reinforcing steel in the pool deck slab. Relevant evidence is found in:

- Concrete casting zones
- Top-of-slab rebar cover and detailing
- Topography & drainage of the slab
- Repairs and evidence of leakage
- Evidence of corrosion of top-of-slab rebar and column rebar

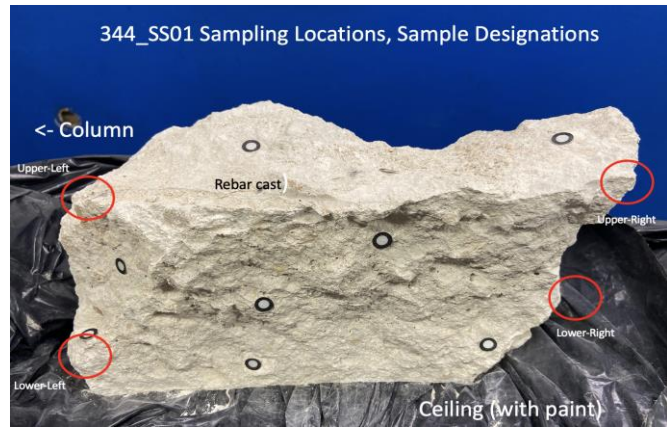
Chips removed from surface for SEM and XRD
source: NIST

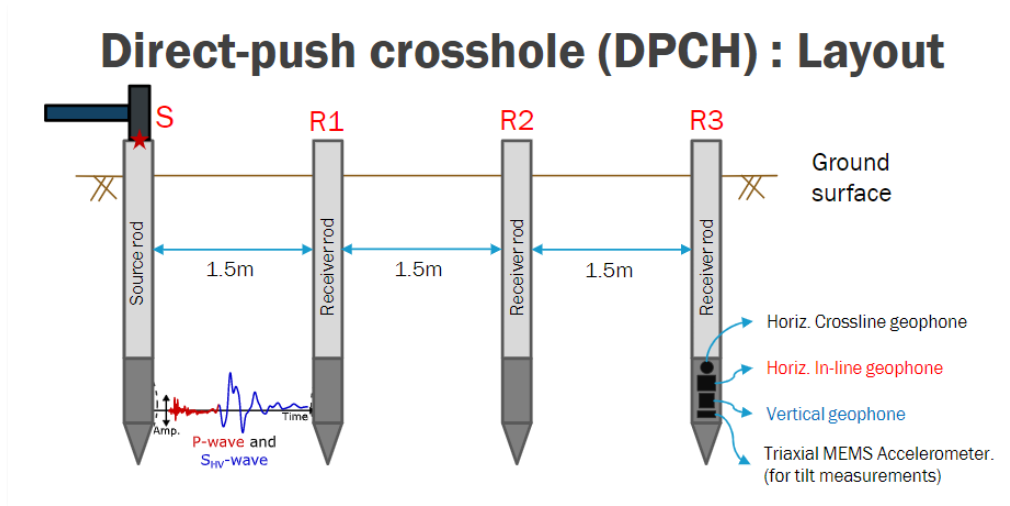
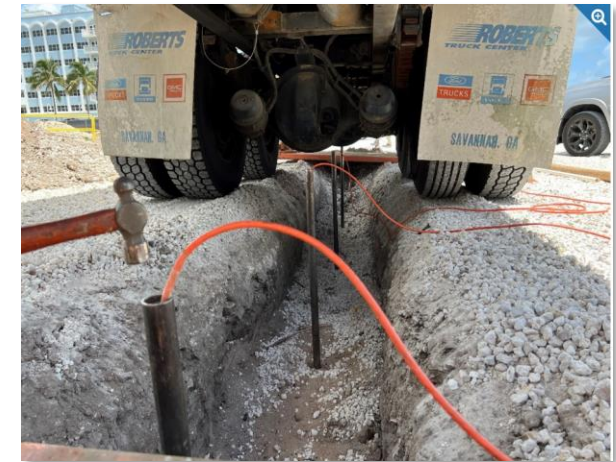
On-site Vibration Testing

source: Utah State University | Subsurface Imaging and Earthquake Engineering Lab

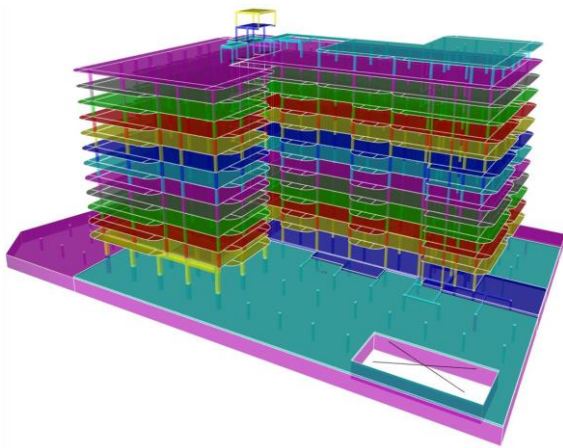
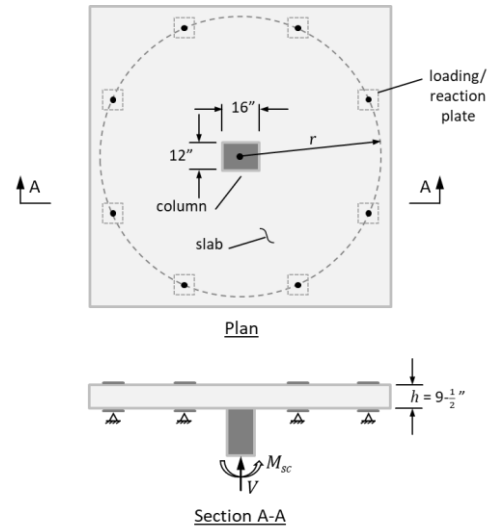
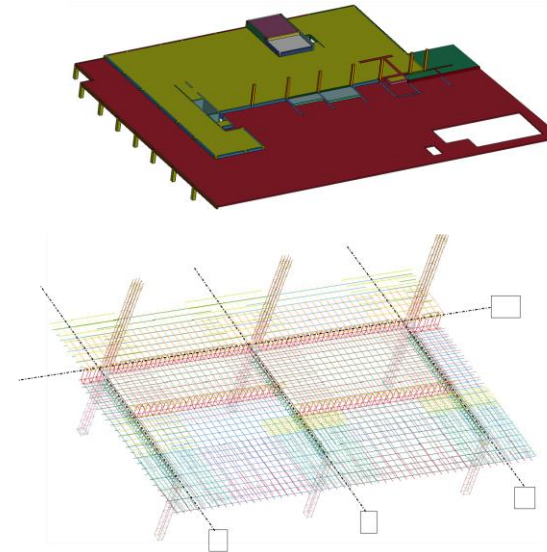
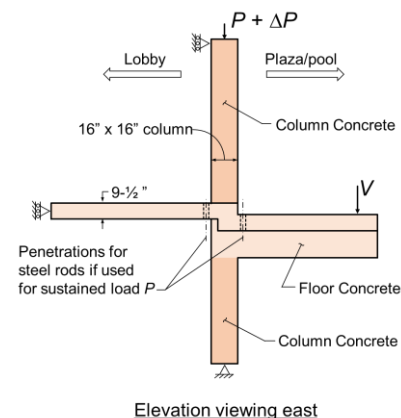
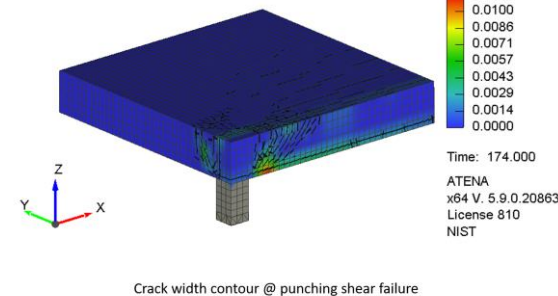
Analysis of Collapse Evidence

Crack width contour @ punching shear failure
