Message from the NIST Director

On September 26, 2022, a NIST staff member on our Gaithersburg, Maryland, campus died after falling from a research structure that partially collapsed during demolition. No similar workplace death had occurred at a NIST facility in nearly 100 years, and it has had a profound effect on us. It has made clear that we must change how we think about and implement safety across the entire organization.

In response to the work-related fatality at the National Fire Research Laboratory on September 26, 2022, the National Institute of Standards and Technology (NIST) initiated a planned, two-step process to understand the causes of the incident and identify actions necessary to prevent future incidents.

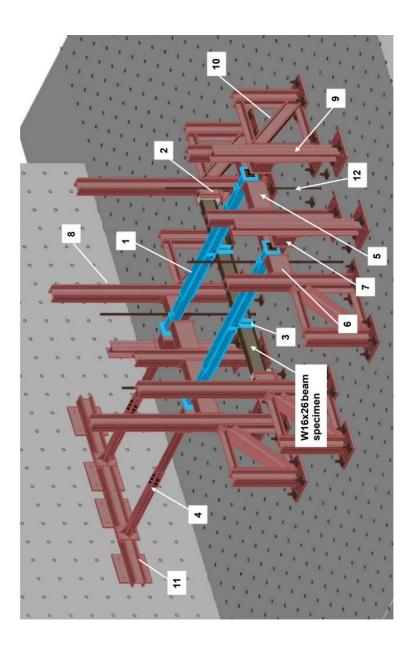
Figure 6.3.1: Schematic of the beam test set-up for the hazard review titled NFRL Commissioning Phase III – Ambient Beam Test (#733.06.0002).

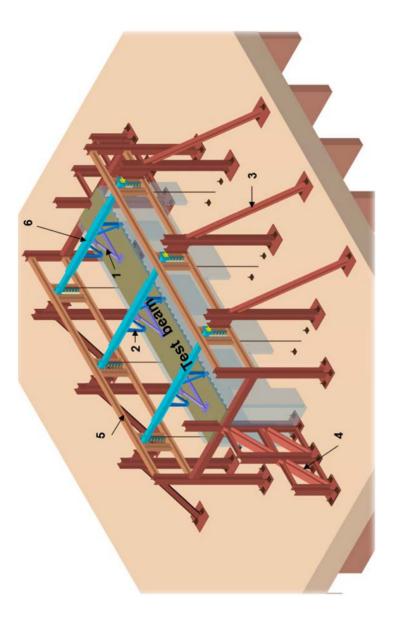
Figure 6.3.3: Schematic of the test apparatus for the hazard review titled Composite Beam Fire Test (#733.06.0078).

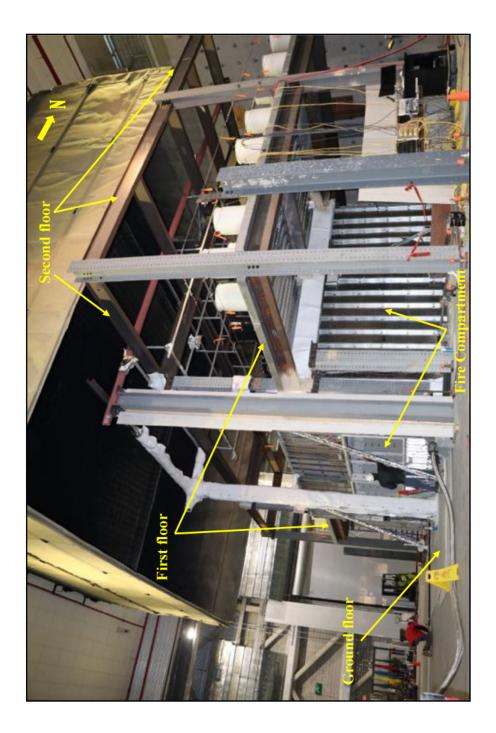
Figure 6.4.1: Construction image of the test frame prior to CF1 experiment.

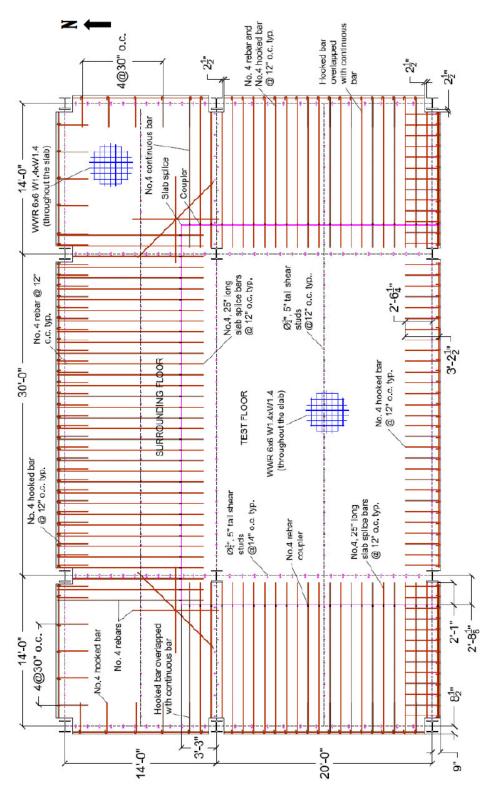
Figure 6.4.11: Steel reinforcement layout for the first floor of the CF1 Test. As the surrounding floor was not demolished between experiments, the steel reinforcement details shown here for the these locations were present at the time of the incident.

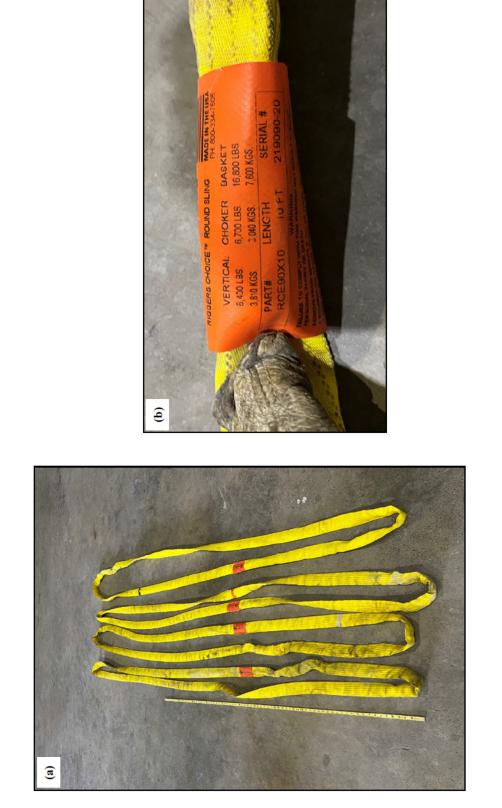
Figure 6.6.5: (a) Rigging slings used during the slab cutting and lifting process. (b) Typical label found on each sling.

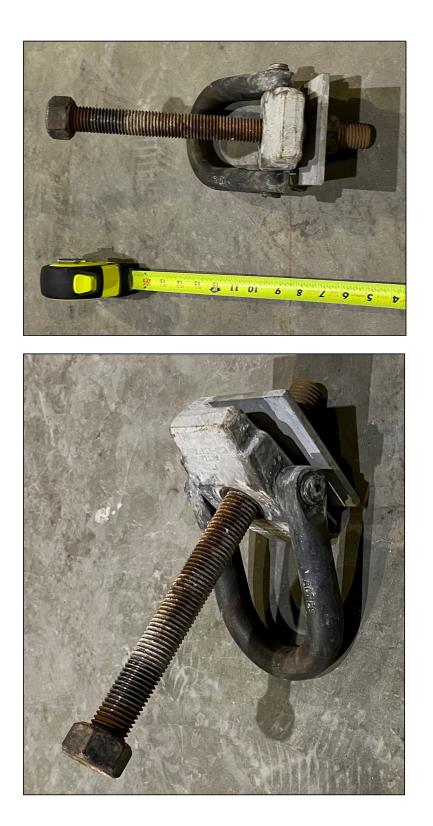
Figure 6.6.6: Rigging hardware assembly used to attach the rigging slings to the concrete slab. This specific set was attached to the northeast corner of Slab 4.

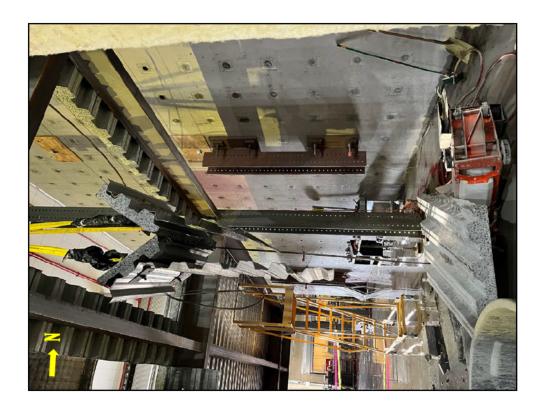
Figure 6.8.6: Image of the suspended concrete debris following the incident. The pile of concrete pieces and floor saw are observed directly below the suspended debris, with the rolling stairs in the background. Image was taken looking west.

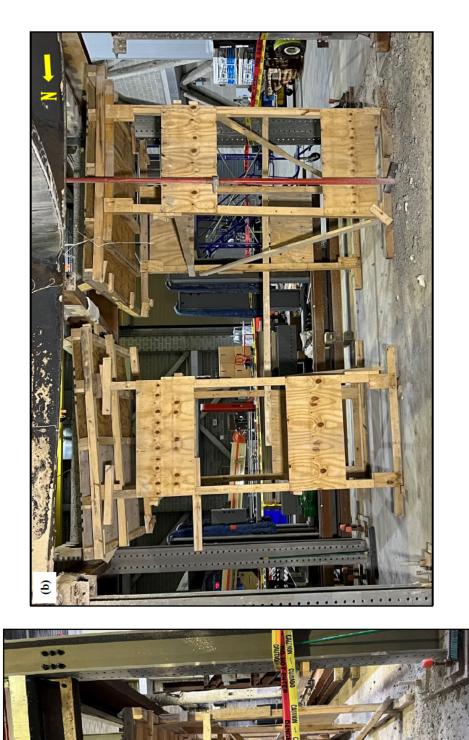
Figure 6.8.7: Image of the wooden structures positioned beneath the two southernmost cut bays (Slabs 1 and 2). (a) Image was taken looking north and (b) image was taken looking east.

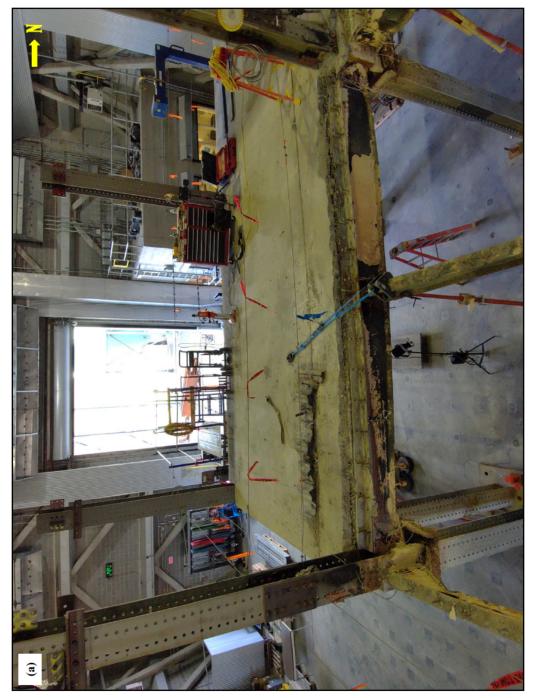
Figure 6.8.16: Images showing the condition of the surrounding floor after the incident. (a) Looking west.

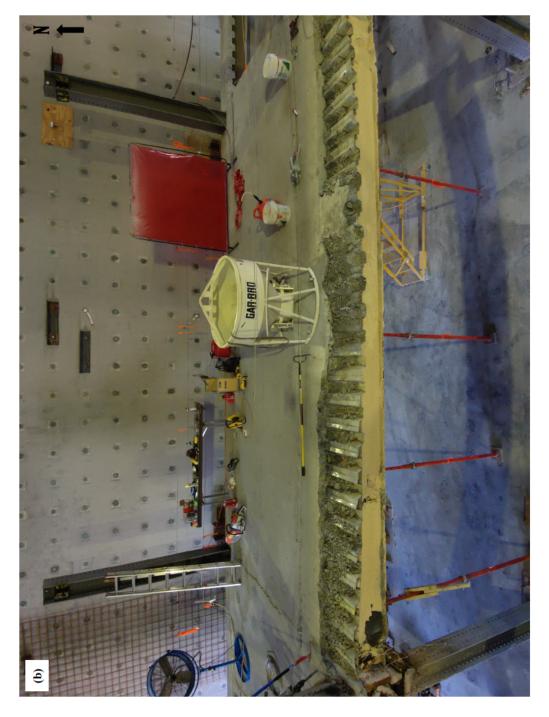
Figure 6.8.16 (cont.): Images showing the condition of the surrounding floor after the incident. (b) Looking north.

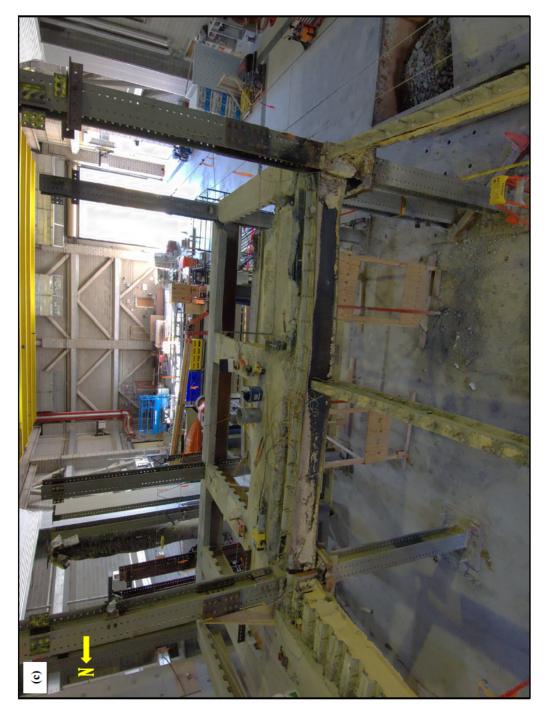
Figure 6.8.16 (cont.): Images showing the condition of the surrounding floor after the incident. (c) Looking east.

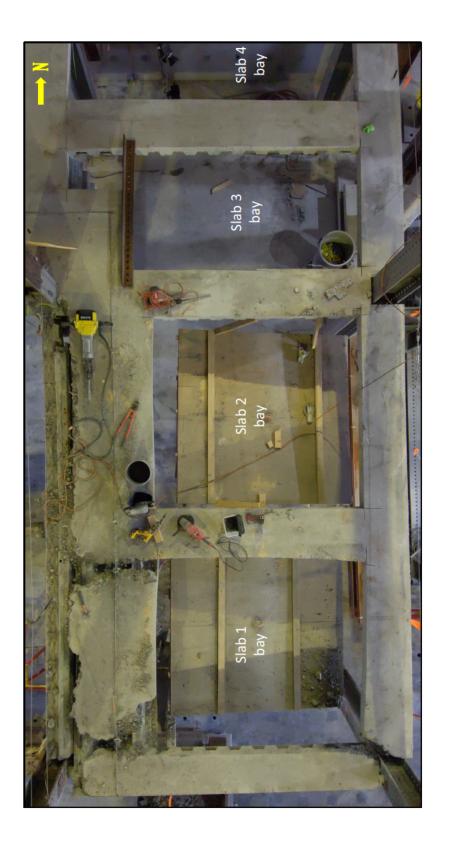
Figure 6.8.17: Image of the east side of the surrounding floor showing tripping hazards and object which could fall from the surrounding floor to the strong floor near unguarded edges.

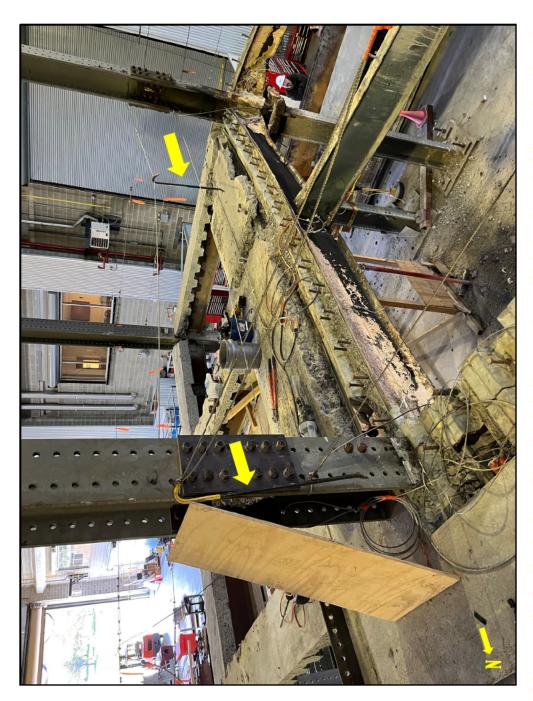
Figure 6.8.18: Images of the surrounding floor showing the conditions after the incident - crowbars are hooked on the passive fall protection cables (yellow arrows) and extra cable is haphazardly found near the column on the concrete slab. Looking southeast.

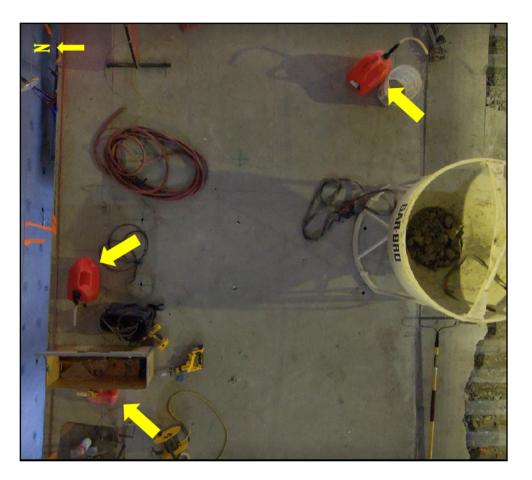
Figure 6.8.19: Images showing the condition of the surrounding floor after the incident – multiple flammable liquid containers are stored on the floor (yellow arrows).

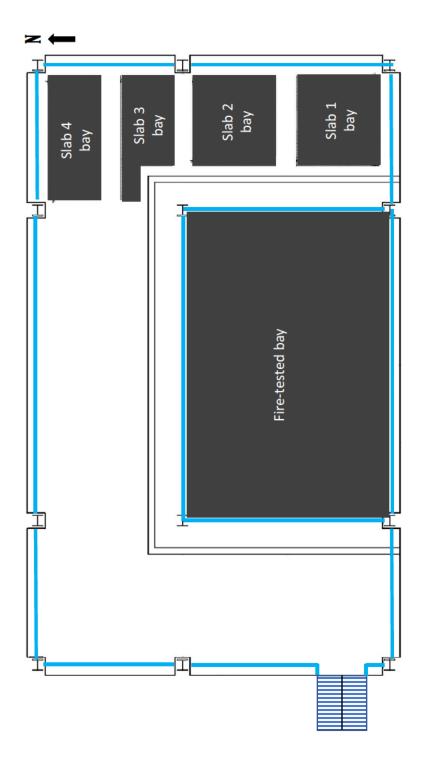
Figure 6.8.20: Diagram of the surrounding floor showing the location of the passive fall protection (blue lines).

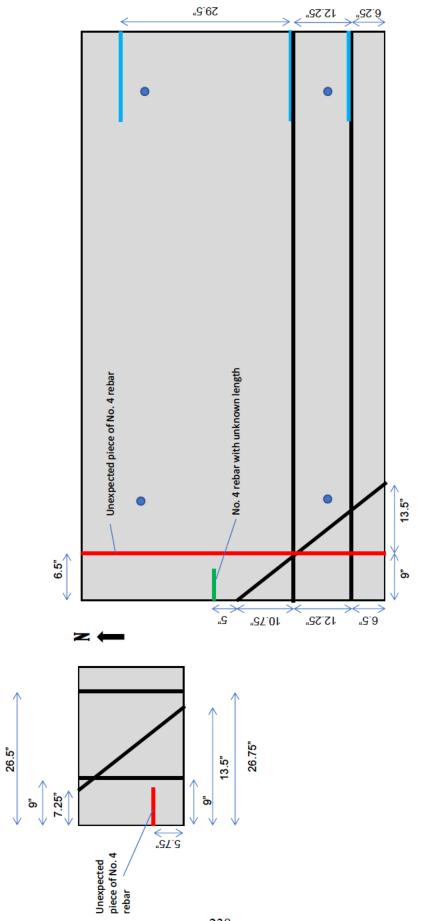
Figure 6.9.20: Observed rebar reinforcement of Slab 3. Blue lines represent the 38" hooked No. 4 rebar and assumed to extend 20" into the slab. The green line represents a piece of rebar with unknown extension into the slab. The red lines represent unexpected rebar observed.

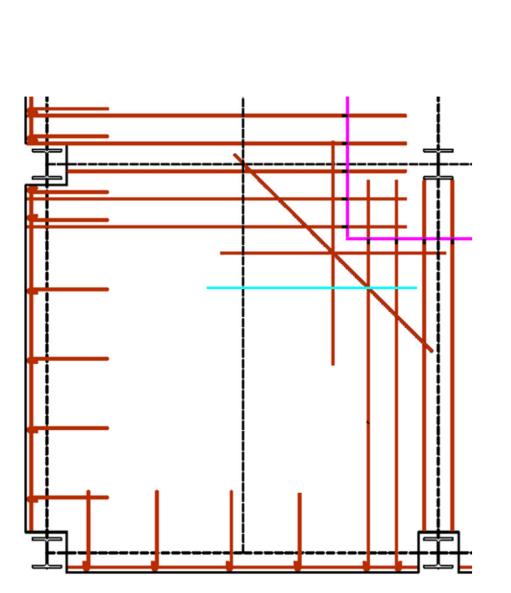
Figure 6.9.21 (cont.): (c) As-built drawing showing the rebar reinforcement of the northwest corner. Blue line represents the piece of rebar observed in the construction image.

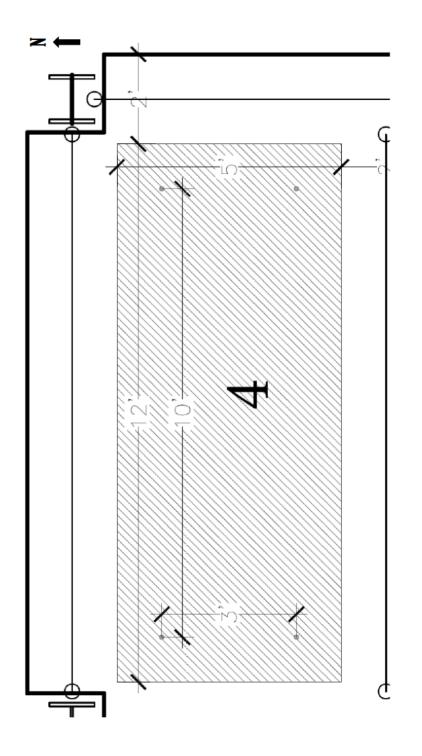
Figure 6.9.23: Approximate Slab 4 outline on the as-built drawing to indicate the anticipated location of the No. 4 rebar reinforcement.

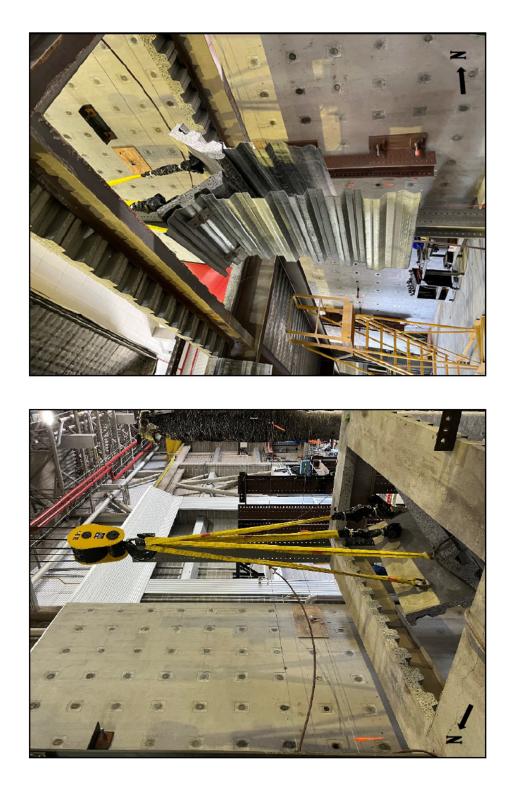
Figure 6.9.24: Two large pieces of Slab 4 were suspended by the rigging after fracture. Viewed from a) the surrounding floor looking east and b) the strong floor looking up and west.

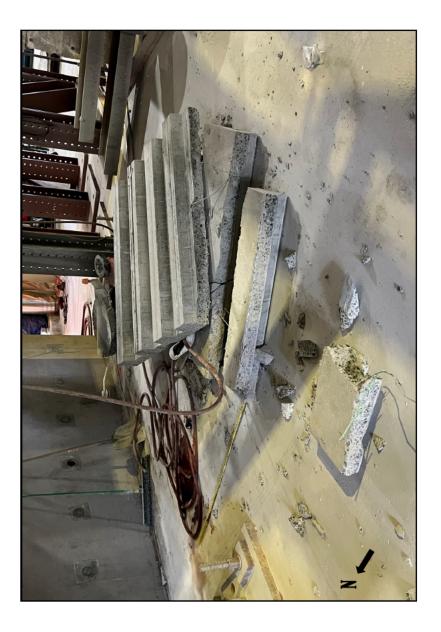
Figure 6.9.25: Four large pieces of Slab 4 found on the strong floor directly beneath the location where the slab was cut. Viewed on the strong floor looking east.

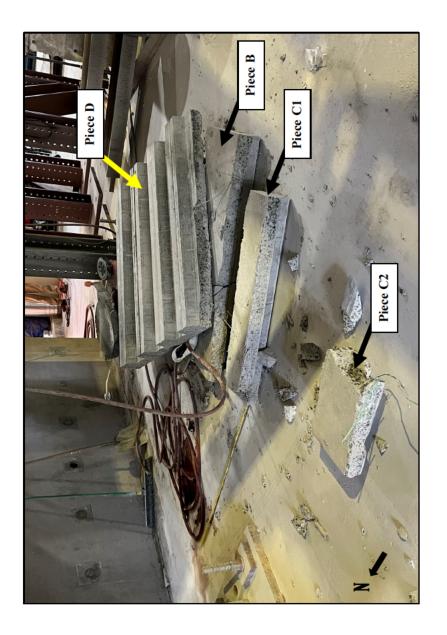
Figure 6.9.28: Four large pieces of Slab 4 were identified by matching up the contours of the fracture surfaces. Viewed on the strong floor looking east.

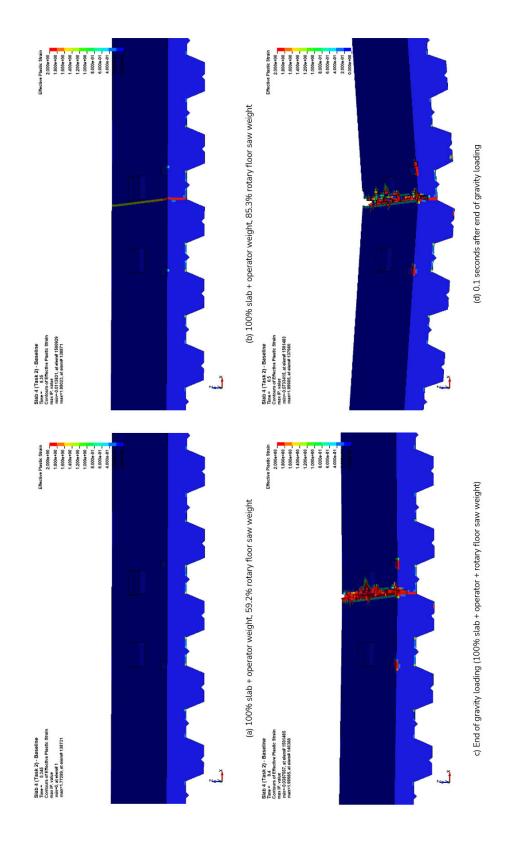
Figure 6.16.1: From Appendix 6.17.1, image showing simulation failure of Slab 4 "As Is".

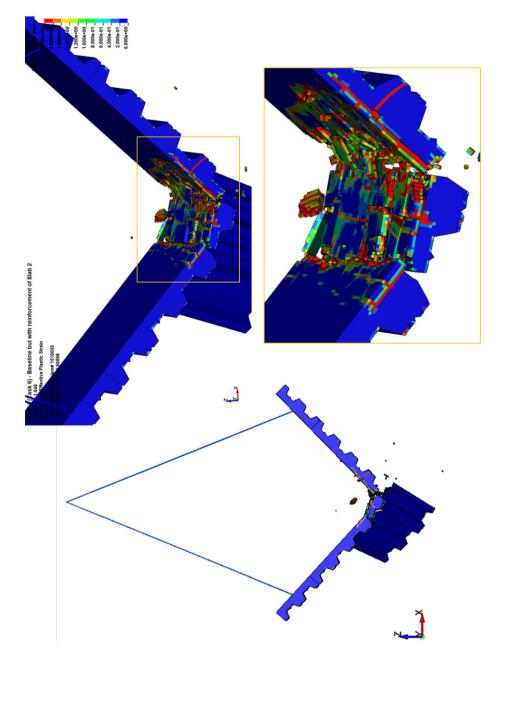
Figure 6.16.2: From Appendix 6.17, image showing simulation failure of Slab 4 "Reinforcement".

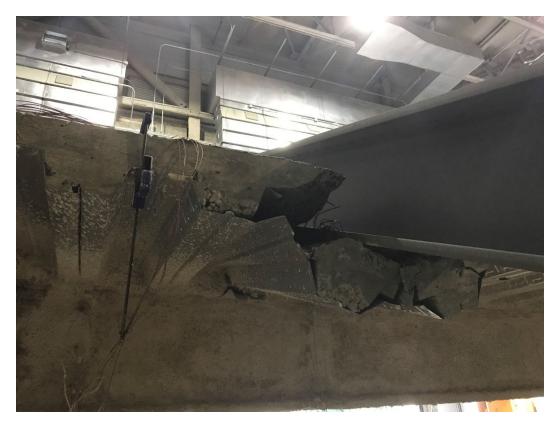
The impact of the column and the west LWACB caused damage to the west LWACB concrete deck (see images below).

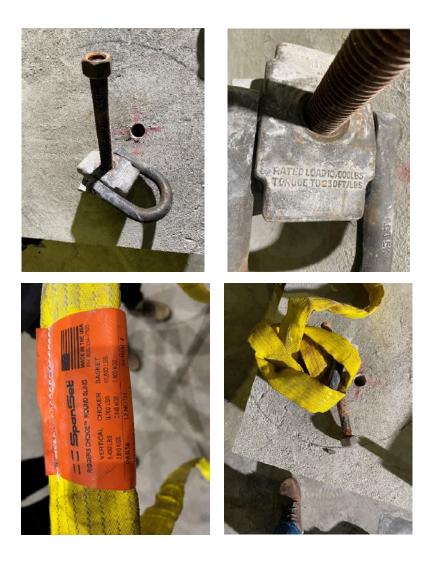
Figure 4-2 – Drilled hole for anchoring sling, load capacity marking on anchor, sling attachment as choker, marking on sling showing a capacity of 3,040 kg (6,700 lbf).

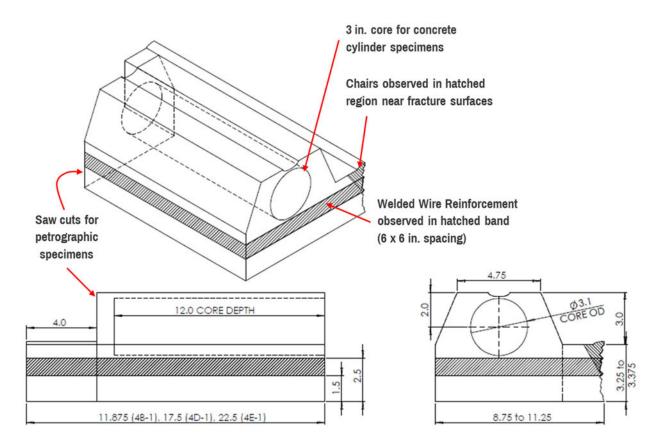
Figure 5-2 – Schematic of concrete cores and saw cuts used to extract specimens for mechanical testing and petrography from Slab 4 samples. (1 in. = 25.4 mm)

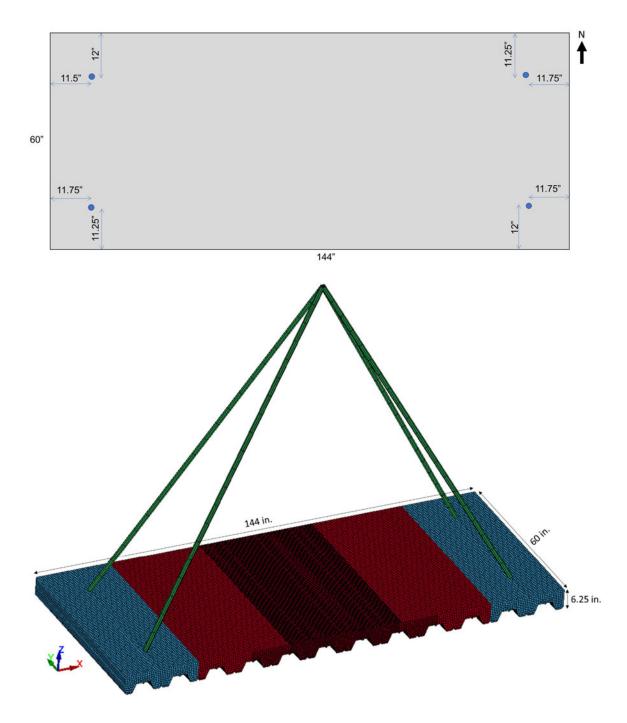
Figure 6-4 – FE model plan dimensions and mesh of Slab 4 (Model 1, Task 2) and Slab 4-Reinforced (Model 5, Task 6). Red elements are those having nonlinear concrete damage response and blue elements are those with linear elastic response. Anchor points were placed relative to slab corners using measurements provided in [9]. (1 in. = 25.4 mm)

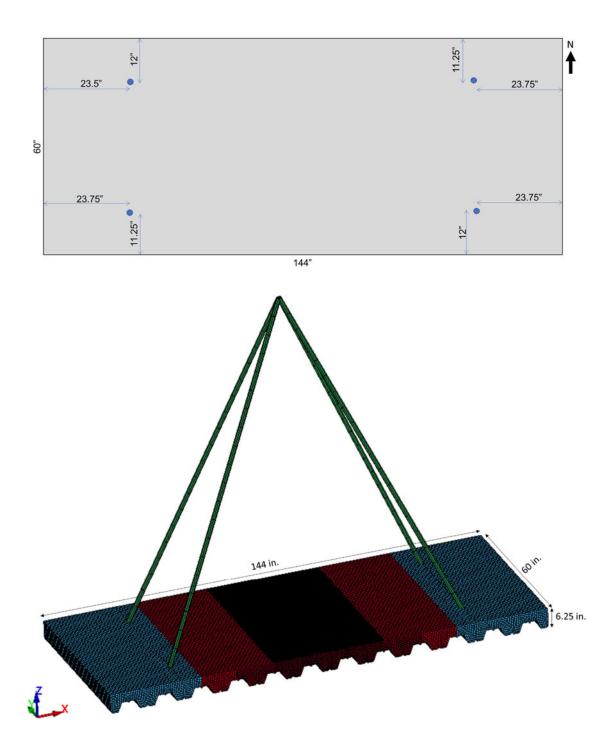
Figure 6-5 – FE model plan dimensions and slab mesh of Slab 4-Rigging (Model 6, Task 7). Red elements are those having nonlinear concrete damage response and blue elements are those with linear elastic response. Anchor points were placed relative to slab corners using measurements provided in [9]. (1 in. =25.4 mm)

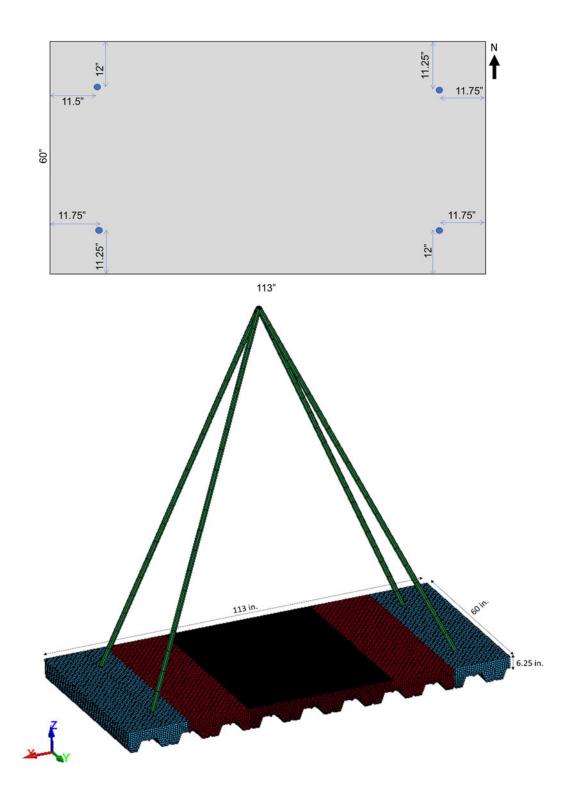
Figure 6-6 – FE model plan dimensions and slab mesh of Slab 4-Short (Model 4, Task 5). Red elements are those having nonlinear concrete damage response and blue elements are those with linear elastic response. Anchor points were placed relative to slab corners using measurements provided in [9]. (1 in. = 25.4 mm)

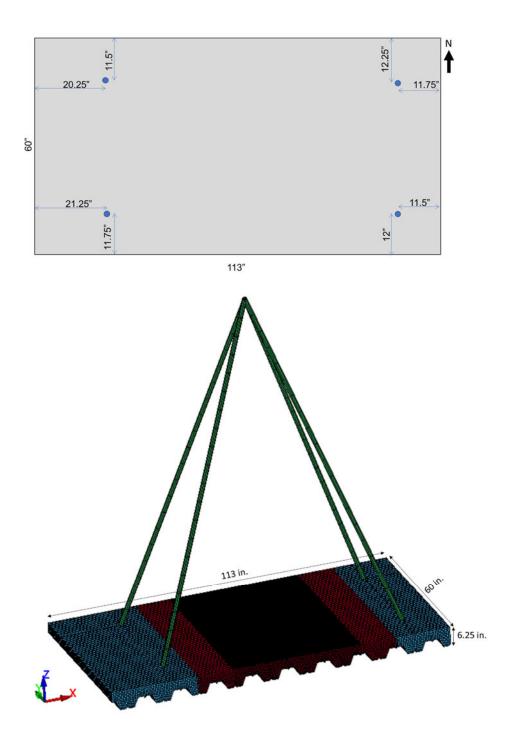
Figure 6-7 – FE model plan dimensions and slab mesh of Slab 3 (Model 2, Task 3). Red elements are those having nonlinear concrete damage response and blue elements are those with linear elastic response. Anchor points were placed relative to slab corners using measurements provided in [9]. (1 in. = 25.4 mm)

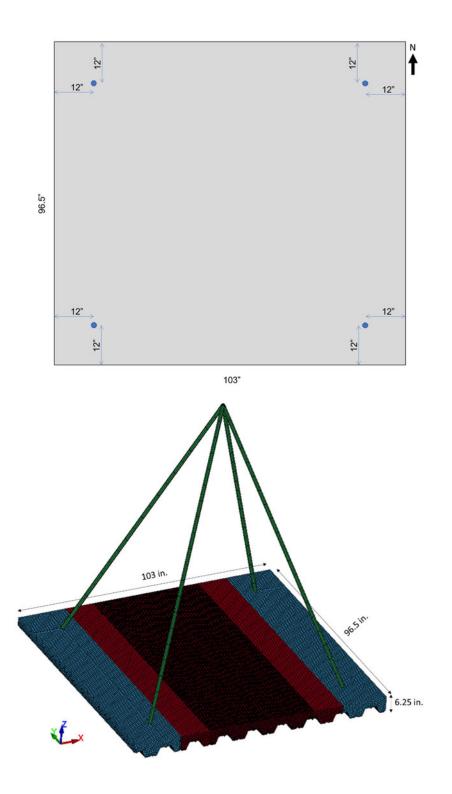
Figure 6-8 – FE model plan dimensions and slab mesh of Slab 2 (Model 3, Task 4). Red elements are those having nonlinear concrete damage response and blue elements are those with linear elastic response. Anchor points were placed relative to slab corners using measurements provided in [9]. (1 in. = 25.4 mm)

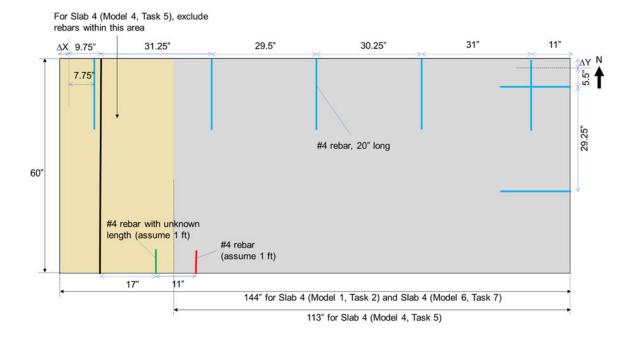
Figure 6-15 – Rebar planar positions in the FE model for Slab 4 (Model 1, Task 2), Slab 4-Short (Model 4, Task 5), and Slab 4-Rigging (Model 6, Task 7). Rebars were centered within the idealized slab dimensions by shifting the N/S bars by $\Delta X = +0.625$ in. and E/W bars by $\Delta Y = -0.5$ in. (1 in. = 25.4 mm)

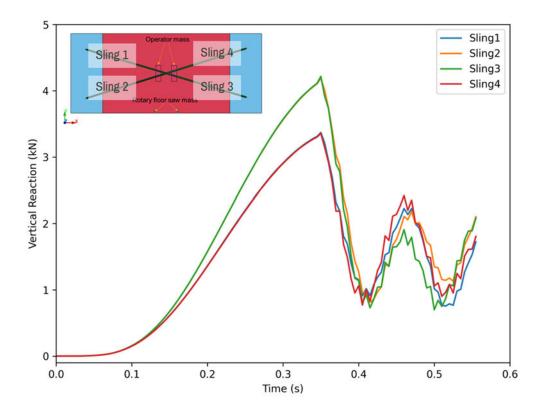
Figure 6-33 – Slab 4 (Model 1, Task 2): sling vertical reactions at anchor points.

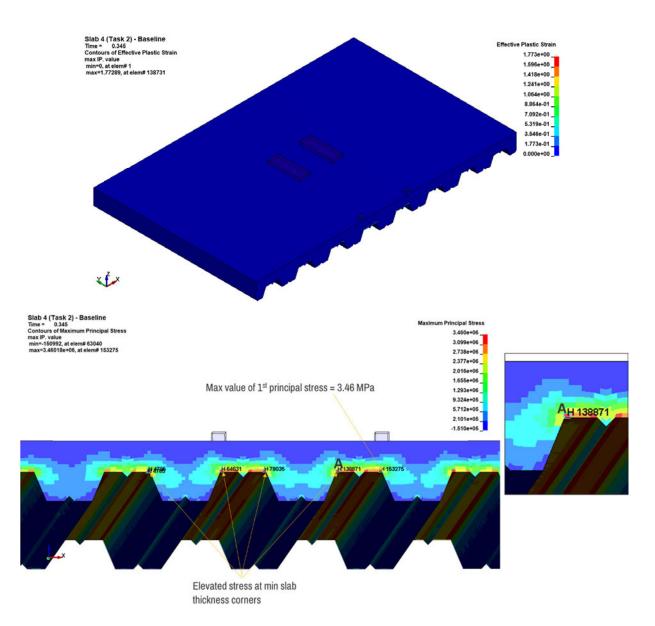
Figure 6-35 – Slab 4 (Model 1, Task 2): damage and maximum principal stress contours at 100% slab + operator weight and 59.2% rotary floor saw weight. The insert figure shows close-up of point A with maximum value of maximum principal stress. Note that under multi-axial stress state that results in confinement, the maximum principal stress can be higher than the uniaxial tensile strength (which is obtained under an unconfined tensile test). (1 MPa = 145.04 psi)

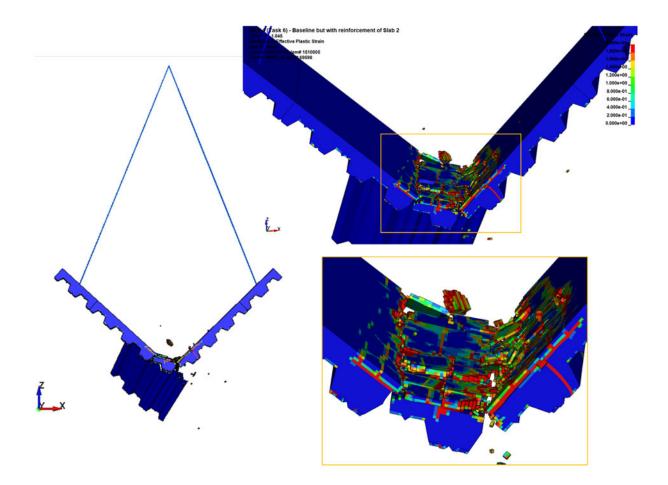
Figure 6-51 – Slab 4 Reinforced (Model 5, Task 6), damage contour at 0.645 seconds after full gravity.

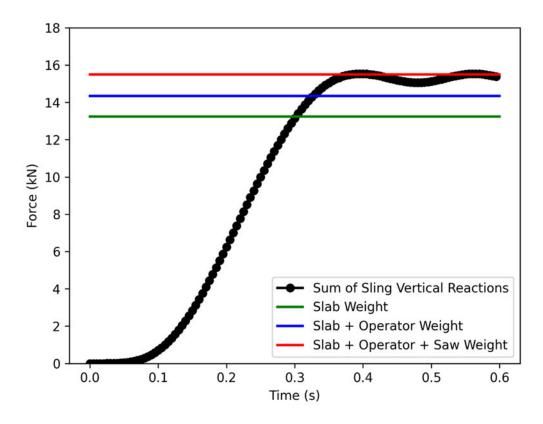
Figure 6-54 – Slab 4 Rigging (Model 6, Task 7), sum of sling vertical reactions.

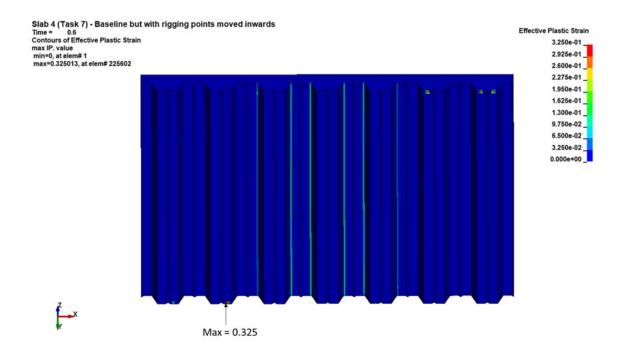
Figure 6-55 – Slab 4 Rigging (Model 6, Task 7), damage contour, view from under the slab. Note absence of cracking or crushing of concrete. Note: maximum damage value is about 0.33, localized at a connection point between slab joist and deck, maximum tensile damage at the minimum slab thickness corners is about 0.13 (maximum principal strain of approximately 70 micro strains).

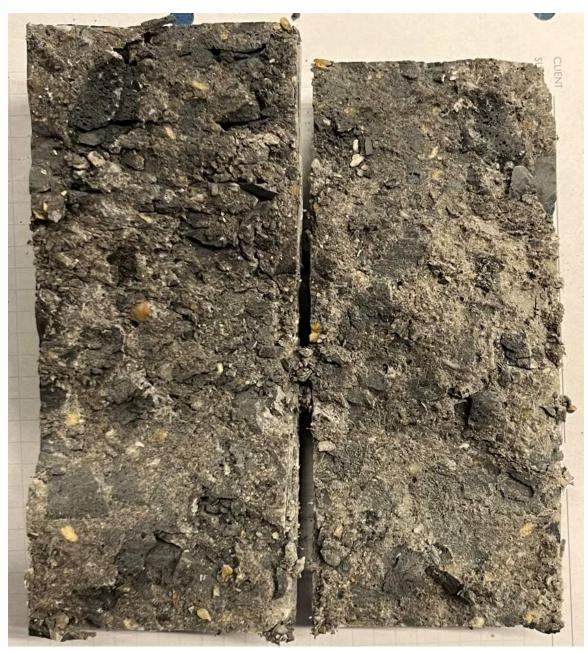
Photo 5-17 – Fracture surfaces of specimen 4D-1 after tension splitting.

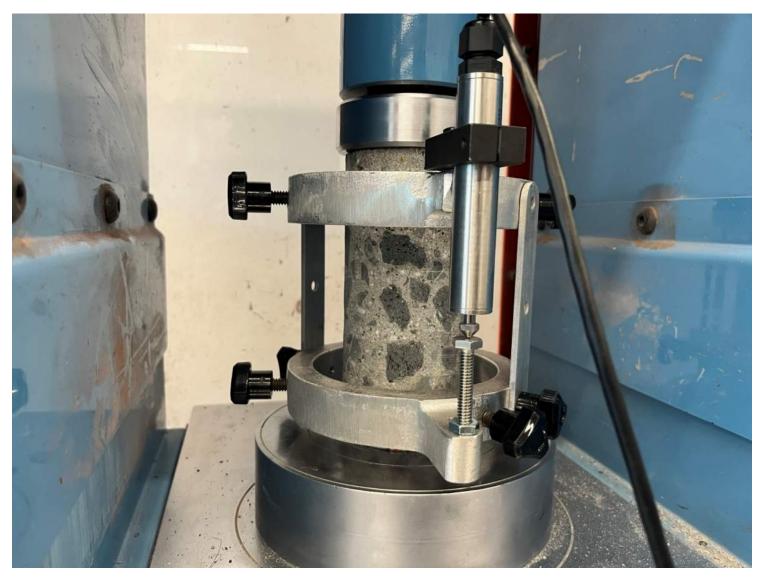
Photo 5-18 – Specimen 4D-1 with compressometer for elastic modulus testing.

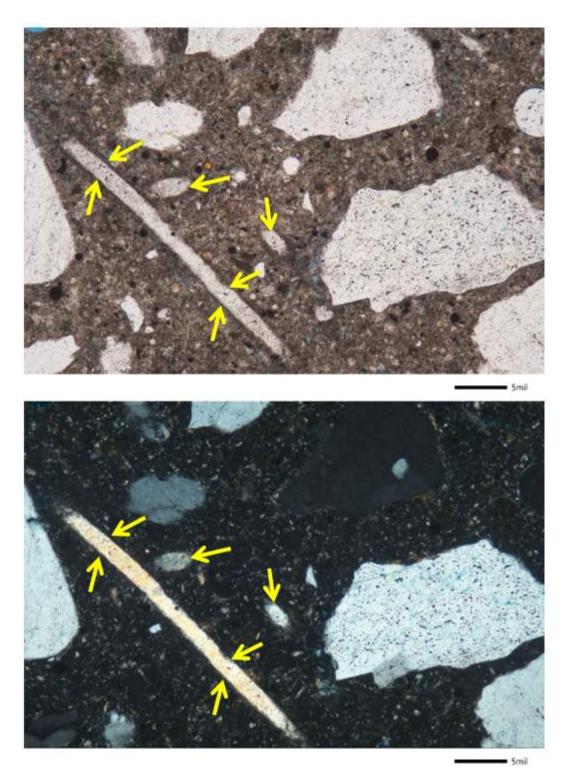
Photo 5-24 – Ultrathin section from Sample 4E-1 showing polymeric microfibers (yellow arrows) in the paste microstructure.

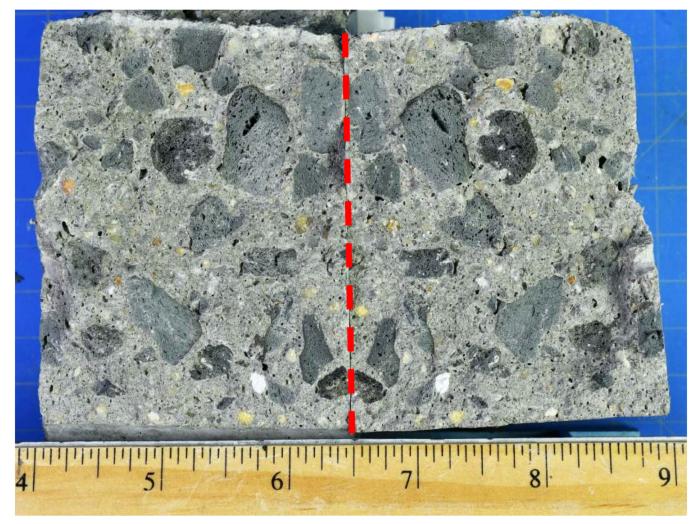
Photo 5-25 – Opposing surfaces along a lab-created fracture plane on a section of Sample 4E-1. Most of the coarse aggregate particles are broken through along this fracture plane, which indicates a well-developed paste-to-aggregate bond. The red dashed line marks the division between the opposing surfaces.
