# NCST Investigation of the Champlain Towers South Collapse

## Investigation Overview and Update

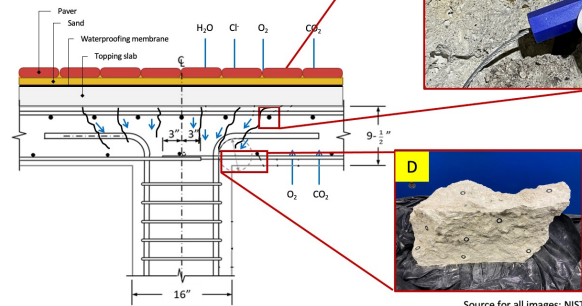
### (a) Degradation Mechanisms

1. Cracking creates a "highway" for Cl<sup>-</sup>, H<sub>2</sub>O, and CO<sub>2</sub> to reach reinforcing bar causing corrosion
2. Concrete microstructure altered by the environment, changing mechanical properties

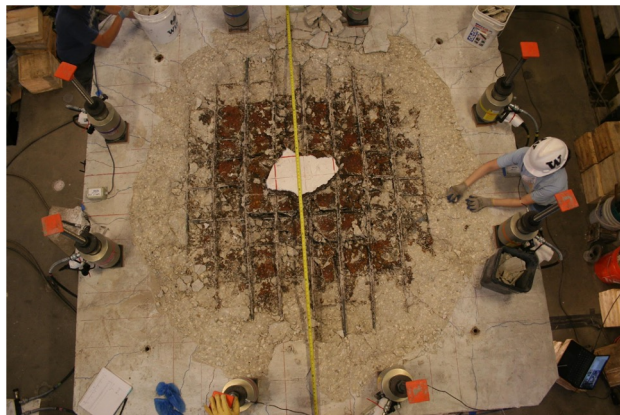
Post-test condition of slab-column connection tested, with corroded reinforcement.

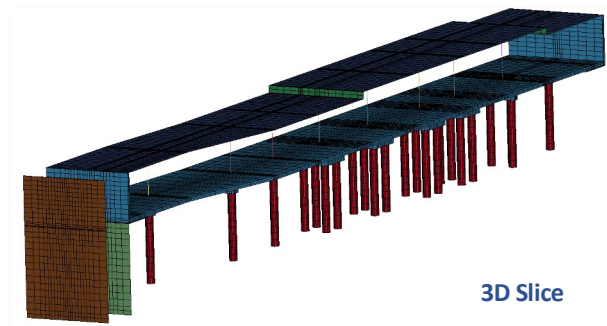
Computational model with substructural parameters (soil, rock, foundation) updated with input and uncertainties from lab tests.

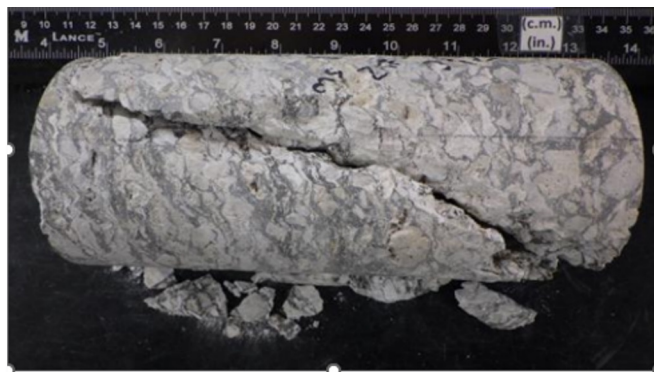
### Low Strength Test Results

Example foundation pile-shaft core with a low compressive strength test result.

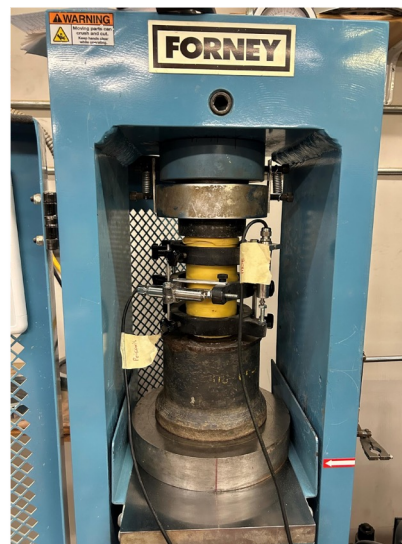
### Uncertainty Quantification

Compression strength tests of concrete cores with variable moisture content.

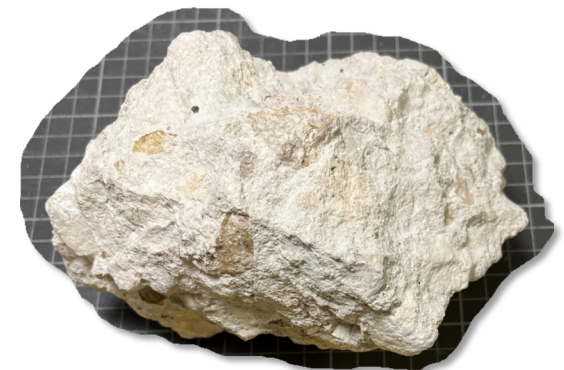
### Specimen Collection Bias

Sample of concrete reported to be “crumbly” by personnel working at collapse site.

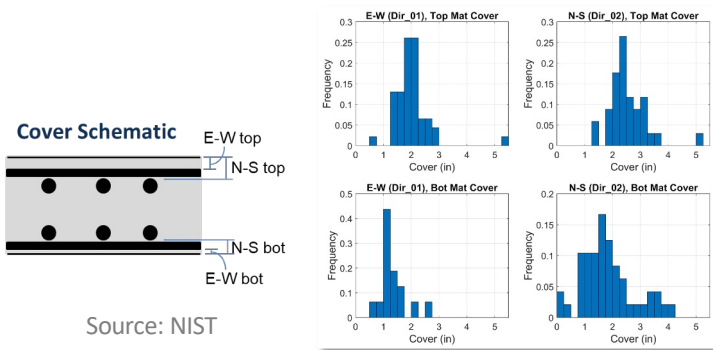
Detailed measurements used to analyze compliance.

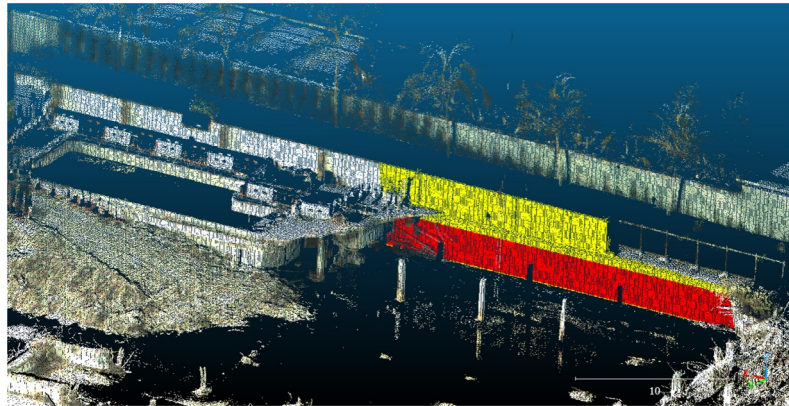
LiDAR Scan of South Basement Wall

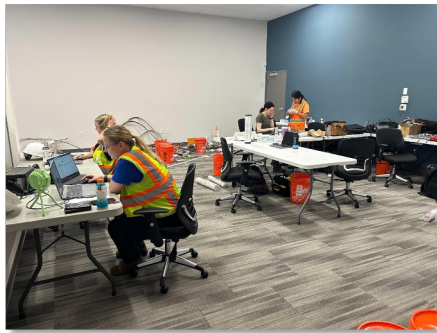
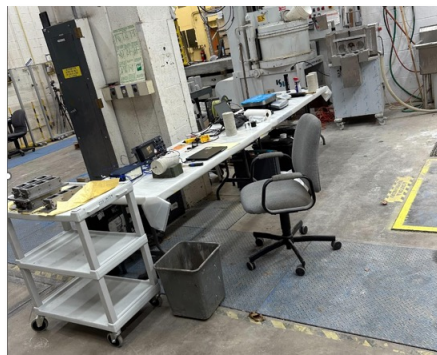
Core check-in and NDT.

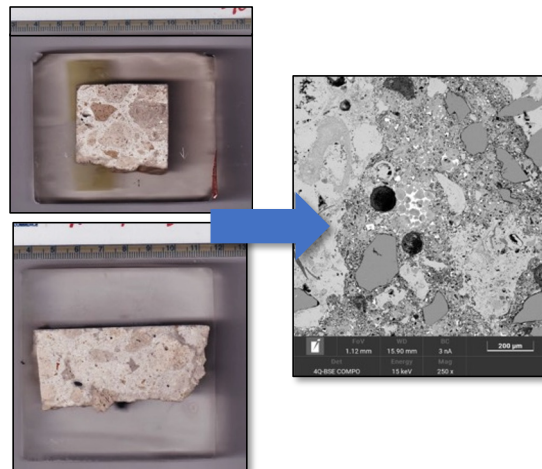
Concrete petrography.

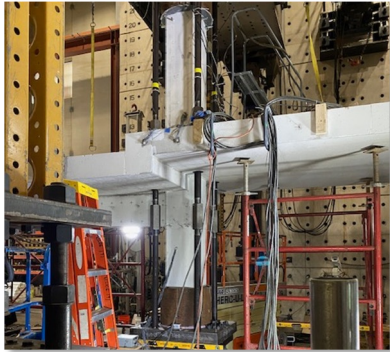
Laboratory slab-beam-column tests.  
(1 of 2 tests in progress)

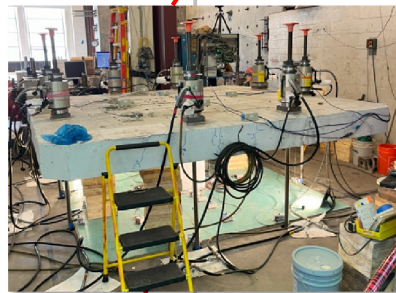
Laboratory slab-column  
connection test.  
(3 of 8 complete)

larger  
**Crack width**  
smaller

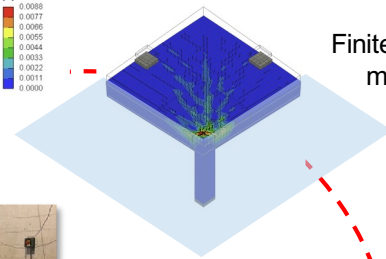
Finite element  
models.

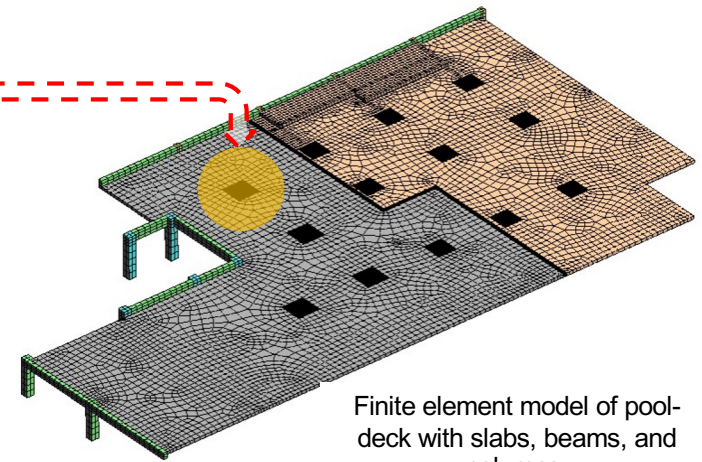
**Critical Shear  
Crack Theory**

Finite element model of pool-  
deck with slabs, beams, and  
columns.
