Presentation on WUI Fires – Data Collection and Case Studies

Alexander Maranghides
Engineering Laboratory
National Institute of Standards and Technology (NIST)
Gaithersburg, MD

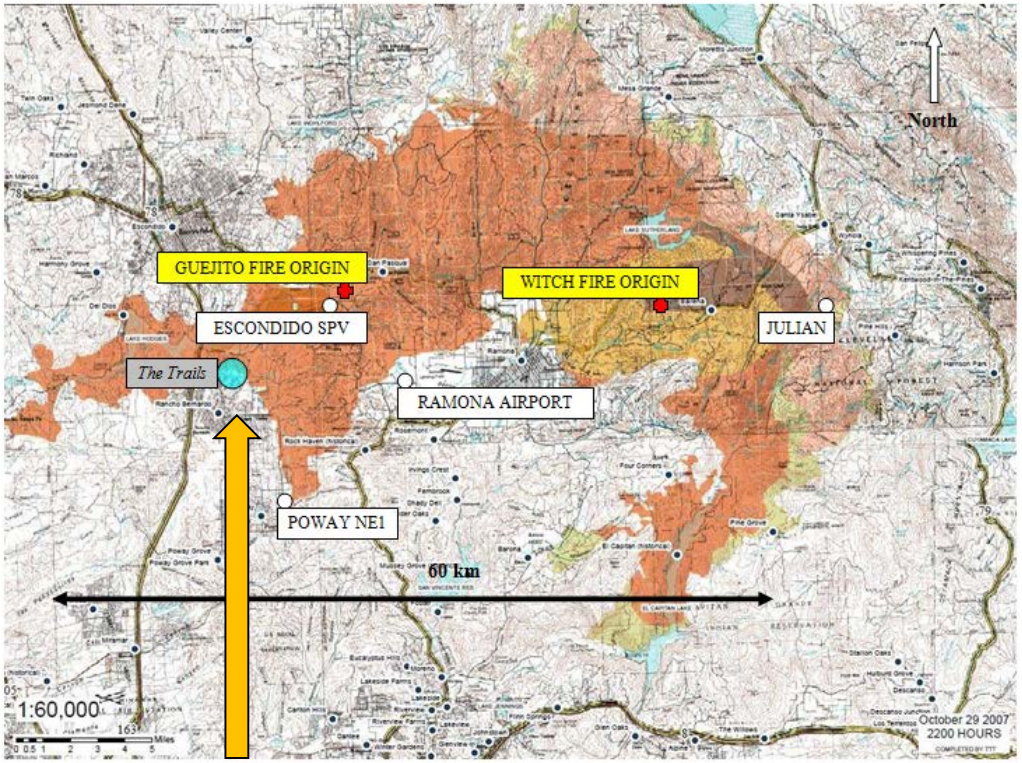
Figure 4: Origins of the Guejito and Witch Creek Fires, the combined perimeter of both fires and the locations of the weather stations used later in the report. (map Courtesy of CALFIRE)

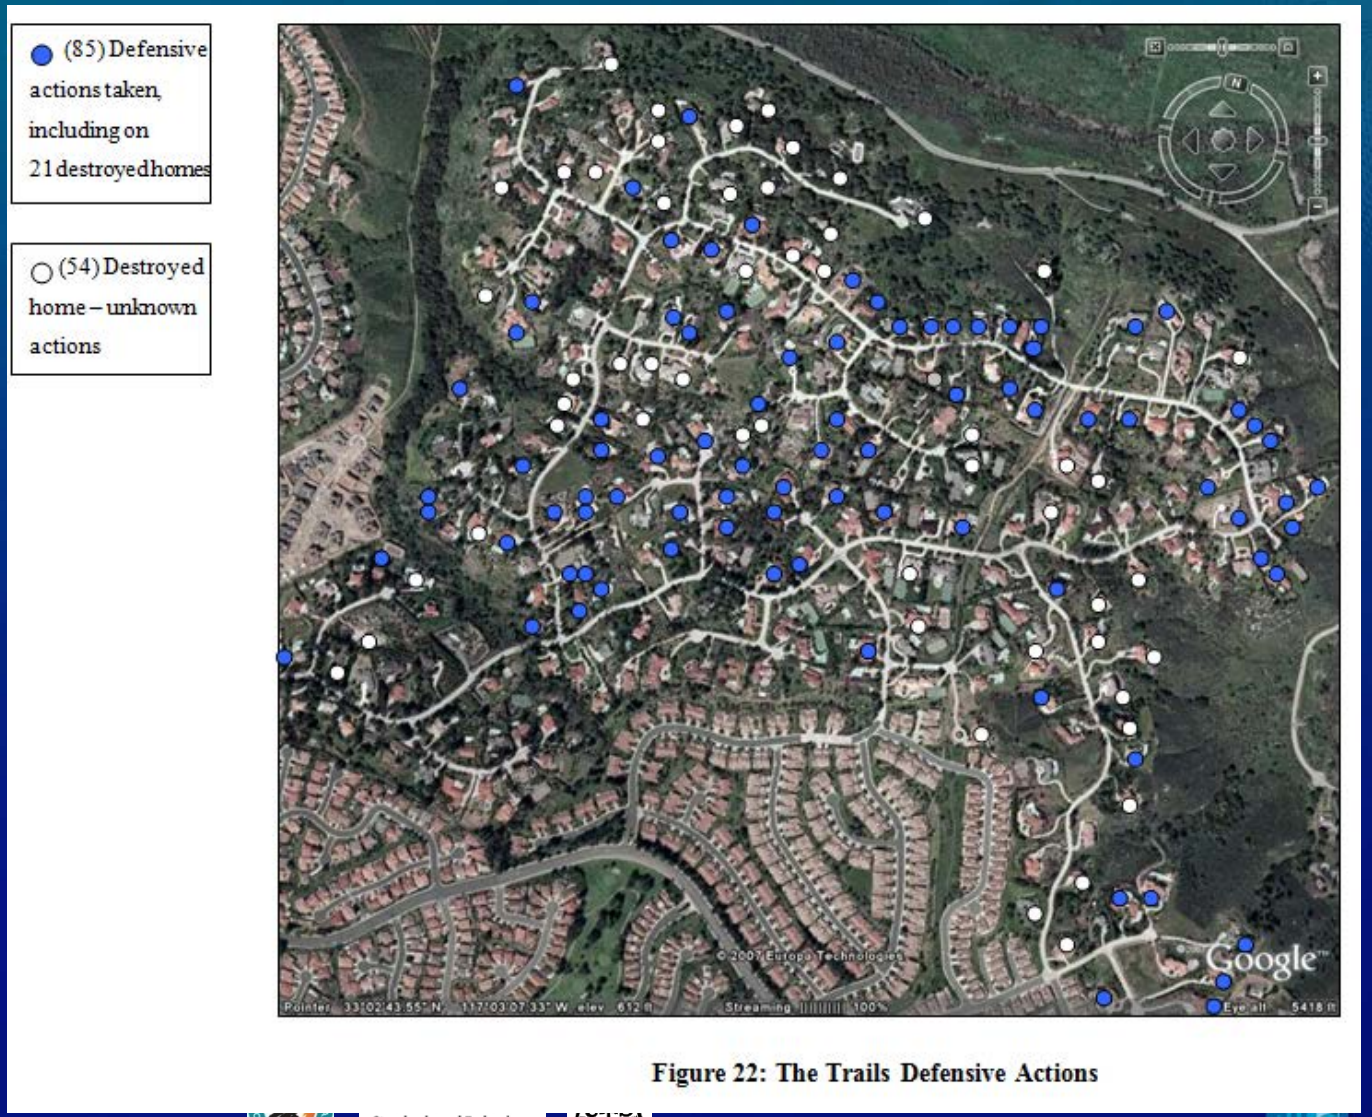
Figure 22: The Trails Defensive Actions

Witch/Guejito – Structures Defended ("no-one there…")

- 1/3 of all structures defended

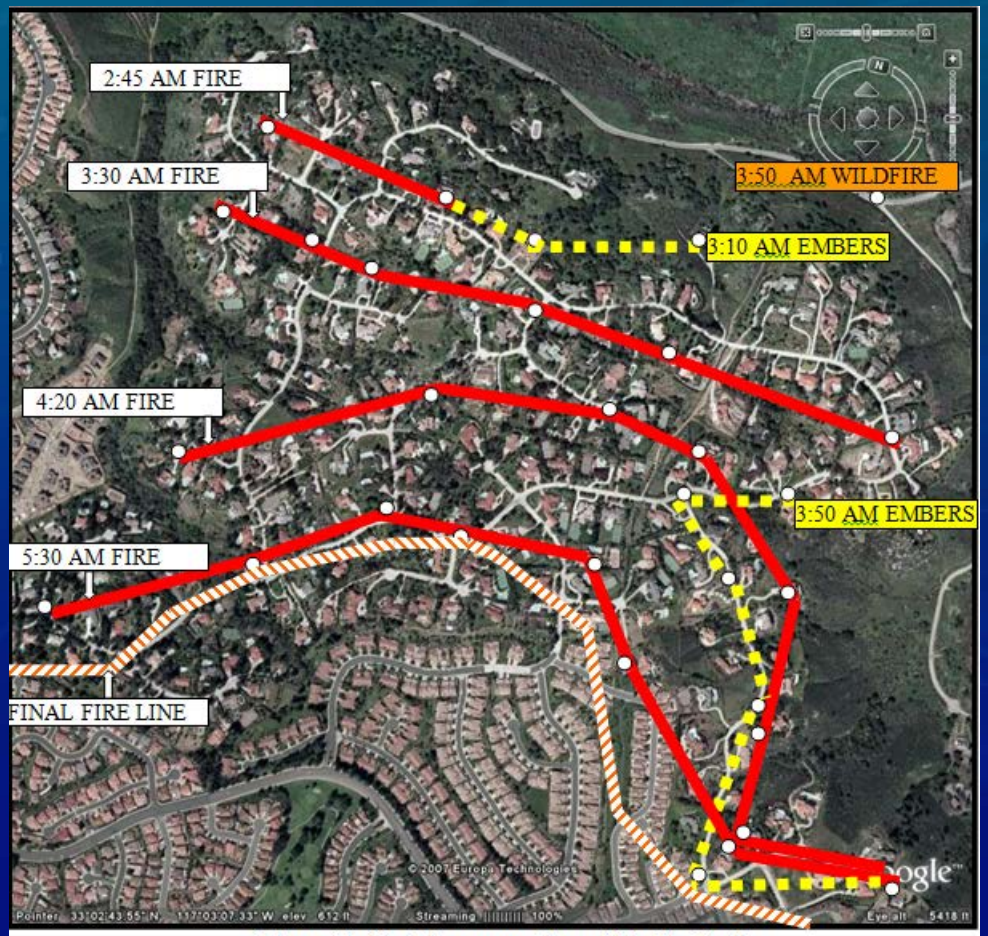
Figure 20: Fire Line progression within The Trails

Witch/Guejito – Fire Progression

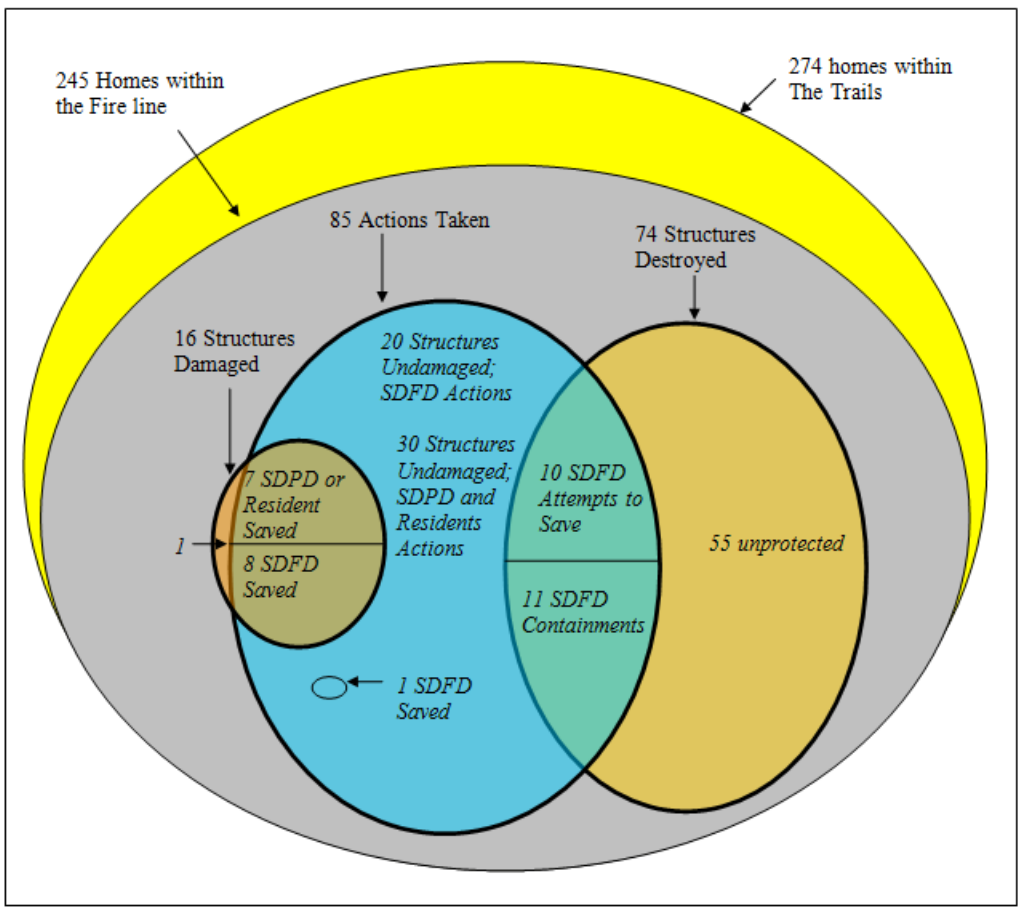
Figure 23: Impacts of the Defensive Actions Taken at The Trails

Witch/Guejito – Effectiveness of Defensive Actions

NIST TN1796 (Witch #2) documented the effectiveness as a function of exposure
