Semiconductor Performance under Reverse Transient Overvoltages

François Martzloff
General Electric Company

Reprinted from declassified *General Electric TIS Report 67-C-066*, March 1967

AUTHOR	SUBJECT	NO.
Martzloff, FD	semiconductors and transients	67-C-066
		DATE: March 1967
TITLE: Semiconductor Performance under Reverse Transient Overvoltages		G.E. CLASS: 2
		GOVT. CLASS: -
ADDITIONAL COPIES AVAILABLE AT: Distribution Unit, Bldg. 5, Room 345, Research and Development Center, P.O. Box 8, Schenectady, New York 12301		NO. PAGES: 57

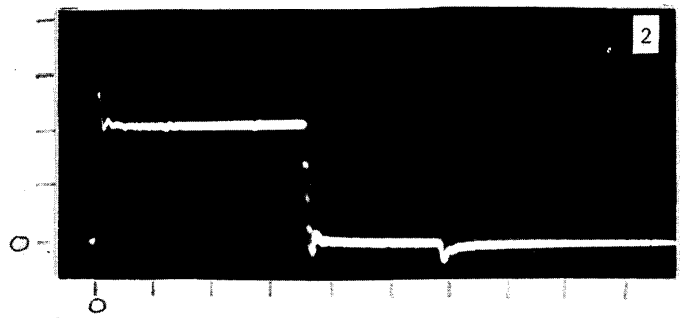
Failure of a C20A SCR in 3.8 μs, while voltage was clamped at 1050 volts.

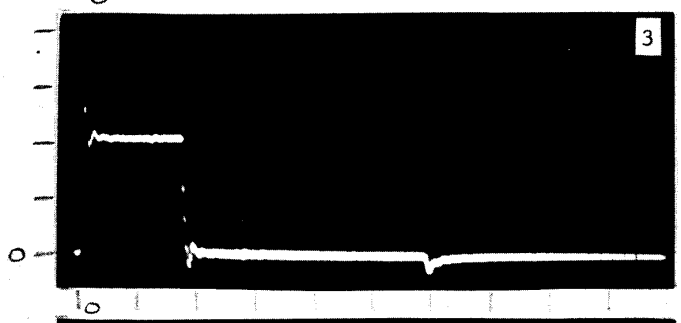
Failure of a C20D SCR in 2 μs, while voltage was clamped at 1000 volts.

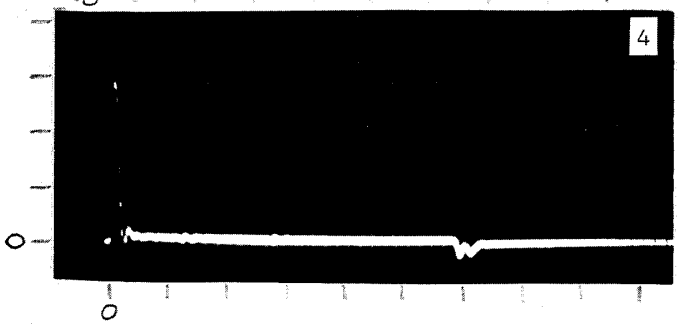
Failure of a C20D SCR in 0.1 μs, before avalanche could produce any voltage clamping.

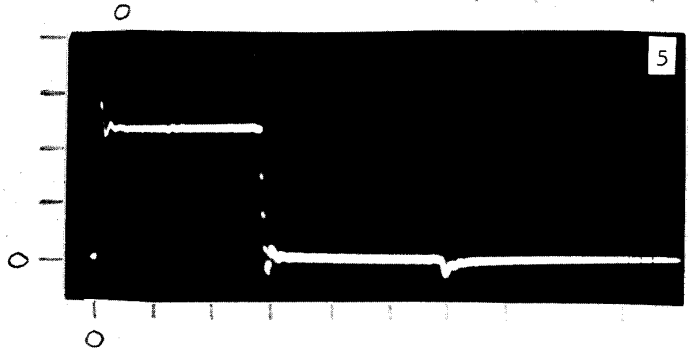
Failure of a C20A SCR (aged by high temperature storage) in 3 μs, while voltage was clamped at 1200 volts.

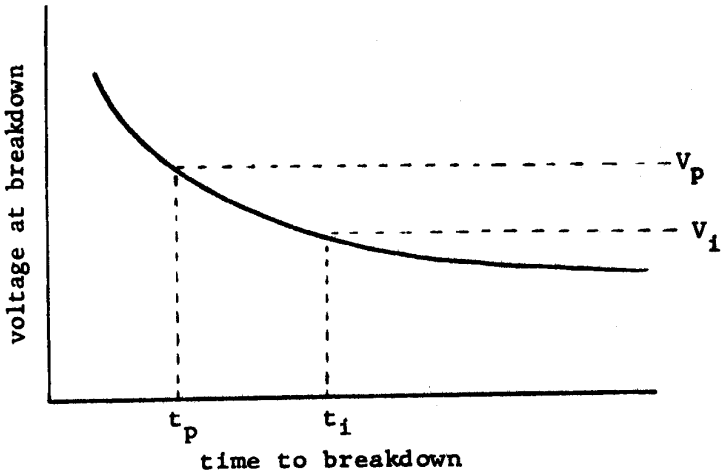
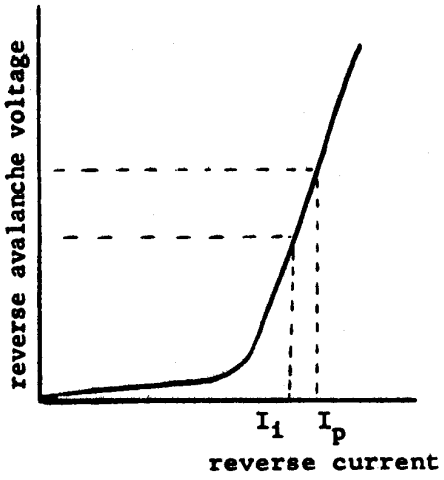
This is shown in the sketch on the opposite page. A hypothetical curve for the breakdown of the surface insulation and a zener curve for the reverse avalanche are drawn. Consider two currents I_p and I_i,

respectively for preset and increasing pulse methods, producing the corresponding avalanche voltages V_p and V_i. These voltages will in turn cause breakdown at the times t_p and t_i, with t_i longer for the lower I_i than t_p for the higher I_p.

4. Increasing the preset voltage value tends to shorten the time to failure, which means that as the corresponding point climbs on the zener characteristic to slowly increase the avalanche voltage, the failure point of the surface dielectric moves towards the left on its ascending volt-time characteristic.

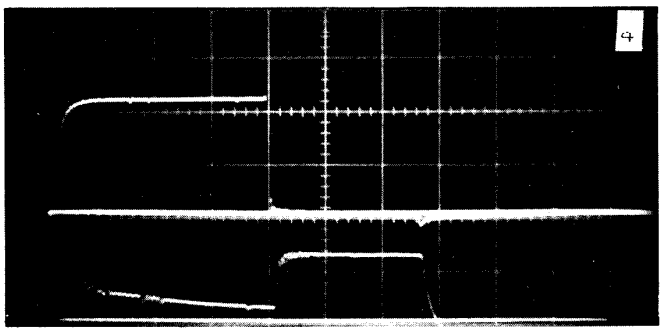
Failure of C20A SCR with forward
current in 3.5 μs
Top: 500 volts/div.
Bottom: 40 amp/div.
Sweep: 1 μs/cm
Available pulse length 6 μs

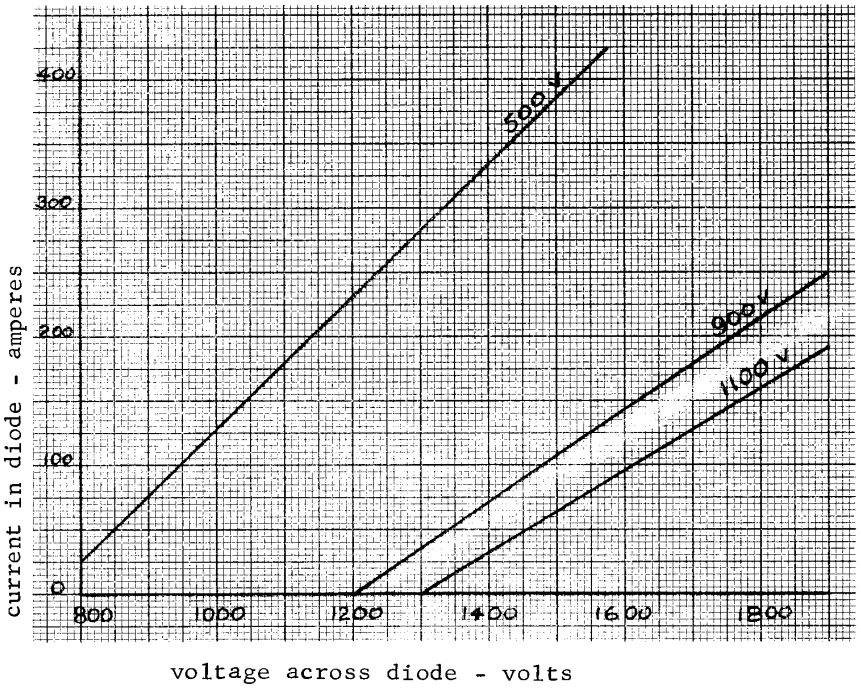
Avalanche characteristics of 500, 900, & 1100 volts A92 test samples

The test points for one device fell on an approximately straight line with linear volt and ampere scale (see Figure 1). Furthermore, the lines for a group of devices graded in the same voltage class lie within a 100 volt band and run parallel; only one has been drawn in Figure 1 in the case of the 500 volt characteristic which corresponds to three test samples. The slope of the 500 volt rectifiers on one hand and 900 and 1100 on the other hand are different, corresponding to constant dynamic resistance of 1.6 and 2.6 ohms respectively.

On the other hand, a lower current is required to bring a high avalanche voltage diode to the danger point (see Figure 1) so that a high voltage diode is more sensitive to a current source type of surge. This is pointed out in the specification sheets and application notes.

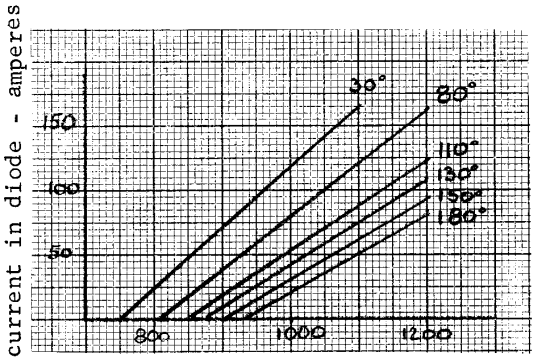
Figure 2

Avalanche characteristics of a 500 volt diode, measured at start of pulse, with junction at the initial temperature shown

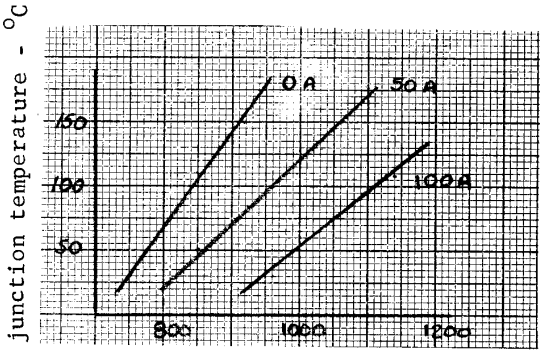
Junction temperature as a function of the voltage measured across the diode for the constant current shown

With increasing current levels, an increase in the voltage across the diode between the start and the end of the pulse became apparent, as seen on the oscillogram on the opposite page. In order to correlate this voltage rise with the change of avalanche voltage (or, more accurately, voltage across the device) due to temperature, a series of recordings were also made on one 500 volt diode with several values of ambient temperature, assumed to be the initial junction temperature. Thus, from the family of curves shown in Figure 2, the instantaneous temperature increase at various times of the pulse duration at constant current can be calculated. This is shown in Figure 3, in a plot of avalanche voltage vs. average junction temperatures.

For two specific current levels, the instantaneous volt amperes dissipated in the device were calculated; these two values of energy input into the semiconductor were compared to the temperature increase derived from Figure 3 and the apparent voltage change. Excellent correlation was found, i.e., for energy inputs with a 2:1 ratio, the calculated temperature increase was also 2:1.

The question then is to know which will increase fastest. The temperature of the semiconductor will increase until the melting temperature is reached at a hot spot (temperatures shown in Figure 3 are average temperatures.) On the other hand, the voltage also increases with this temperature, so that flashover voltage may be

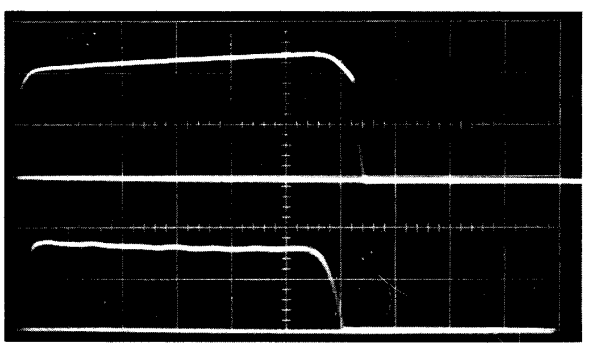
Oscillogram recorded with 500 volt diode at 30°C ambient temperature

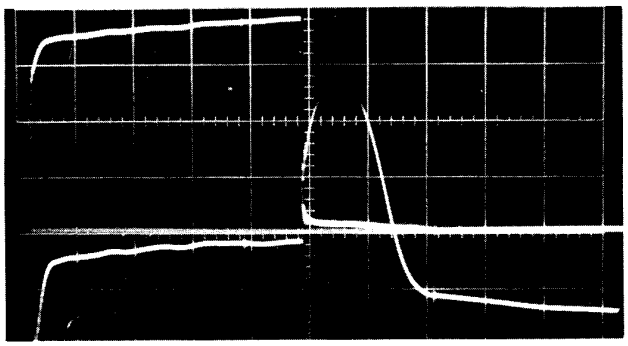
Failure of 1100 volts unit at
1900 volts, arc across varnish
Test at 30°C ambient

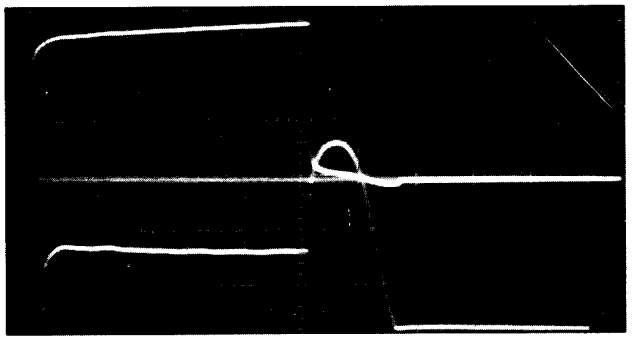
Failure of 500 volts unit at
1400 volts, arc at upper PP^+
junction due to field pinch
Test at 150°C ambient

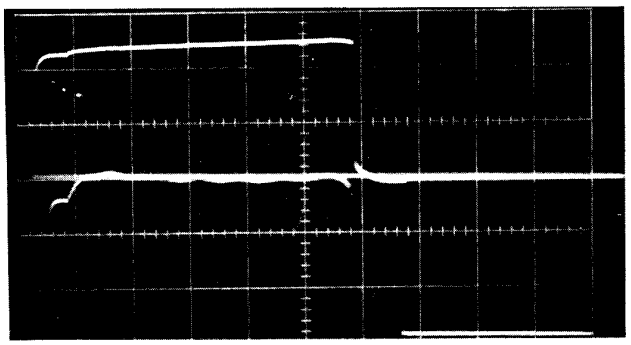
Failure of 500 volts unit at
1250 volts, bulk failure
Test at 150°C ambient

Bulk failure vs. Arc failure

Note how breakdown occurred as voltage had begun to decrease shortly before end of applied pulse, in contrast with arc failure which occurred during voltage rise.

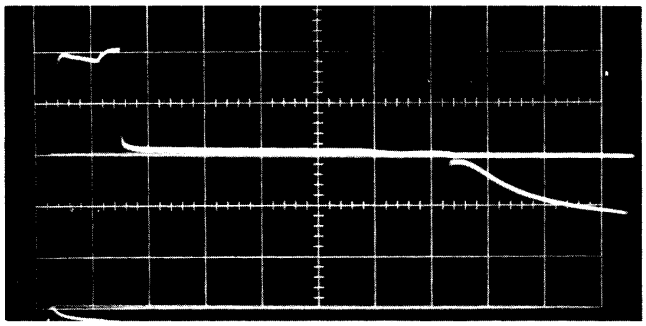
1200 volts PIV unit test at 30°C ambient

Failure at 2000 volts in 12 μs
Arc across varnish

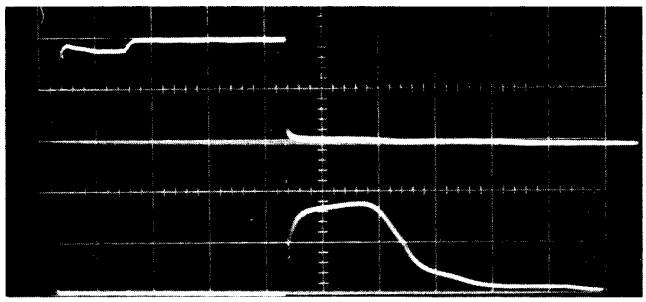
200 volts PIV unit test at 30°C ambient

Failure at 2000 volts in 40 μs
Arc across varnish

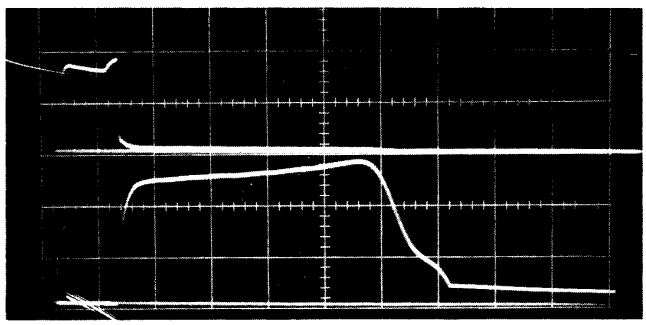
1200 volts PIV unit test at 150° ambient

Failure at 1800 volts in 12 μs
Arc at upper PP^+ junction

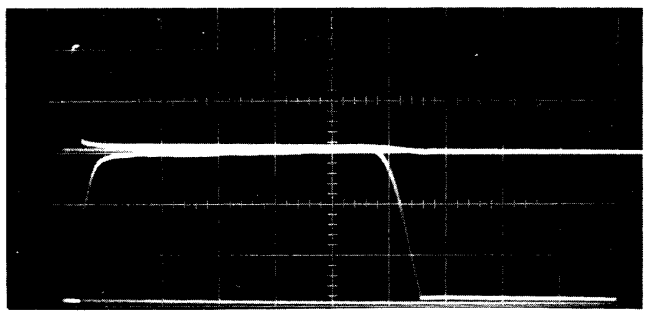
200 volts PIV unit test at 150°C ambient

Failure at 2000 volts in 4 μs
Arc across varnish

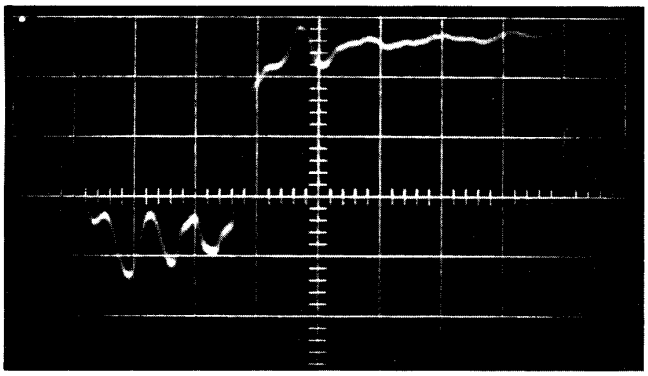
Failure of 200 volts PIV unit
same generator setting as above,
with oscillations caused by
interaction of the diode capacitance.
Failure at 1800 average volts in
250 ns
Arc across varnish

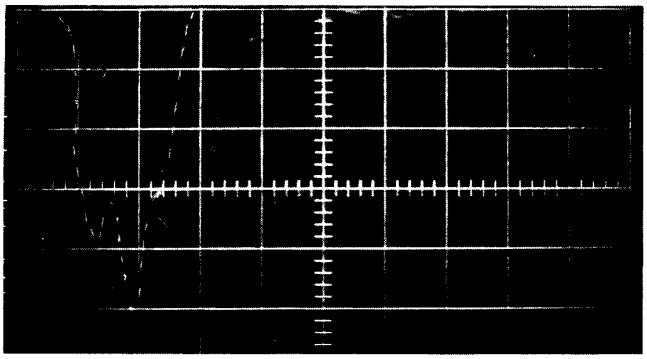
Failure of 1200 volts PIV unit
No-load generator setting 2200 volts
Failure at 1900 average volts in
200 ns
Arc across varnish
(trace indicated by scratches for
reproduction)

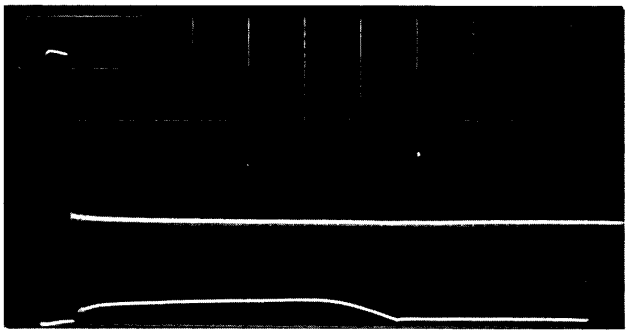
1000 volts unit

Failure at 1600 volts with
low current - 10A

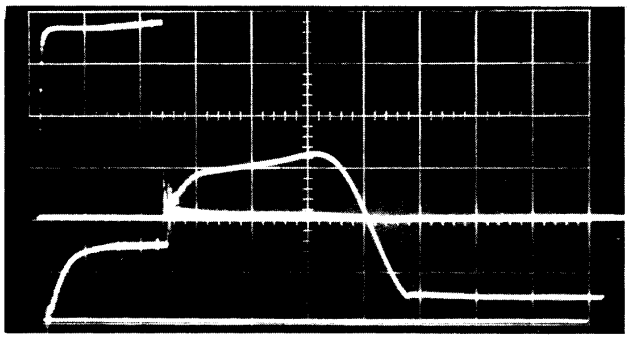
1000 volts unit

Failure at 1900 volts with
high current - 300A

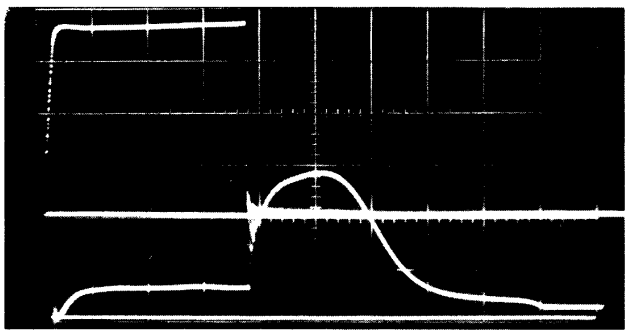
800 volts unit

Failure at 1850 volts with
medium current - 60A

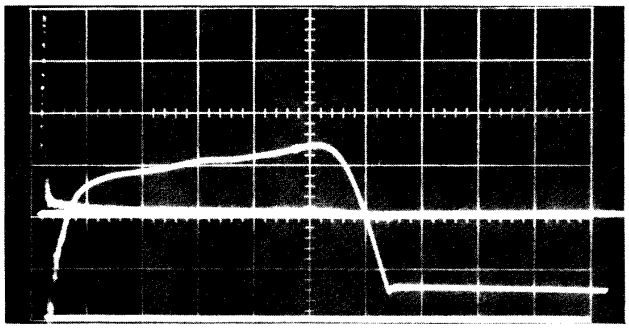
500 volts unit - preset test

Failure at 1900 volts in short time

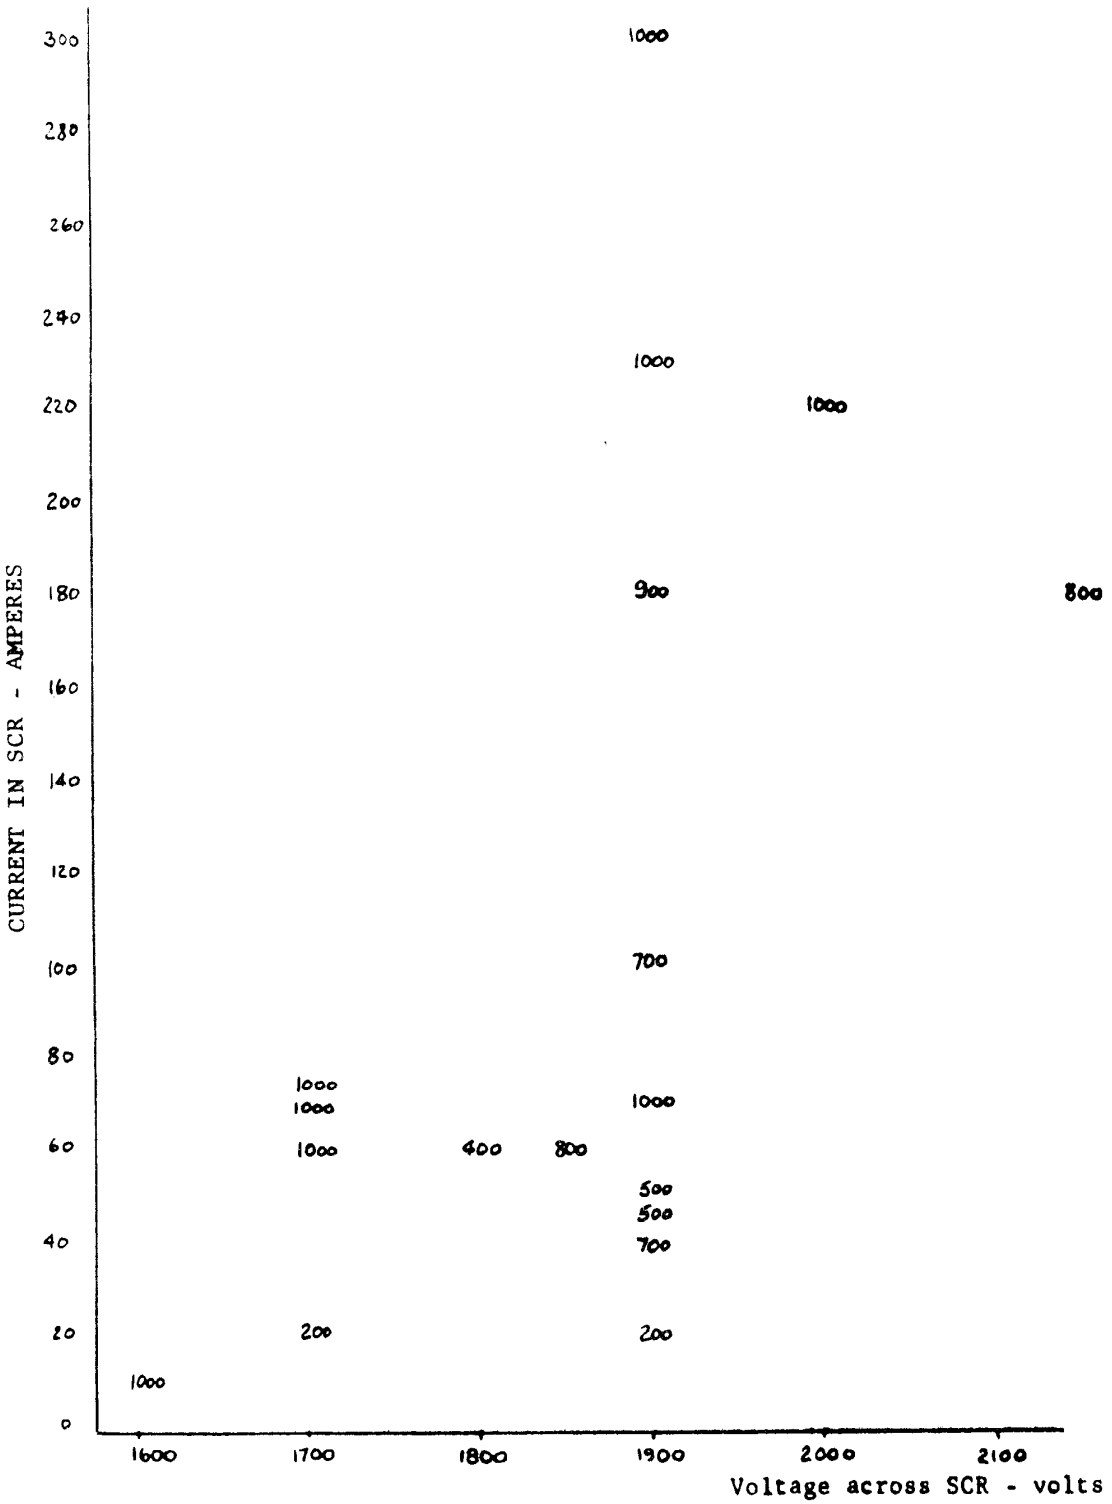
DISTRIBUTION OF FAILURE POINTS - VOLTAGE VS CURRENT FOR VOLTAGE CLASS SHOWN
