Performance and durability of photovoltaic backsheets and comparison to outdoor performance

William Gambogi

DuPont Photovoltaic Solutions, Wilmington, DE, 19803

Atlas NIST Workshop on PV Materials Durability,
Gaithersburg, MD

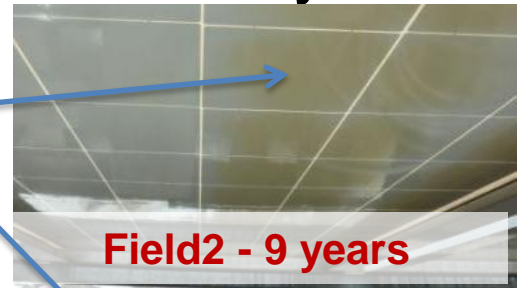
Field2 - 9 years

Failures from UV damage observed in the field early in expected module lifetime

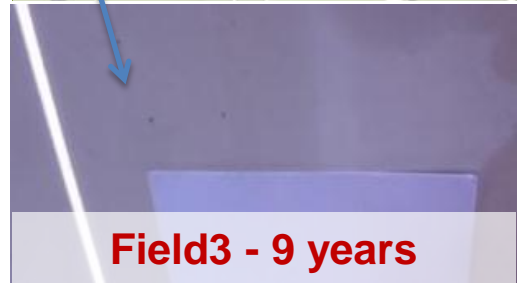
Field3 - 9 years

Cracking on the outer polyester layer of backsheet

- Modules were removed from a commercial MW plant after 5 years for cracking and delamination on the backsheet along the rear tabbing ribbons and 9% loss of power.
- The IR analysis identified outer layer as polyester.
- Thermal image shows localized heating at cell contacts.

Cracking of the backsheet is likely due to indirect UV exposure. Backsheet testing to reflected light from albedo can identify instability in the outdoor environment.

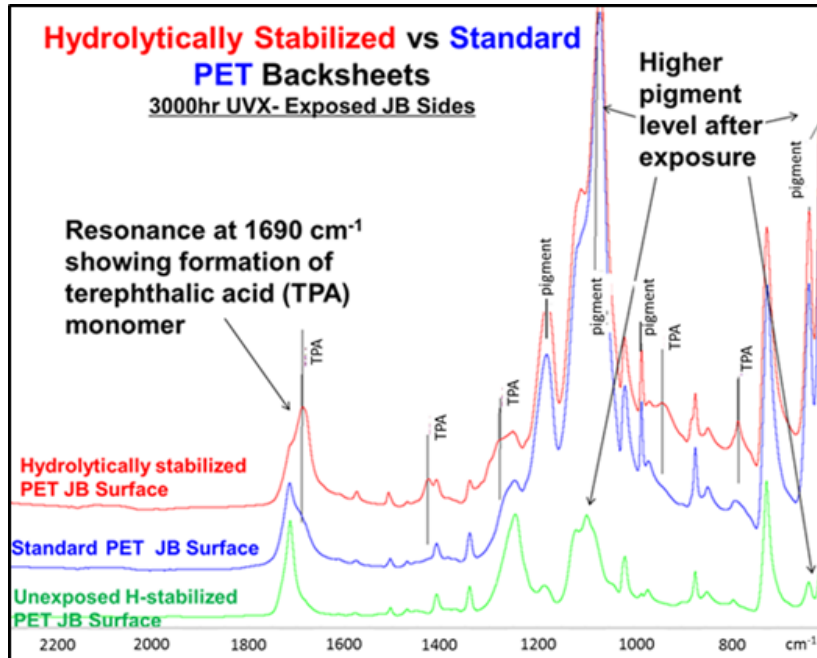
Atlas Weather-o-Meter exposure

PET before exposure shows resonance at 1710 cm⁻¹.
Both Weather-o-Meter exposed and fielded sample show 1690 cm⁻¹ resonance, evidence of degradation of PET to TPA monomer

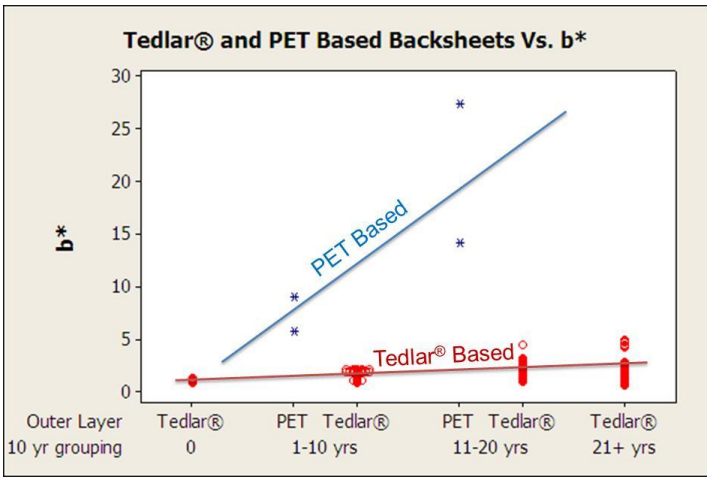
227 Tedlar® and 4 PET based backsheet modules from various locations and manufacturers

- Small color change consistent with changes seen in damp heat and UVA exposure for Tedlar®-based backsheets
- Significantly larger changes in b* (9~27) for PET-based backsheets indicating polymer damage and degradation

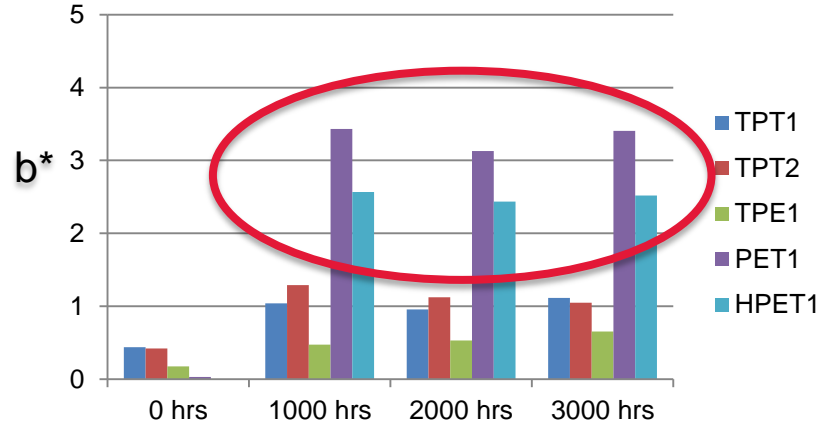
UVA Exposure of Modules

UV exposure of PET-based backsheets more damaging and likely responsible for much higher yellowing observed in the field

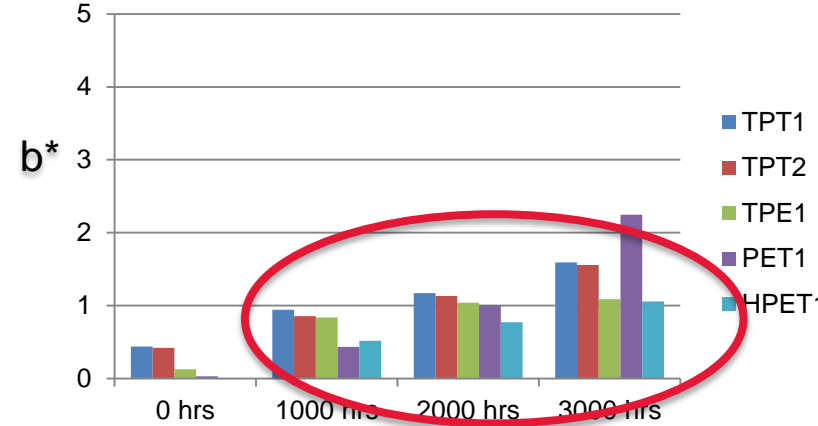
Damp Heat Exposure of Modules

- Level of yellowing in damp heat not changing appreciably from 1000 to 3000h
- Level of yellowing for PET modules in damp heat not consistent with yellowing in the field

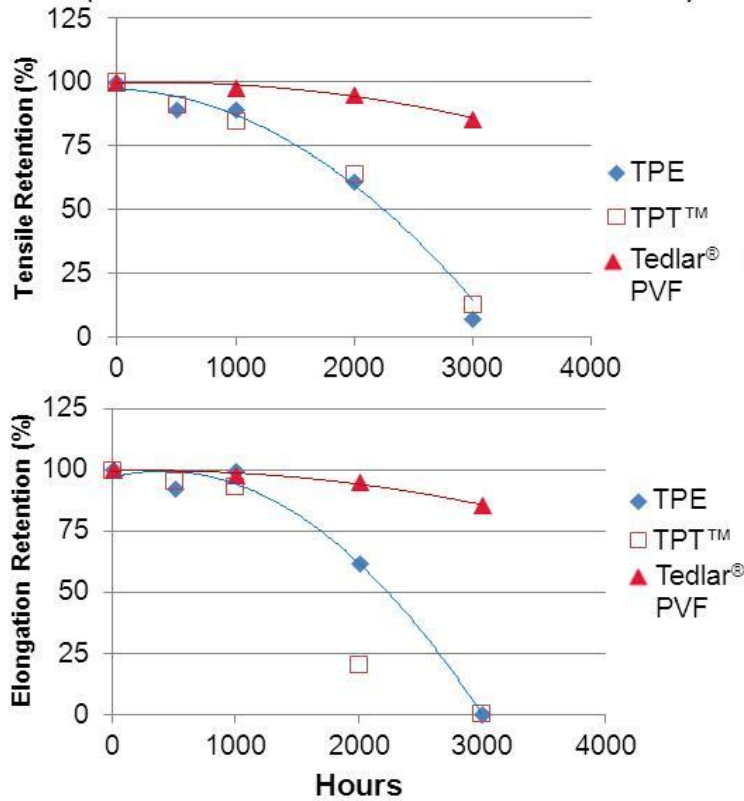
Damp Heat Exposure Mechanicals

- Loss in mechanical properties in damp heat (>1000h) due to hydrolysis of PET core layers (not Tedlar®)
- No loss in mechanical properties for humid environment – Miyako Island, Japan
- Mechanical loss at 2000h and 3000h much greater than observed in the field
- Fielded modules from different environments obtained from DuPont (USA), AIST (Japan) and JRC (Italy)

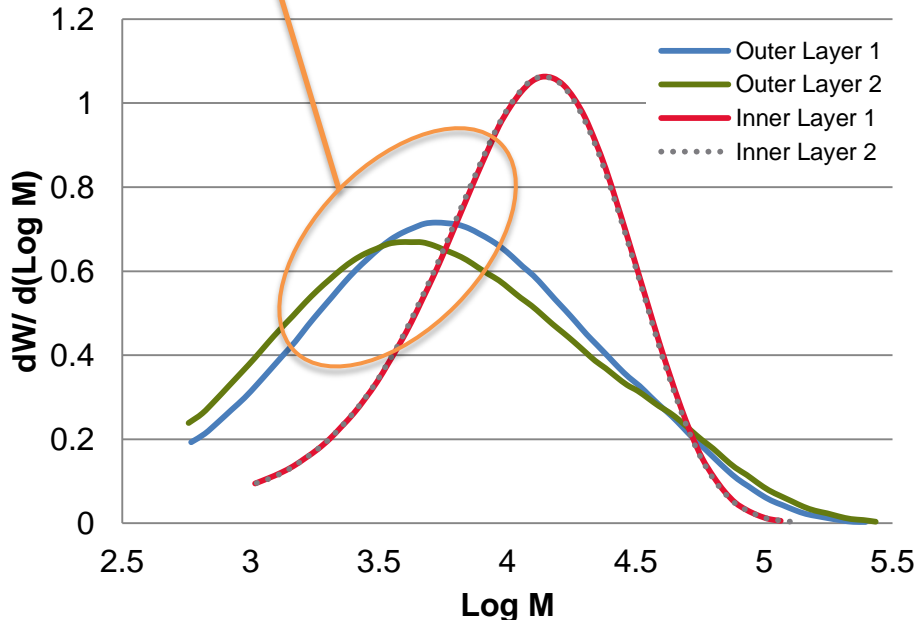
- Outer PET layer shows likely drop and broadening of Mw
- Inner PET layer no changes were observed
- These changes are most likely due to stresses during service (UV, moisture, etc.)

- Compared to a standard PET, the inner layer of PET dropped 60% in tensile (MD) and 40% in elongation properties
- Outer layer lost all mechanical properties

Outer PET degraded – Mw changes and loss of mechanical properties

Inner PET degraded – loss of mechanical properties with no Mw changes

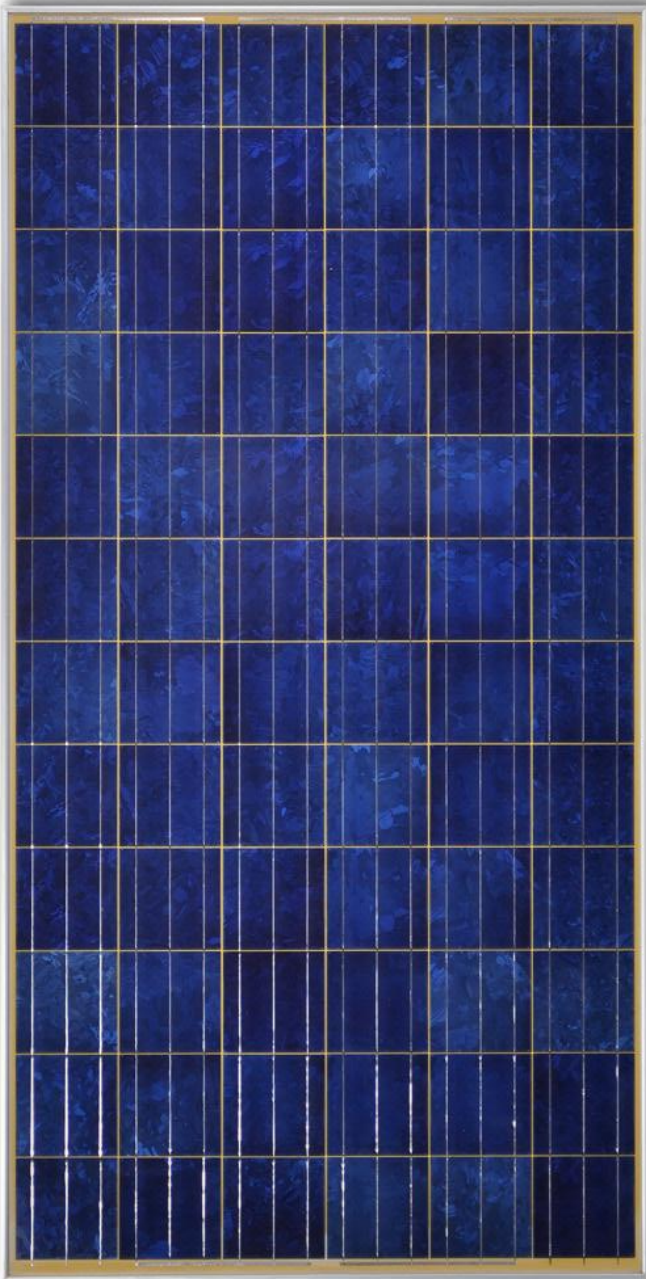
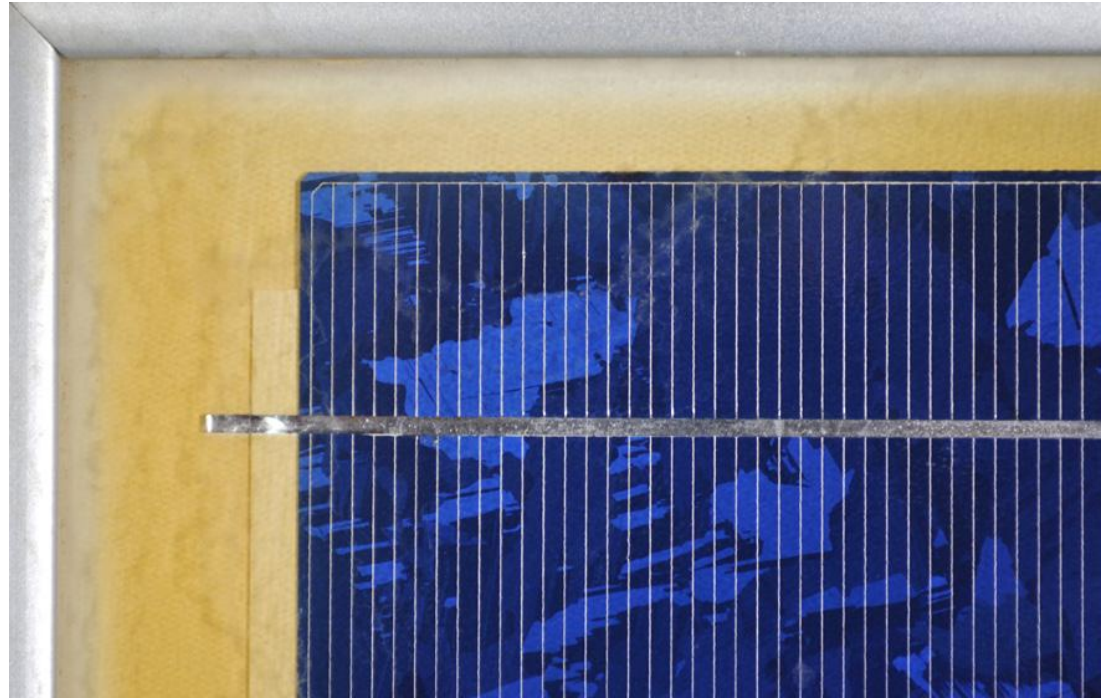
Front side yellowing observed in:

- 5 different countries (Belgium, Spain, USA, Israel and Germany)
- 5 different module manufacturers
- **Modules less than 5 years in the field**

Failures from UV damage observed in the field early in expected module lifetime

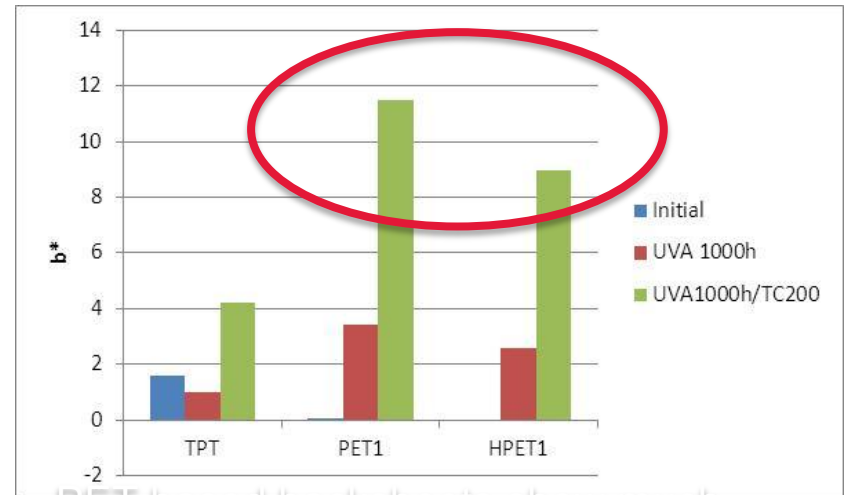
Sequential Stress (UVA vs. UVA+TC)**

PET-based backsheets show much greater color change after UVA/TC indicating polymer degradation and damage

- Greater than UVA alone
- Similar to levels seen in fielded modules

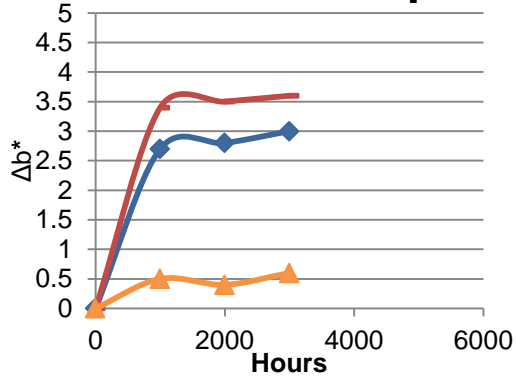
Δb^* UVA Exposure

Yellowing of PET-based backsheets using recommended UVA and UVX exposure and tie layer cracking with UVX
