Technical Study of the Sofa Super Store Fire - South Carolina, June 18, 2007

Draft for Public Comments

*Fire Research Division
Engineering Laboratory
National Institute of Standards and Technology*

October 2010

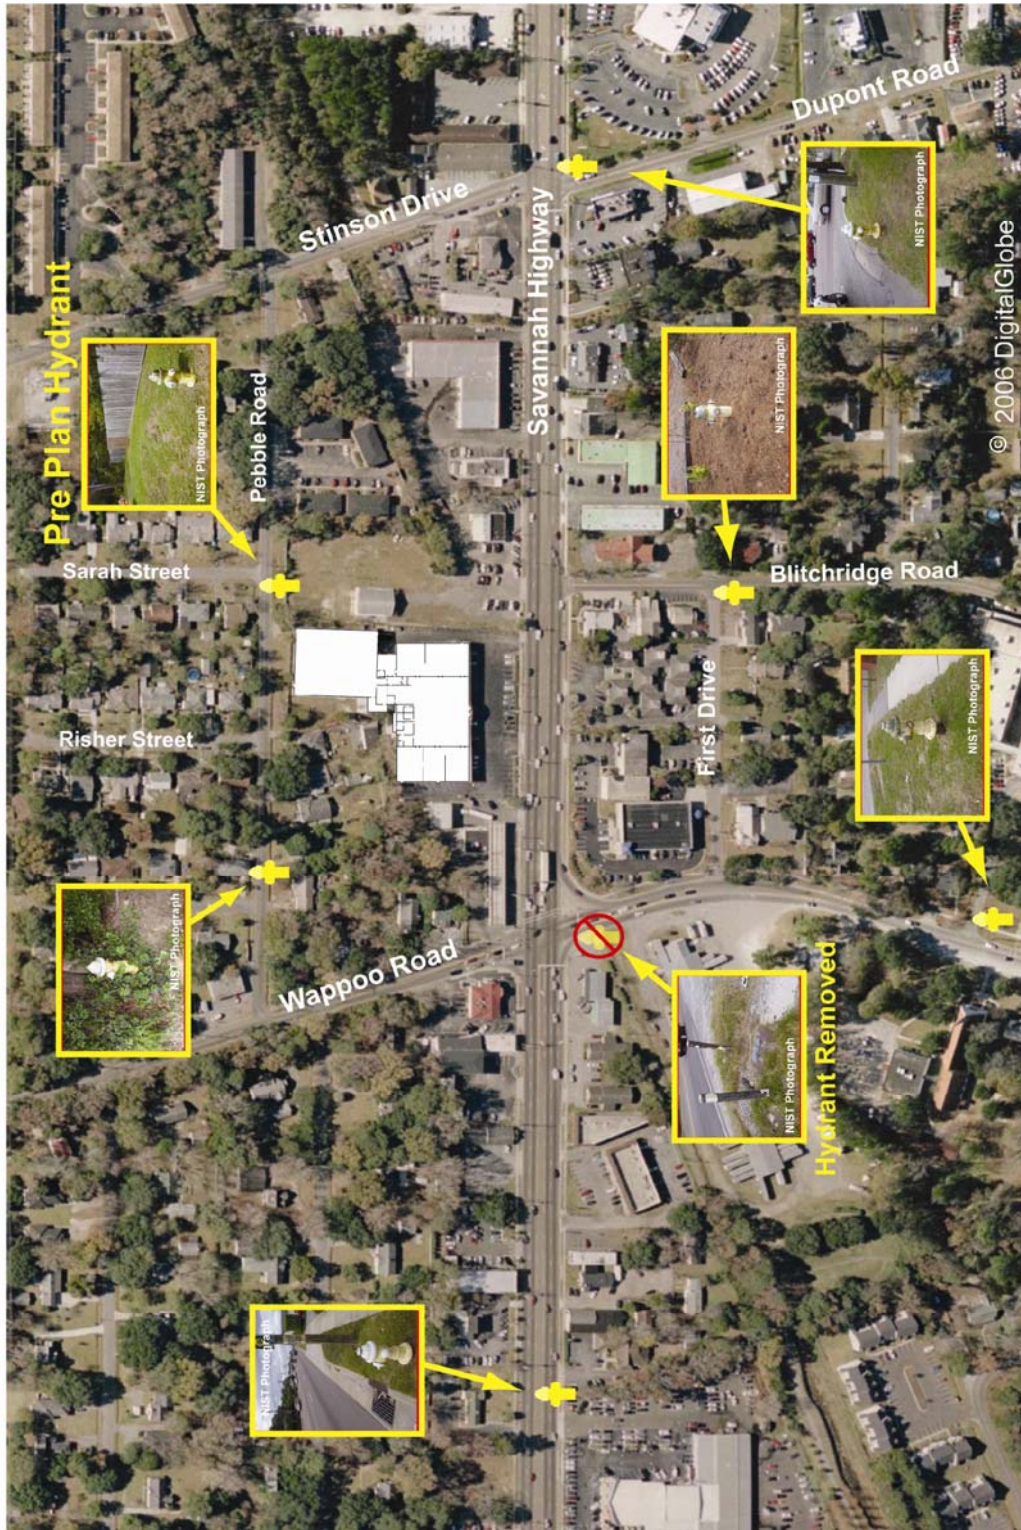
The area in which the Sofa Super Store was located had immediate access to a municipal hydrant system to support fire ground operations. Water hydrants were located along Savannah Highway to the west and east of the store, on Pebble Road behind the store, and at Blitchridge and Wappoo Roads to the north of the store. The location of the six hydrants is shown in Figure 1-17. Each hydrant typically had a pair of 6.4 cm (2.5 in) outlets and a single 10.2 cm (4 in) outlet.

Figure 1-17. Location of fire hydrants near Sofa Super Store. Hydrant identified during pre-plan inspection was on Pebble Road (upper right of figure). Hydrant at corner of Savannah Highway and Wappoo Road had been removed and not replaced (center left of figure). Background image used with permission of DigitalGlobe. Enhancements by NIST.

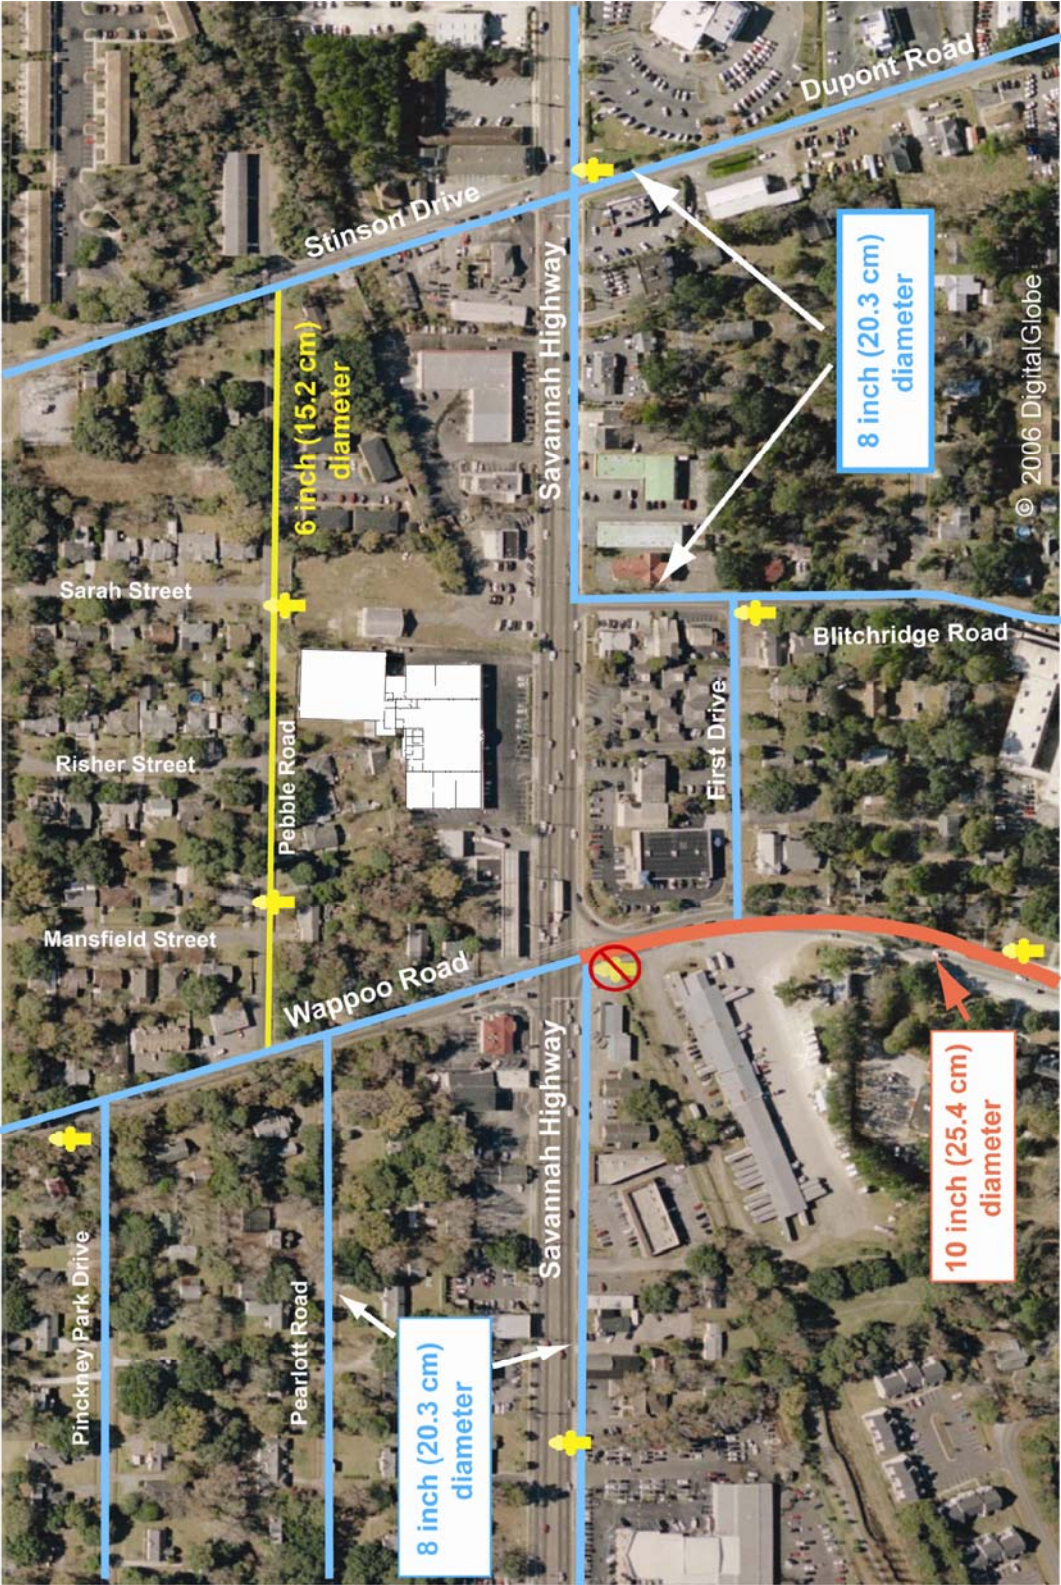
Water supply lines, 20.3 cm (8 in) diameter, were located along Savannah Highway, Stinson Drive, Dupont Road, First Drive, and Blitchridge Road (Figure 1-18). A smaller supply line, 15.2 cm (6 in) diameter, ran south of the warehouse along Pebble Road. On Wappoo Road, the water line was 20.3 cm (8 in) south of Savannah Highway and 25.4 cm (10 in) north of Savannah Highway.

Figure 1-18. Water supply lines near Sofa Super Store. Hydrants behind store on Pebble Road were on 15.2 cm (6 in) diameter lines while hydrants located along Savannah Highway were on 20.3 cm (8 in) diameter lines. Background image used with permission of DigitalGlobe. Enhancements by NIST.

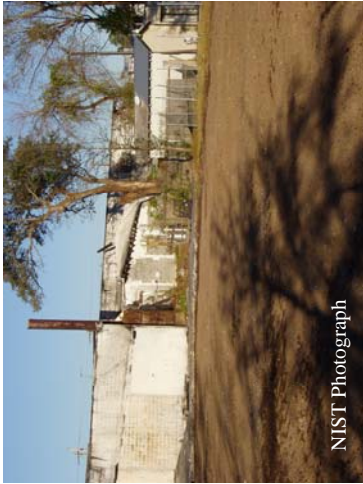
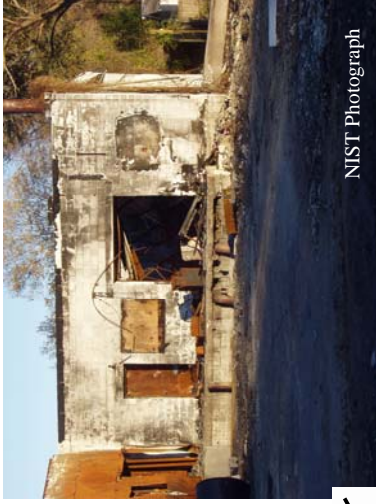
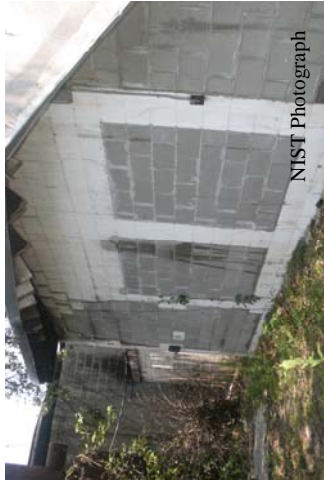
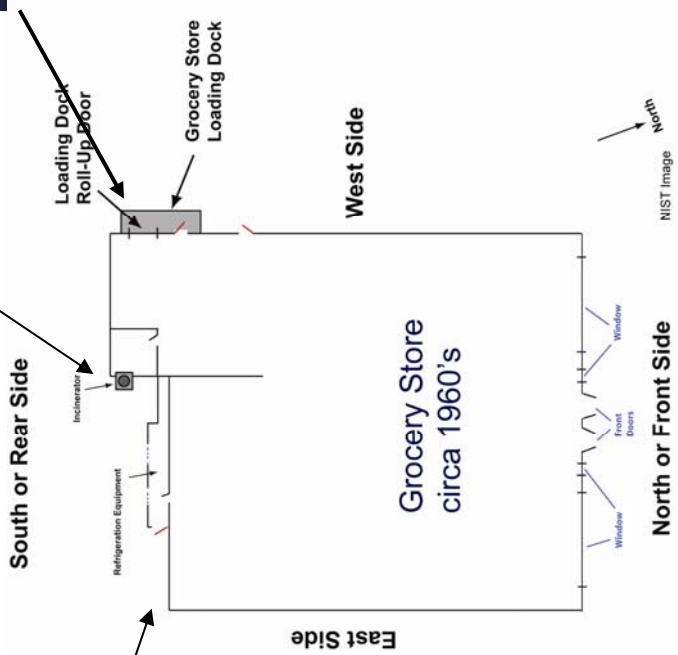
Figure 1-19. Grocery store loading dock, incinerator, and refrigeration equipment areas. Loading dock and incinerator photographs taken after warehouse was torn down and removed from site.

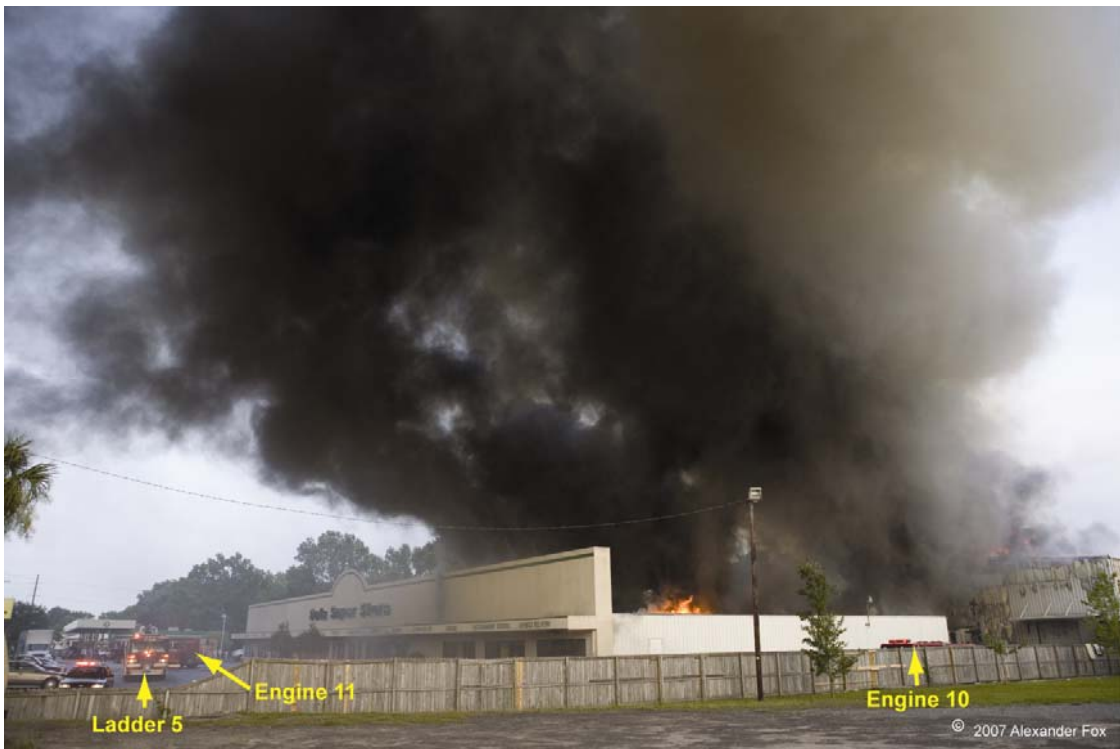
Figure 2-3. Engine 11 and Ladder 5 at front of Sofa Super Store. Engine 10 next to loading dock. Both engines connected to water supply. Photo taken at approximately 7:30 p.m. Background image used with permission of Alexander Fox. Enhancements by NIST.

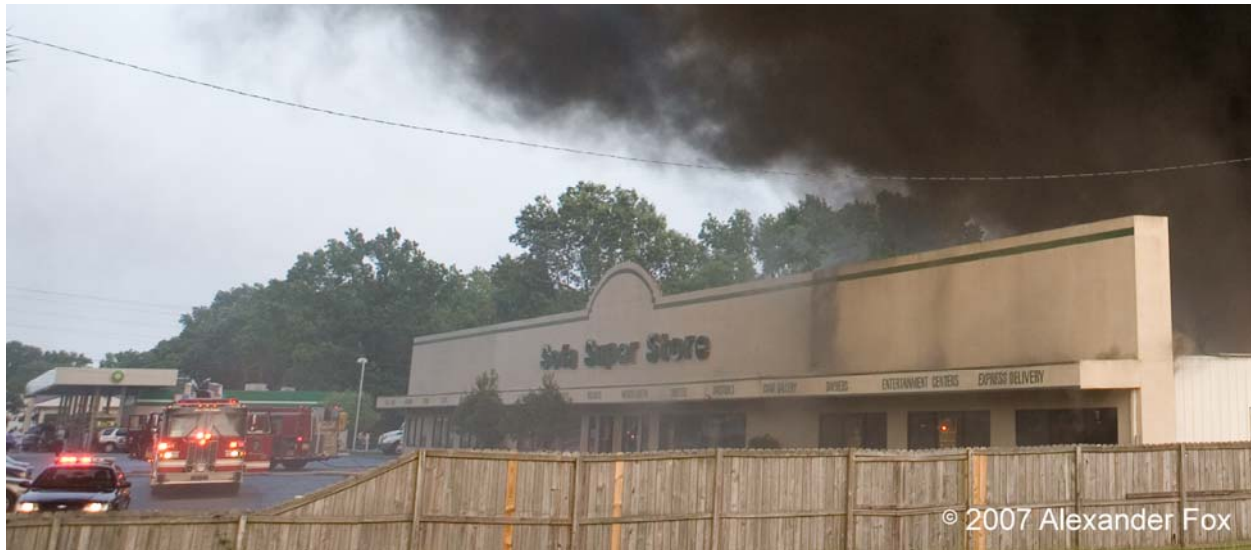
Figure 3-5. Engine 11 and Ladder 5 positioned in front of store. Smoke plume from loading dock fire visible. Photo used with permission of Alexander Fox.

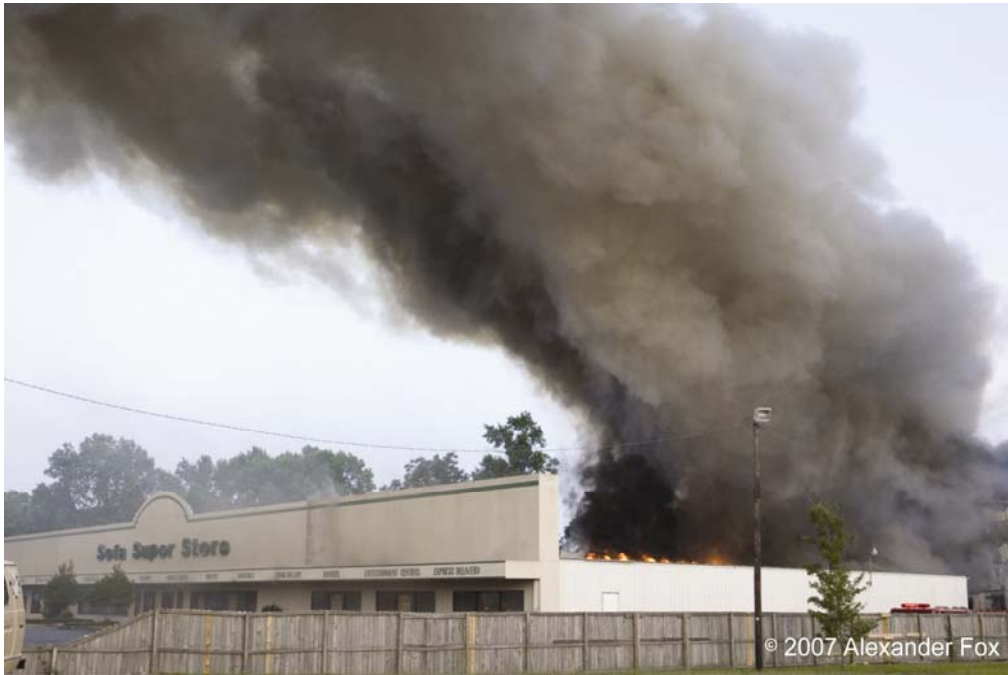
Photographs taken during the early stages of the fire show heavy smoke and flames exiting at the roof level. Figure 4-6 shows a photograph taken at 7:28:15 p.m. This photo shows heavy smoke venting from the loading dock and rear of the main showroom. Flames are also visible and appear to be coming from the roof of the main showroom. Because it was not possible to determine the exact location or size of the holes in the ceiling and roof, several holes were used in the simulations to represent the ventilation that took place. Table K-4 summarizes the ventilation conditions used in the simulations.

Figure 4-6. Photograph showing the north and west sides of the showroom. Photo was taken at 7:28:15 p.m.

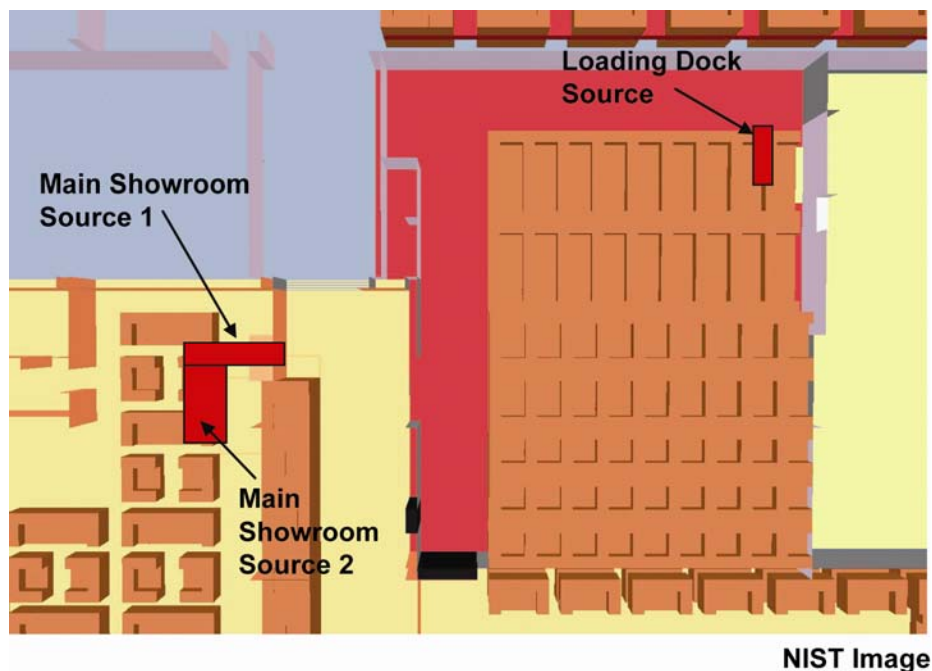
In the simulation, the fire was initiated³ in the loading dock at floor level, between the door and the ventilation fan access hole. This is identified as “Loading Dock Source” in Figure 4-8 and produced a peak HRR of 700 kW. The fire source was activated at the start of the simulation, operated for 600 s, and then shut off. No attempt was made to simulate the fire on the exterior side of the wall.

Figure 4-8. Diagram showing locations of initiating fire sources in the loading dock and rear of main showroom.

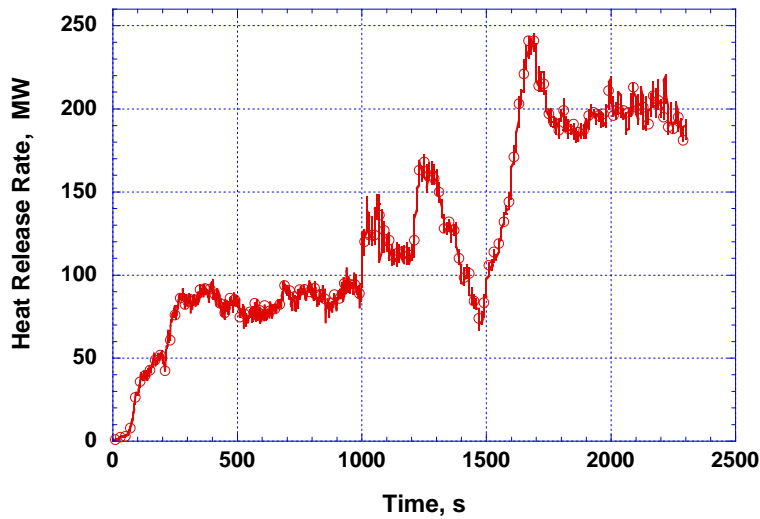
The total HRR for the fire, excluding the warehouse, is plotted as a function of time in Figure 4-9. The HRR produced by the warehouse contents dominated the total HRR in the mid and late stages of the simulation, but since the breezeway door closed early in the fire time line, there was no flow or transfer of

Figure 4-9. Total heat release rate, excluding the warehouse.

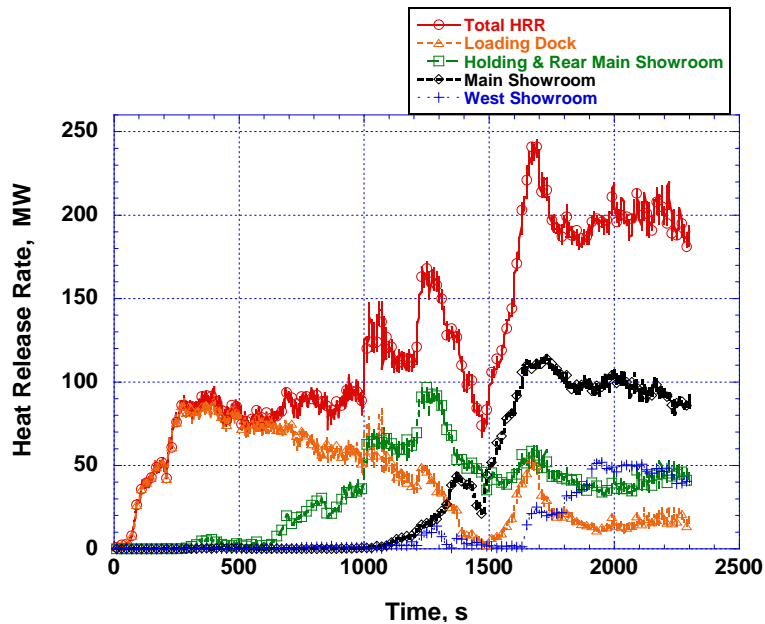
The HRR grew quickly from the initiating 700 kW fire, reaching 90 MW in 280 s as fire spread through the loading dock and into the holding area. Figure 4-10 separates the HRR events in the loading dock, holding area and rear showroom, main showroom, and west showroom. During the first 500 s, the loading dock fire dominated the HRR at about 85 MW. As the fire-spread into the holding area and rear of the main showroom the HRR for the holding area and the rear of the main showroom began to increase to about 100 MW at around 1200 s. This increase in fire-spread to the holding area and main showroom was simulated by turning on Source 1 and 2 (Figure 4-8) in the computer model. As the fire spread into the rear of the main showroom, the fire became underventilated and began to decrease in HRR. The total HRR continued to decrease until about 1450 s when the removal of the windows in the main showroom, beginning at 1457 s (7:35:10 p.m.), provided a fresh influx of oxygen leading to the subsequent rapid fire growth. The HRR of the fire grew to over 100 MW in the main showroom and 50 MW in the west showroom. The energy release rate of the holding area/rear main showroom increased slightly and then leveled out at about 40 MW. The loading dock HRR exhibited a transient peak at about 50 MW and then decreased to about 15 MW.

Figure 4-10. Component heat release rates for the loading dock, holding area, main showroom, and west showroom.

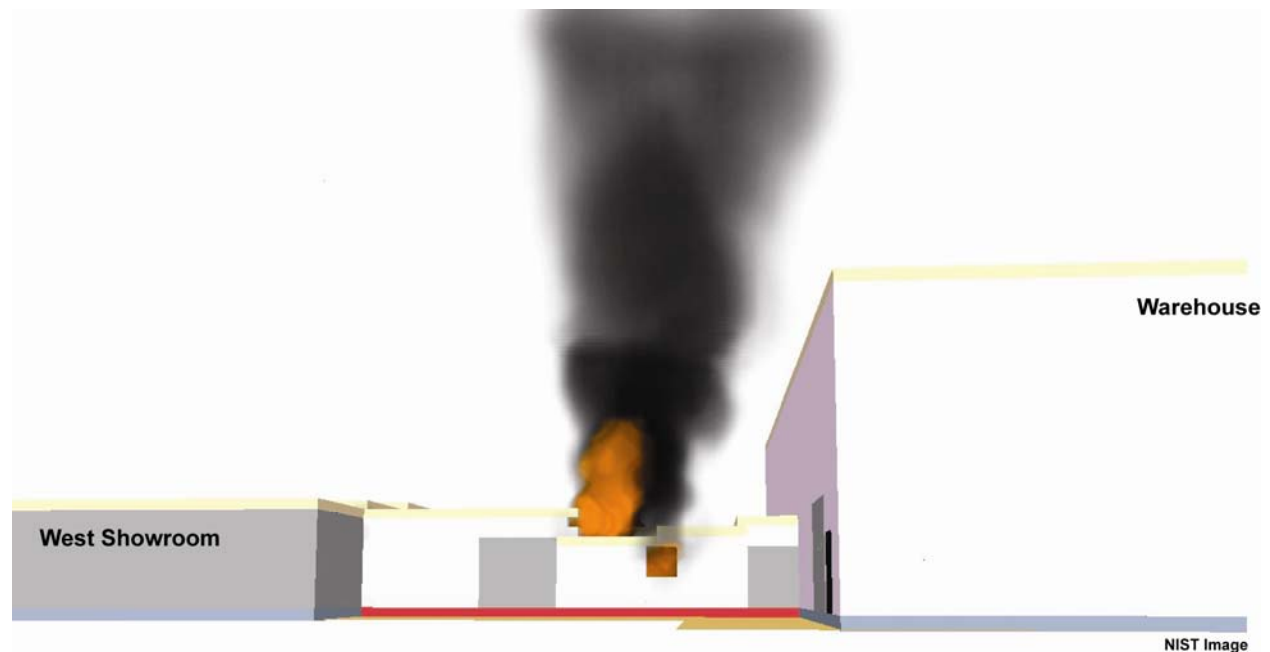
had progressed to the point that flames were venting from the exhaust fan in the west wall as well as through a gap between the roof sections of the loading dock. Figure 4-11 is an image rendered 110 s into the simulation viewing the west side of the structure that shows fire and smoke venting from the loading dock wall and roof.

Figure 4-11. Rendered image showing the west side of the loading dock 110 s into the simulation.

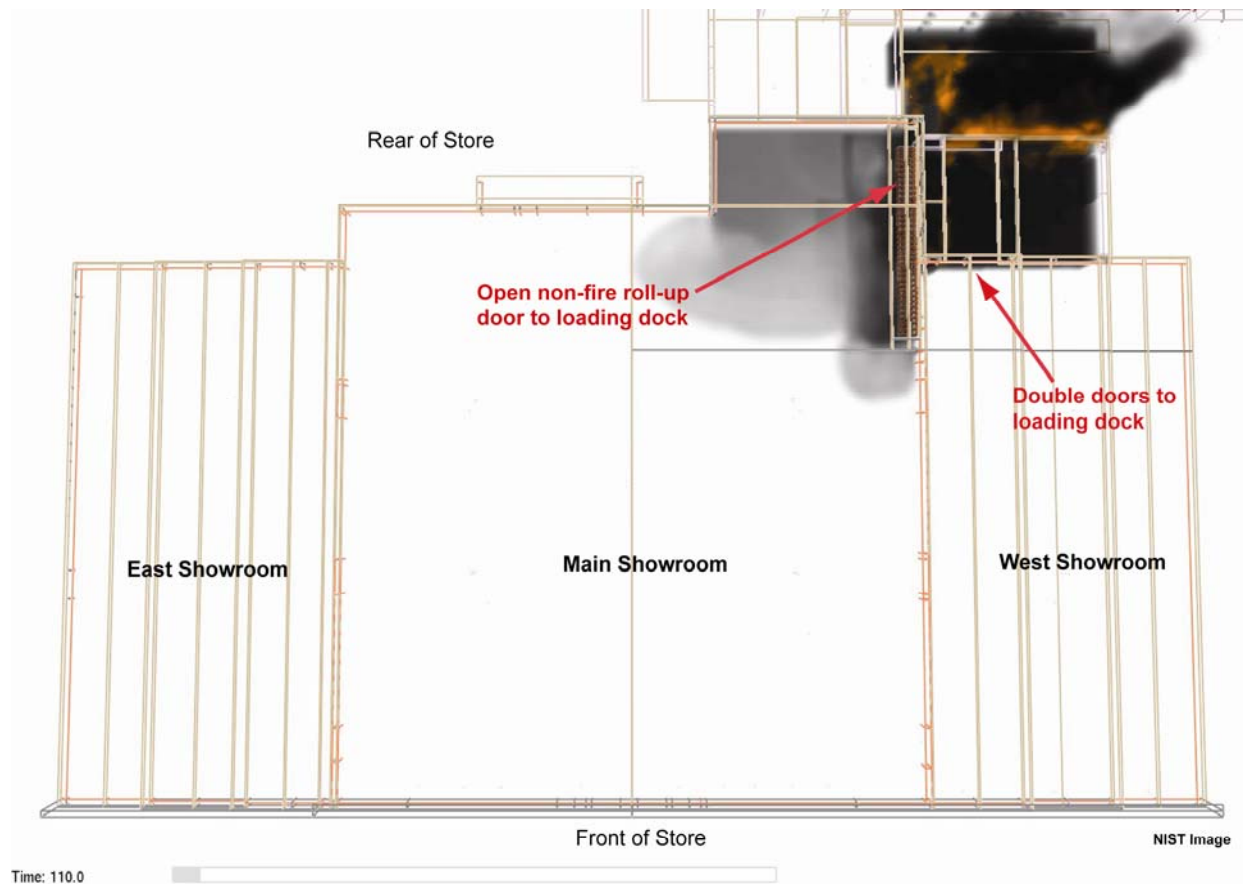
By this time (110 s), smoke had filled the loading dock and begun entering the void space above the main showroom ceiling through the holding area. The holding area was adjacent to the loading dock and was accessible through an open roll-up door. This room did not have a drop ceiling and had shelves upon which futon cushions were stored. Smoke and heated combustion gases produced by the fire passed into the void space above the main showroom. This development was concealed from the fire fighters upon first entry into the building.

Figure 4-12 shows a rendered image of the loading dock and showrooms at 110 s. In this figure, obstructions below ceiling level have been removed and all remaining obstructions are transparent (indicated only by their outlines) to allow visible access to the fire and smoke. This figure shows that very early in the fire event smoke had entered the holding area through the open roll-up door and entered the void space above the main showroom ceiling.

Figure 4-12. Smoke filling in void space above main showroom. Image was rendered 110 s into the simulation.

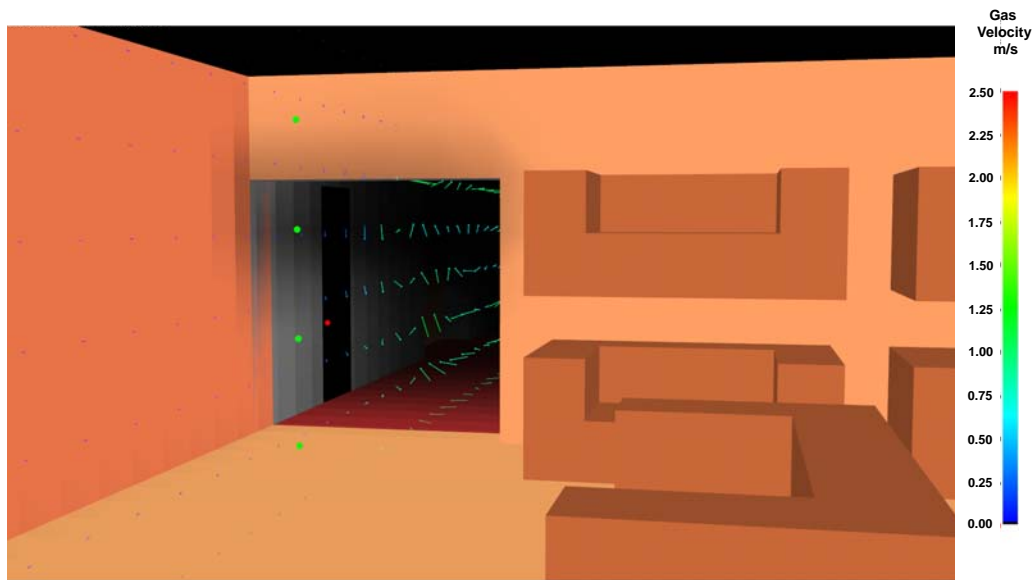
At 7:13:17 p.m. (144 s) the E-11 captain called over his radio “I need an inch and a half inside this building.” The AC opened the double doors connecting the west showroom to the loading dock and had the door pulled out of his hand by the force of air rushing into the loading dock.

Figure 4-14. Image rendered 145 s (7:13:18 p.m.) into the simulation from the west showroom, near the double doors that lead to the loading dock. Arrows indicate direction and relative speed of air moving from the showroom into the loading dock (The relative speed is proportional to the length of the arrow, i.e. longer arrows indicate higher relative speeds and color scale indicates velocity magnitude).

Figure 4-15 shows a rendered image of the double doors from inside the west showroom at 145 s, 1 second after they were opened. The arrows or velocity vectors indicate that the air was flowing from the rear of the west showroom into the loading dock just after the doors were opened.

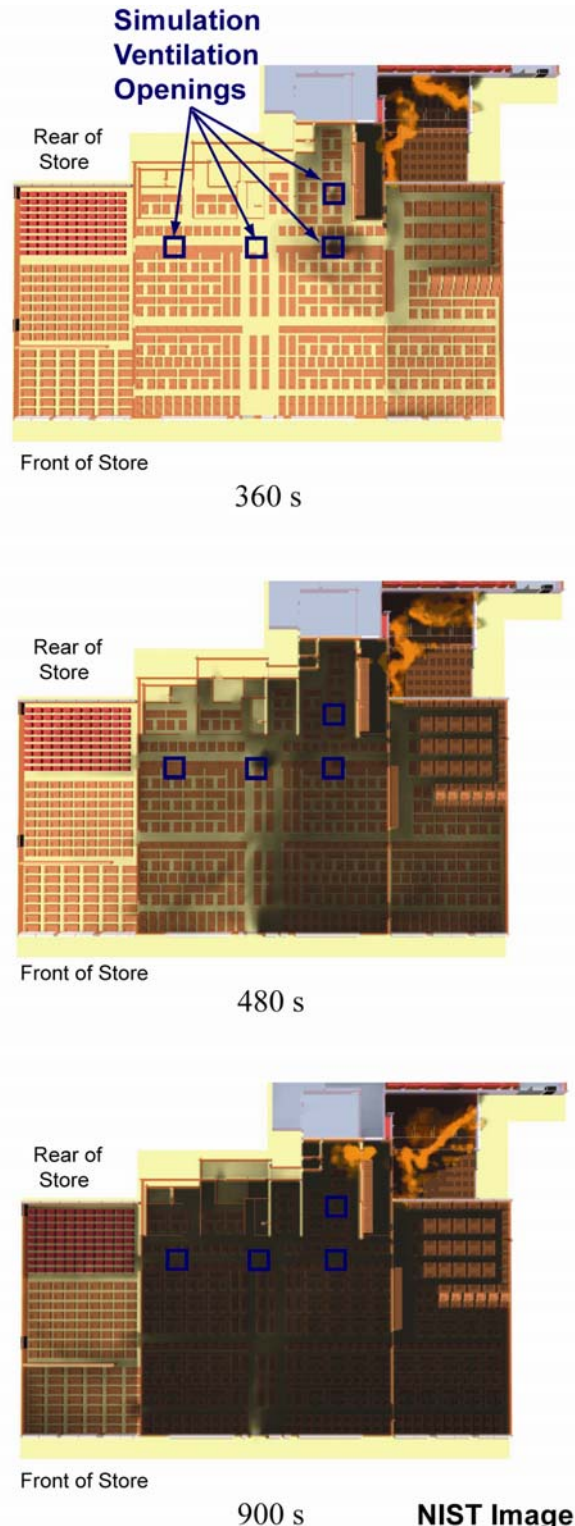
Smoke penetration through the ceiling was modeled by creating an opening in the rear of the main showroom when the adjacent temperature reached 50°C. Figure 4-15 shows the progression of fire and smoke below the ceiling level (2.6 m) throughout the loading dock, holding area and showrooms between 300 s (7:15:53 p.m.) and 900 s (7:25:53 p.m.). The images in this figure have been clipped down to the level of the ceiling in the showrooms.

At 300 s (7:13:53 p.m.) there is light smoke in the rear of the main and west showrooms. Initially, smoke in the west showroom entered through the double doors while the smoke in the main showroom entered through the ceiling. The ventilation openings in the ceiling in the main showroom (blue colored squares in Figure 4-15) opened between 261 s (7:15:14 p.m.) and 976 s (7:27:09 p.m.).

By 600 s (7:20:53 p.m.), the smoke layer had permeated the west and main showrooms, and there was evidence of a “tunneling” as fresh air was being pulled into the front door to supply oxygen. This is consistent with the account of Engineer 6, who entered the structure at approximately 7:24 p.m. (787 s) and reported a tunnel of clear space that extended several feet inside the showroom as fresh air was being pulled through the open door. Beyond this space he reported heavy smoke conditions. By 900 s (7:25:53 p.m.), the fire in the rear of the main showroom had grown to approximately 23 MW.

NIST Image
Figure 4-15. View of fire and smoke progression from above the showrooms from 300 to 900 s (7:15:53 p.m. to 7:25:53 p.m.). The images are clipped to view conditions below the ceiling.

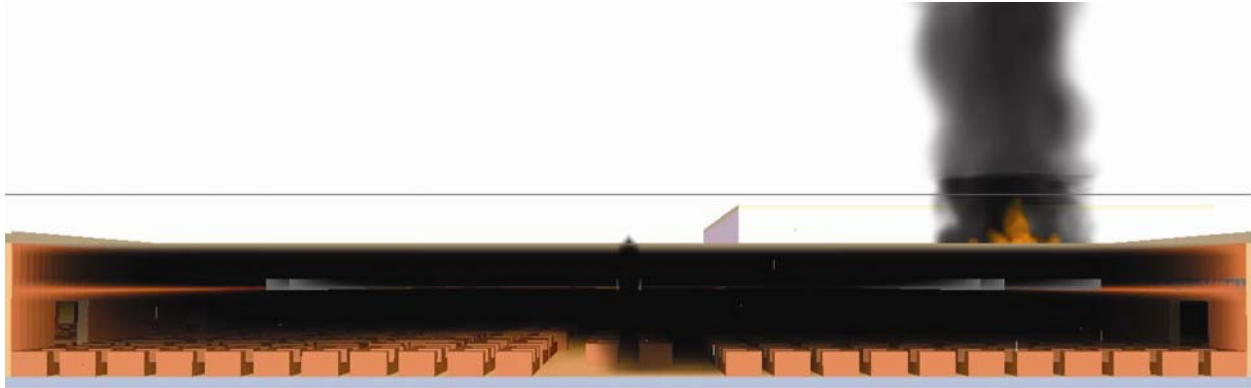
Figure 4-16. Model rendering of view inside the front of the main showroom at 487 s (7:19:00 p.m.).

self-contained breathing apparatus (SCBA) face pieces. Figure 4-16 shows an image of the front of the main showroom, with the front wall removed, at 487 s. This image shows that smoke had filled the void space above the ceiling and banked down to the showroom floor. Conditions on the east side, including the area near the entrance, are not as severe. However, as one progresses toward the rear and west, conditions degrade significantly.

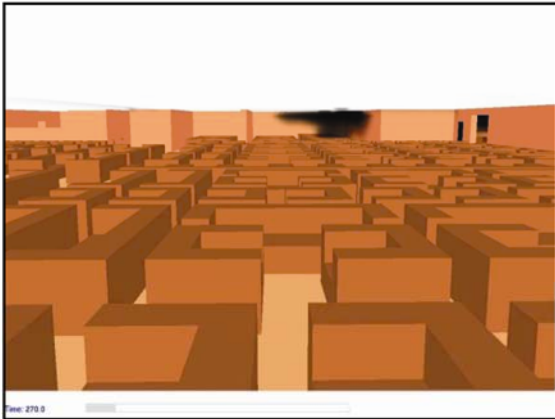
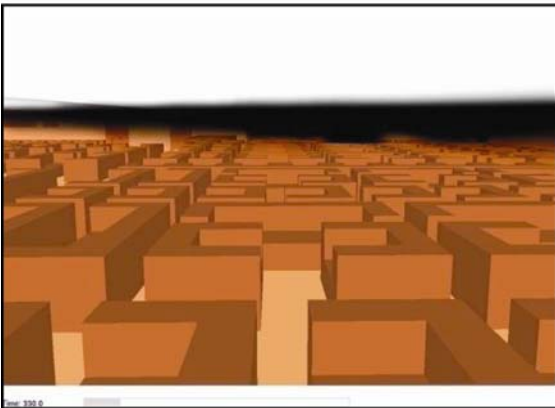
Figures 4-17 and 4-18 show smoke filling in, respectively, the main and west showrooms from the perspective of someone at the front of the room. The sequence in Figure 4-17 begins at 270 s (7:15:23 p.m.), after smoke began penetrating the ceiling. The sequence in Figure 4-18 begins at 270 s (7:15:23 p.m.). In both showrooms, conditions deteriorate considerably within a 120 s span.

Figure 4-17. Smoke progression inside the west side of the main showroom between 270 s to 390 s (7:15:23 p.m. to 7:17:23 p.m.).

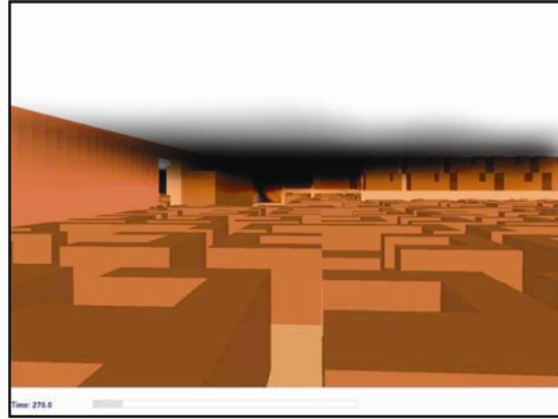
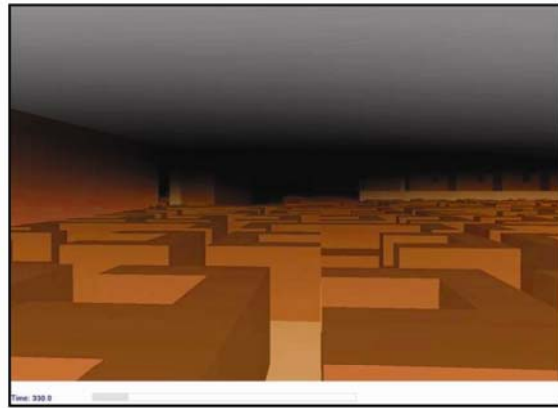
Figure 4-18. Smoke progression inside the west showroom between 270 s to 390 s (7:15:23 p.m. to 7:17:23 p.m.).

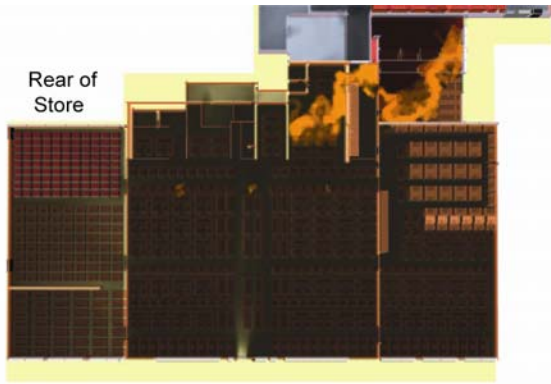
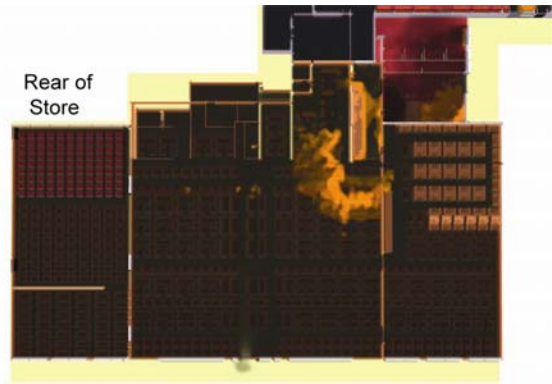
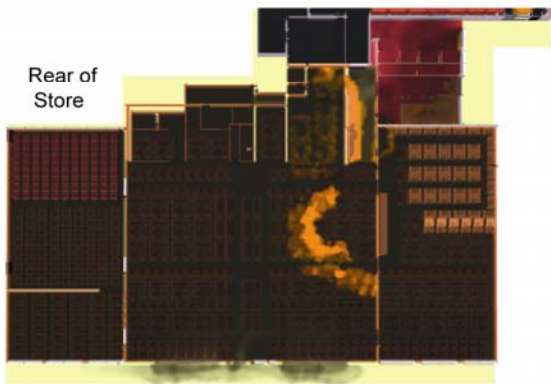
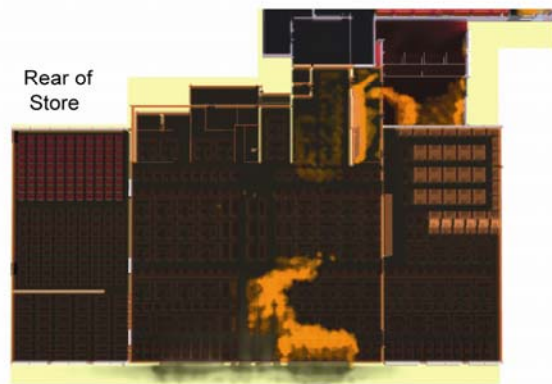
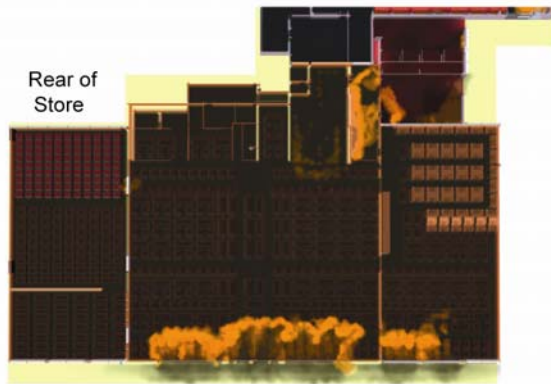
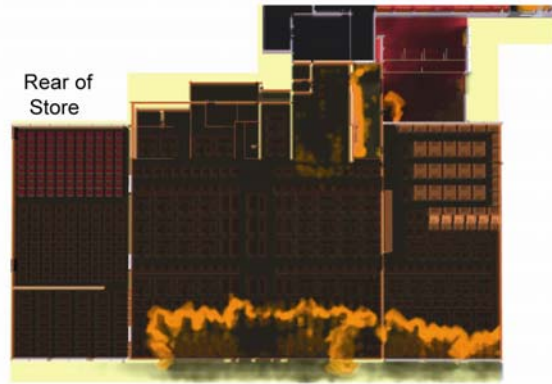
At 1020 s (7:27:53 p.m.), the fire in the main showroom reached about 70 MW and had begun moving forward toward the front of the showroom. Figure 4-19 shows the progression of fire and smoke throughout the loading dock, holding area and showrooms between 1020 and 2040 s. The front windows were vented during the period between 1457 through 1530 s (7:35:10 through 7:36:23). Fire reached the front of the main showroom at approximately 1540 s (7:36:33 p.m.) and spread across the west side of the main showroom by 1590 s (7:37:23 p.m.). By 1680 s (7:38:53 p.m.), the fire had moved into the front of the west showroom. This is consistent with the image in Figure 4-23, where the fire is visible in the west showroom through the window opening.

Figure 4-19. View of fire (orange color indicates stoichiometric boundary) and smoke progression from above the showrooms from 1020 s to 2040 s (7:27:53 p.m. to 7:44:53 p.m.). The images are clipped to view conditions below the ceiling.

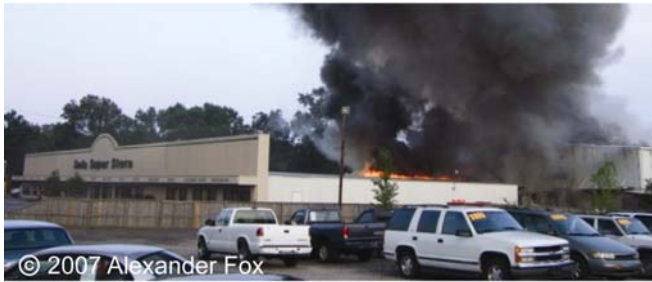
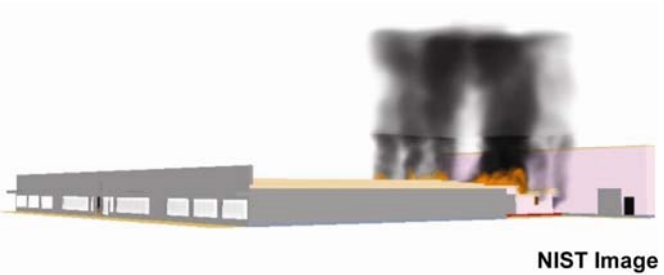
Figures 4-20 through 4-24 show comparisons of the fire and smoke progression with available photos at various times during the critical time between 7:23 p.m. and 7:45 p.m. (740 s through 2040 s). Figure 4-20 shows one of the earliest photos that were obtained of the fire, taken at 7:23:16 p.m. (743 s). At this time the fire was still mainly concentrated in the loading dock and holding area. Although the showrooms were charged with smoke, there was no smoke pushing out the open door at the front of the store. The fire had impinged on the underside of the roof over the holding area and flames were visible from the exterior at the roof level. At 1530s (7:36:23 p.m.), shown in Figure 4-21, the main sections of the front windows had been broken out and smoke was pushing out the front of the main showroom. At this

Figure 4-20. Comparison between photo and rendered image from the simulation at 743 s (7:23:16p.m.). The view is of the north west corner of the structure.

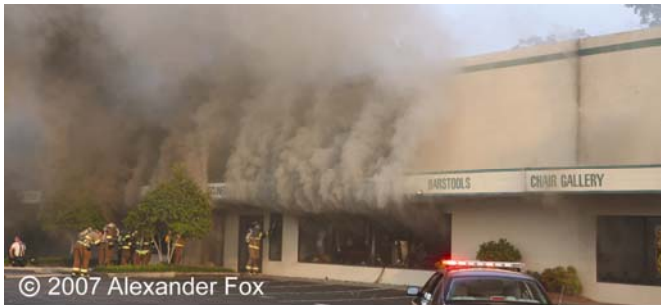
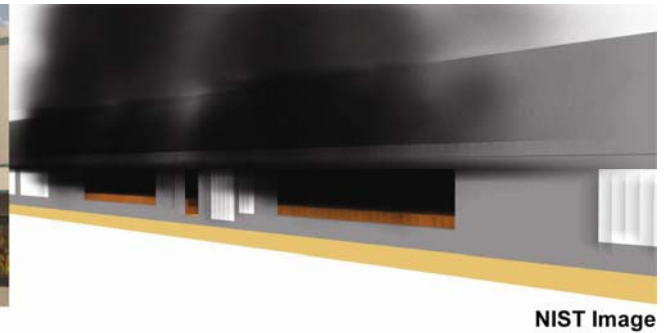
Figure 4-21. Comparison between photo and rendered image from the simulation at 1530 s (7:36:23 p.m.). The view is of the front of the main showroom.

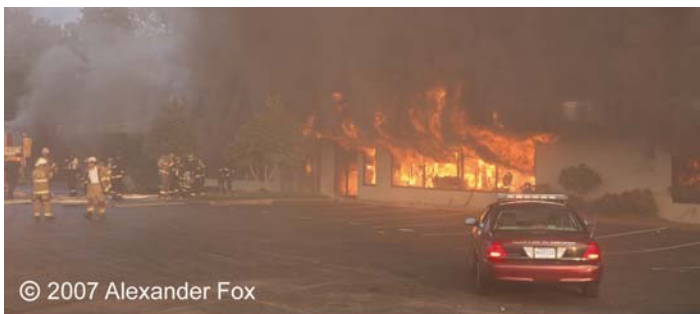
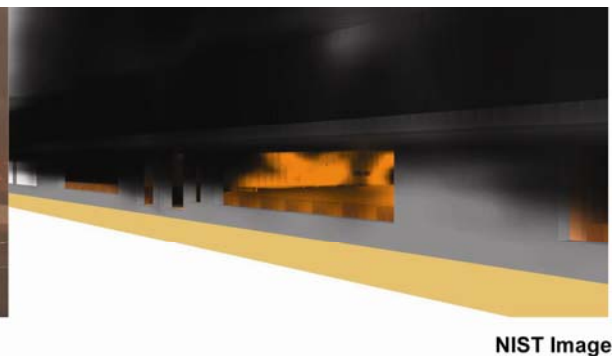
time, flames were not yet visible from the exterior through the front windows. By 1655 s (7:38:28 p.m.), shown in Figure 4-22, fire had reached the front of the main showroom and had stretched across the west side of the main showroom. At 1686 s (7:38:59 p.m.) flames were visible inside the west showroom, Figure 4-23, and the first window in this side had failed. By 1884 s (7:42:17), shown in Figure 4-24, fire had stretched across the front of the west showroom and two of the three windows were broken out.

Figure 4-22. Comparison between photo and rendered image from the simulation at 1655 s (7:38:28 p.m.). The view is of the front of the main showroom.

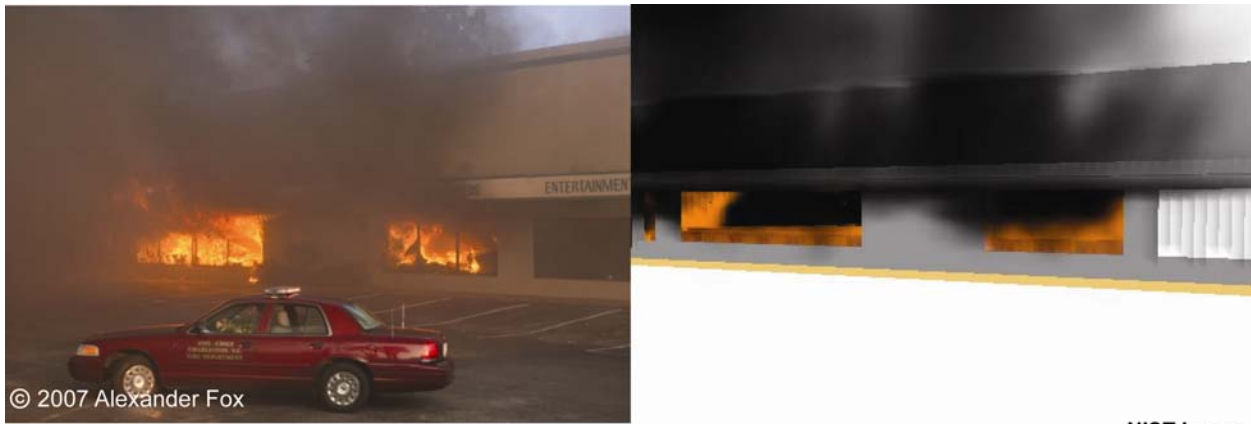
Figure 4-23. Comparison between photo and rendered image from the simulation at 1686 s (7:38:59 p.m.). The view is of the front of the main and west showrooms.

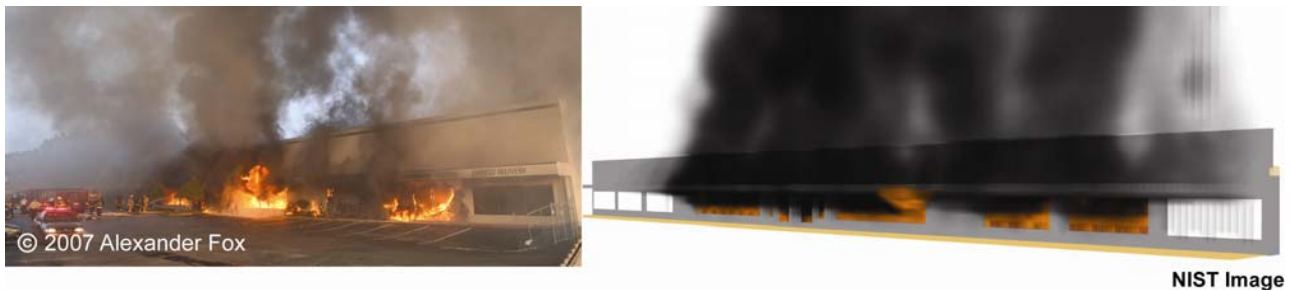
Figure 4-24. Comparison between photo and rendered image from the simulation at 1884 s (7:42:17 p.m.). The view is of the front of the main and west showrooms.

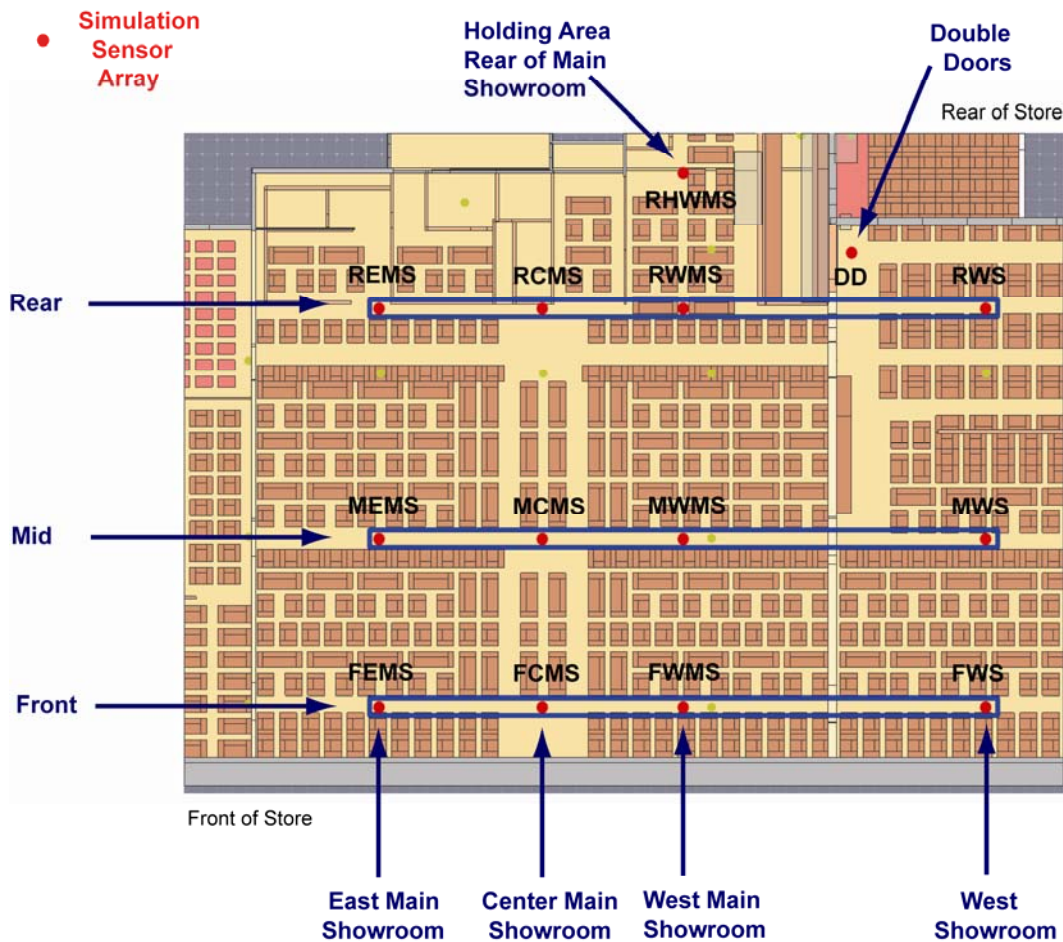
Temperatures were examined to assess tenability conditions that existed during the evolution of the fire. Horizontal slices were taken 1.5 m (5 ft) above the floor with the roof and ceiling rendered transparent to display the temperature distribution throughout the structure. Additionally, temperatures were tracked over time at different elevations at specific horizontal locations as shown in Figure 4-25 with the filled red circles. These temperature monitoring locations were defined in the simulation in order to track temperatures at a specific location during each simulation. The labels in Figure 4-25 that identify temperature locations (referred to as "sensor arrays") are consistent with those used throughout this report. The three positions indicated to the left of the figure (front, mid, rear) were located, respectively, 3.38 m (11.1 ft), 14.62 m (48.0 ft), and 26.62 m (87.3 ft) from the front of the showrooms. Sensors in the west showroom were located near the center, 7.5 m (24.6 ft) from the west wall. In the west side of the main showroom, the front and mid sensors were positioned 7.9 m (25.9 ft) from the west wall. The rear and corner sensors were located 9.8 m (32.2 ft) from the same wall; the corner position was 39 m (128.0 ft) from the front wall. The sensors positioned in the center of the main showroom were located 19.1 m (62.7 ft) from the west wall of the main showroom. Sensors in the east side of the main showroom were positioned 30 m (98.4 ft) from the west wall of the main showroom.

Figure 4-25. Location of simulation sensor arrays in main and west showrooms.
