Technical Study of the Sofa Super Store Fire - South Carolina, June 18, 2007

Draft for Public Comments

*Fire Research Division
Engineering Laboratory
National Institute of Standards and Technology*

October 2010

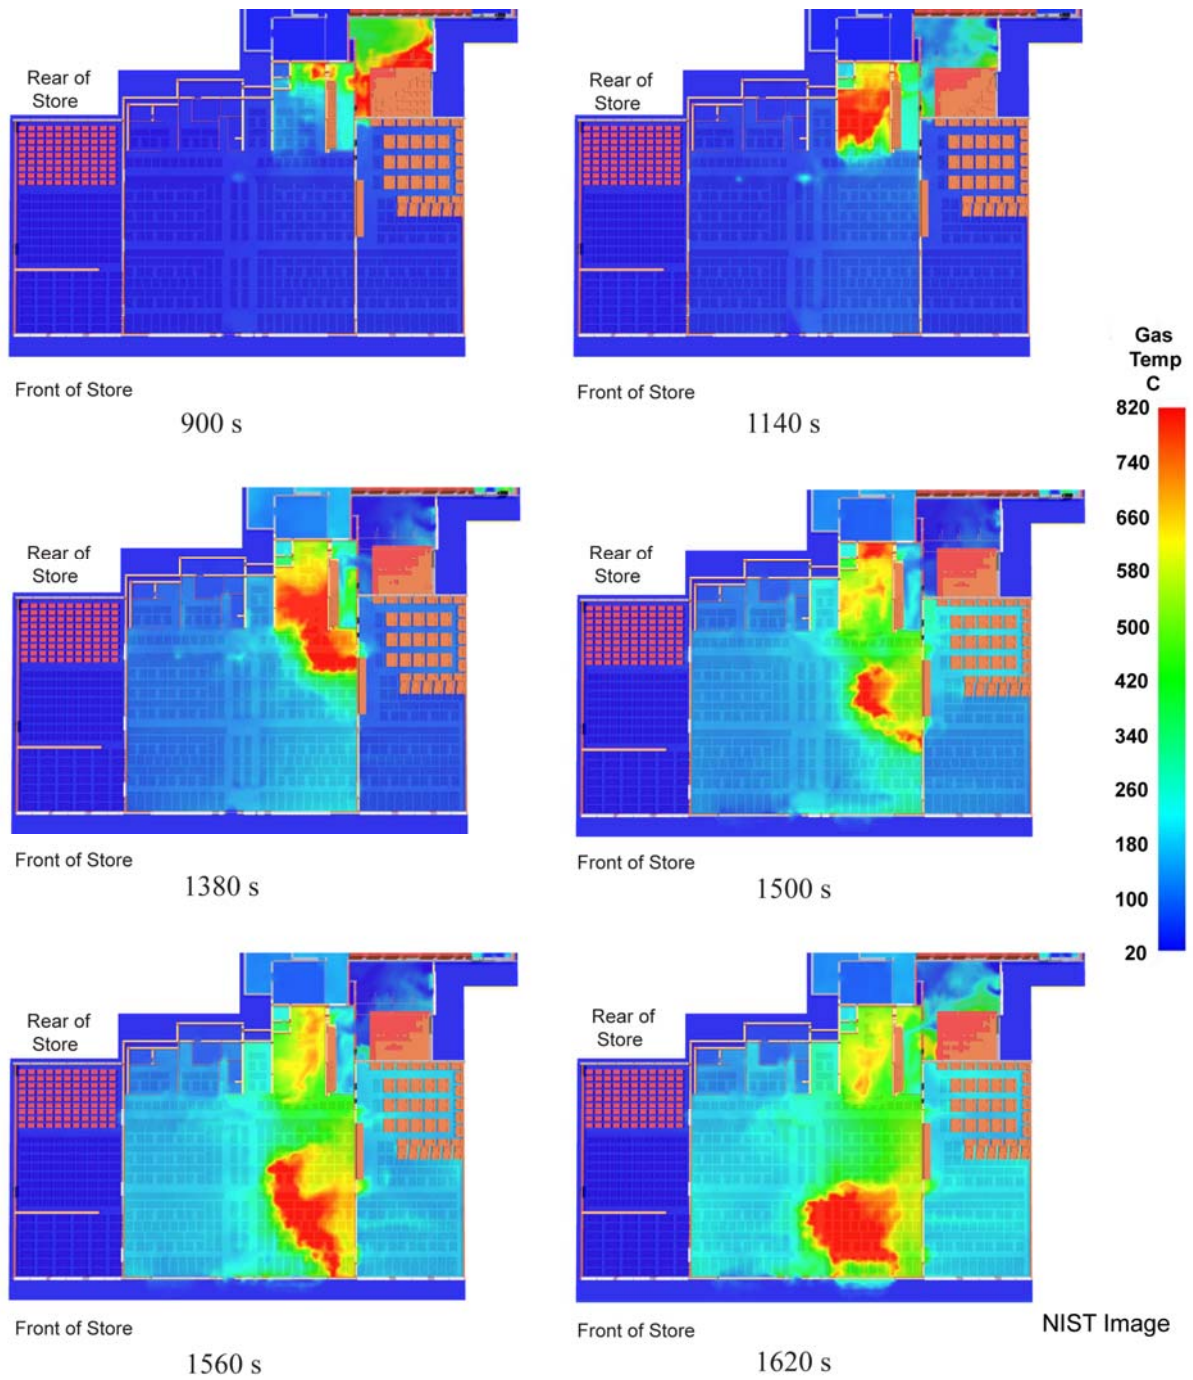
Figure 4-26 shows a series of images with a temperature slice 1.5 m (5 ft) from the floor rendered at a range of times between 900 s through 1620 s (7:25:53 p.m. through 7:37:53 p.m.). These images show the progression of the elevated temperatures from the loading dock, into the holding area, and eventually into the main showroom. Temperatures above 100 °C (approximately indicated by the border between dark blue and light blue) are first observed in the holding area approximately three minutes into the simulation. Note that the double doors separating the west showroom from the loading dock were opened at 144 s, but the temperature in the west showroom remained low even as fire was spreading into the holding area.

Figure 4-26. Temperature slices located 1.5 m (5 ft) above the floor.

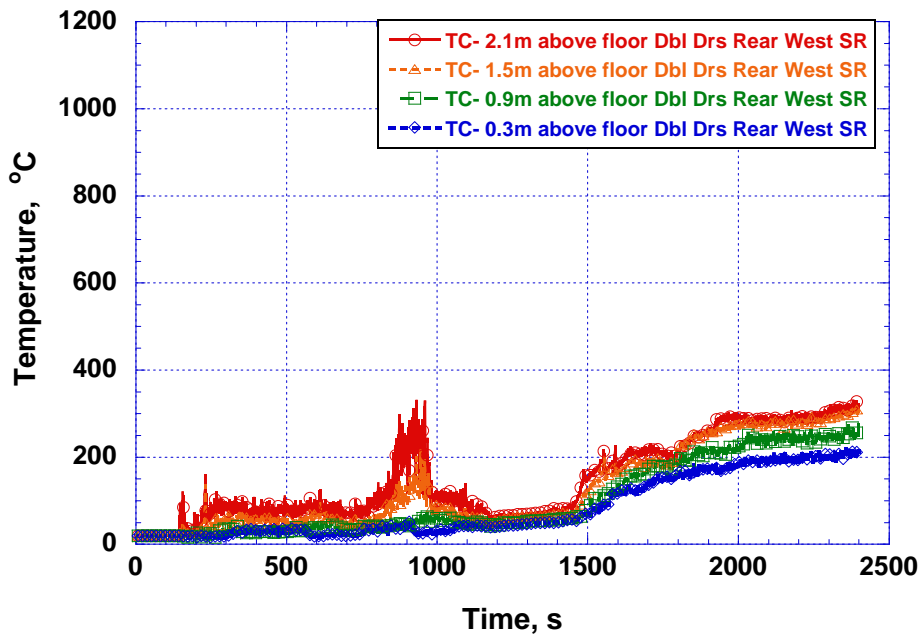
Figure 4-27 shows a chart of temperatures recorded in the west showroom, near the double doors. The data are from sensors located 0.3 m (1 ft), 0.91 m (3 ft), 1.52 m (5 ft), and 2.13 m (7 ft) from the floor. Figure 4-27 shows that temperatures remained below 100 °C through approximately 750 s (7:23:23 p.m.). The fire was positioned near the double doors to the loading dock; however, during the early stages much of the heat was venting through the loading dock roof and later through the main showroom roof. Air was being pulled through the doorway to feed oxygen to the fire in the loading dock and holding area. There was a surge in temperature in the upper layer lasting several minutes caused by fire progression into the showroom. At 900 s (7:25:53 p.m.), a section of the roof above the holding area was removed and this resulted in the subsequent temperature drop. Temperatures dropped below 100 °C, but as the fire increased in the main showroom the temperatures in both showrooms began to rise quickly. A second temperature surge, which began at approximately 1460 s (7:35:13 p.m.), was due to the fire entering the west showroom through the open roll-up door as it moved to the front of the main showroom. It should be noted that the focus of suppression efforts was in this area of the showroom, and that the simulation does not take this into account.

Figure 4-27. Temperatures at different elevations, 0.3 m (1 ft), 0.91 m (3 ft), 1.52 m (5 ft), and 2.13 m (7 ft) in rear of west showroom near double doors.

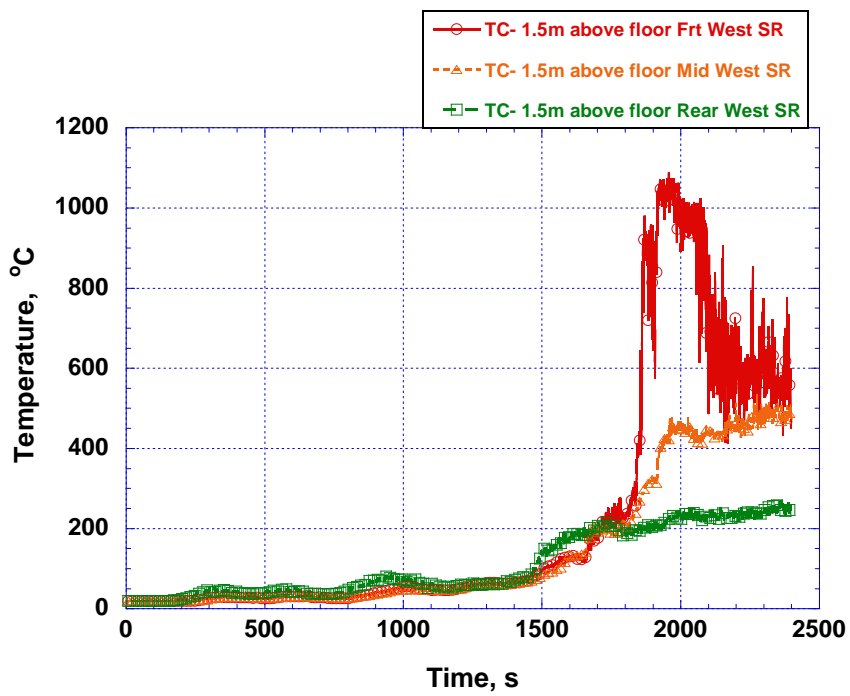
Figures 4-28 through 4-30 show charts of temperatures recorded at the locations throughout the main and west showroom as indicated in Figure 4-25. All data in these charts were recorded 1.5 m (5 ft) above the floor. Figure 4-28 shows temperatures in the west showroom. Temperatures in the west showroom remained relatively low, below 100 °C, until the fire began moving toward the front of the main showroom. The temperature at the rear sensor surpassed 120 °C at 1350 s (7:33:23 p.m.). As the fire in the main showroom continued to move forward, the temperature at the mid and front sensors reached 120°C at 1400 s (7:34:13 p.m.)

Figure 4-28. West showroom temperatures for 1.5 m (5 ft) above floor.

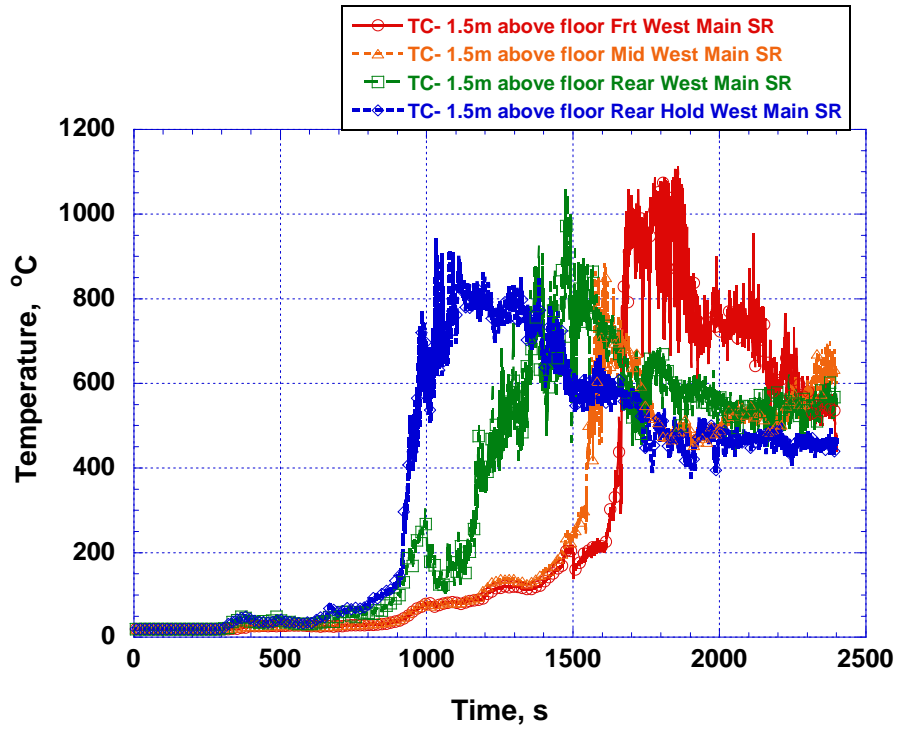
Figure 4-29 shows a temperature chart that displays data from sensors located on the west side of the main showroom. This chart contains a fourth data location, labeled Rear Hold, which was identified in Figure 4-25. Temperatures in the west side of the main showroom became elevated at an earlier point than in the other areas of the showroom because the fire moved across these sensors as it moved to the front of the showroom. The rear holding area location reached 120 °C at 864 s (7:25:17 p.m.); the rear location was roughly 30 s behind, reaching 120 °C at 900 s (7:25:53 p.m.). The mid and front locations reached 120 °C simultaneously at 1250 s (7:31:43 p.m.). Temperatures in the center and east areas of the main showroom showed similar trends.

Figure 4-29. Main showroom west temperatures for 1.5 m (5 ft) above floor.

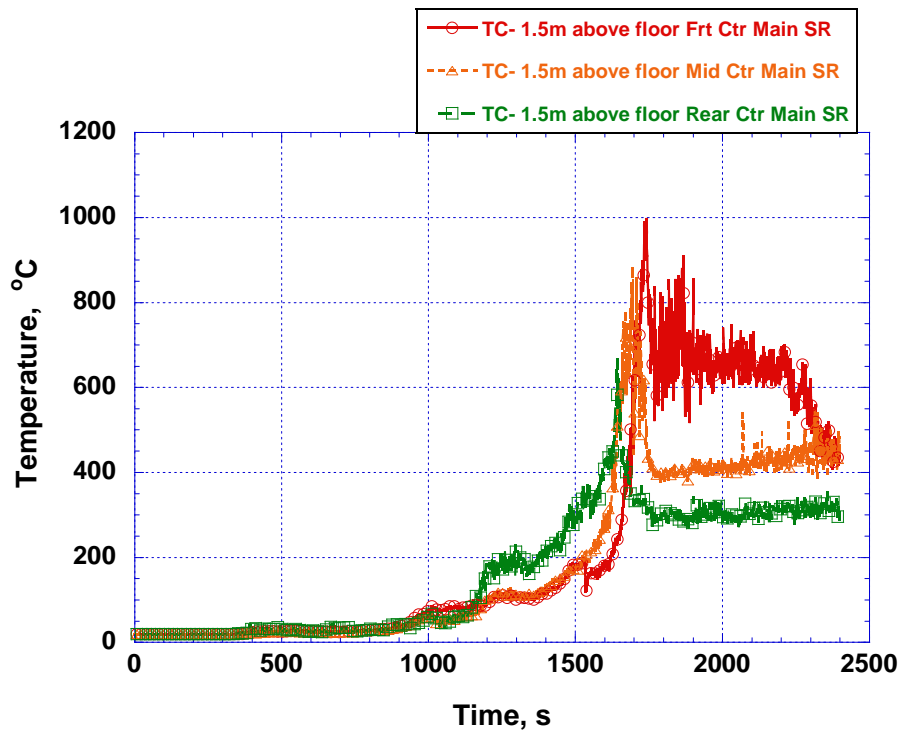
Figure 4-30. Main showroom (center) temperatures for 1.5 m (5 ft) from floor.

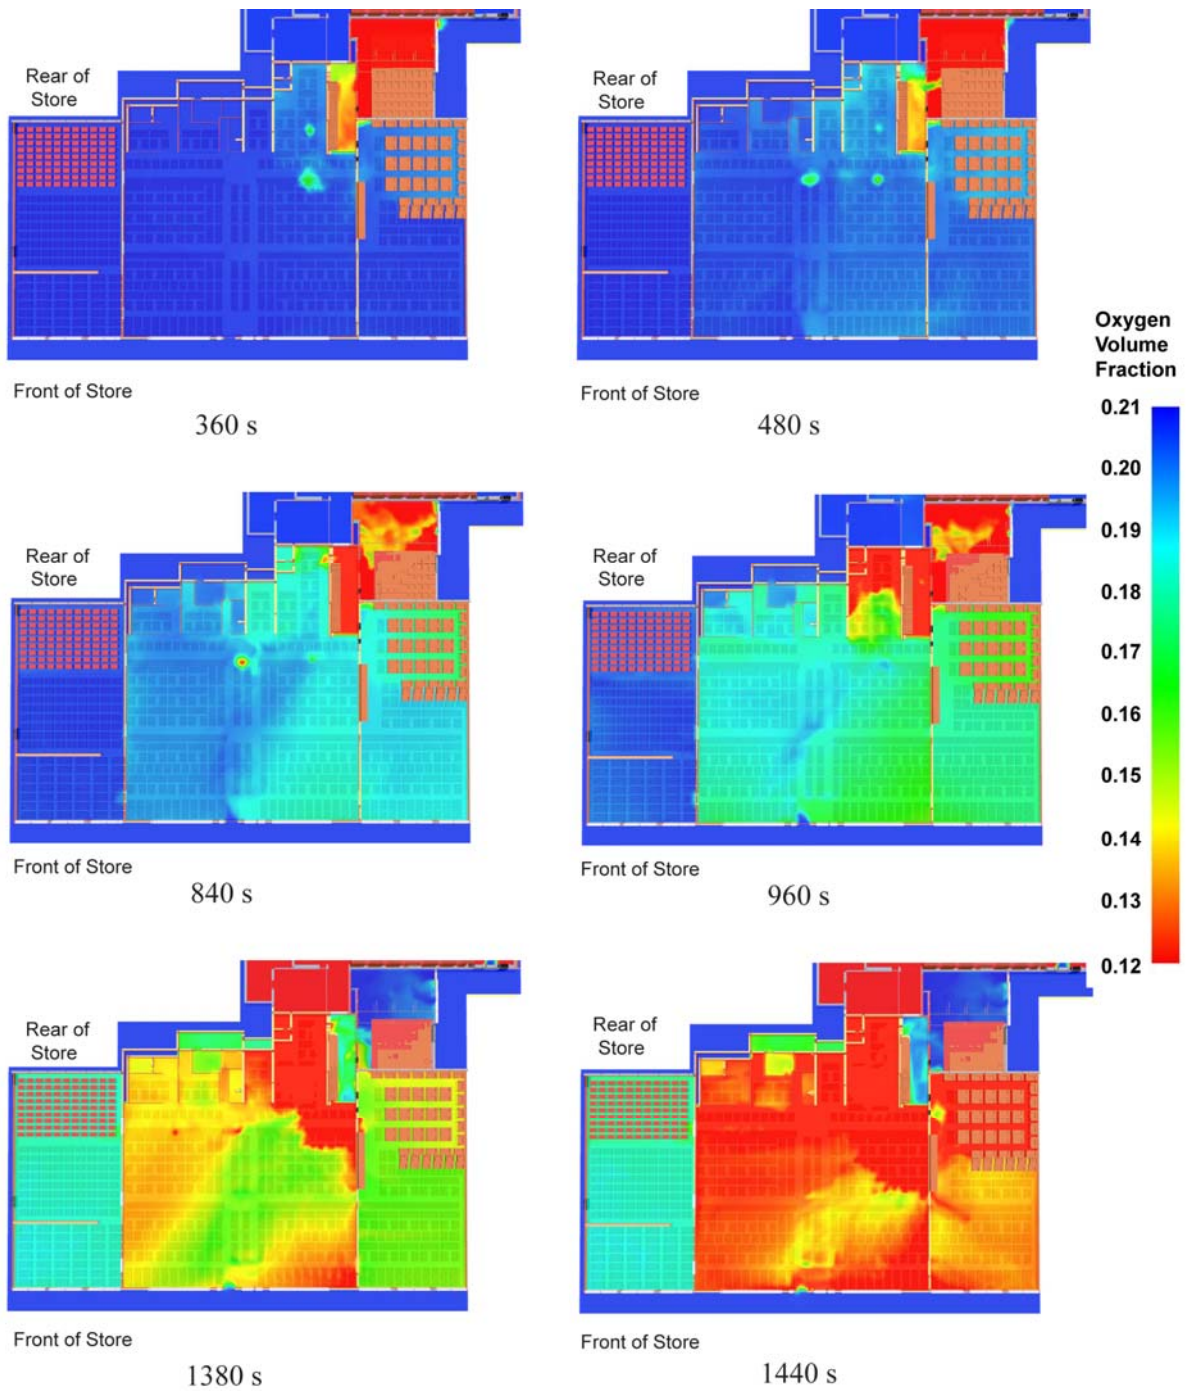
Figure 4-31 shows a series of images with an oxygen slice 1.5 m (5 ft) from the floor rendered at a range of times between 360 s and 1440 s (7:16:53 p.m. through 7:34:53 p.m.).

Figure 4-31. Oxygen volume fractions (slice images) for 1.5 m (5 ft) above the floor.

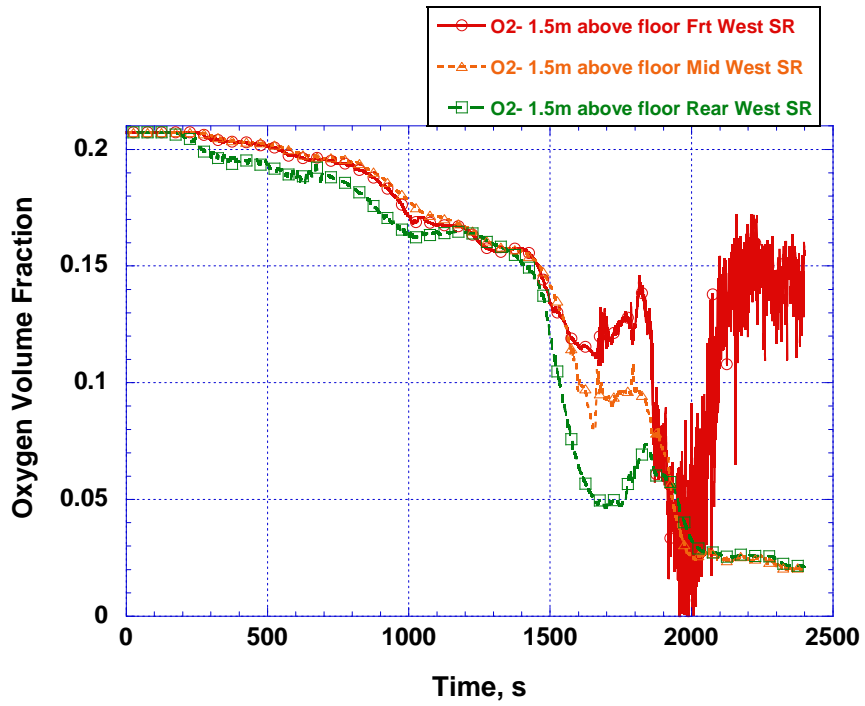
Figures 4-32 through 4-34 show charts of oxygen volume fraction recorded at several locations throughout the main and west showroom. All data in these charts were recorded 1.5 m (5 ft) above the floor. The locations correspond to those used for the temperature results shown in Figures 4-28 through 4-30. The oxygen volume fraction at the sensor in the rear of west showroom fell below 0.12 at 1500 s (7:35:53 p.m.). As the fire in the main showroom continued to move forward, the oxygen at both the mid and front sensors reached 0.12 volume fraction at 1600 s (7:37:33 p.m.).

Figure 4-32. West showroom oxygen volume fractions for 1.5 m (5 ft) above the floor.

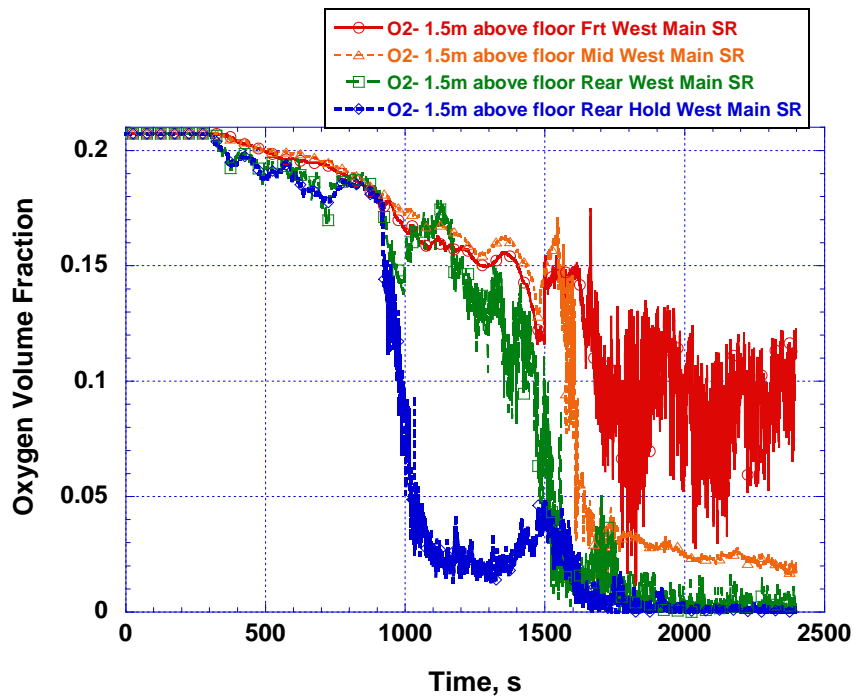
Figure 4-33 shows a chart that displays oxygen data from sensors located on the west side of the main showroom. Oxygen in the west side of the main showroom became depleted at an earlier point than in the other areas of the showroom because this was the path of the fire as it moved to the front of the showroom. The holding area location reached 0.12 volume fraction at 950 s (7:26:43 p.m.); the rear location was roughly six minutes behind, reaching 0.12 volume fraction at 1250 s (7:31:43 p.m.). The mid and front locations initially reached 0.12 volume fraction approximately the same time at 1400 s (7:34:13 p.m.). The mid and front locations then increased up to 0.15 volume fraction as the front windows were broken. Oxygen volume fractions in the center and east areas of the main showroom had similar trends.

Figure 4-33. Main showroom (west) oxygen volume fractions for 1.5 m (5 ft) above the floor.

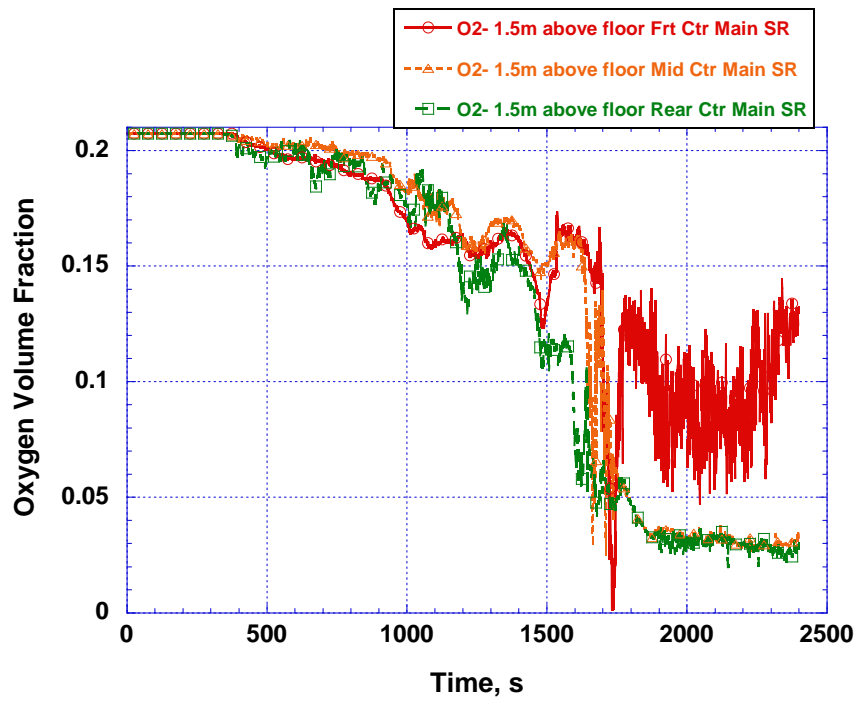
Figure 4-34. Main showroom (center) oxygen volume fractions for 1.5 m (5 ft) above the floor.

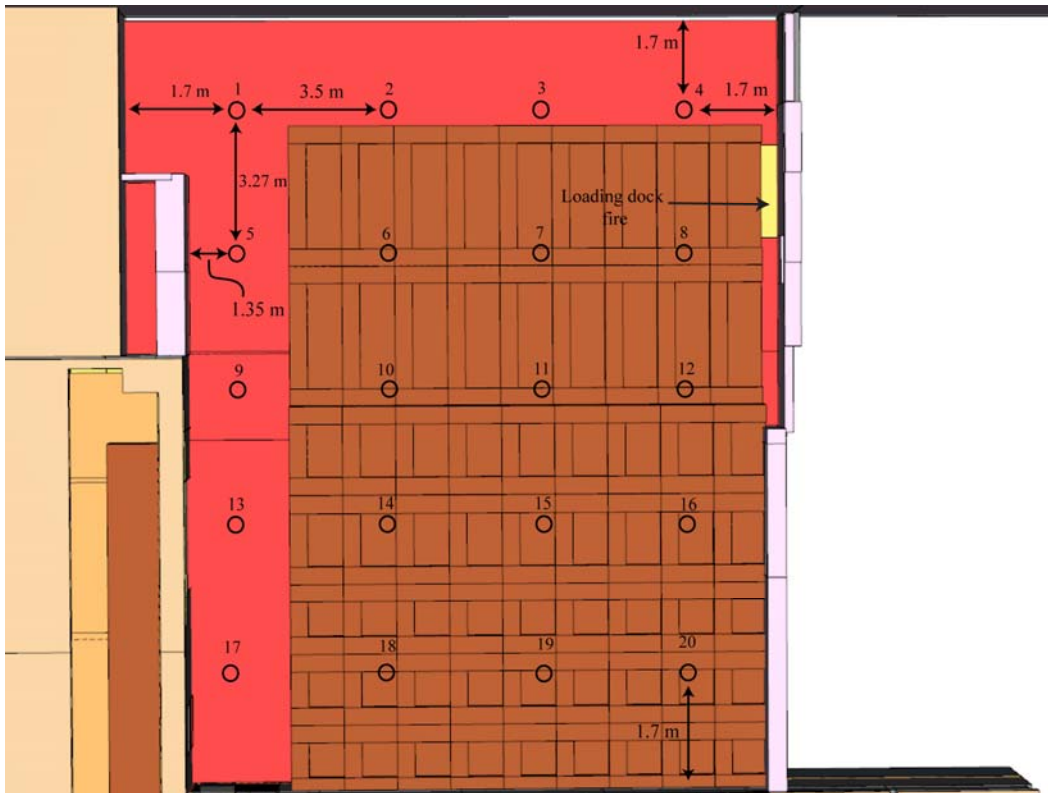
Figure 4-35. Sprinkler layout inside the enclosed loading dock.

Twenty sprinklers were placed inside the loading dock in a 3 x 4 mesh, as shown by the black circles in Figure 4-35. The sprinkler specifications that were used in the simulation are detailed in Appendix K, Table K-6. In this configuration, the coverage for each sprinkler was 6 L/min/m² (0.15 gpm/ft²). Two sprinklers, labeled 3 and 6 in Figure 4-35, activated in the simulation. Sprinkler 3 was the first to activate, at 50 s, while sprinkler 6 activated at 75 s.

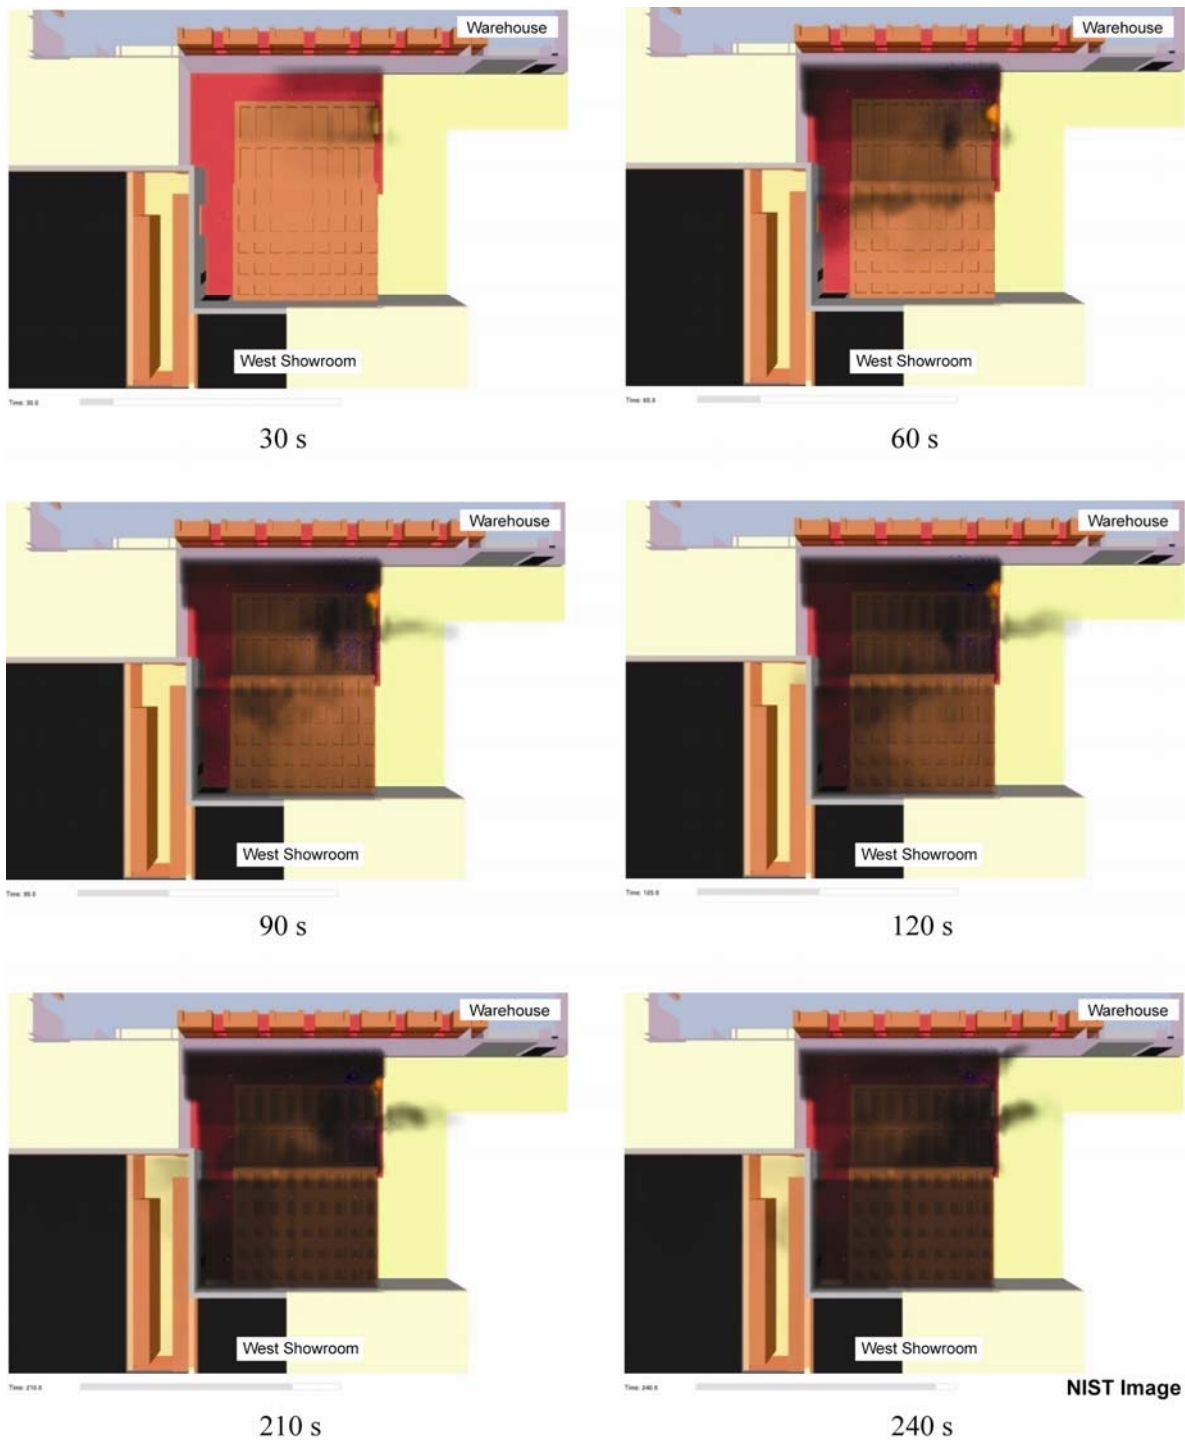
Figure 4-36 shows a series of images indicating the progression of fire and smoke in the loading dock during the sprinklered simulation. These images show an overhead view, centered on the loading dock (the area shaded in red). The north end of the warehouse is shown at the top of the images and the south end of the west showroom is at the bottom. The southwest corner of the main showroom (including the holding area) is shown in the lower left corner. In these images, the roof and walls of the loading dock were made invisible in order to facilitate viewing the loading dock interior. Additionally, the roofs over the main and west showrooms were clipped so that the interior of the holding area was visible. The areas colored black are the showroom ceilings. The west showroom ceiling is only partially revealed because this addition had a sloped roof and only the upper section was clipped away.

The quantity of fire generated smoke increases through the first five images in this sequence, from 30 through 210 s. Smoke spread across the underside of the loading dock roof and began to fill downward. At 210 s, the smoke layer was low enough to begin spilling into the holding area where there is access to the space above the showroom ceiling. By 240 s however, the fire is no longer burning and the smoke is beginning to dissipate.

Figure 4-36. Fire and smoke progression in the early stages of the sprinklered scenario. Sprinkler 3 was the first to activate, at 50 s, while sprinkler 6 activated at 75 s.

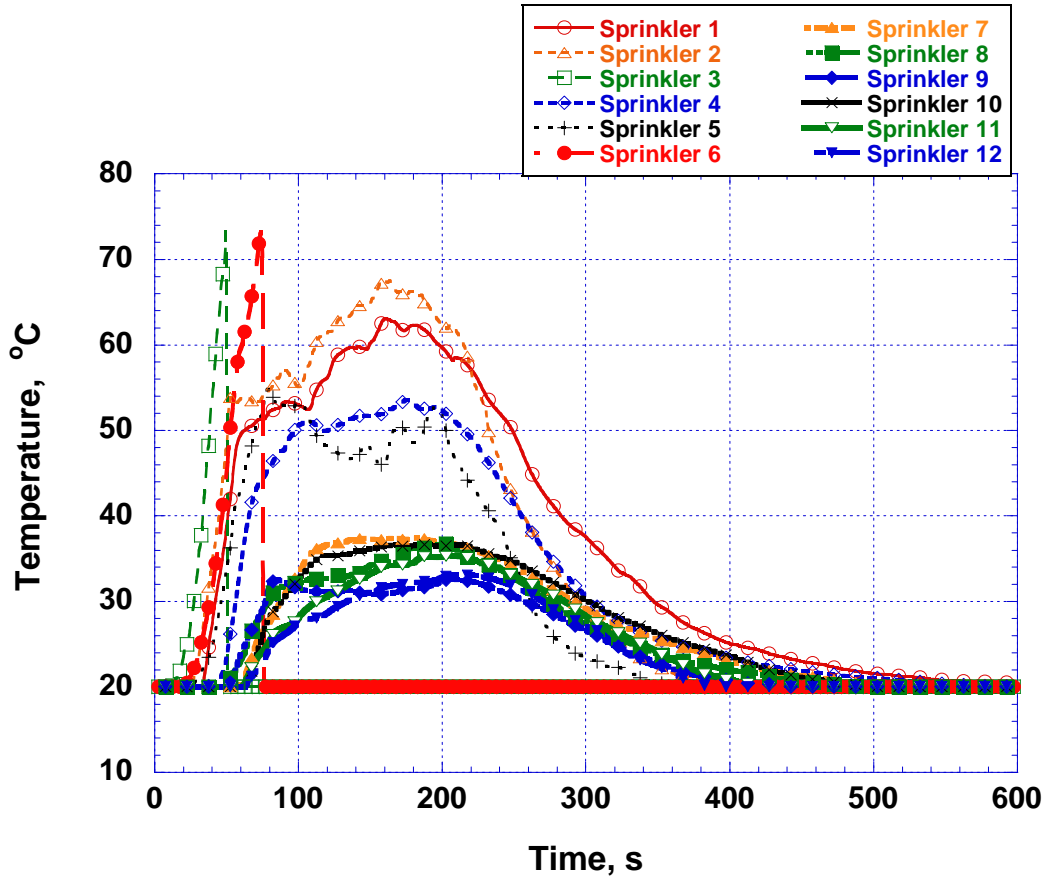
Figure 4-37 shows the temperature at each of the sprinkler locations. The graph indicates that the temperature at locations 3 and 6 reached 74°C, at which point the sprinklers were activated in these locations. Temperatures at locations 1 and 2 peaked in the 60°C to 70°C range but never reached the threshold for activation.

Figure 4-37. Temperatures near sprinkler head inside the loading dock.

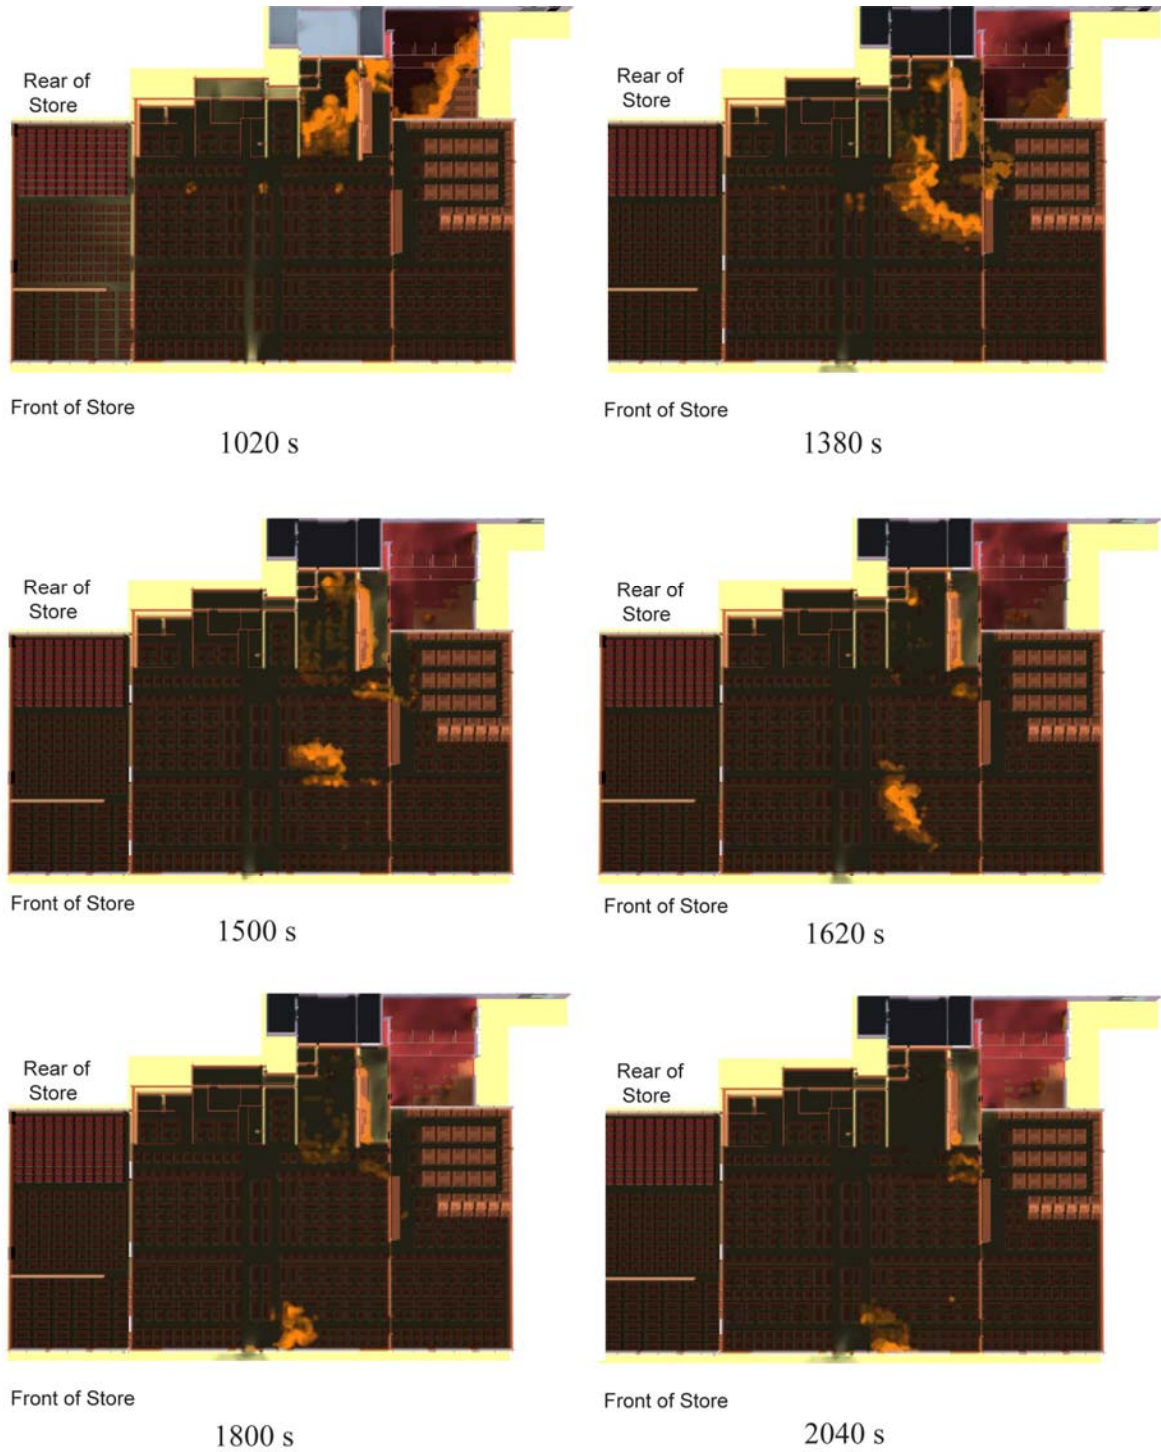
Figure 4-40. Fire and smoke progression in case with front windows intact.

Figure 4-40 shows the progression of fire and smoke throughout the loading dock, holding area and showrooms between 1020 s and 2040 s (7:27:53 p.m. through 7:44:53 p.m.). The first three images in this figure are indistinguishable from the corresponding images in Figure 4-19 (the baseline simulation). The differences appear in the later images – 1500 s and beyond. Compared to Figure 4-19, Figure 4-40 shows far less burning in the northwest quadrant of the main showroom.

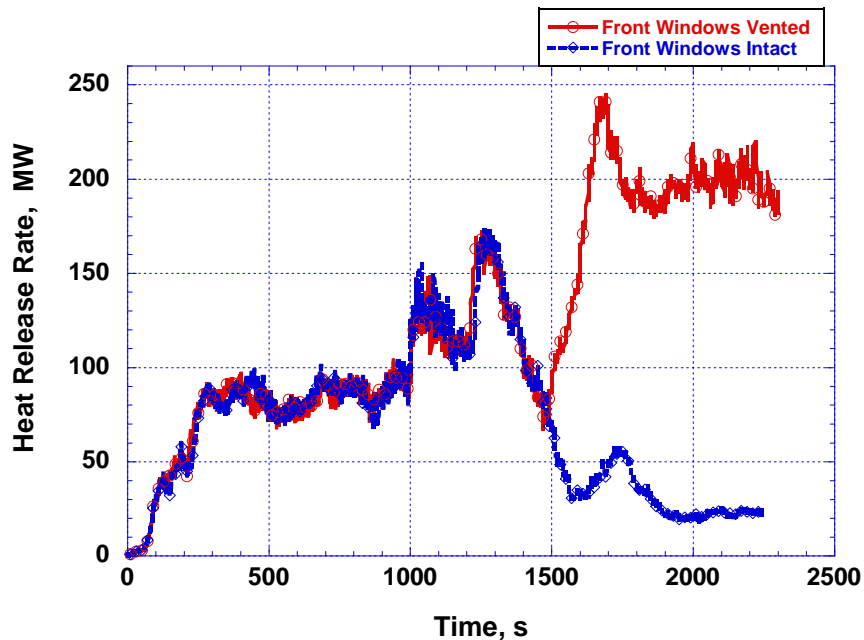
Figure 4-41. Comparison of the heat release rate in the main showrooms for front windows vented and front windows intact.

Figure 4-41 shows the change in HRR over time for this scenario and the baseline simulation. In both scenarios, HRR peaked at 120 MW at around 1300 s after which the HRR decreased. This would be consistent with the fire becoming underventilated. The venting of the front windows in the main showroom at 1457 s corresponds with the subsequent rapid increase in HRR for the base case. In the simulation with the windows intact, the HRR did not increase at approximately 1500 s, but continued to decrease until about 1600 s.

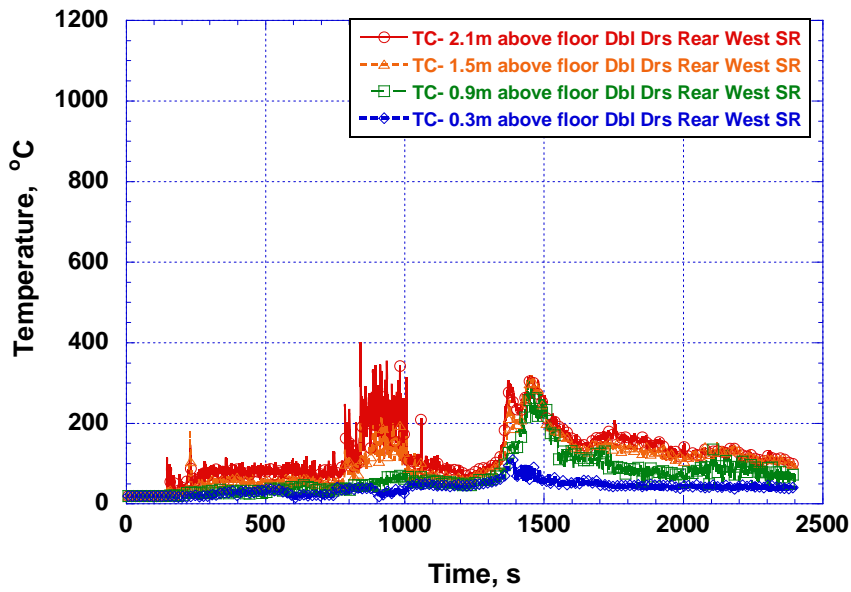
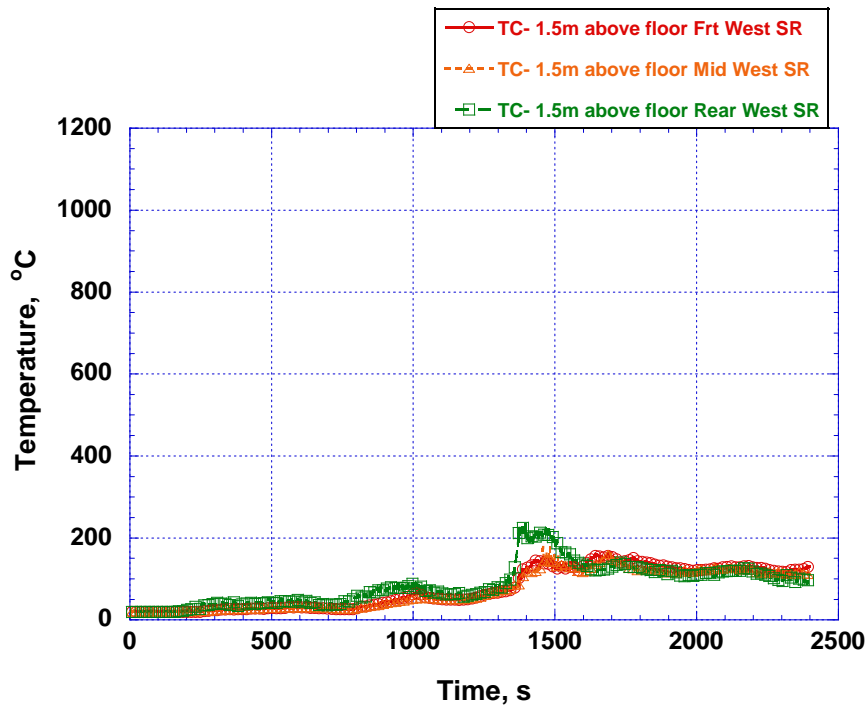
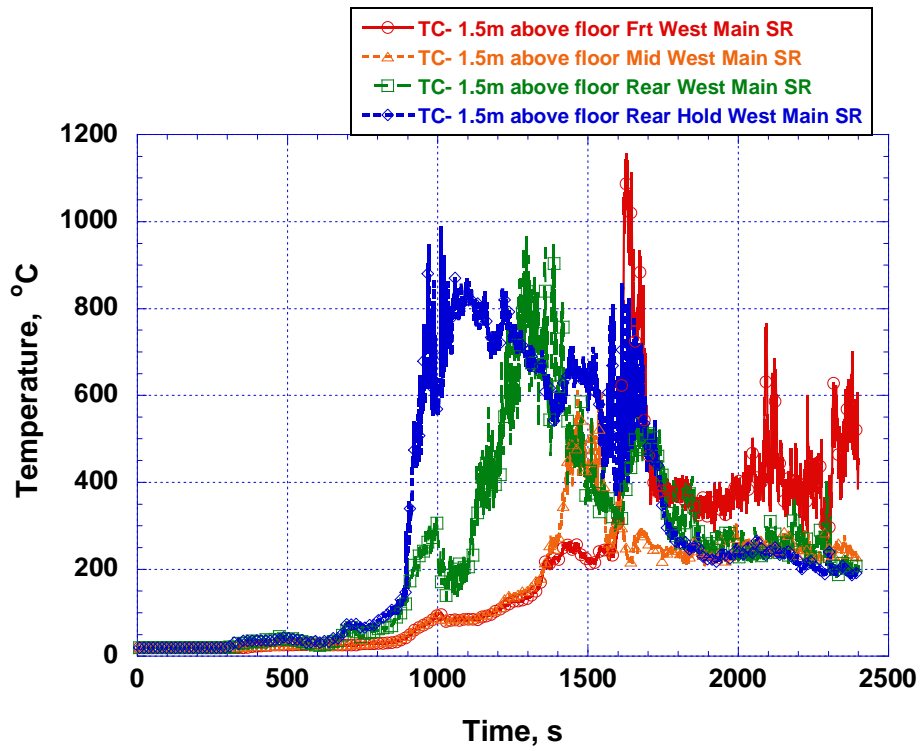
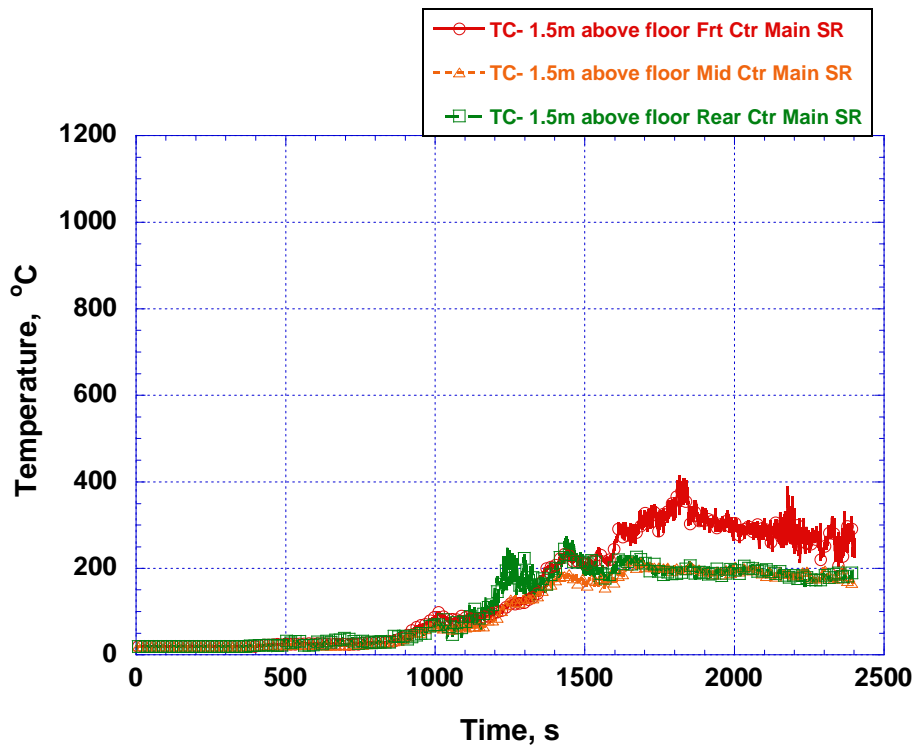
Figures 4-43 through Figure 4-46 show temperature data recorded at the same sensor locations used in Figure 4-25 for the baseline simulation. For comparison purposes, the scale in these figures was kept the same as the corresponding scale in Figure 4-27 through Figure 4-30. After 1500 s, the temperatures were lower in the scenario with the front windows intact as compared to the base case. The temperatures with the windows intact exceeded the 120 °C tenability threshold at each sensor location before the time at which the windows would have been broken out.

Figure 4-43. Temperatures at different elevations, 0.3 m (1 ft), 0.91 m (3 ft), 1.52 m (5 ft), and 2.13 m (7 ft) in rear of west showroom near double doors.

Figure 4-44. West showroom temperatures for 1.5 m above the floor.

Figure 4-45. West main showroom temperatures for 1.5 m above the floor.

Figure 4-46. Center main showroom temperatures for 1.5 m above the floor.

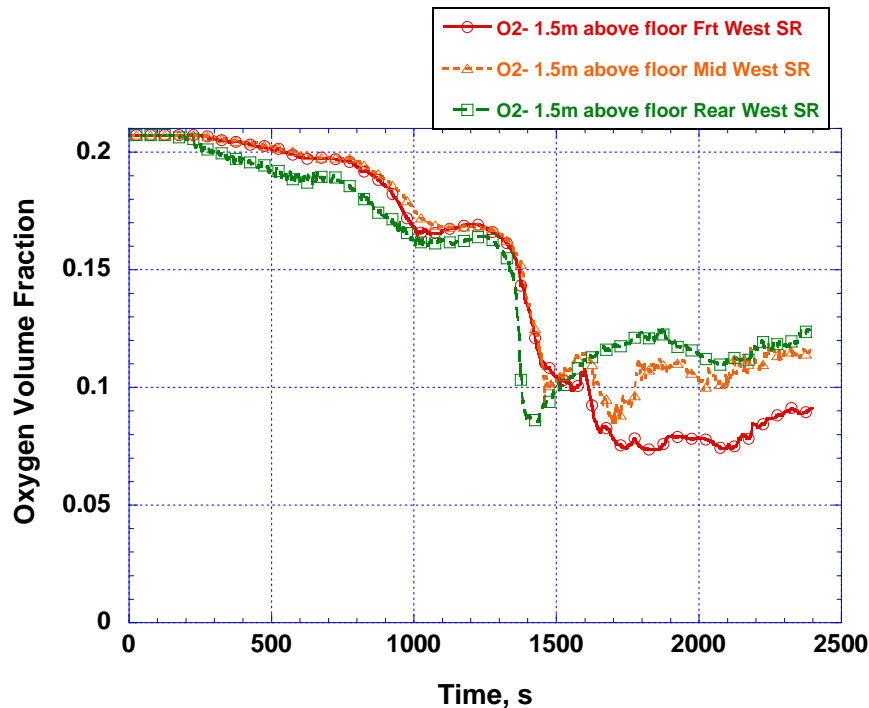
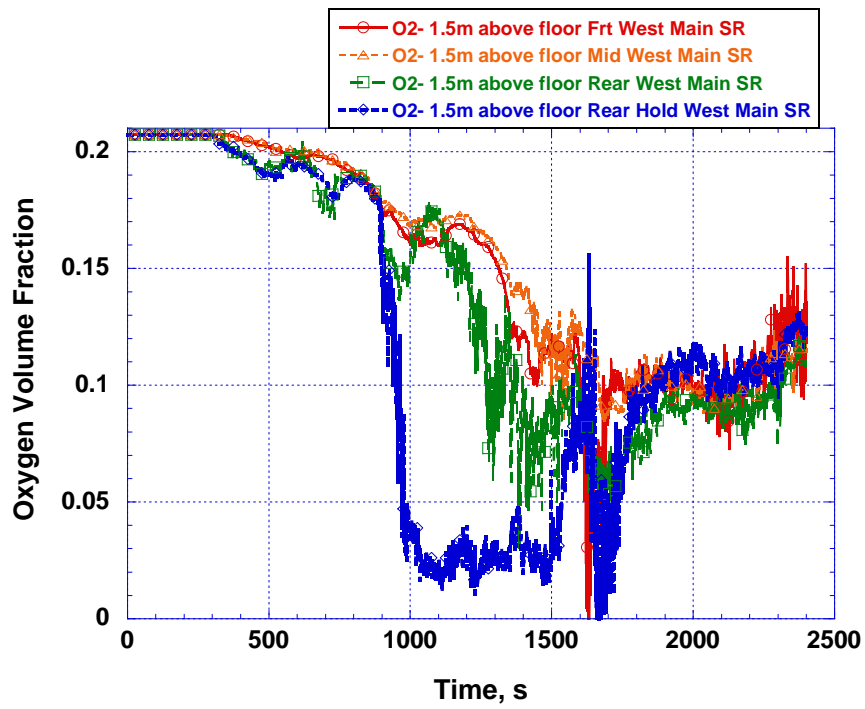
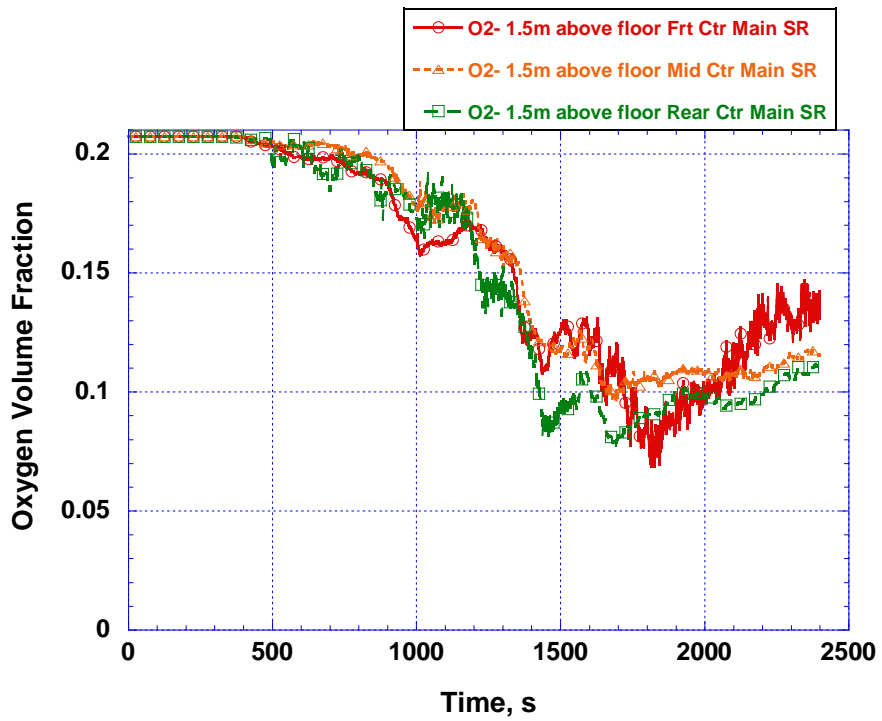
Figures 4-47 through 4-49 show oxygen volume fraction data for the front windows intact case that were recorded at the same sensor locations (Figure 4-25) as the baseline case. For the first 1000 s, the oxygen volume fraction in the west showroom (Figures 4-47 and 4-32) drops to about

0.16 for both cases. For about the next 400 s, the oxygen volume fraction decreases more slowly in both cases. By 1400 s the volume fraction drops below 0.1 for the windows intact case, but decreases to 0.15 for the base scenario. For the windows intact case, after the time when the windows would have been broken at 1457 s, the oxygen volume fraction in the rear of the west showroom begins to increase and peak at about 0.12 at 1850 s. The oxygen volume fractions in the mid and front of the west showroom decrease to 0.09 and 0.07, respectively. The oxygen volume fractions in the rear of the main showroom (Figures 4-48 and 4-33) show similar trends during the first 1300 s. For the windows intact case, the oxygen volume fraction became more steady between 0.07 and 0.09. The oxygen volume fraction for the same location in the base scenario continues to drop to less than 0.02. For the base case, after 1700 s, the oxygen volume fraction is less than 0.03 for the holding area, rear, and mid showroom. For the windows intact scenario, at about the same time, 1700 s, the oxygen volume fraction for the rear, mid, and front showroom locations are all above 0.07. Overall, the trends for both cases are similar during the early portion of the simulations, but after the time at which the windows were broken out in the base scenario, the oxygen volume fractions appear lower than in the front windows intact case for the rear holding, rear, and mid showroom locations.

Figure 4-47. West showroom oxygen volume fractions for 1.5 m above the floor.

Figure 4-48. West main showroom oxygen volume fractions for 1.5 m above the floor.

Figure 4-49. Center main showroom oxygen volume fractions for 1.5 m above the floor.

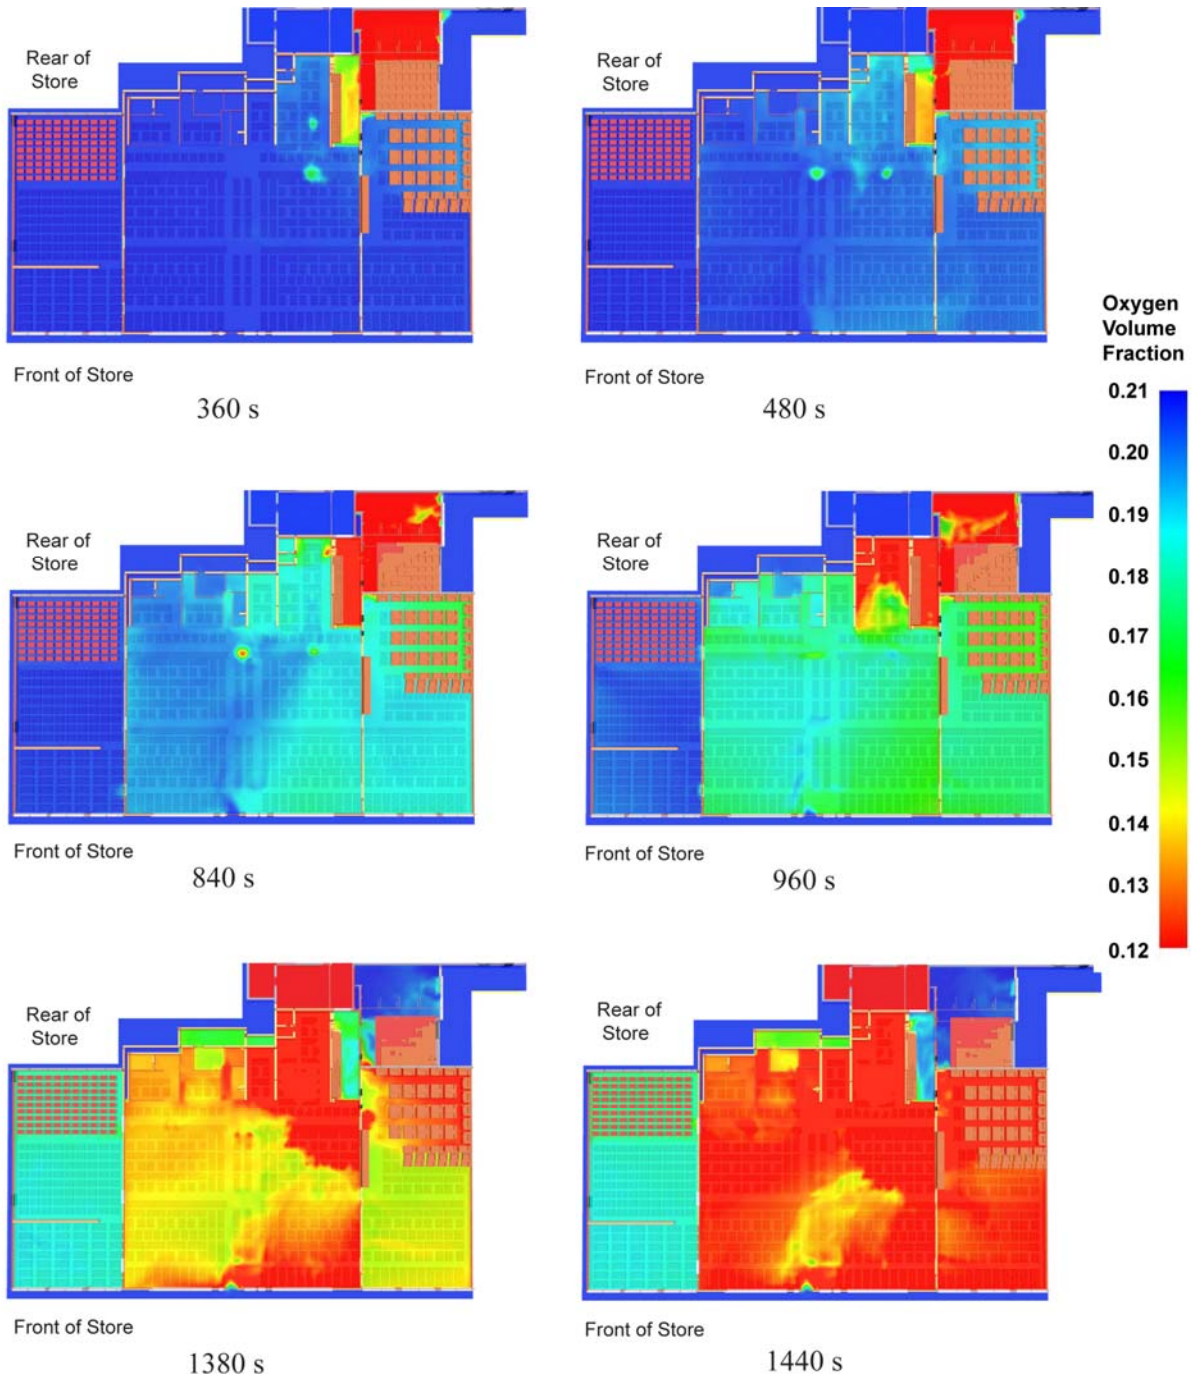
Figure 4-50. Oxygen volume fractions (slice images) 1.5 m (5 ft) above the floor in simulation with front windows intact.

Figure 4-50 shows a series of images with an oxygen slice 1.5 m (5 ft) from the floor rendered at a range of times between 360 s and 1440 s. As was the case with temperature, the conditions in the main and west showrooms become untenable because of oxygen depletion prior to 1440 s (7:34:53 p.m.). While minimum oxygen volume fractions were not as low in the case with the windows intact, they nonetheless dropped below 0.12 (indicated by the red shaded areas in Figure 4-50) in the main and west showrooms.
