# DEGRADATION STUDY OF FIELDDED PV MODULES FROM DIFFERENT CLIMATES IN CHINA

Dec 8<sup>th</sup>, 2015

Xian Dong

Shunde SYSU Institute for Solar Energy

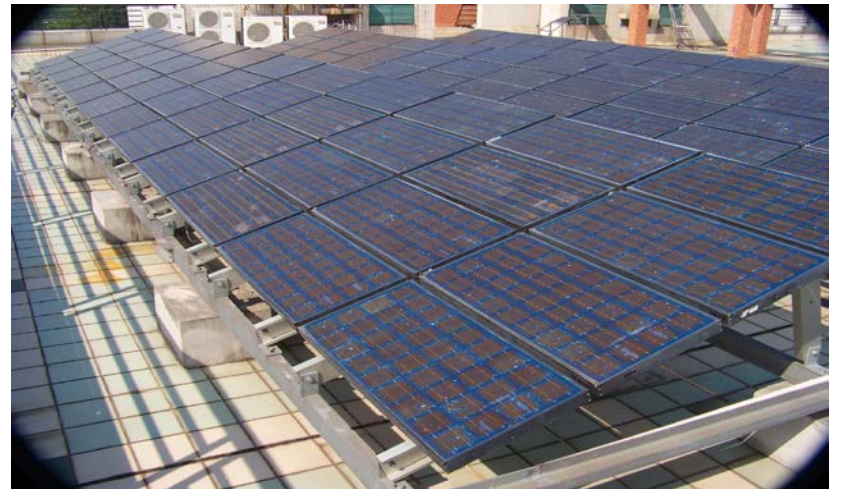
Re-installation of fielded Solarex modules
