# Update on NIST's Investigation of the Partial Collapse of Champlain Towers South in Surfside, Florida

Judith Mitrani-Reiser  
*Lead Investigator*

**STRUCTURES CONGRESS 2025** | [structurescongress.org](https://structurescongress.org)

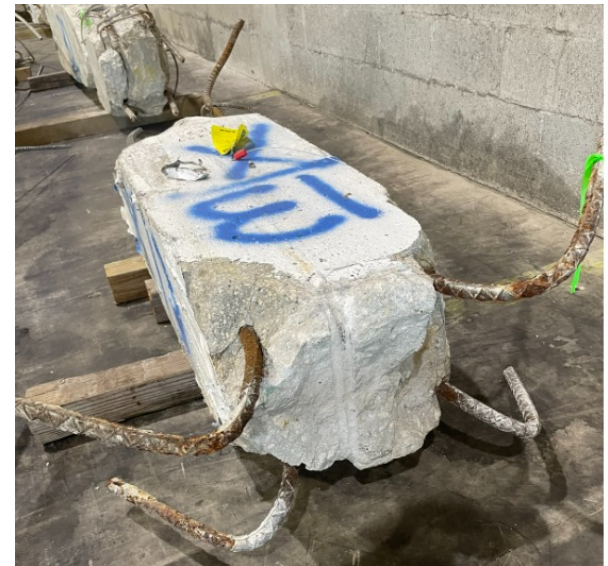
Same Column in Primary Evidence Facility

Corrosion of Pool Deck Hooked Column Reinforcement Bars that Were Embedded into Pool Deck Slab

Enlargement of Column Top Showing Hooked Reinforcement Bars with Corrosion

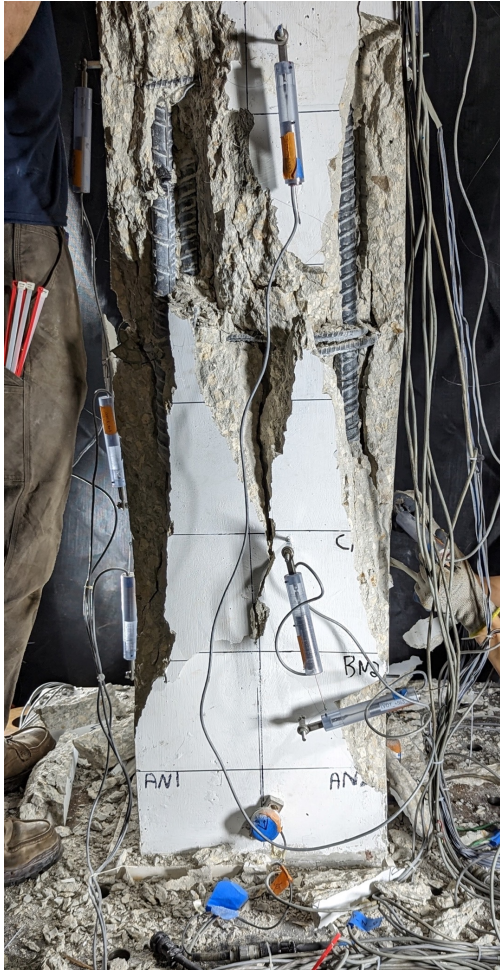
Several columns found with longitudinal bars where the lap splice is shorter than specified.

Left: specimen with short lap splice and sustained load

Below: close up of same specimen

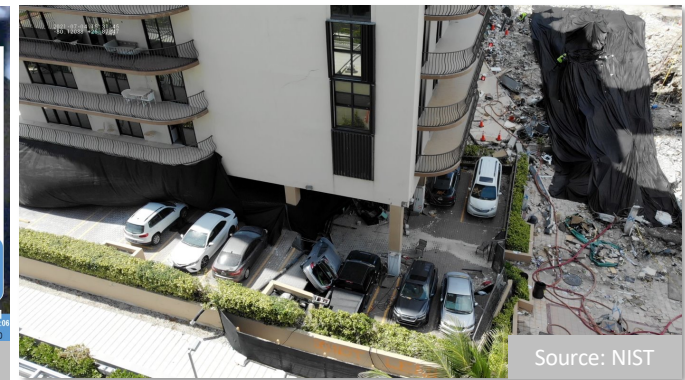
1. The pool deck collapsed between its southern extremity and its connection to the tower more than four minutes before the general collapse of the tower.
