PV Array Differential Backside Exposure Conditions: Backsheet Degradation and Site Design

4th Atlas/NIST Workshop on Photovoltaic Materials Durability

NIST CNST site overview

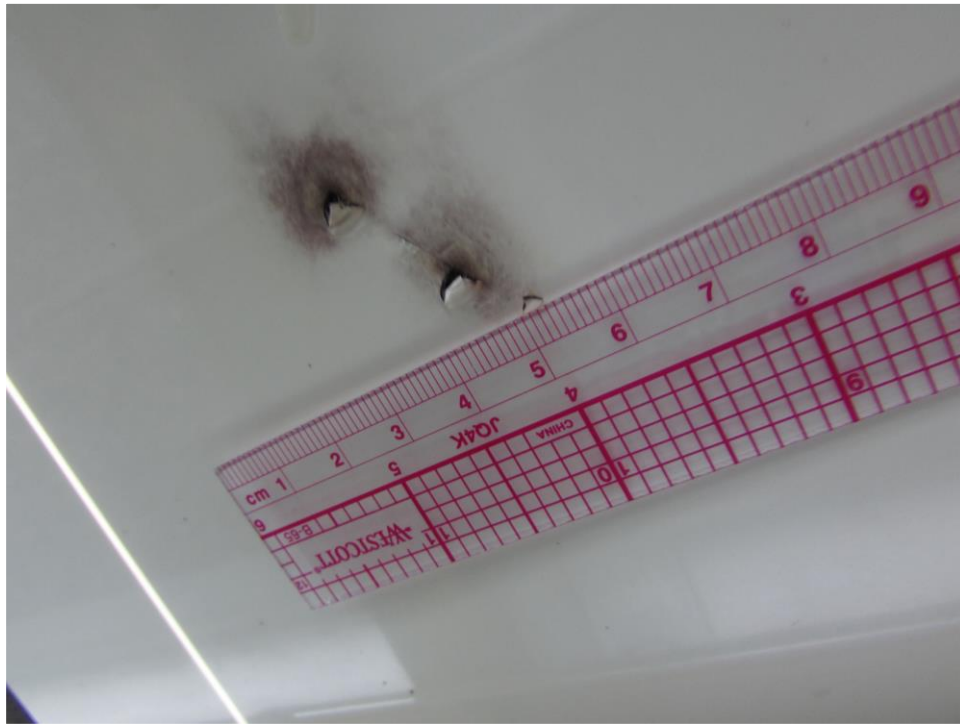
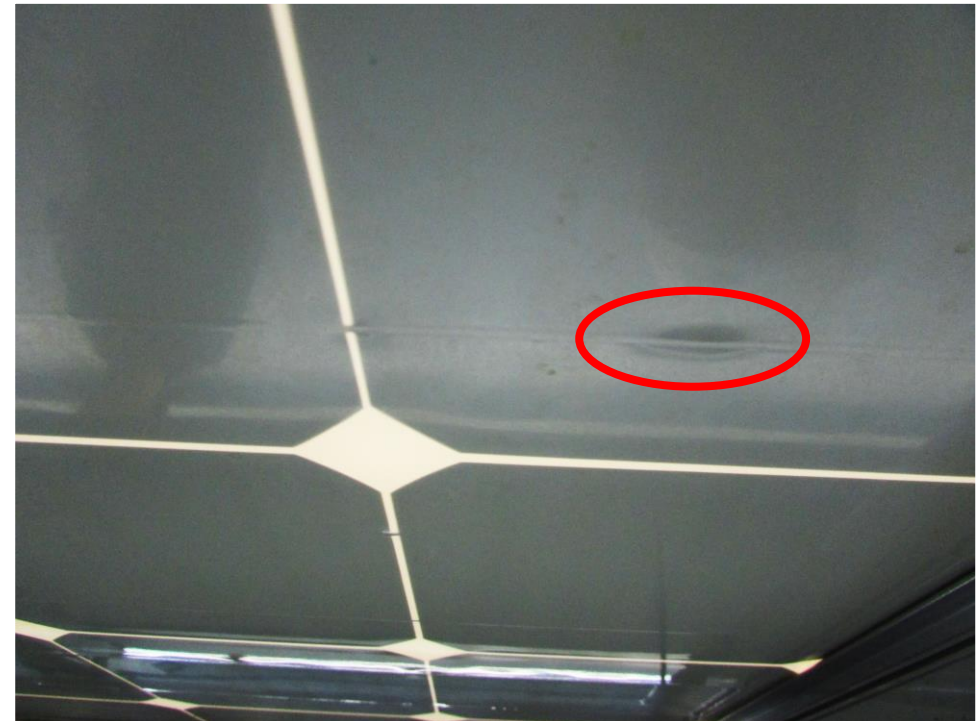
Two major backsheet defects observed:

- 1) Burn-throughs
- 2) Busbar bumps

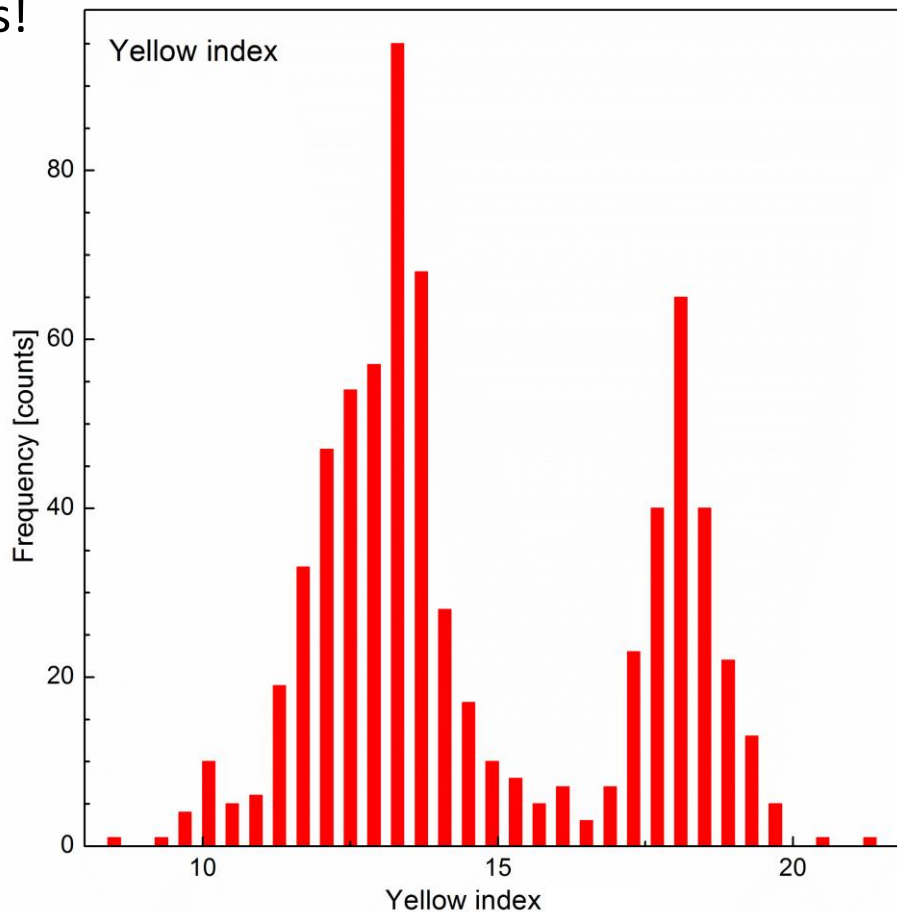
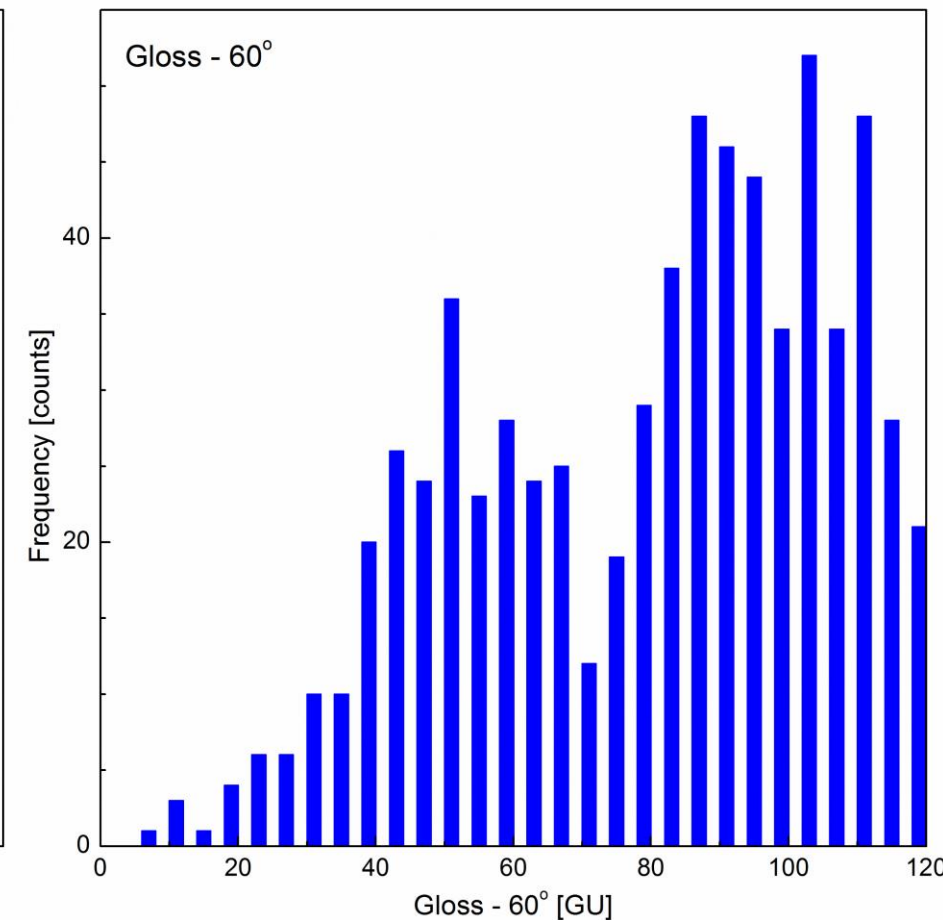
Huge range of yellow index and gloss values!

Array should be divided into sub-sections to identify yellowing and gloss trends

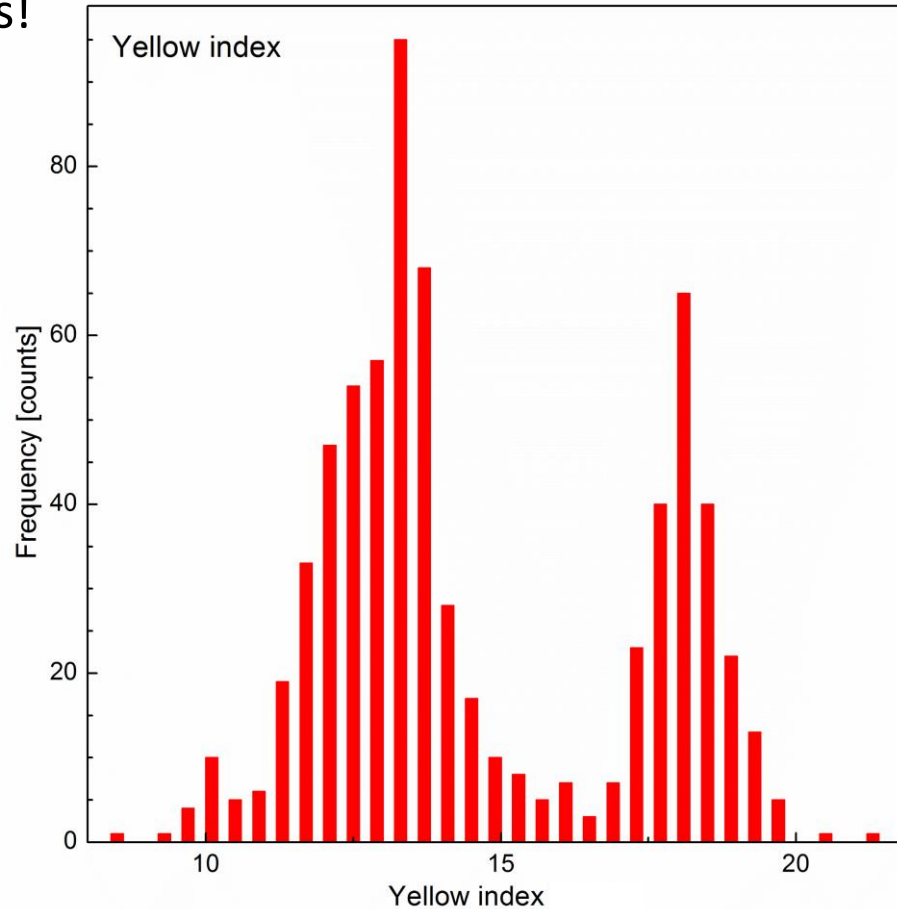
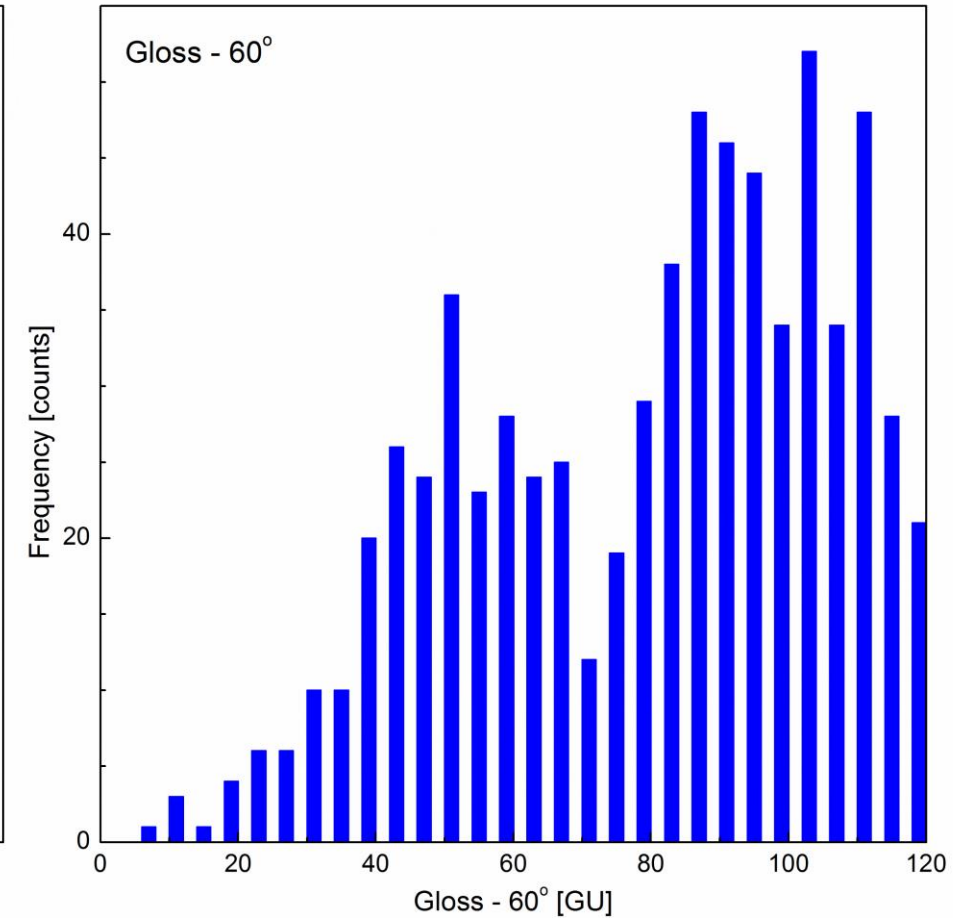
Huge range of yellow index and gloss values!

Array should be divided into sub-sections to identify yellowing and gloss trends:

- Row (height)
- Column (edge proximity)
- Shed (various ground covers)

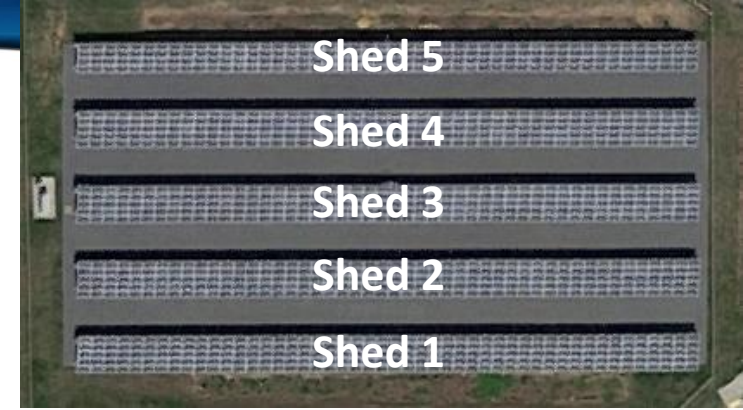
Proximity to array edge (<6 m) also influences YI and gloss

Center col. → edge
YI: 13.6 → 19.6
Gloss: 87 → 28

Effect is weaker in top row

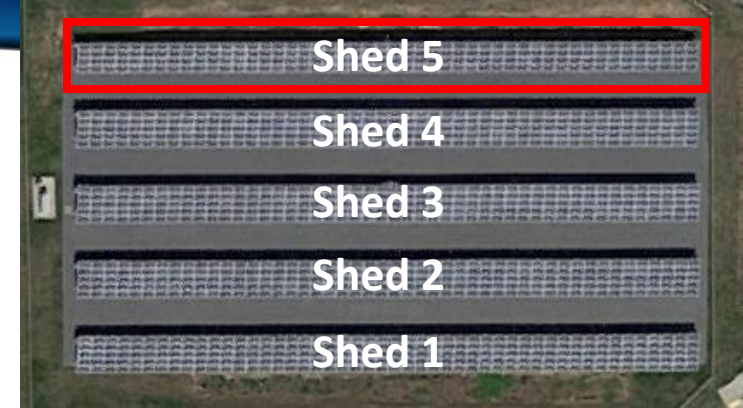
Ground albedo (rock v. grass) influences YI and gloss

Rock shed → grass

YI: 18.1 → 13.7

Gloss: 50 → 103

Also observed in shed 1 bottom row

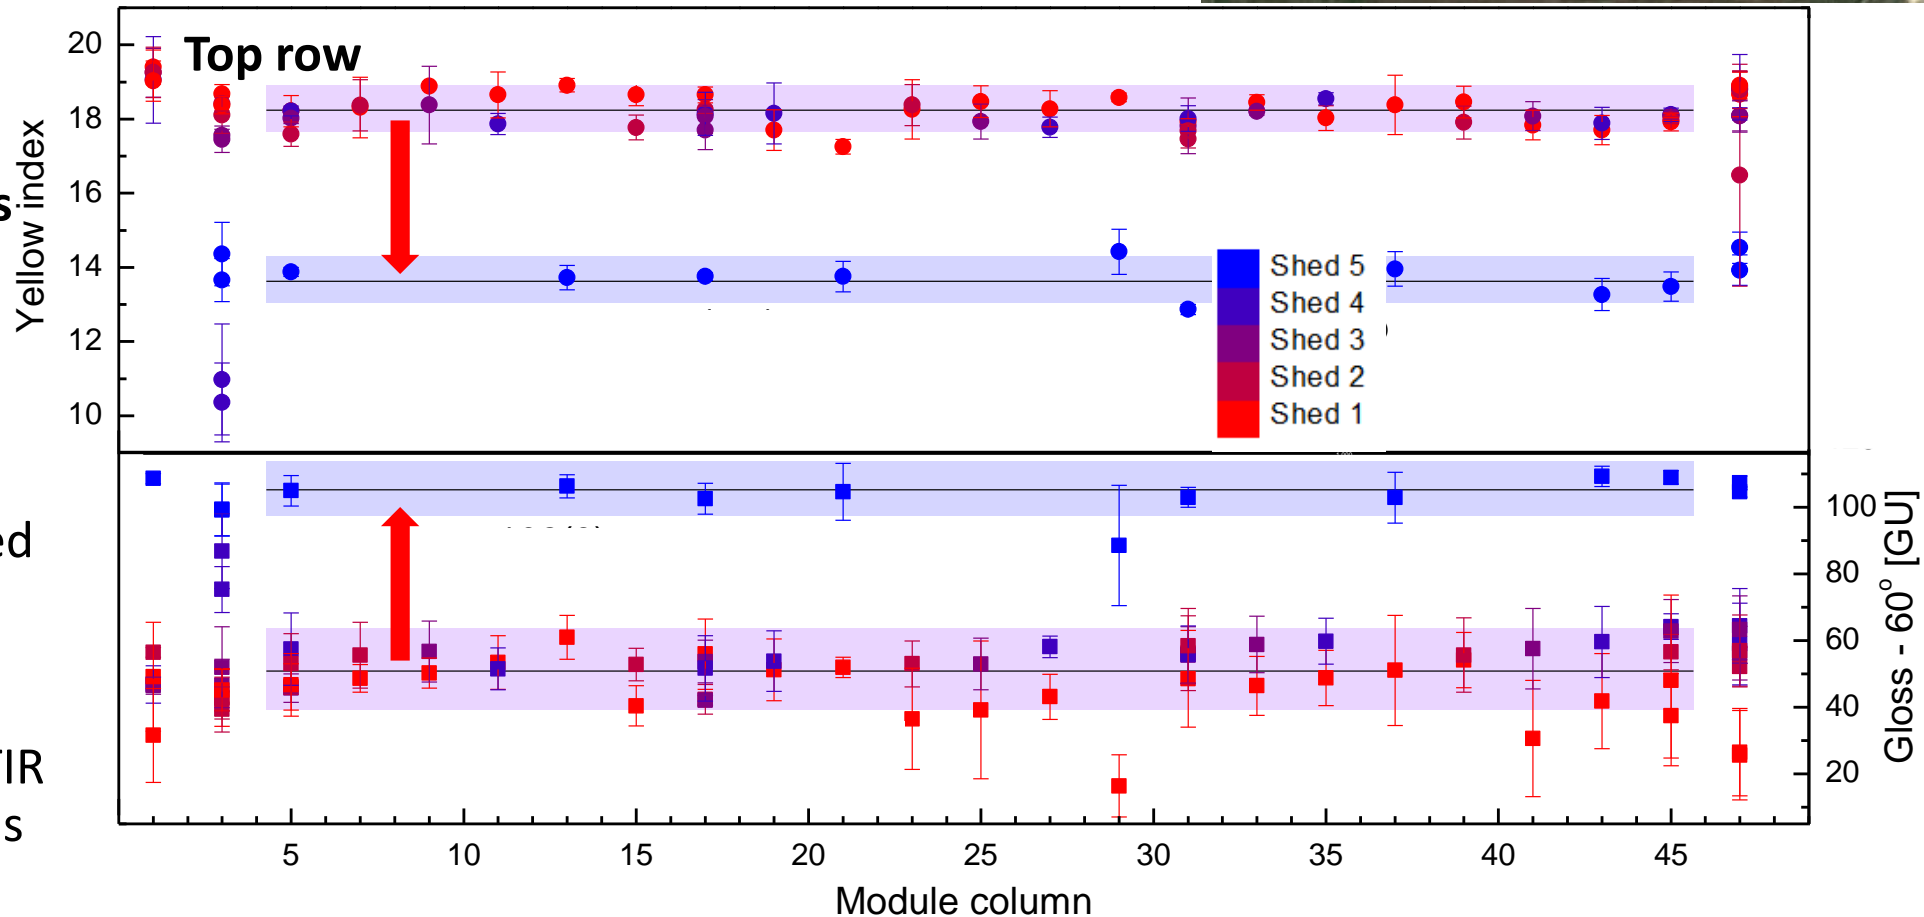
Oxidation peak in FTIR follows similar trends for the height, edge, and albedo effects

Changes in carbonyl (oxidation) peak consistent with those observed in YI and gloss

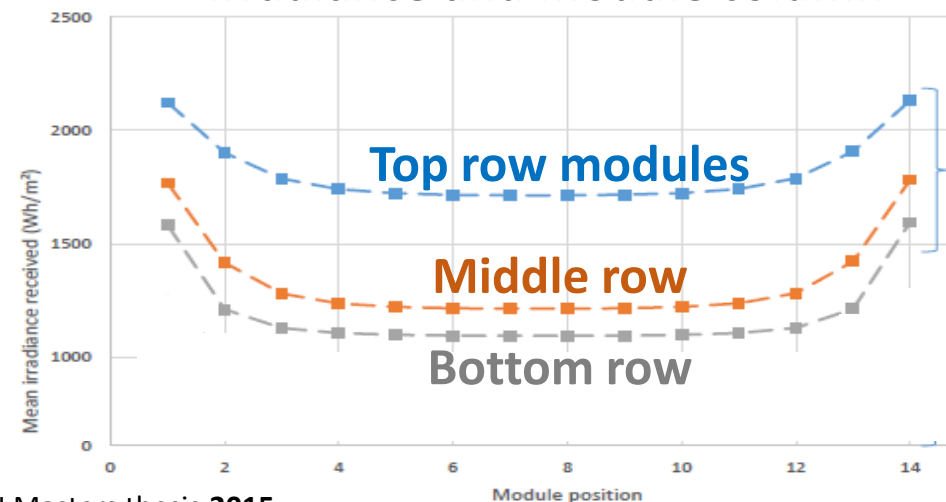
Irradiance and module column

Irradiance may be higher for the lower modules during winter

An edge effect is expected

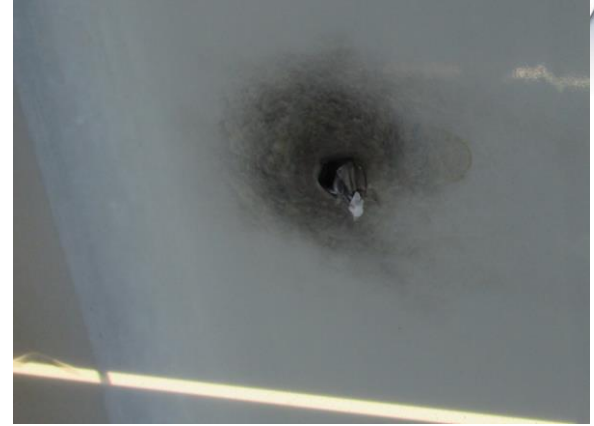
Safety: to date, no modules have been removed due to backsheet degradation, though the burn-throughs may be a concern

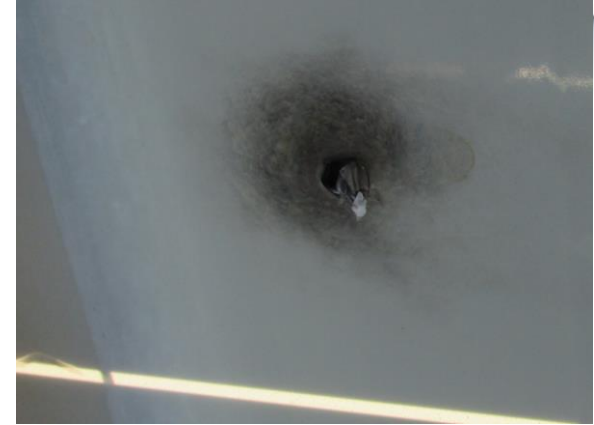
Performance: 96 (out of 1152) modules have I-V tracers

First comparisons of output (power) and module position do not show a significant correlation after 4 years in the field

Too soon? Backsheet degradation is cumulative, and effects may become more apparent at mid- to end-of-life

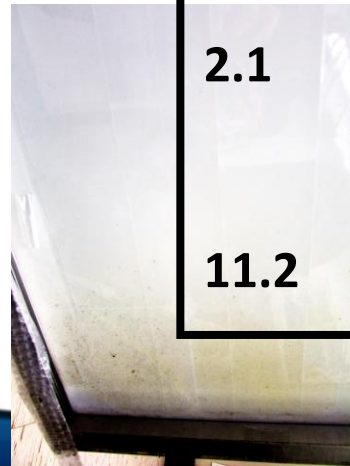
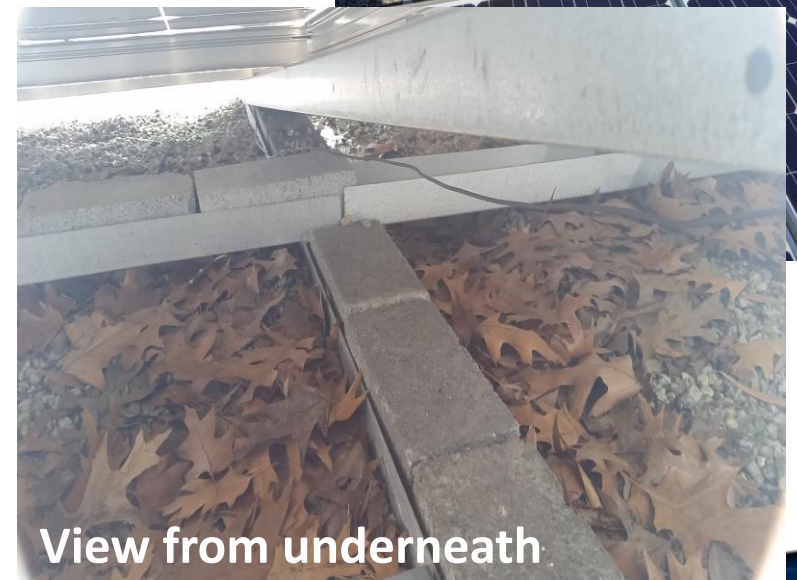
View from underneath

3) Miscellaneous:

- Junction boxes appear okay, some have dirt buildup
- Organic growth on frame (bottom) and backsheet near frame
- Birds, wasps...
- Dirt, scratches, tape, epoxy, etc...

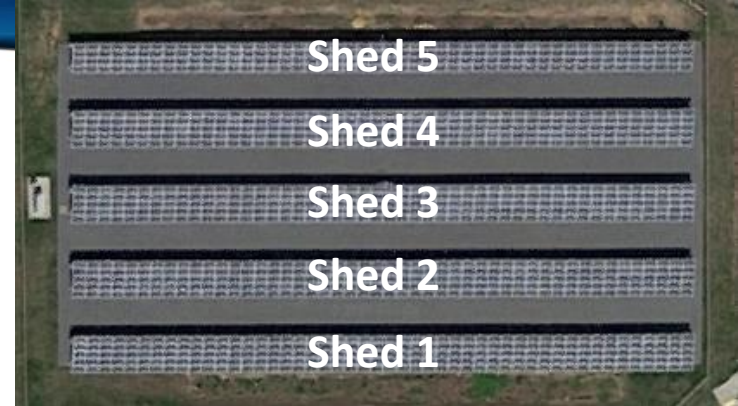
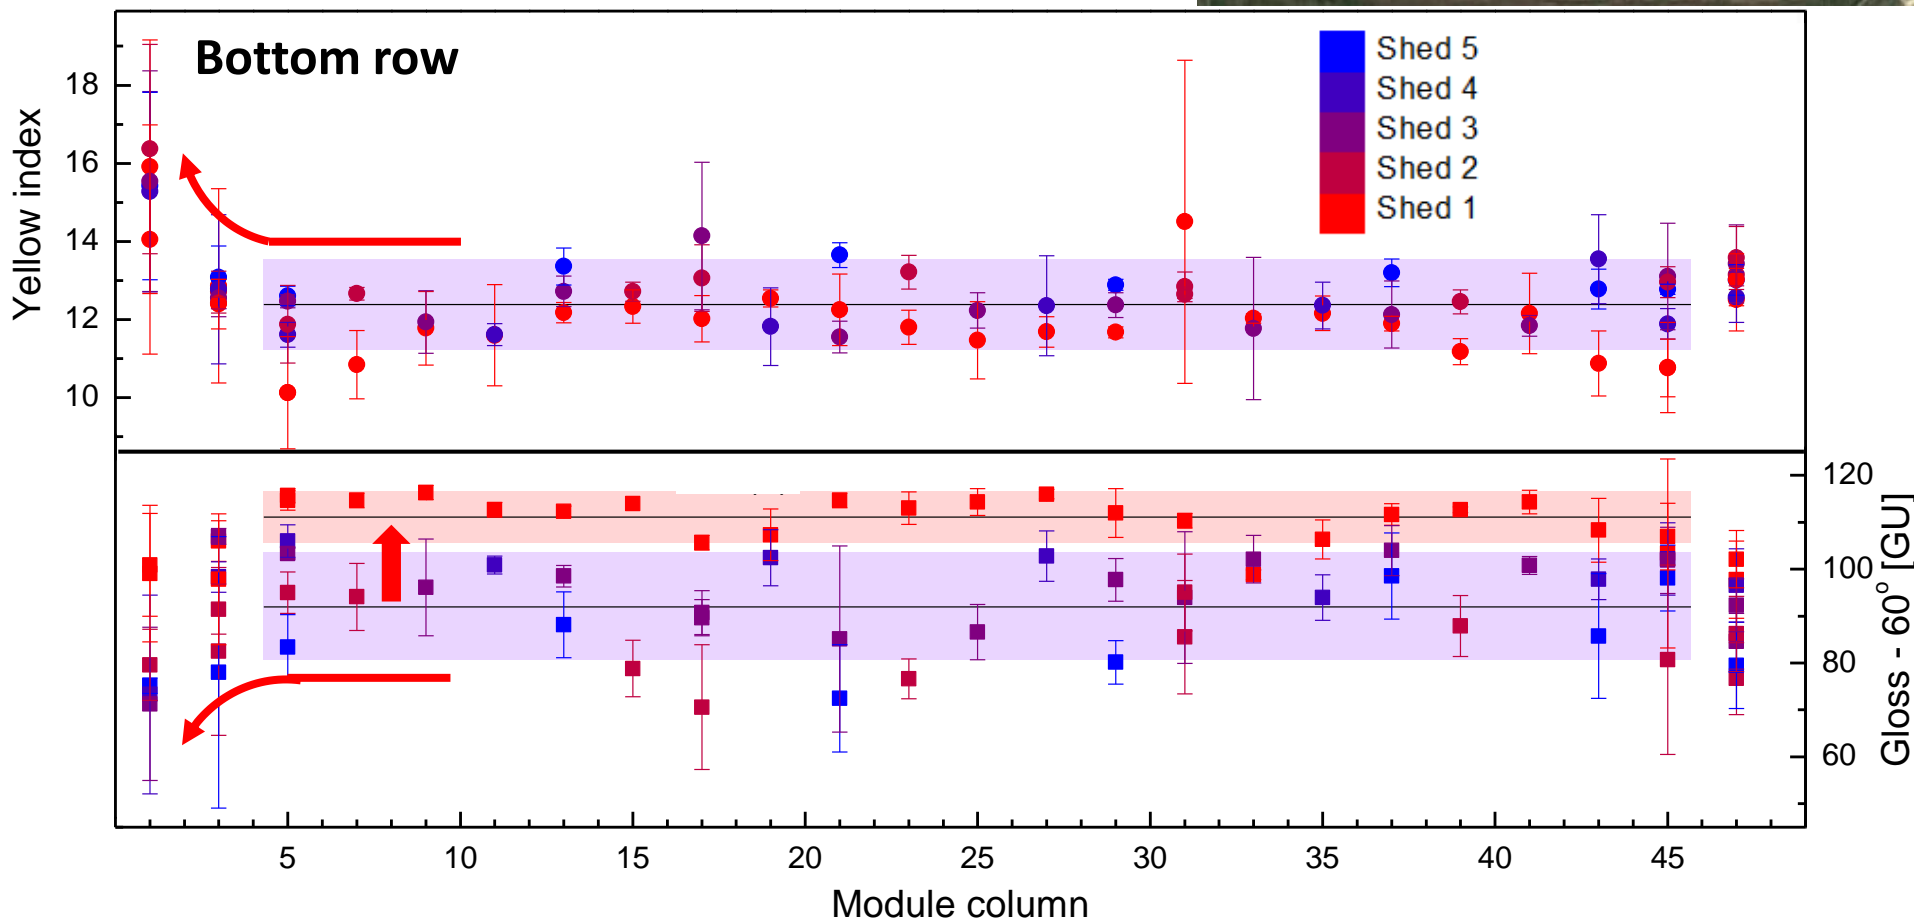
- Structural and environmental factors significantly influence backside exposure conditions, esp. to light:
 - Height effect: top row modules experience more weathering
 - Edge effect: columns within ~6 m from edge undergo greater weathering
 - Ground albedo effect: high UV albedo surfaces accelerate degradation

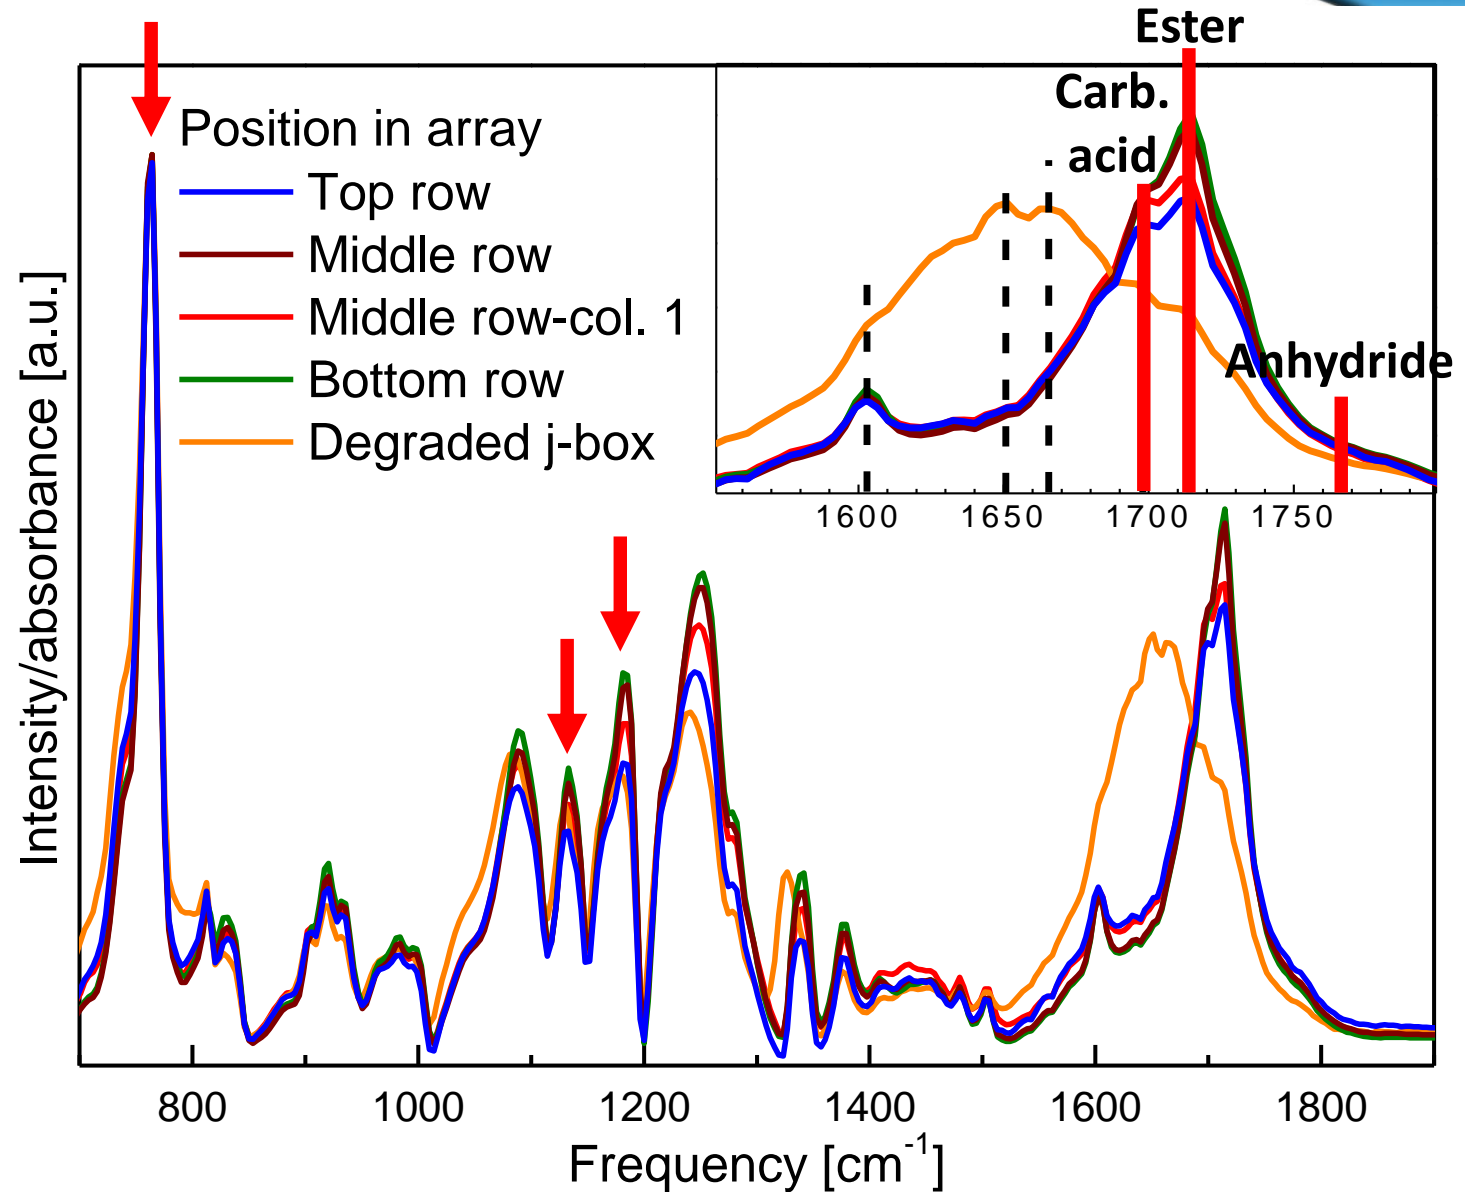
Chemical changes

Formation of carboxylic acid and anhydrides
