**Photo C-1. NIST Nain Entrance – Front of the House shown with library on the left side and auditorium on the right side of entrance (view southwest)**

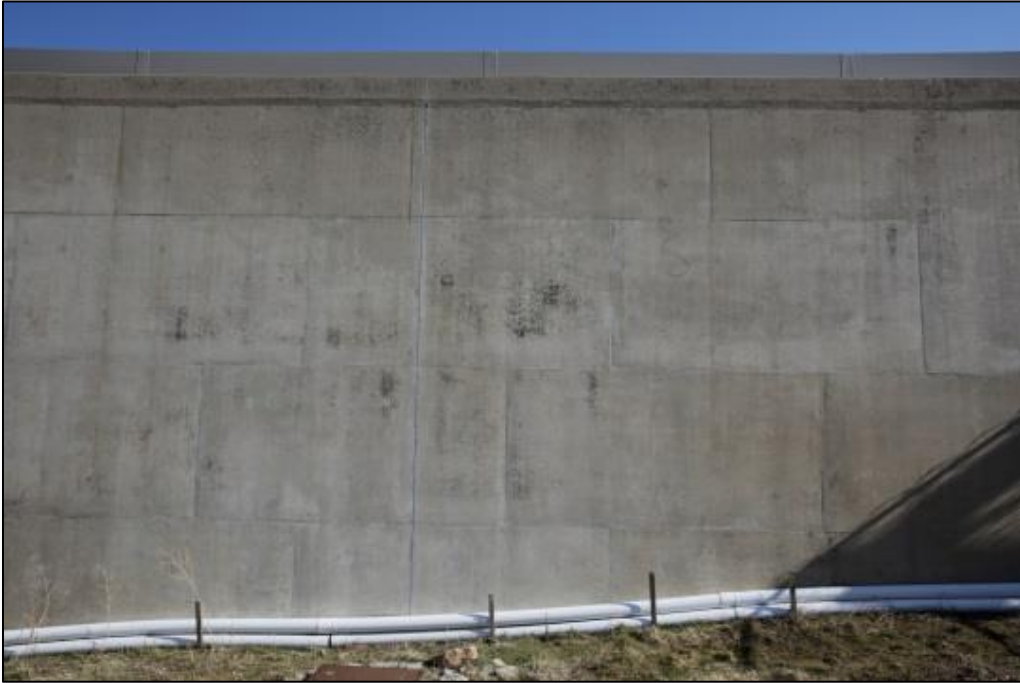
**Figure C-2. Exposed Concrete Wall on West Elevation of Auditorium (view southeast)**

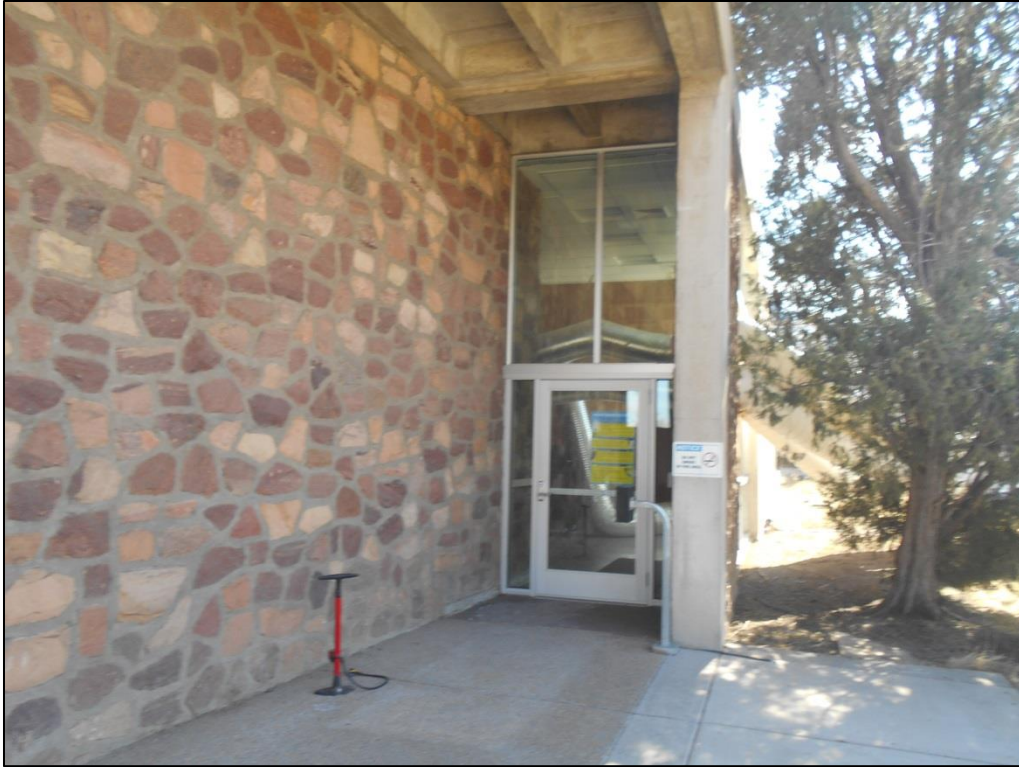
**Figure C-5. North-Facing Exterior Door on the West Side of the Auditorium (view southwest). This door was replaced in 1981.**

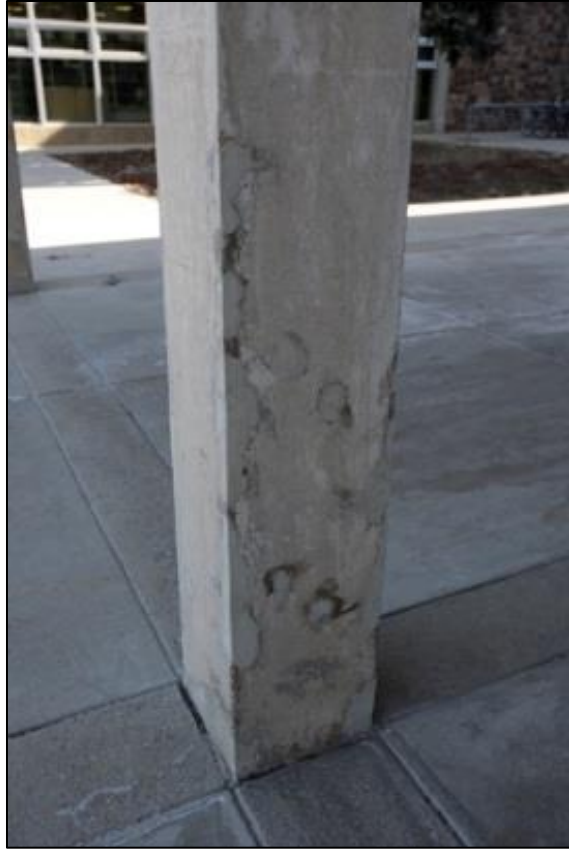
**Photo C-23. Patched Columns in Courtyard**

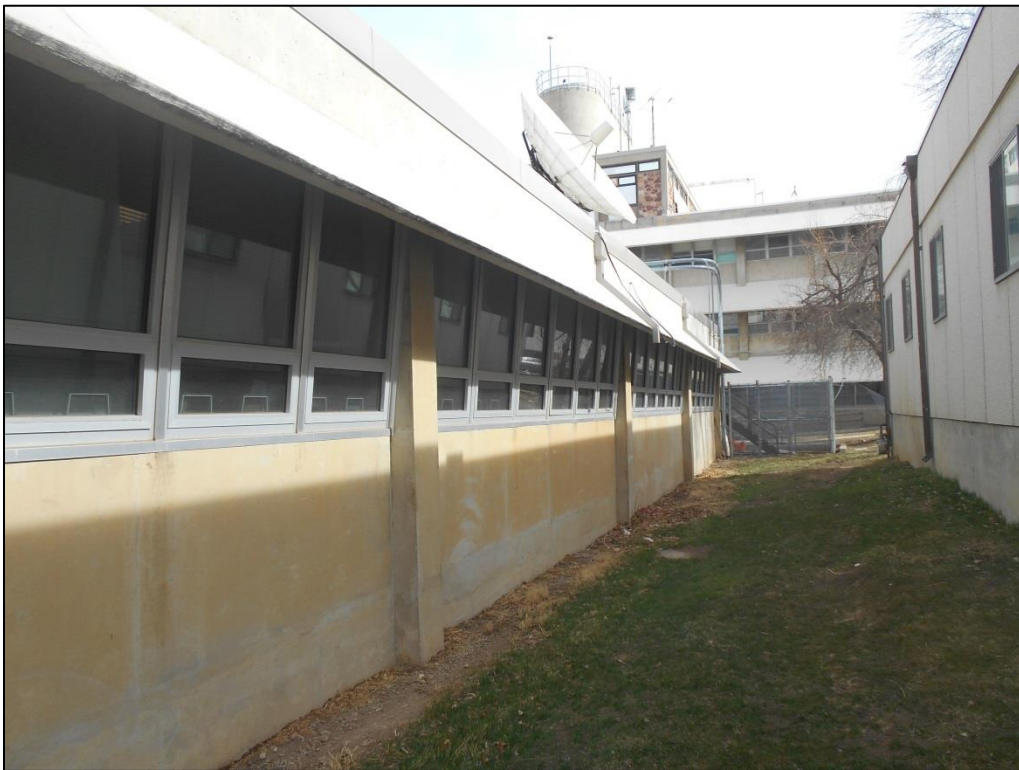
**Photo C-34. Orange Staining on Concrete and Replacement Windows on North Elevation of Wing 1 (view southeast)**

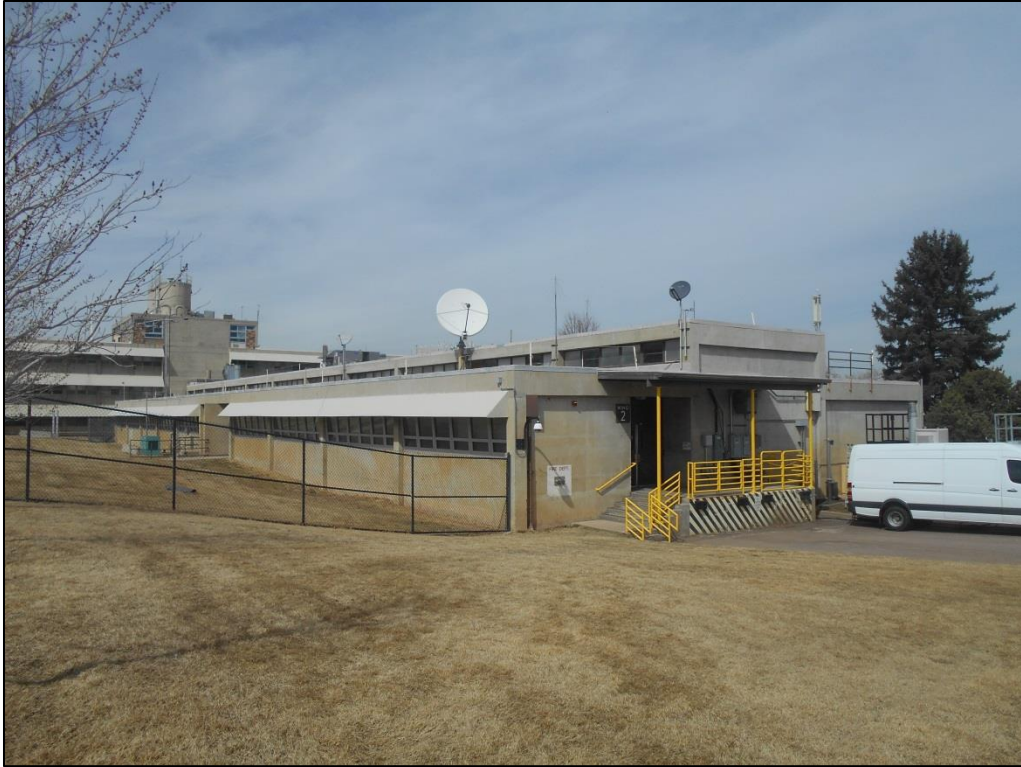
**Photo C-46. Annexes D and E (view northwest)**

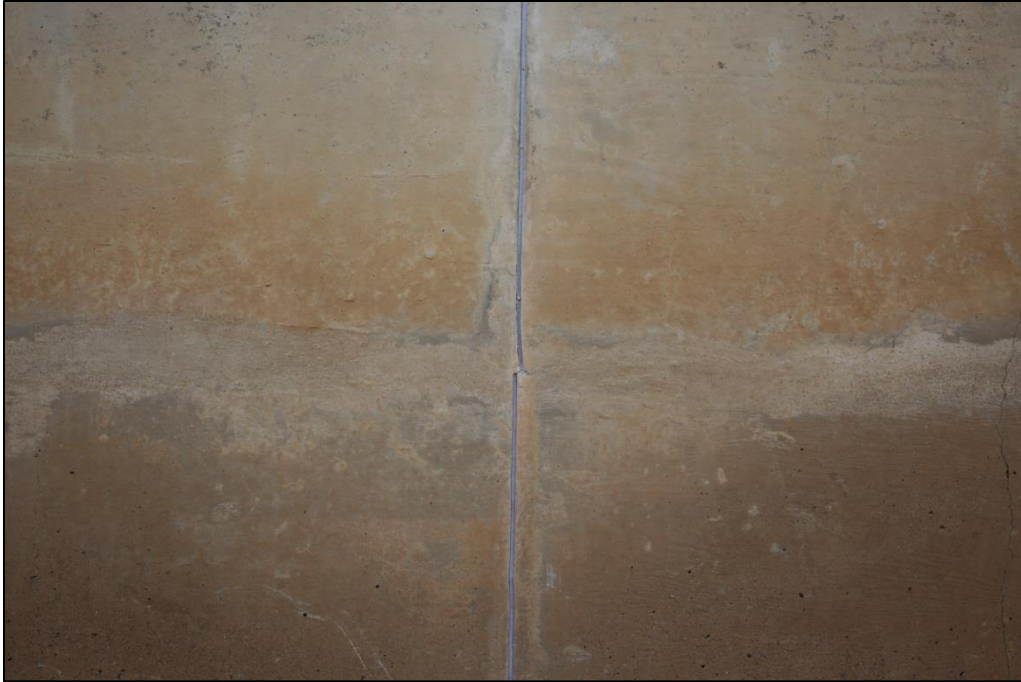
**Photo C-48 North Elevation of Wing 2 (view southwest)**

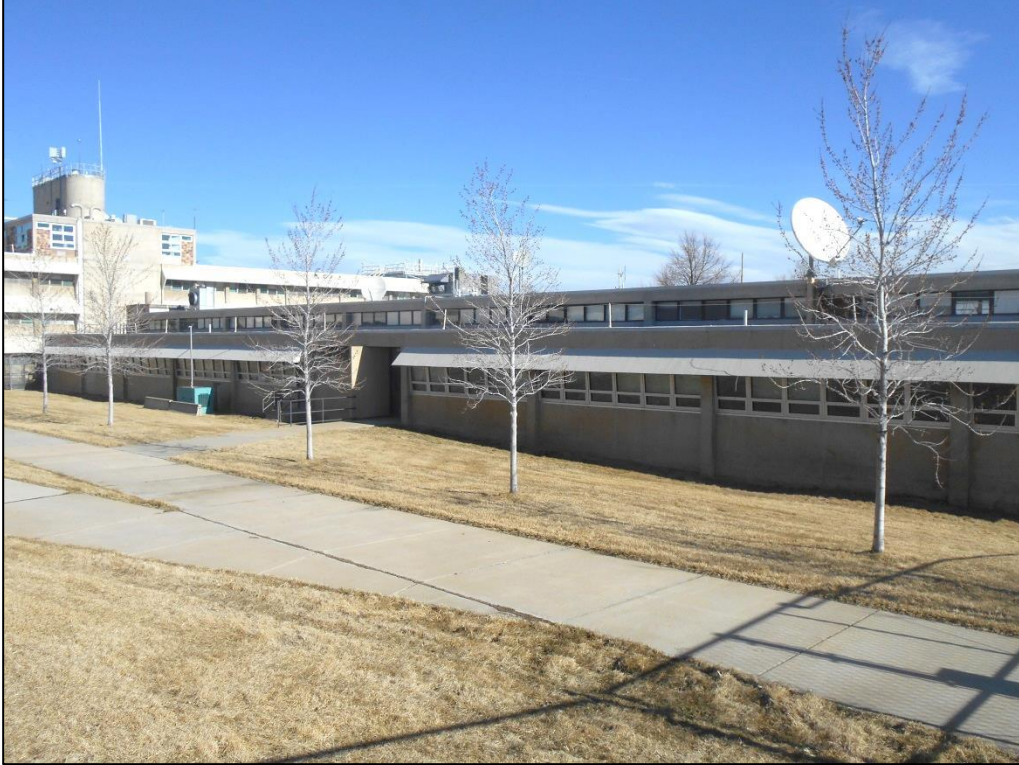
**Photo C-50. Replacement Windows on North Elevation of Wing 2 (view northwest)**

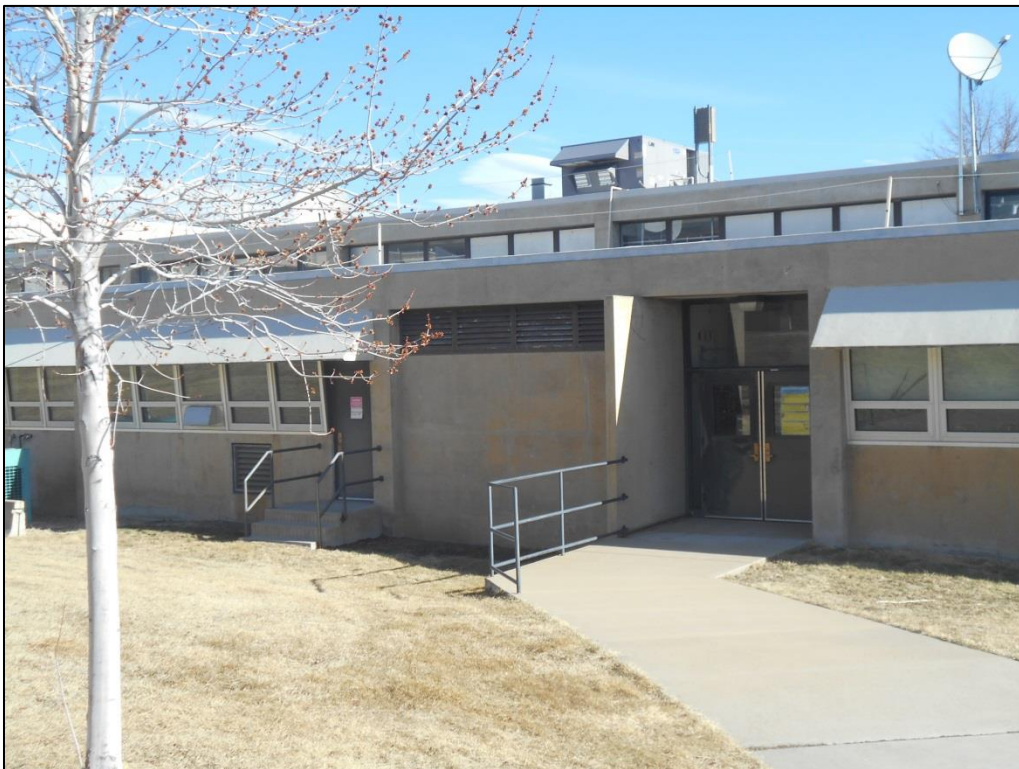
**Photo C-51. South Elevation of Wing 2 (view north)**

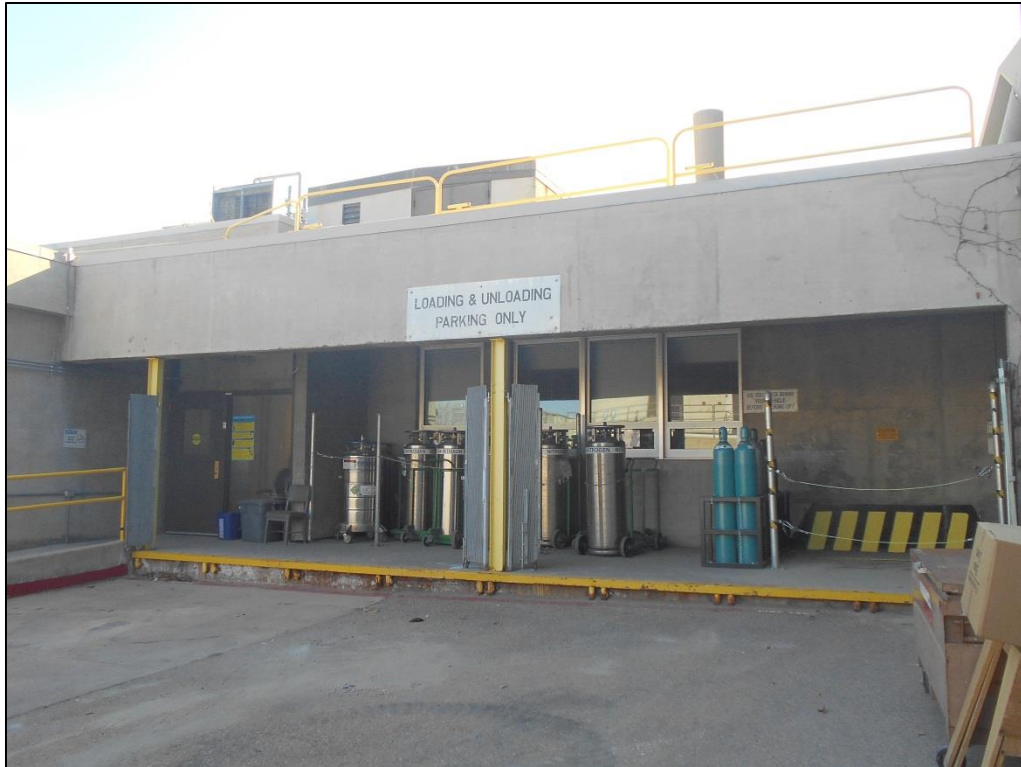
**Photo C-52. Doors on South Elevation of Wing 2 (view north); the single-leaf door on the left is a later addition and is not an original feature of Wing 2**

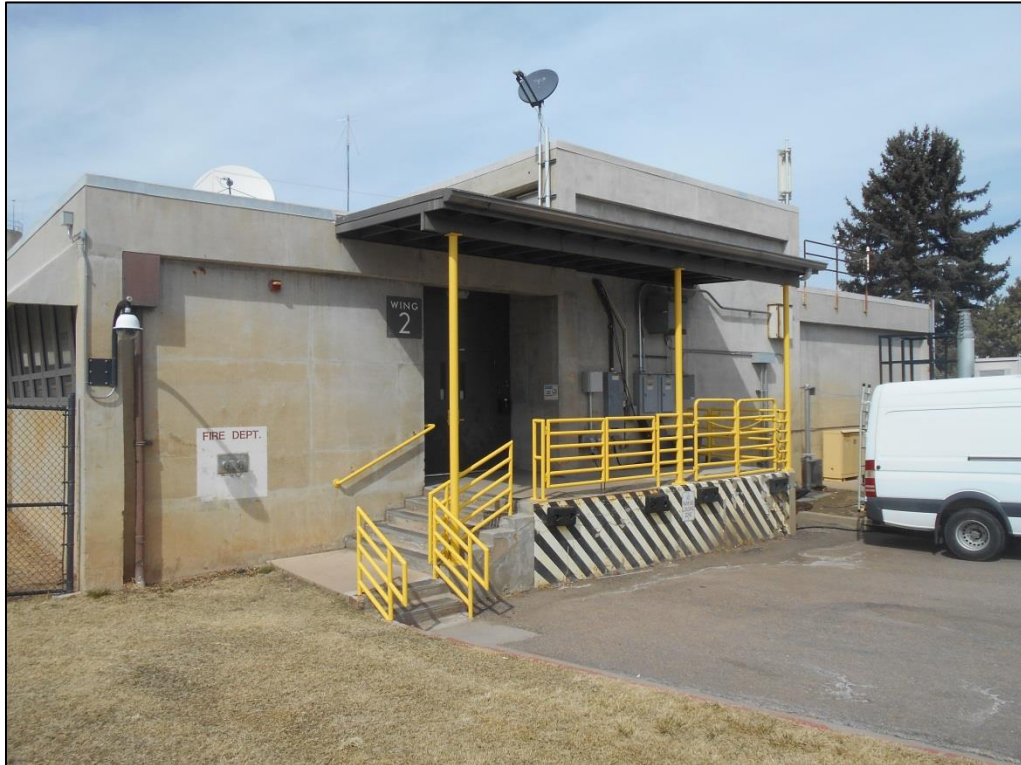
**Photo C-53. Loading Dock on the North Elevation of the Hyphen between the Spine and Wing 2 (view southwest)**

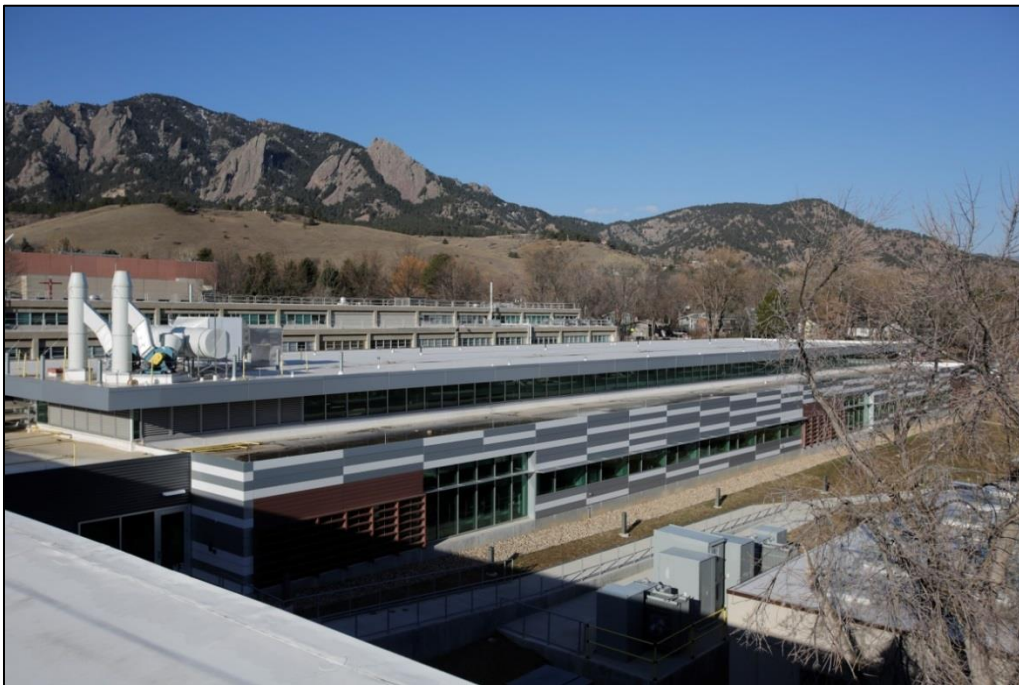
**Photo C-55. View of Roof of Wing 2 from the Roof of the Spine (view south)**

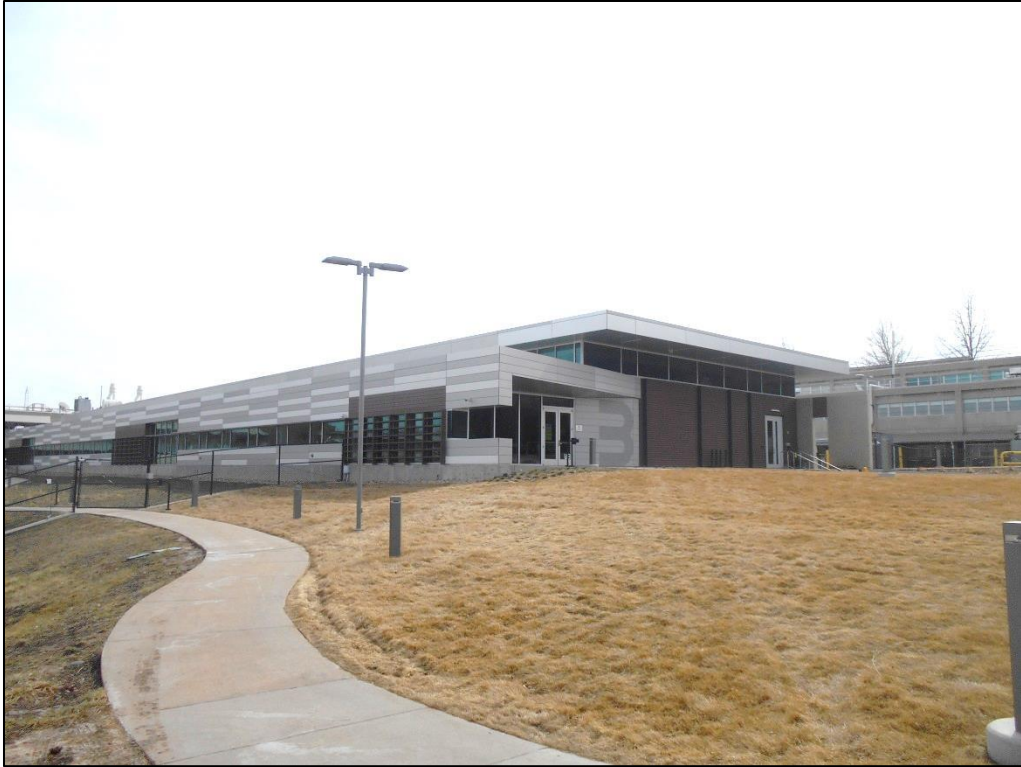
**Photo C-56. North Elevation of Wing 3 (view west).**

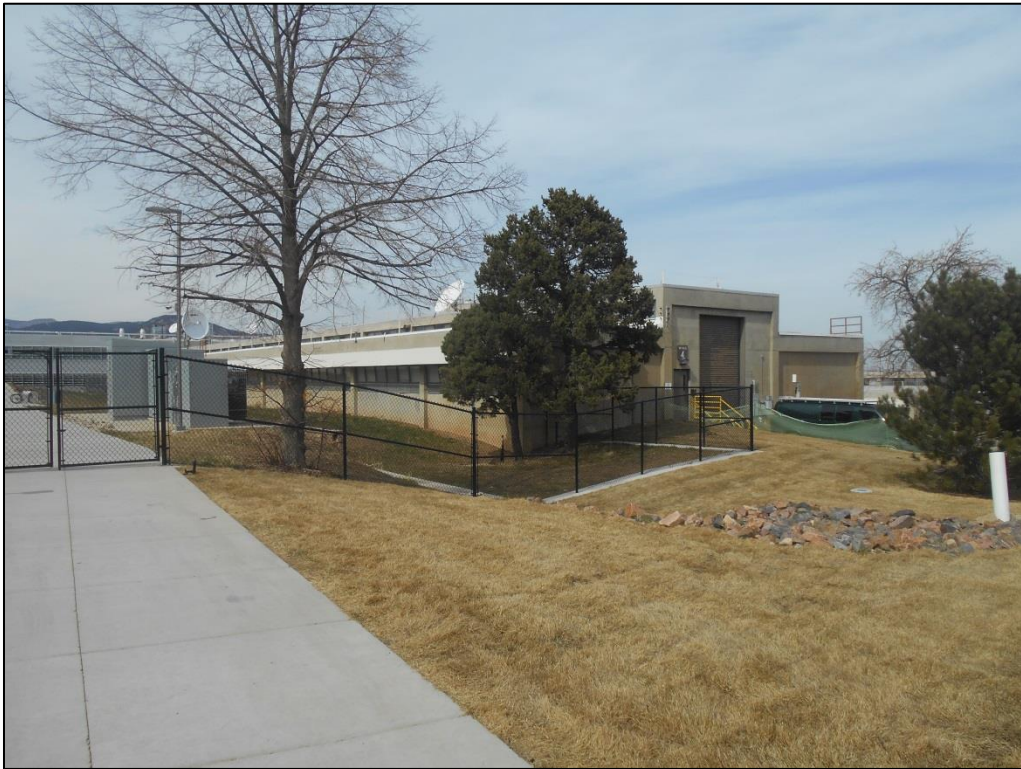
**Photo C-57. North and West Elevations of Wing 3 (view south)**

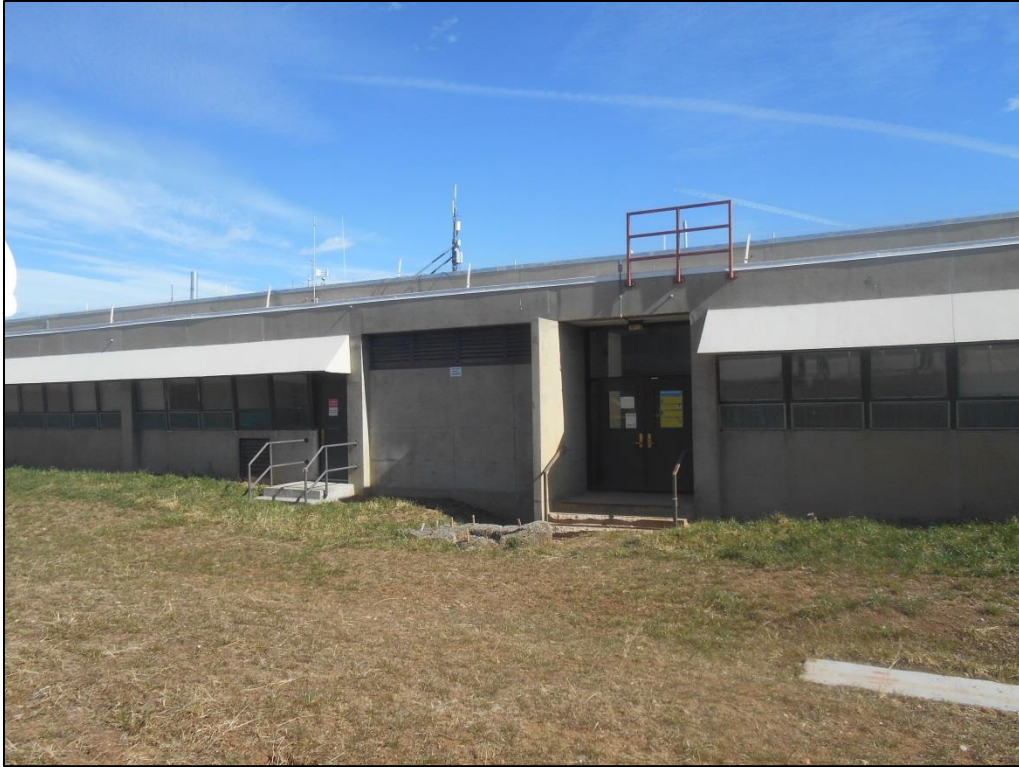
**Photo C-60. South Elevation of Wing 4 (view east)**

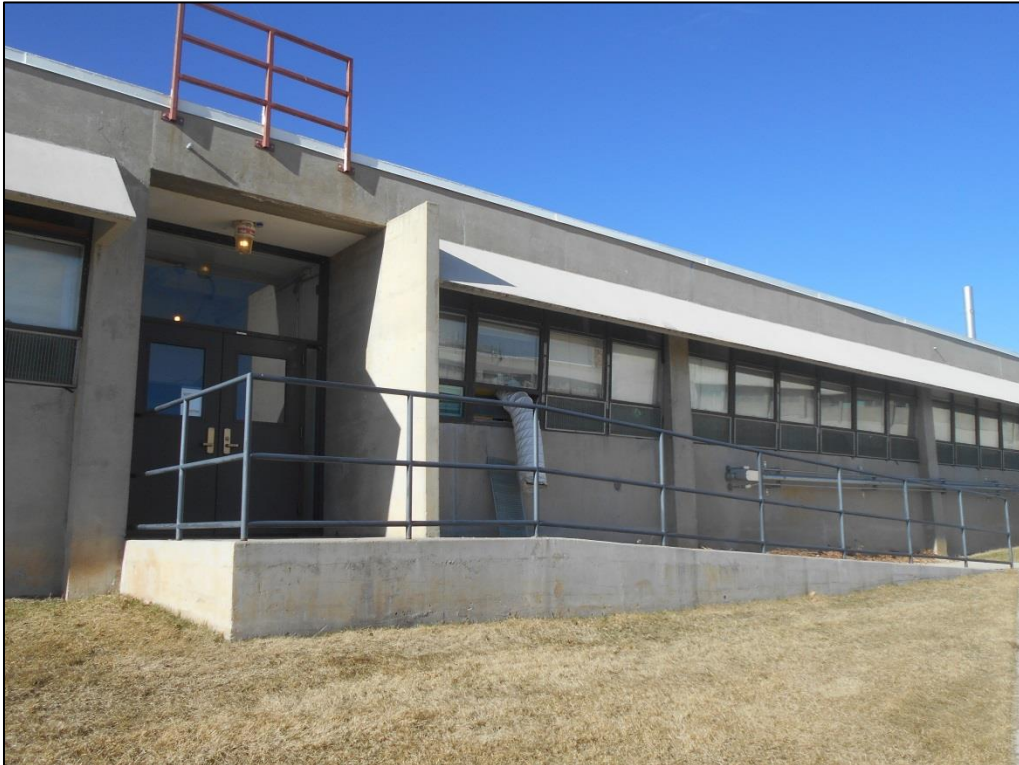
**Photo C-61. Doors on South Elevation (view north); the single-leaf door on the left is a later addition and is not an original feature of Wing 2**

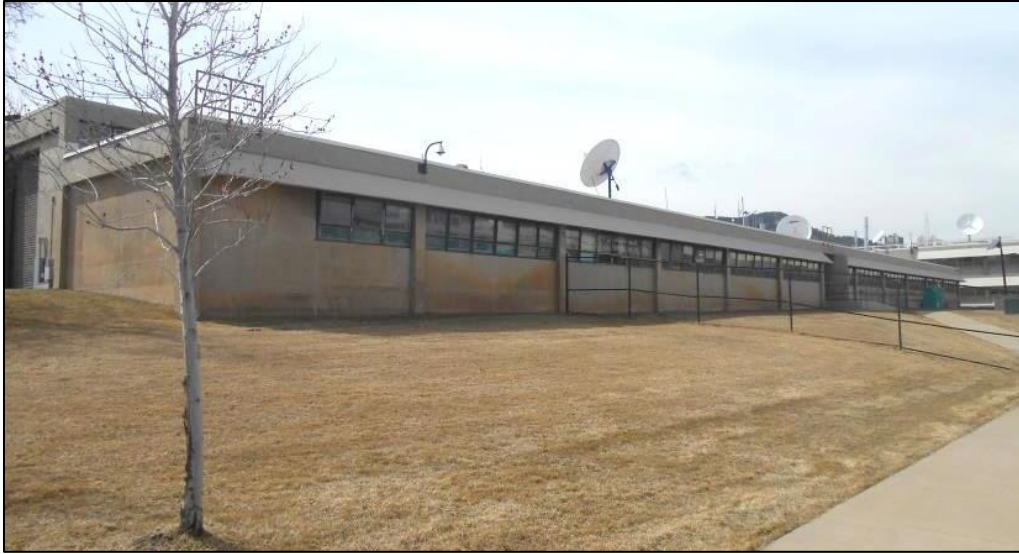
**Photo C-62. Door on North Elevation (view west)**

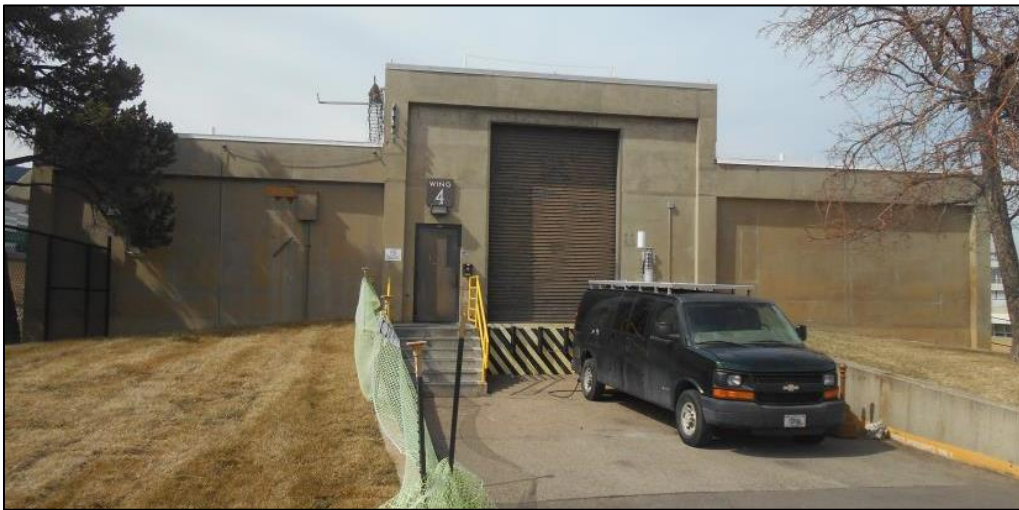
**Photo C-63. East Elevation of Wing 4 (view west); three original windows have been removed from the first bay**

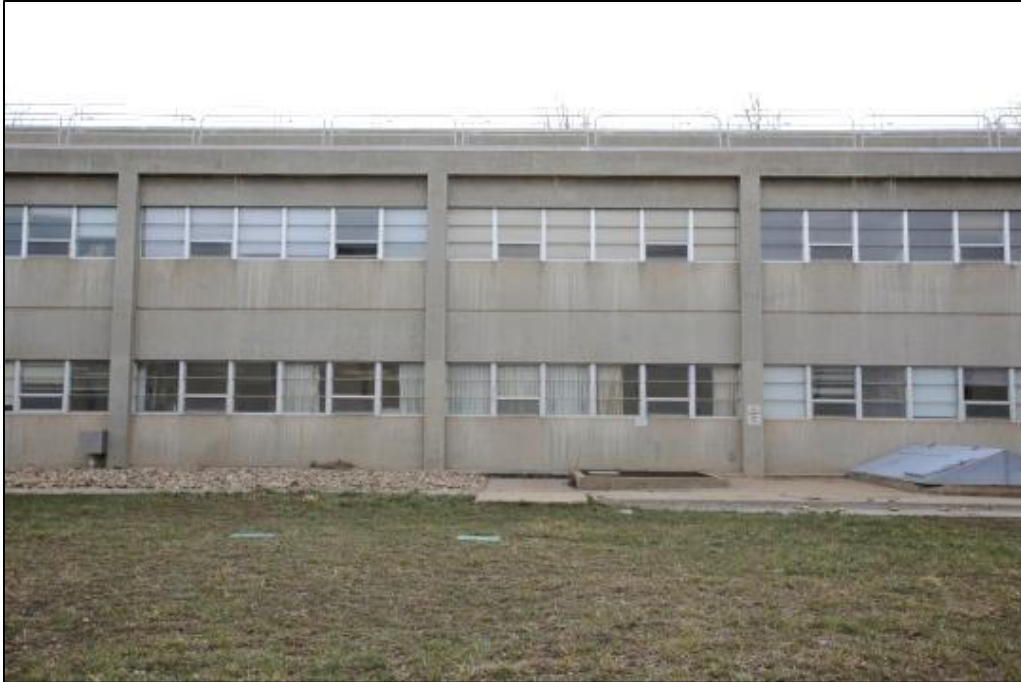
**Photo C-64. Wing 4, South Elevation (view northwest)**

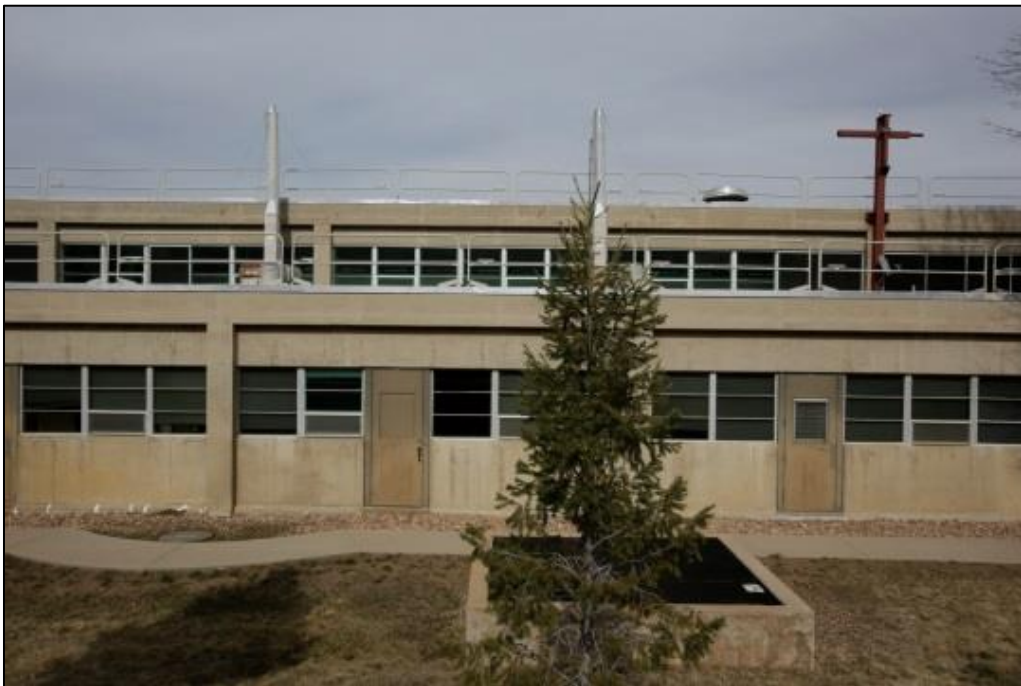
**Photo C-65. Wing 5, North Elevation (view southwest)**

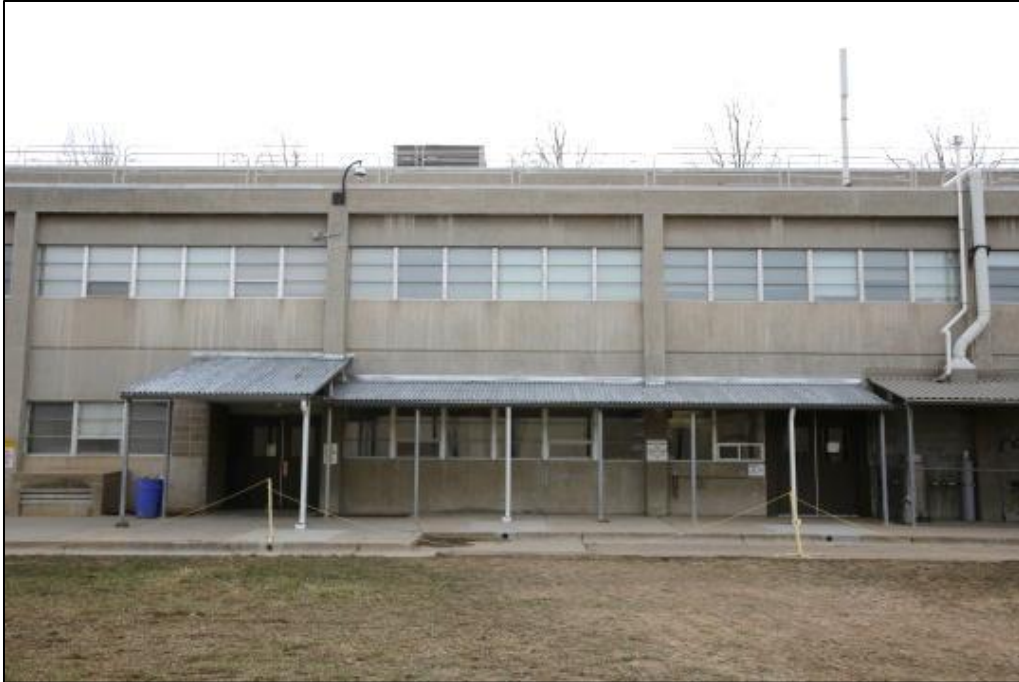
**Photo C-66. Wing 5, South Elevation (view northeast)**

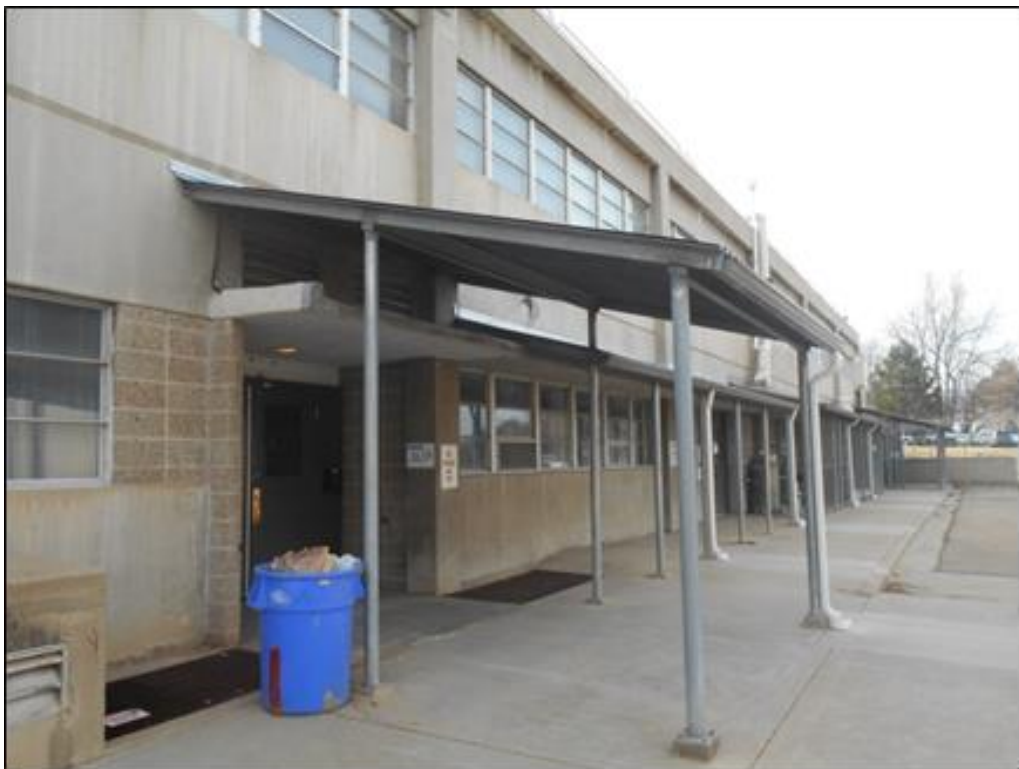
**Photo C-67. Metal Awnings on North Elevation (view southwest)**

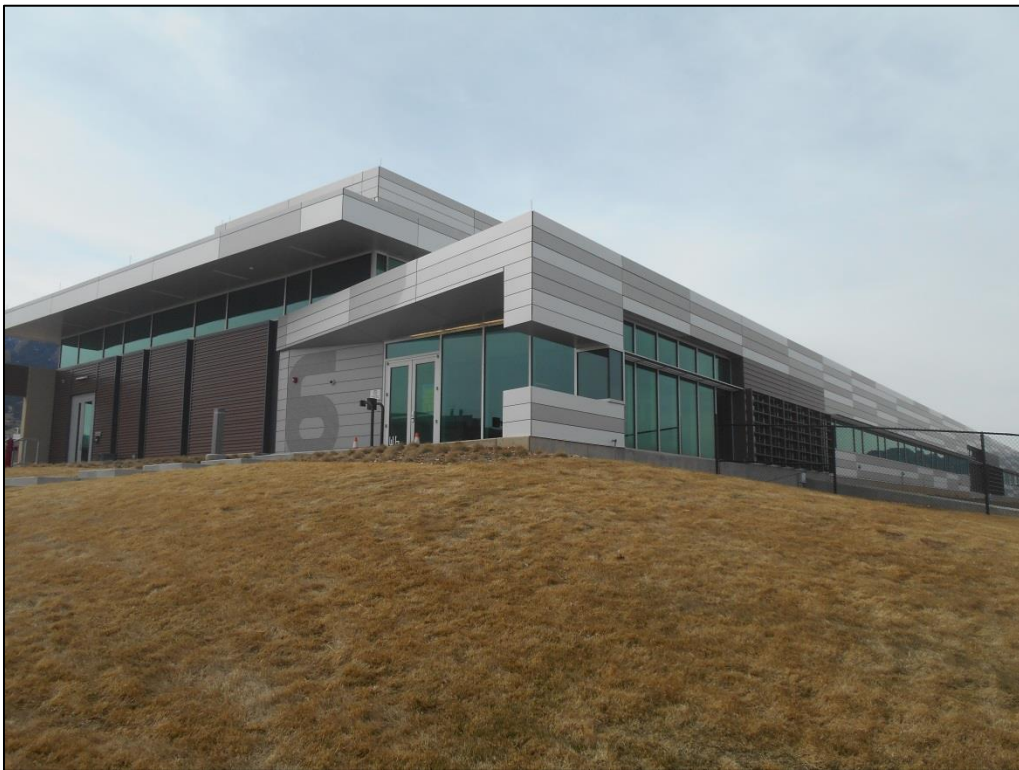
**Photo C-69. West Elevation of Wing 5 (view southeast)**

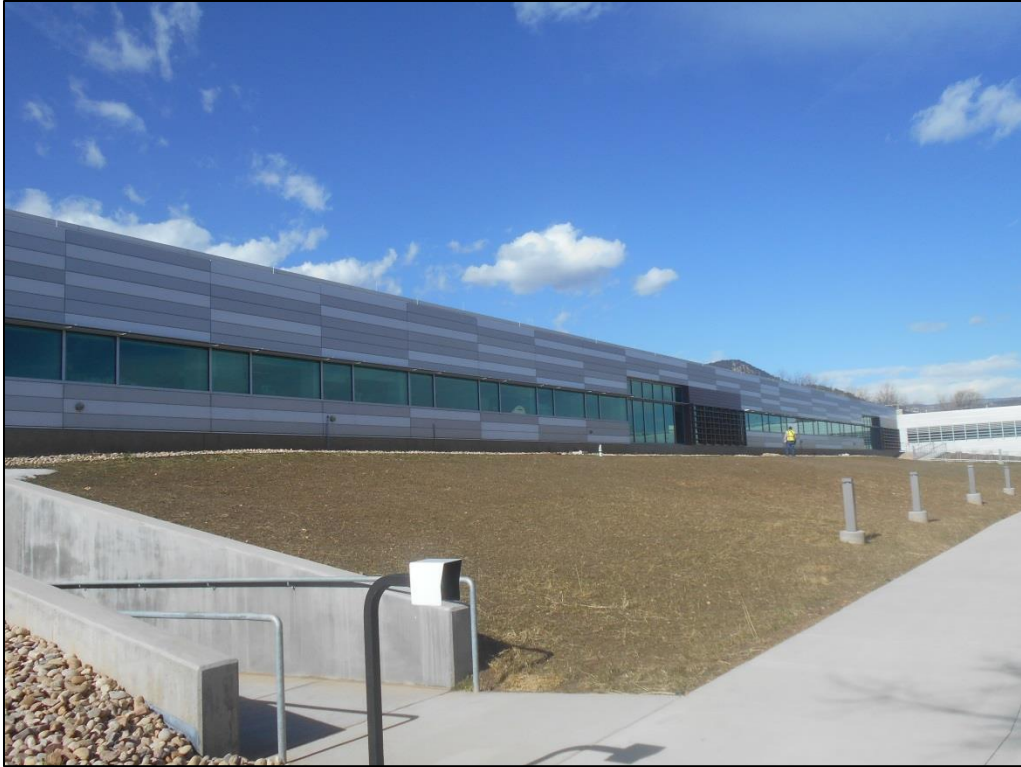
**Photo C-70. South and East Elevations of Wing 6 (view west)**

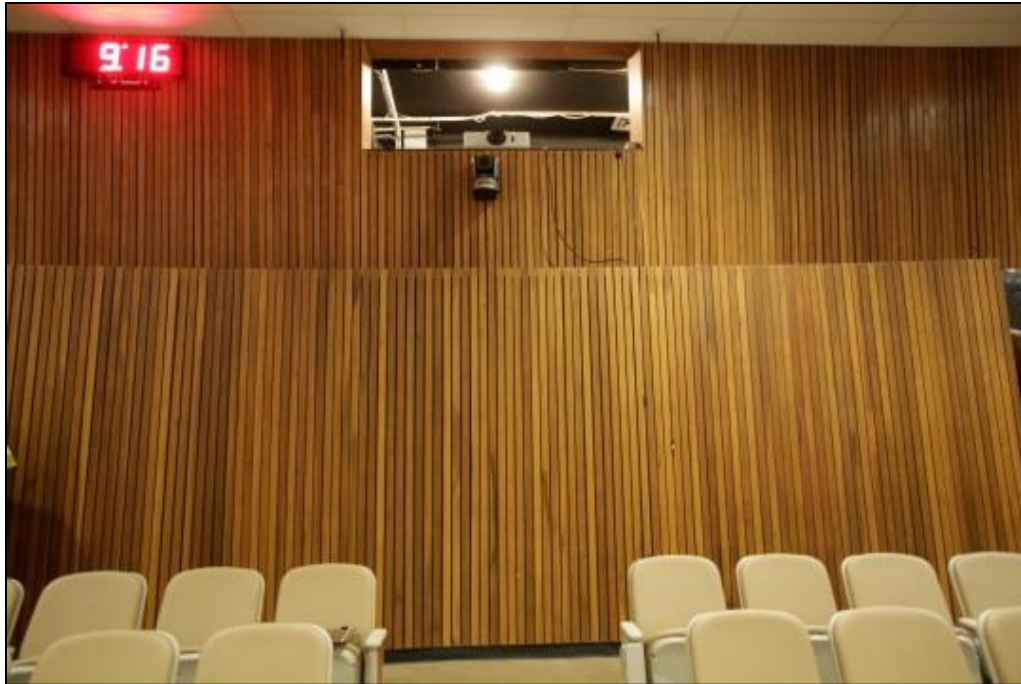
**Photo C-74. East Wall of Auditorium (view southeast)**

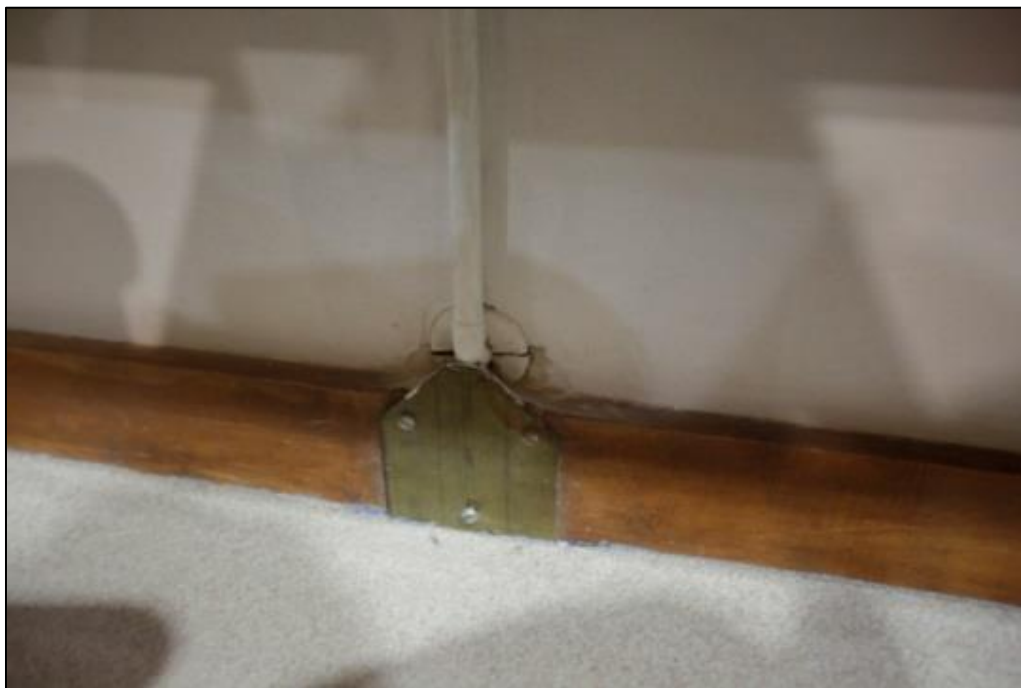
**Photo C-75. South Wall of Auditorium (view southwest)**

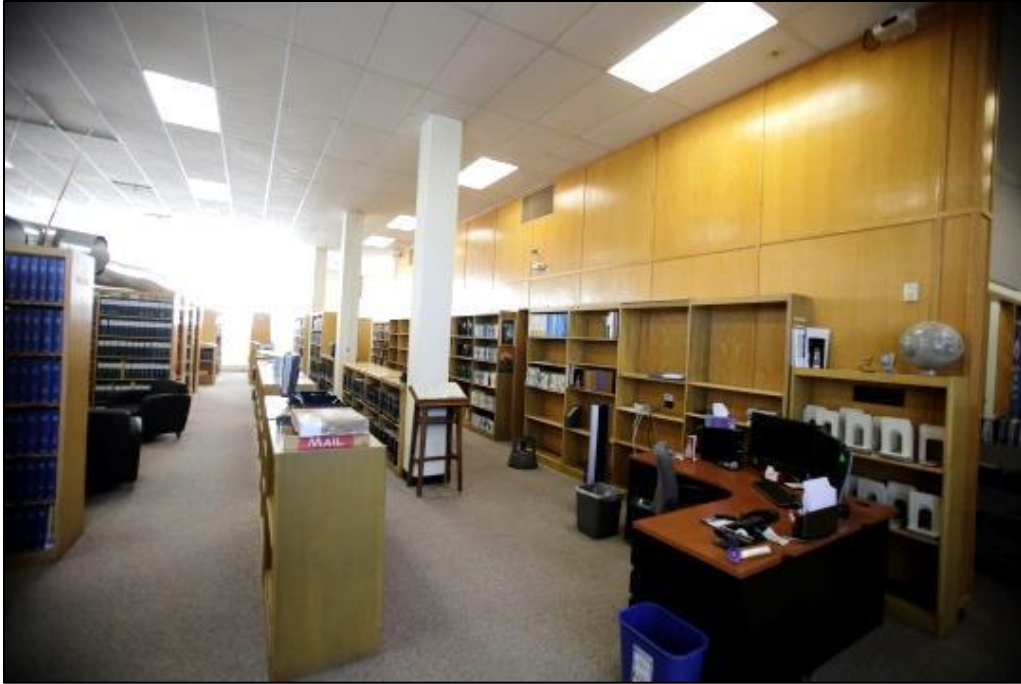
**Photo C-84. Library Entrance (view northwest)**

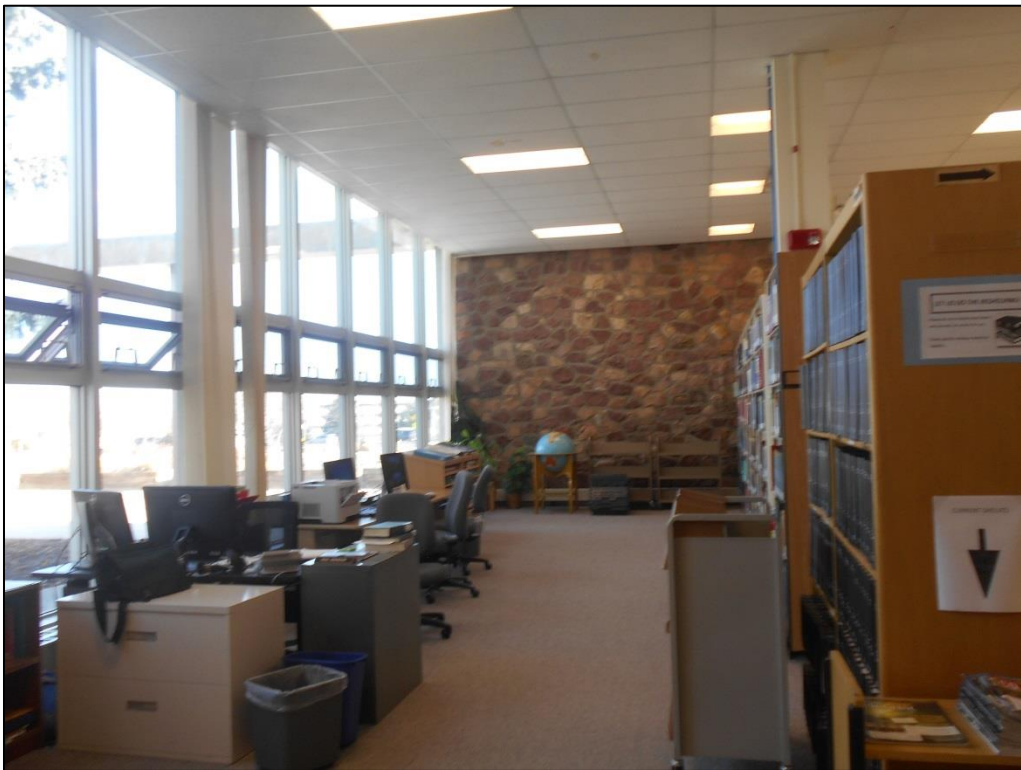
**Photo C-85. Library Stacks (view southeast)**

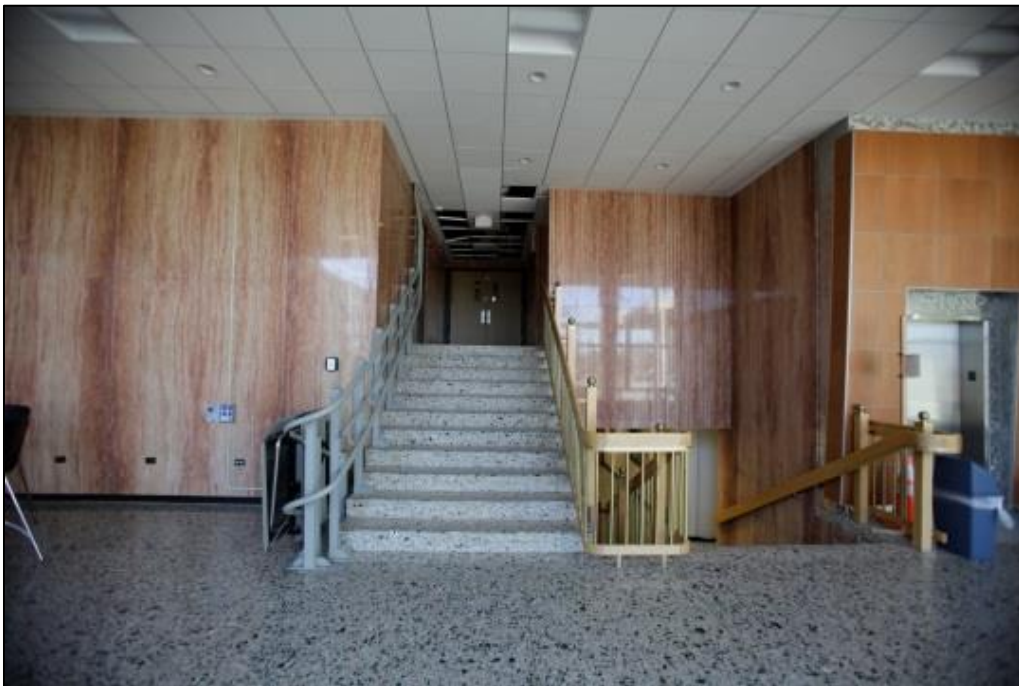
**Photo C-98. Lobby Stairs to Levels 1 and 2 of the Spine (view southwest); the handrails were originally 1.5-inch steel pipe**

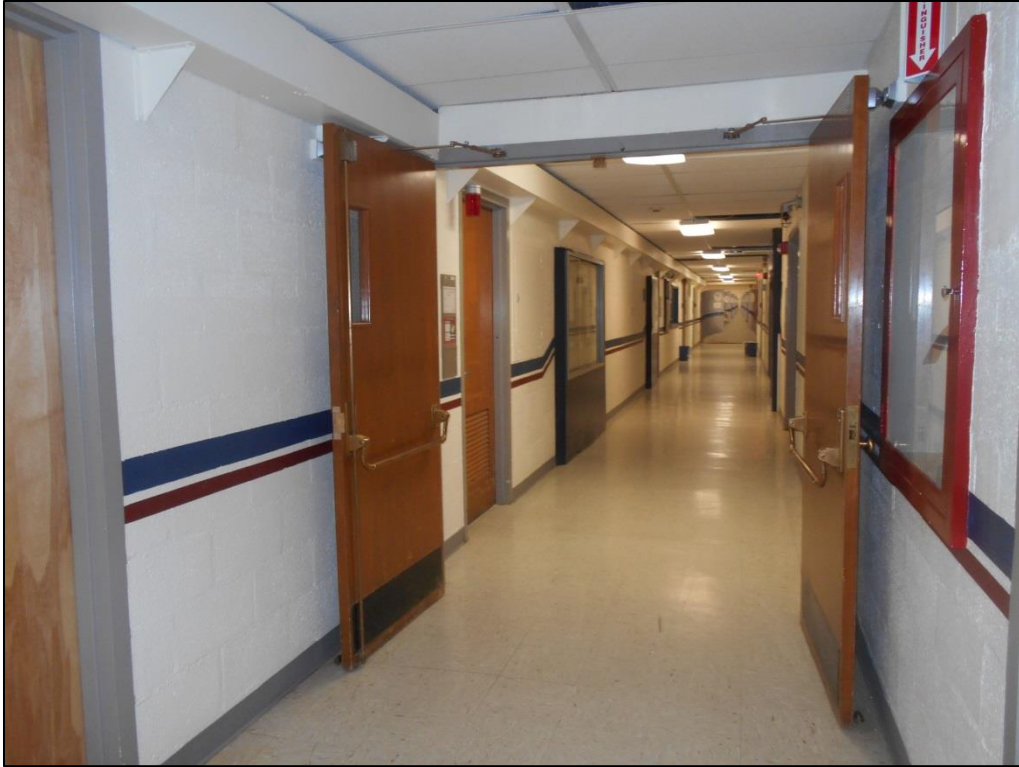
**Photo C-127. Double Loaded Corridor in Level 2 of the Spine, South of the Intersection of Wings 1 and 2 (view southwest)**

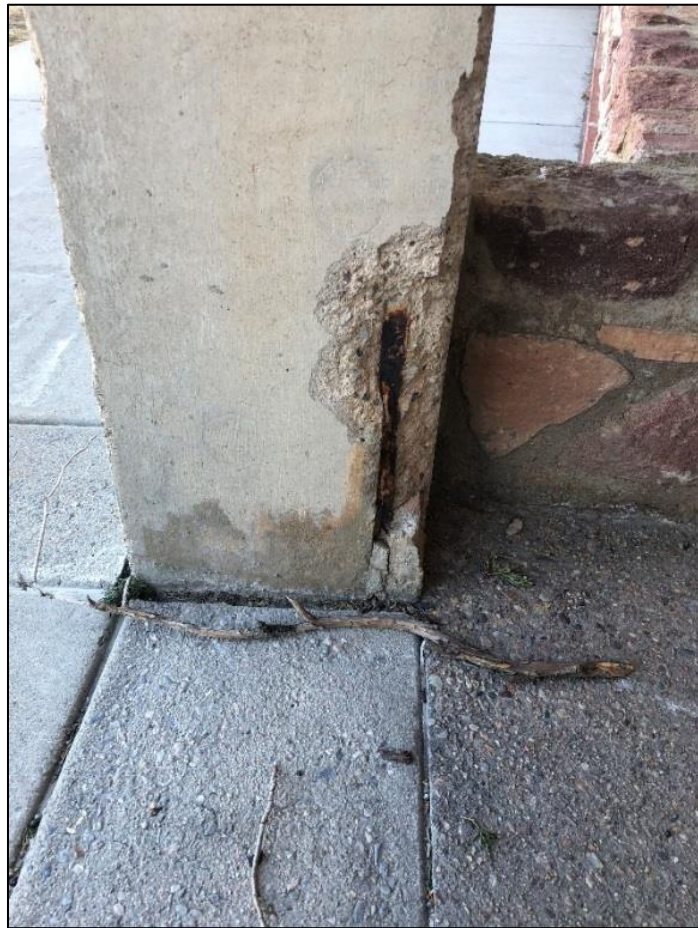
**Photo C-154. Spalls at Steel Embed**
