HISTORIC STRUCTURE REPORT

NATIONAL BUREAU OF STANDARDS RADIO BUILDING (BUILDING 1)

U.S. Department of Commerce Boulder Laboratories
Boulder, Colorado

July 2018

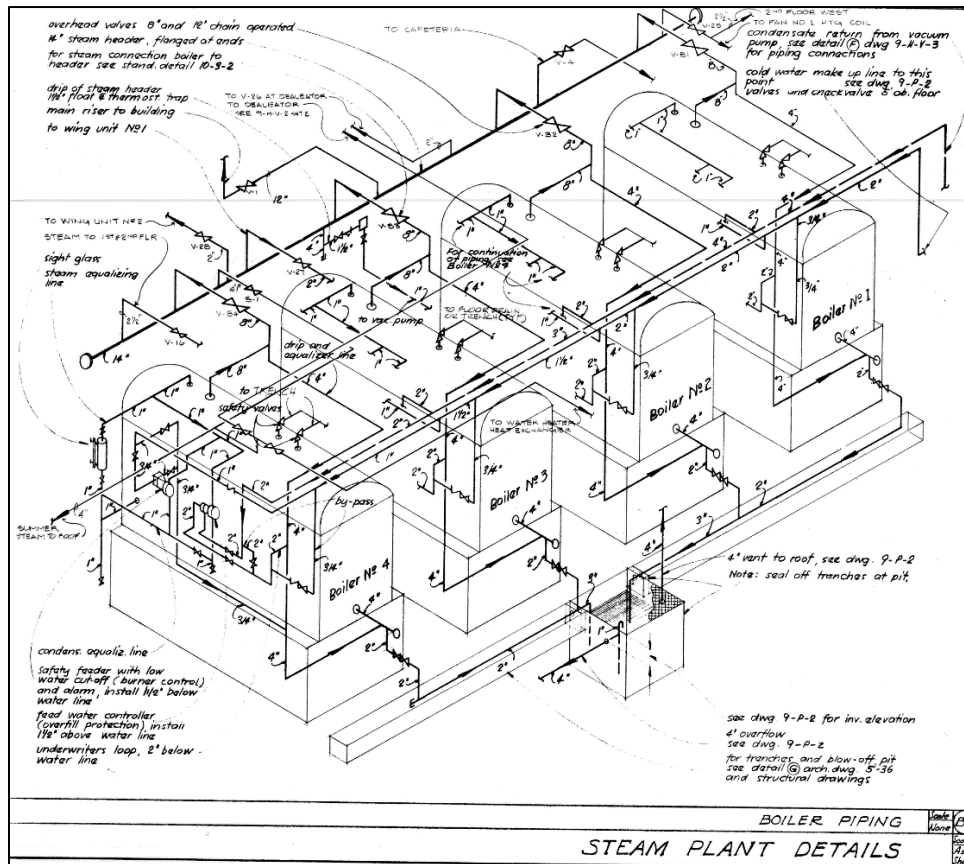
Figure 3-1. Building 1 Steam Plant Design (Pereira & Luckman, Stanton, and Ditzen 1952)

Original drawings by Pereira & Luckman and J.E. Stanton indicate an original steam boiler plant in Level 1 of the Spine between Wings 1 and 2. The steam plant housed as many as four dual-fuel steam boilers that fired off natural gas or diesel fuel oil (**Figure 3-1**). Three boilers were part of the original installation, supporting Wings 1 through 4, with space allocated for a fourth boiler to support Wings 5 and 6. They provided steam to the various terminal heating equipment, air handling unit heating coils, and hot water generators.

Piping distribution throughout for steam and condensate return is steel piping, originally insulated with asbestos-containing materials. Much of the renovated piping has been remediated, but many areas in Wings 1, 2, 4 and 5 still contain asbestos-covered piping directly above occupied spaces. Undisturbed or coated, the piping has been systematically abated and removed with each renovation project.

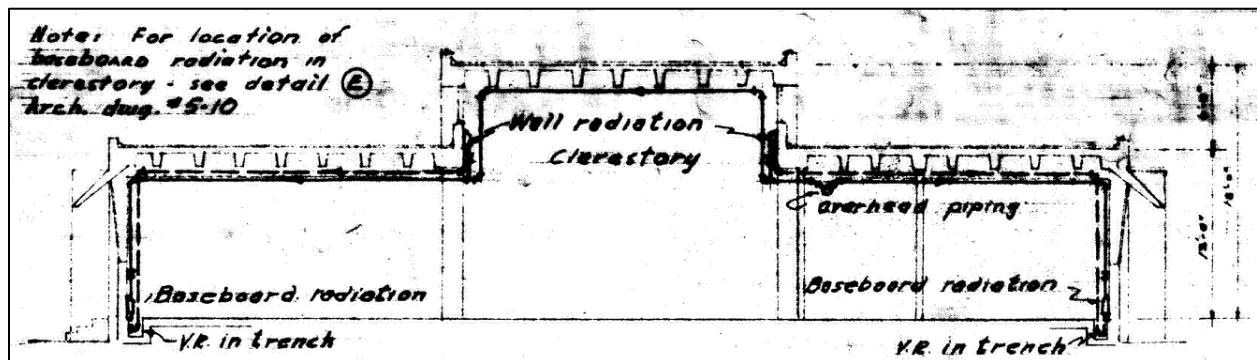
Figure 3-2. Building 1 Perimeter Heating Design (Pereira & Luckman, Stanton, and Ditzen 1952)

There was no design for a central building cooling system because the facility was only equipped to provide heating throughout the majority of spaces (**Figure 3-2**). Laboratories, offices, and drafting rooms all had perimeter steam radiation units and relied on operable windows both for ventilation and cooling (when practical). Baseboard radiation units were installed at floors and wall-mounted radiation equipment at the clerestory windows. Distinctive trenches at the perimeter walls were created to allow for the routing of steam condensate (vacuum) return lines back to the central boiler room. Even the auditorium, library, and other densely occupied areas which were equipped with air handling units were only provided with heating and ventilation. The lack of a central building cooling system is typical of 1950's design.
